A Survey of Steel Moment-Resisting Frame Buildings Affected by the 1994 Northridge Earthquake

Nabih F. G. Youssef
David Bonowitz

Nabih Youssef & Associates
Los Angeles, California 90017

John L. Gross

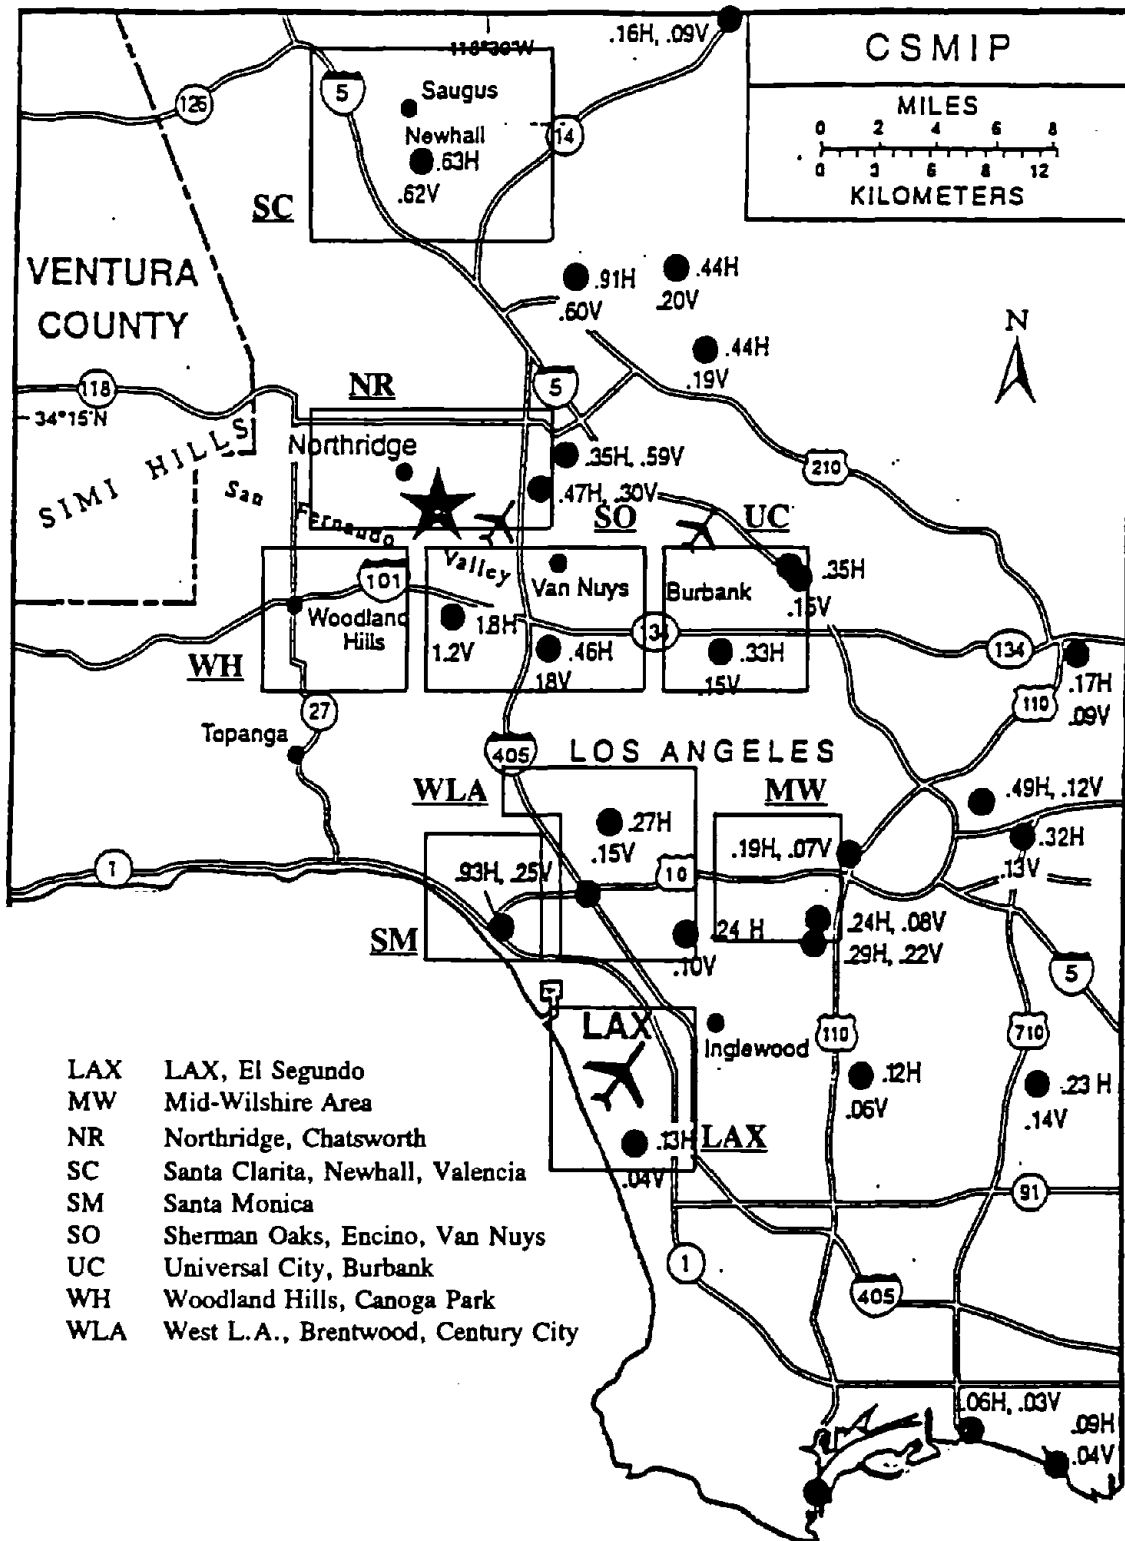
Figure 3-1. Location of Surveyed Buildings and Recorded Ground Accelerations
 Source: CSMIP

Each building is located in one of nine geographic zones, as listed in Table 3-1 and shown in Figure 3-1. The zones suggest themselves according to patterns of development and the clustered nature of the 51 buildings. Table 3-2 summarizes the data of Table 3-1 for each

Figure 3-1 also shows recorded peak accelerations, as published by CSMIP [CSMIP]. The nearest recorded horizontal acceleration is less than 0.33g for only two zones, MW and LAX, which are represented in the survey by one building each. However, four buildings in the eastern portion of zone WLA are nearer to the station recording 0.27g peak horizontal acceleration than to the Santa Monica station recording 0.93g. Downtown Los Angeles, near recorded peak horizontal accelerations of 0.32g and 0.49g, currently has no buildings in the survey.

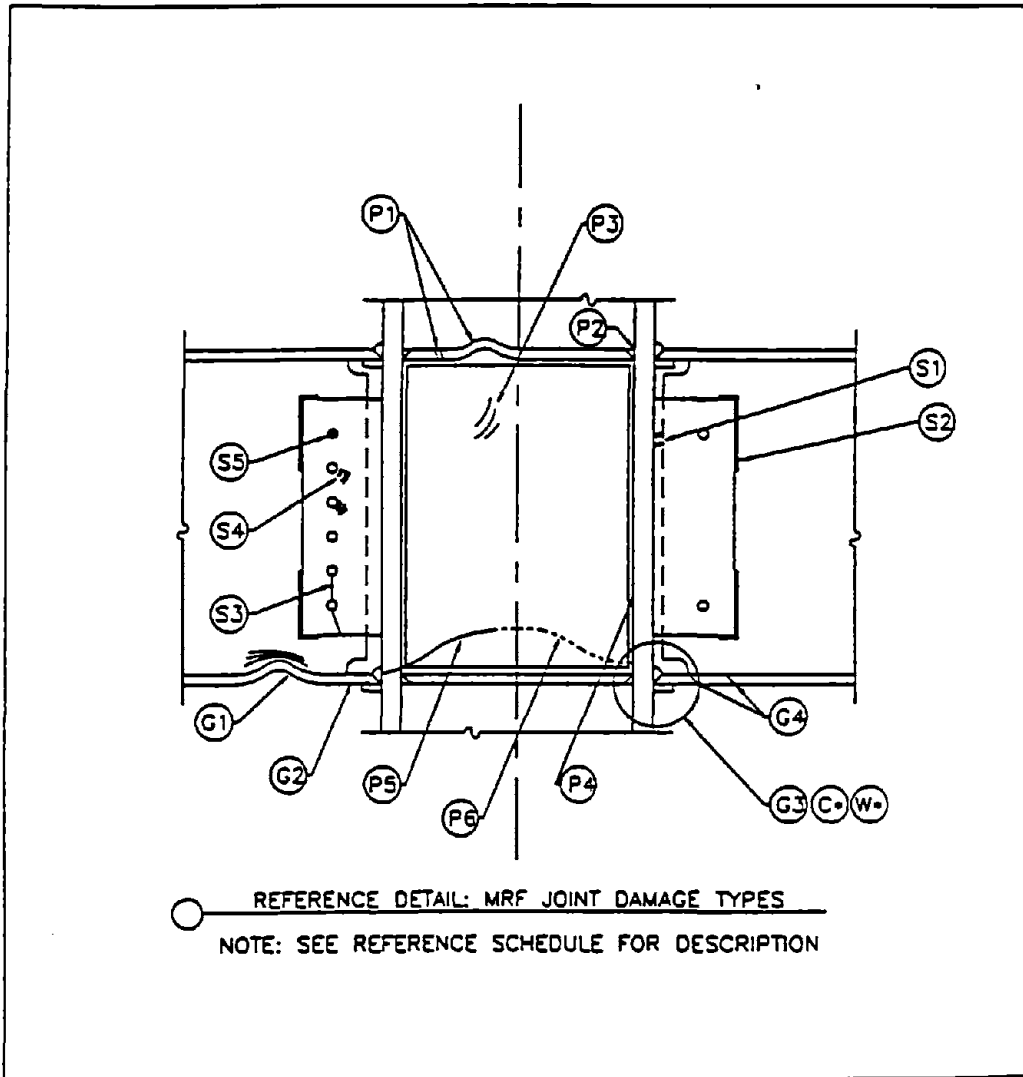
**Figure 4-2. Survey Form Damage Types
(See Appendix B)**

REFERENCE DETAIL (See Reference Schedule above for damage type descriptions.)

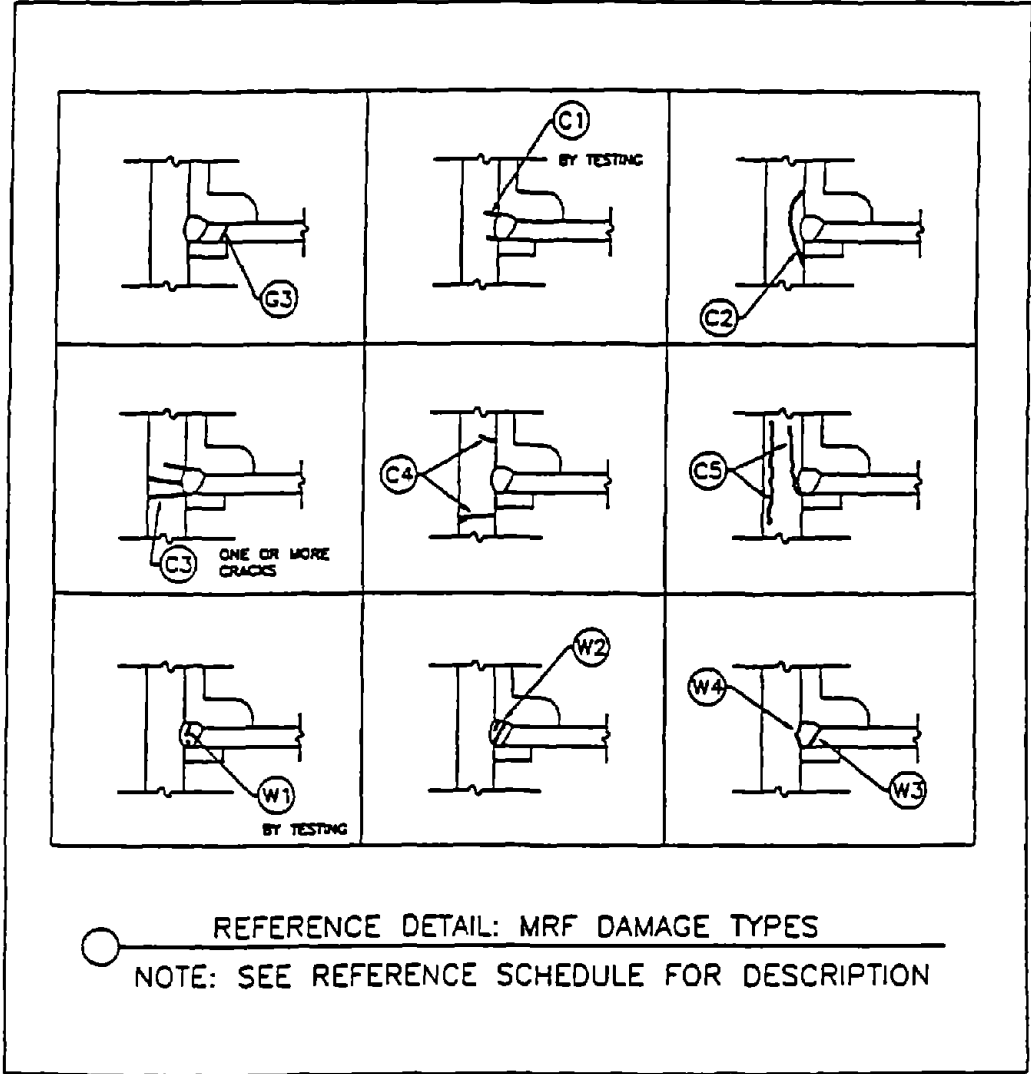
**Figure 4-3. Survey Form Damage Types
(See Appendix B)**

REFERENCE DETAIL (See Reference Schedule above for damage type descriptions.)

The most commonly observed damage was in bottom flange welds (class BW), and a large portion of these conditions are small or incipient root cracks detected by UT (type W1). No descriptions or definitions beyond those in Figure 4-3 were provided to the survey engineers. Instead, many survey engineers relied on definitions provided by their testing lab, examples of which are given in Appendix C. Although procedures and acceptance criteria became more detailed and standardized as more buildings were inspected, UT results for many buildings were submitted without complete descriptions of the testing scope and findings.

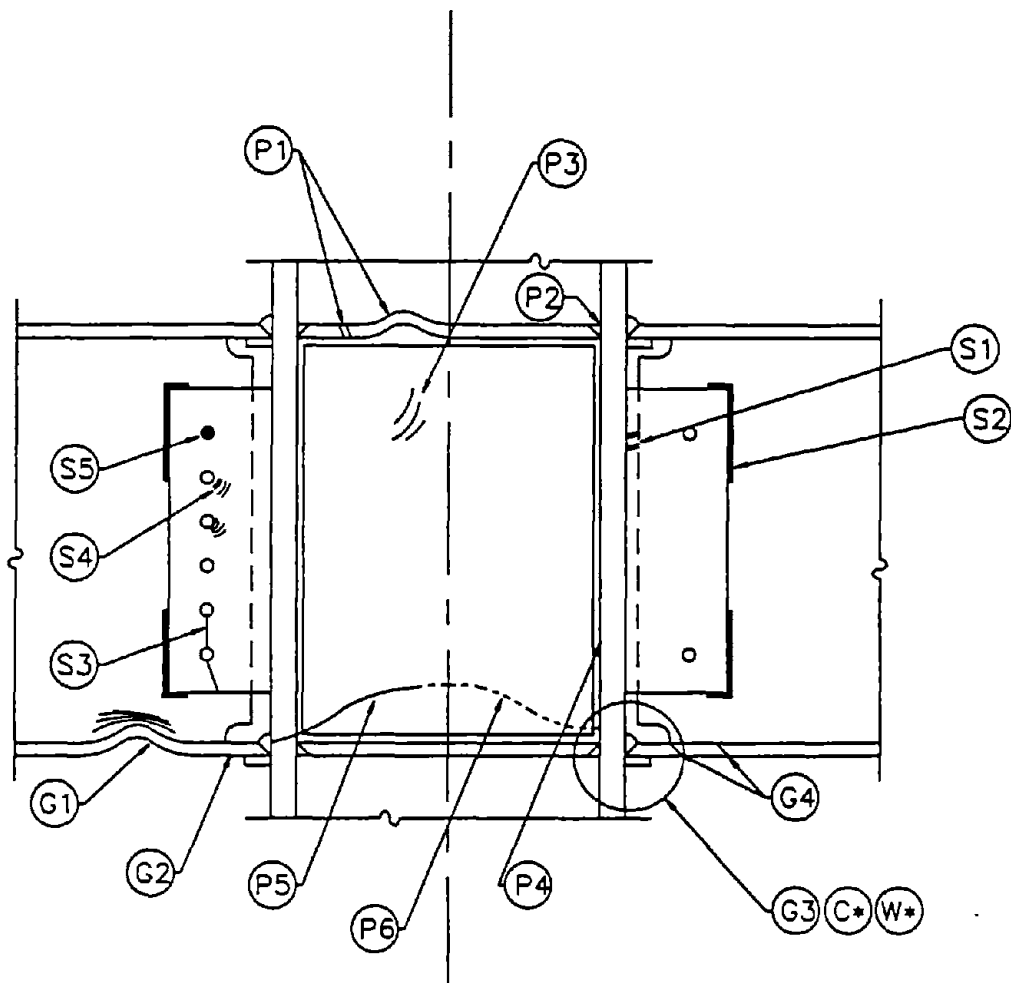
○ REFERENCE DETAIL: MRF JOINT DAMAGE TYPES

REFERENCE DETAIL (See Reference Schedule above for damage type descriptions.)

NOTE: SEE REFERENCE SCHEDULE FOR DESCRIPTION

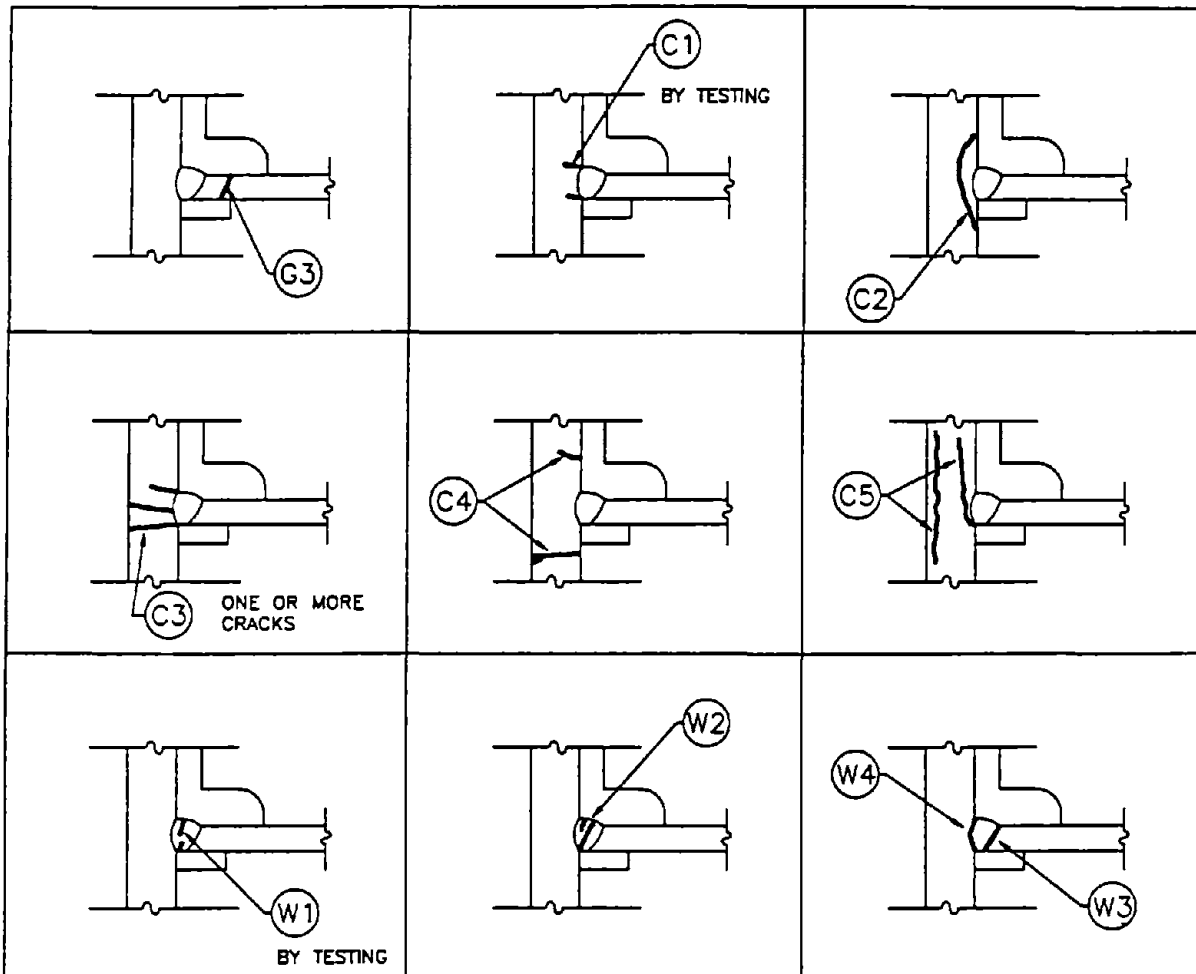
○ REFERENCE DETAIL: MRF DAMAGE TYPES
NOTE: SEE REFERENCE SCHEDULE FOR DESCRIPTION

REFERENCE DETAIL (See Reference Schedule above for damage type descriptions.)

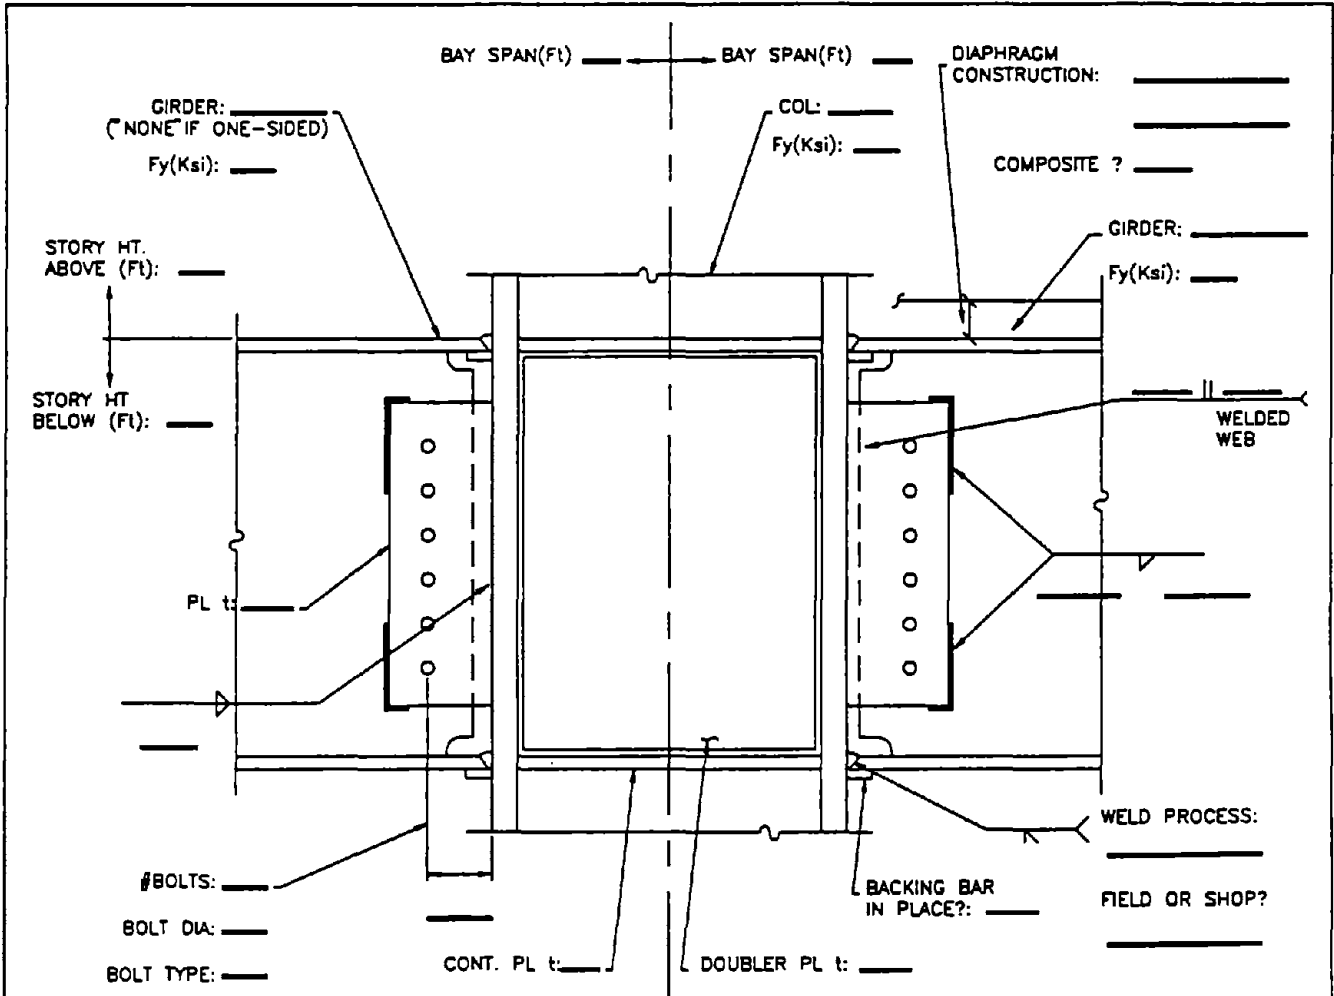
○ JOINT DAMAGE TEMPLATE DETAIL - STRONG AXIS COL. ELEV.

Instructions to Survey Engineer: Complete details shown for one or two specific conditions per building. Show damage and identify by type according to Reference Schedule above.

- NOTES: 1. U.N.O., AS-BUILT DIMENSIONS AND SIZES SHOWN ON ONE SIDE TOP OR BOTTOM ARE TYP. , TO BOTH SIDES, TOP AND BOTTOM.
2. SEE PLAN DETAILS FOR ADDITIONAL INFORMATION.
3. REFER TO DAMAGE TYPE DETAIL/SCHEDULE FOR EXPLANATION OF DAMAGE FLAGS.

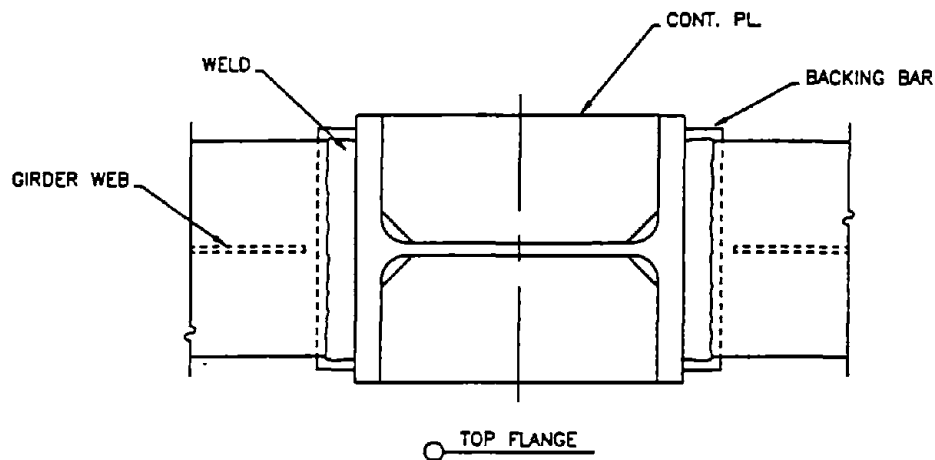
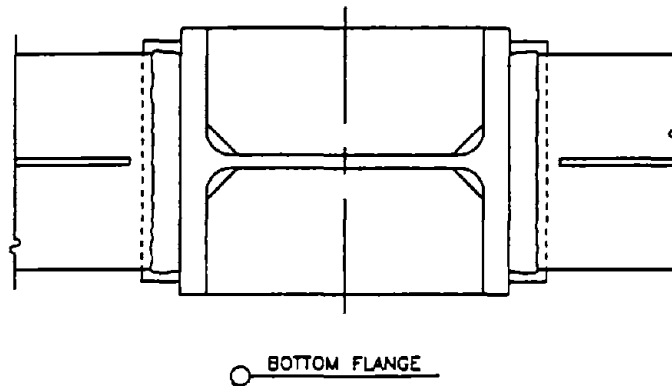
○ ———— JOINT DAMAGE TEMPLATE DETAIL — STRONG AXIS PLAN ————

Instructions to Survey Engineer: Complete details shown for one or two specific conditions per building. Show damage and identify by type according to Reference Schedule above.

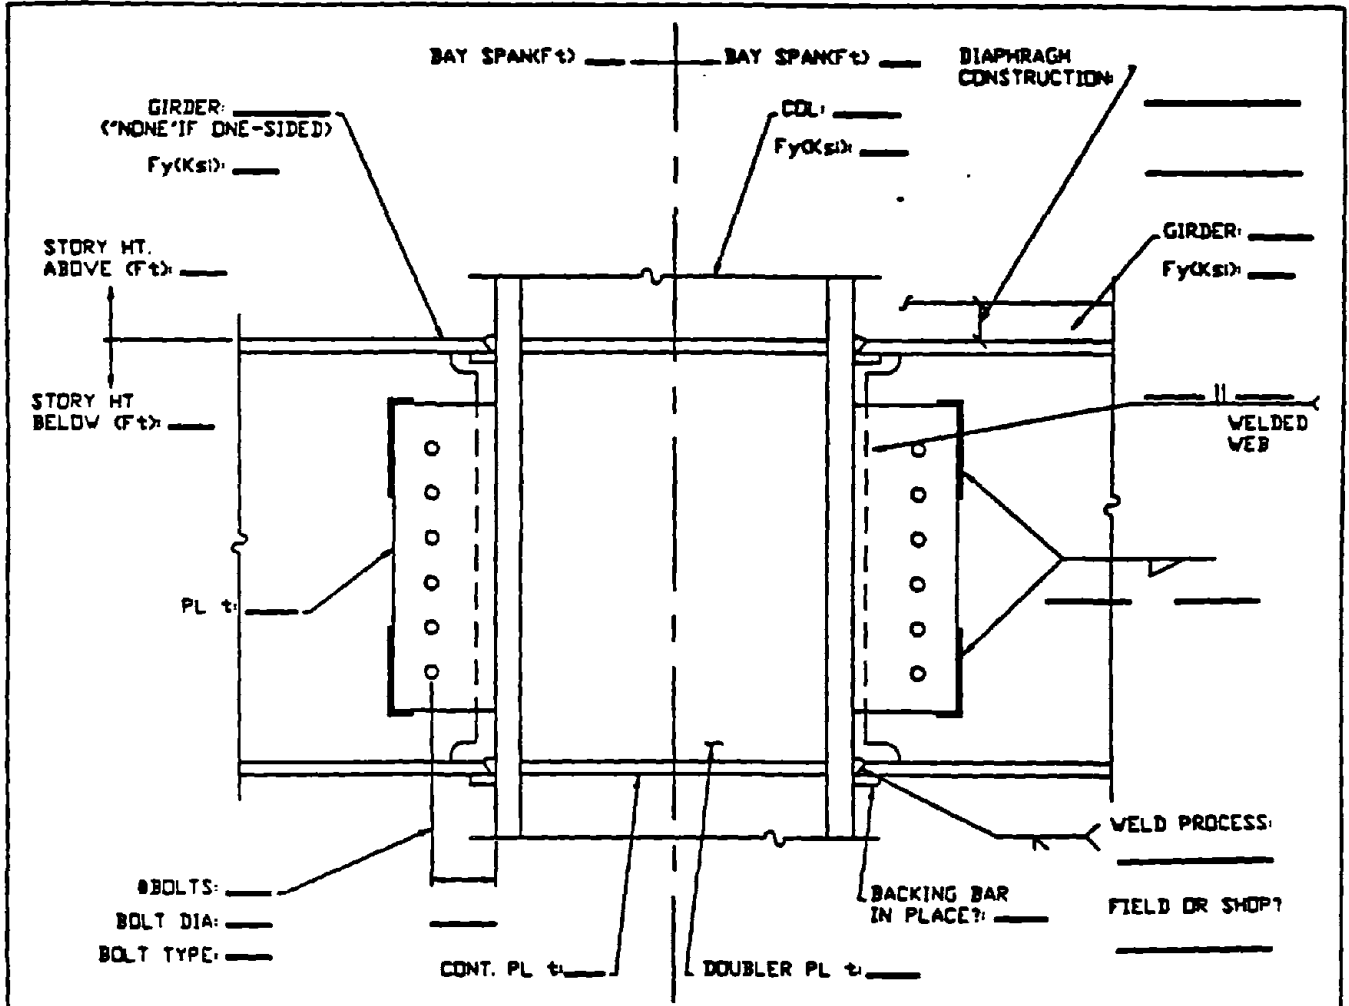
○ JOINT DAMAGE TEMPLATE DETAIL - STRONG AXIS COL. ELEV.

1. COMPLETE DETAIL FOR SPECIFIC (NOT GENERIC) JOINT BY FILLING IN ALL BLANKS.
2. SKETCH DAMAGE OBSERVED AT SPECIFIC (NOT GENERIC) JOINT ON DETAIL AND ADD FLAGS, E.G. (C) TO INDICATE DAMAGE TYPE CL TO REFERENCE SEPARATE DAMAGE TYPE SCHEDULE.
3. COMPLETE INFORMATION BELOW.

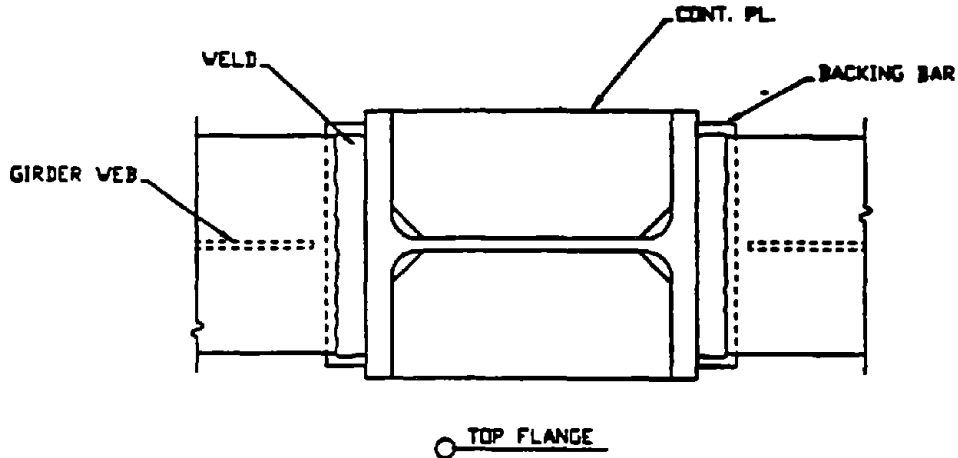
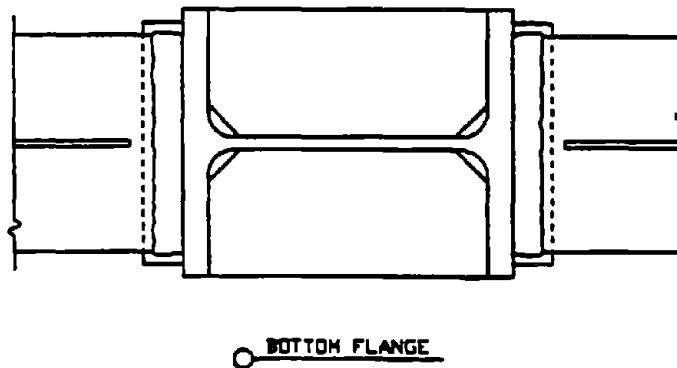
○ JOINT DAMAGE TEMPLATE DETAIL - STRONG AXIS PLAN

1. COMPLETE DETAIL FOR SPECIFIC (NOT GENERIC) JOINT BY FILLING IN ALL BLANKS.
2. SKETCH DAMAGE OBSERVED AT SPECIFIC (NOT GENERIC) JOINT ON DETAIL AND ADD FLAGS. E.G. ⊕ TO INDICATE DAMAGE TYPE CL TO REFERENCE SEPARATE DAMAGE TYPE SCHEDULE.
3. COMPLETE INFORMATION BELOW.

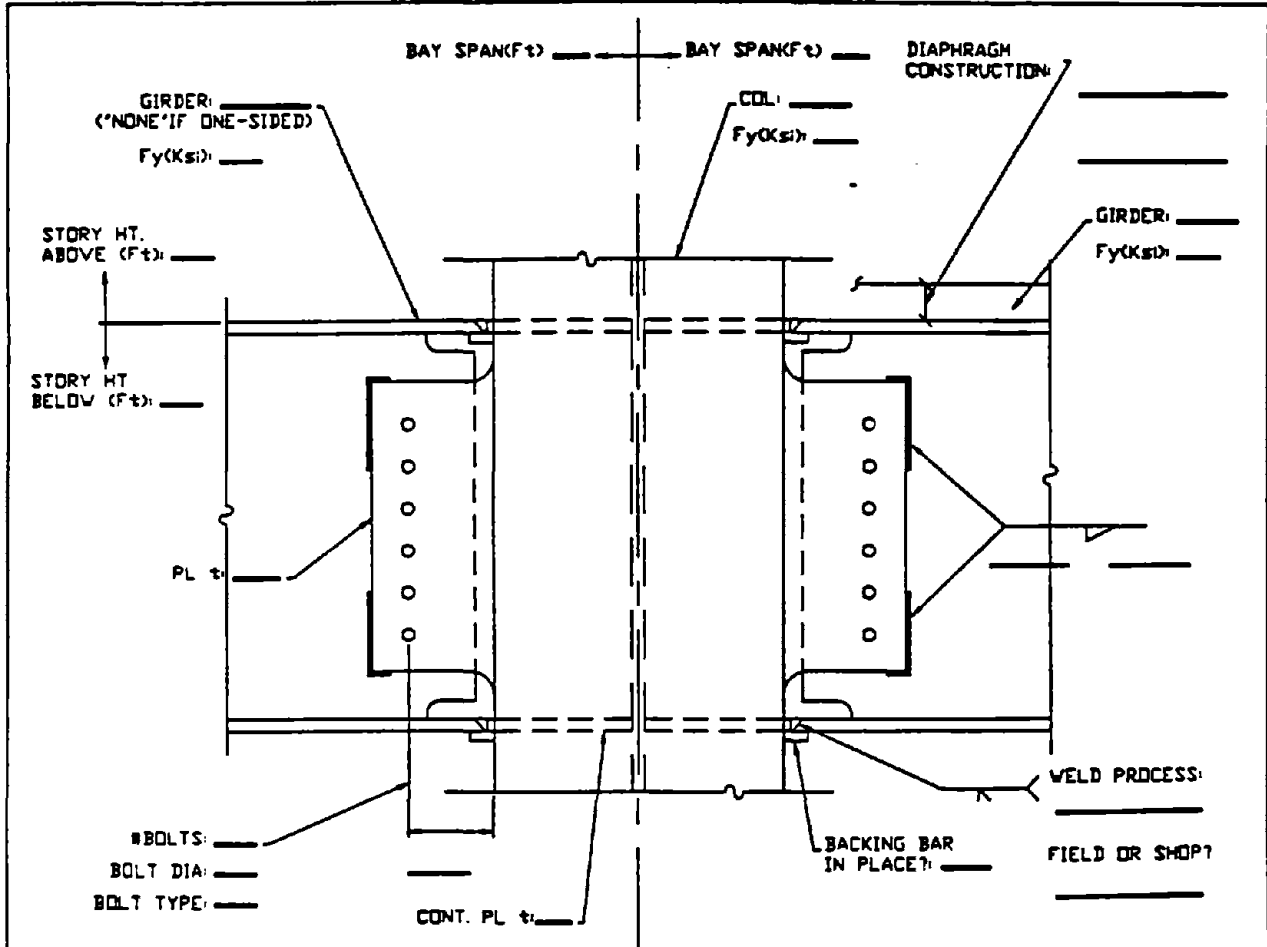
JOINT DAMAGE TEMPLATE DETAIL - WEAK AXIS COL. ELEV.:

1. COMPLETE DETAIL FOR SPECIFIC (NOT GENERIC) JOINT BY FILLING IN ALL BLANKS.
2. SKETCH DAMAGE OBSERVED AT SPECIFIC (NOT GENERIC) JOINT ON DETAIL, AND ADD FLAGS, E.G. (C) TO INDICATE DAMAGE TYPE CL TO REFERENCE SEPARATE DAMAGE TYPE SCHEDULE.
3. COMPLETE INFORMATION BELOW.

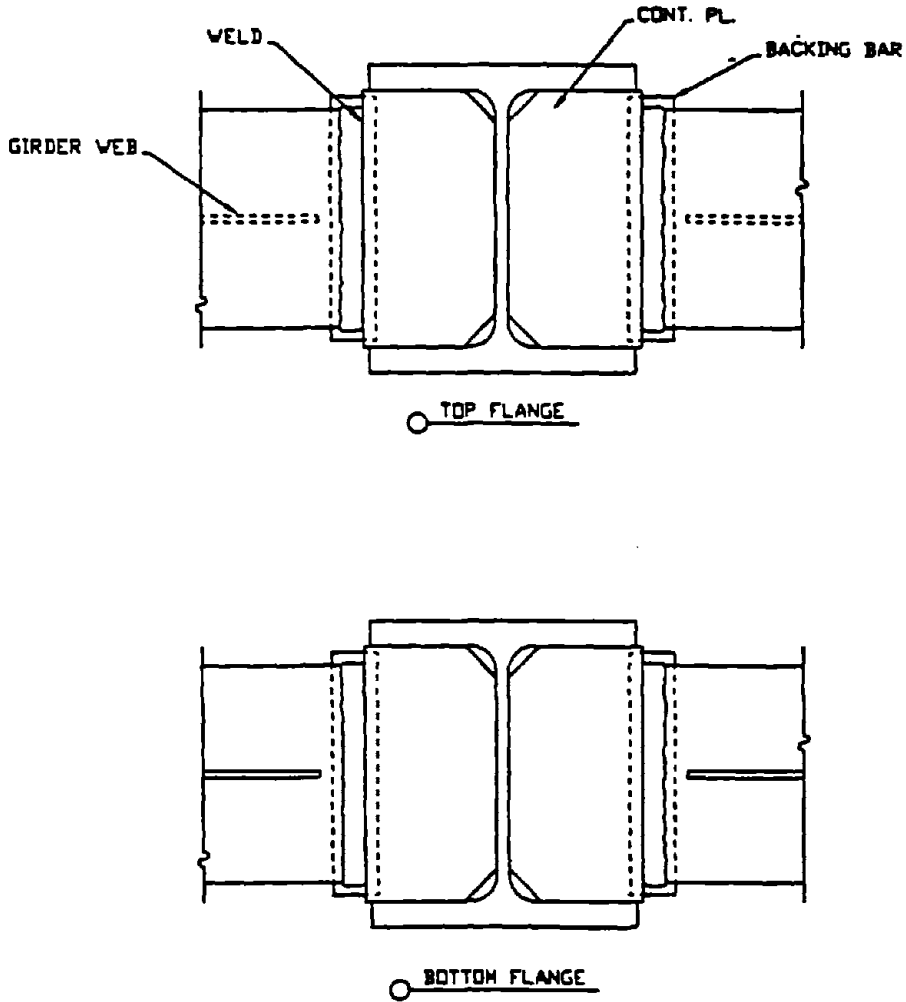
○ JOINT DAMAGE TEMPLATE DETAIL - WEAK AXIS PLAN

1. COMPLETE DETAIL FOR SPECIFIC (NOT GENERIC) JOINT BY FILLING IN ALL BLANKS.
2. SKETCH DAMAGE OBSERVED AT SPECIFIC (NOT GENERIC) JOINT ON DETAIL, AND ADD FLAGS, E.G. (C) TO INDICATE DAMAGE TYPE CL TO REFERENCE SEPARATE DAMAGE TYPE SCHEDULE.
3. COMPLETE INFORMATION BELOW.

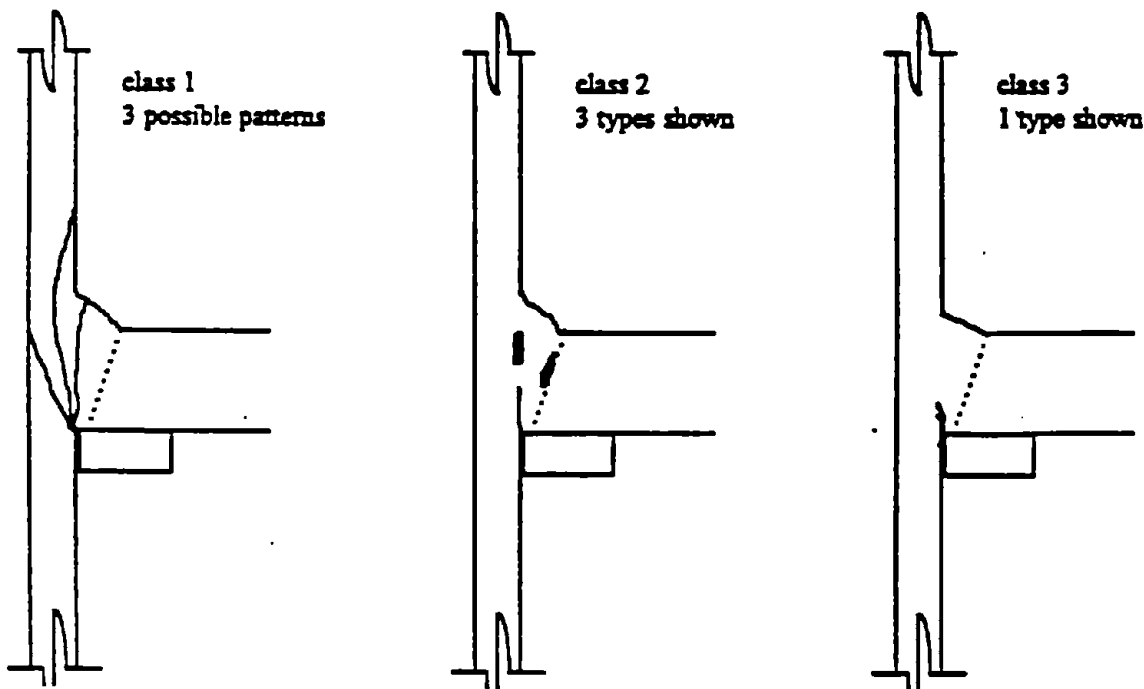
- CLASS 1** Severe crack in flange or crack propagating into the column. Exhibiting Planar Flaw Characteristics* or reject levels associated with defects believed to be stress induced.
- CLASS 2** Reject level indications possibly from the original construction. May be a prior "Acceptable Level" discontinuity which has been developed by stress. Location is a good indicator, i.e. bevel or mid-weld discontinuity is probably original. Root or cap area discontinuities may be opened up to a reject level by building motion.
- CLASS 3** Welds containing discontinuity signals at an acceptable level. Normally disregarded. But due to signal type pattern may be small root tears which would be beneficial to investigate and remove.

***CAUTION: FLAW CHARACTERISTICS ARE SUCH THAT AN AWS TABLE 8.3 REJECT CLASSIFICATIONS AMPLITUDE MAY NOT BE ACHIEVED. EVALUATION OF SIGNAL TYPE IS OF UTMOST IMPORTANCE. See Notes 5 on Table 8.2.**
