# Reliability and Restoration of Water Supply Systems for Fire Suppression and Drinking Following Earthquakes

Donald B. Ballantyne, P.E.  
EQE International

C.B. Crouse, Ph.D., P.E.  
Dames & Moore

November 1997

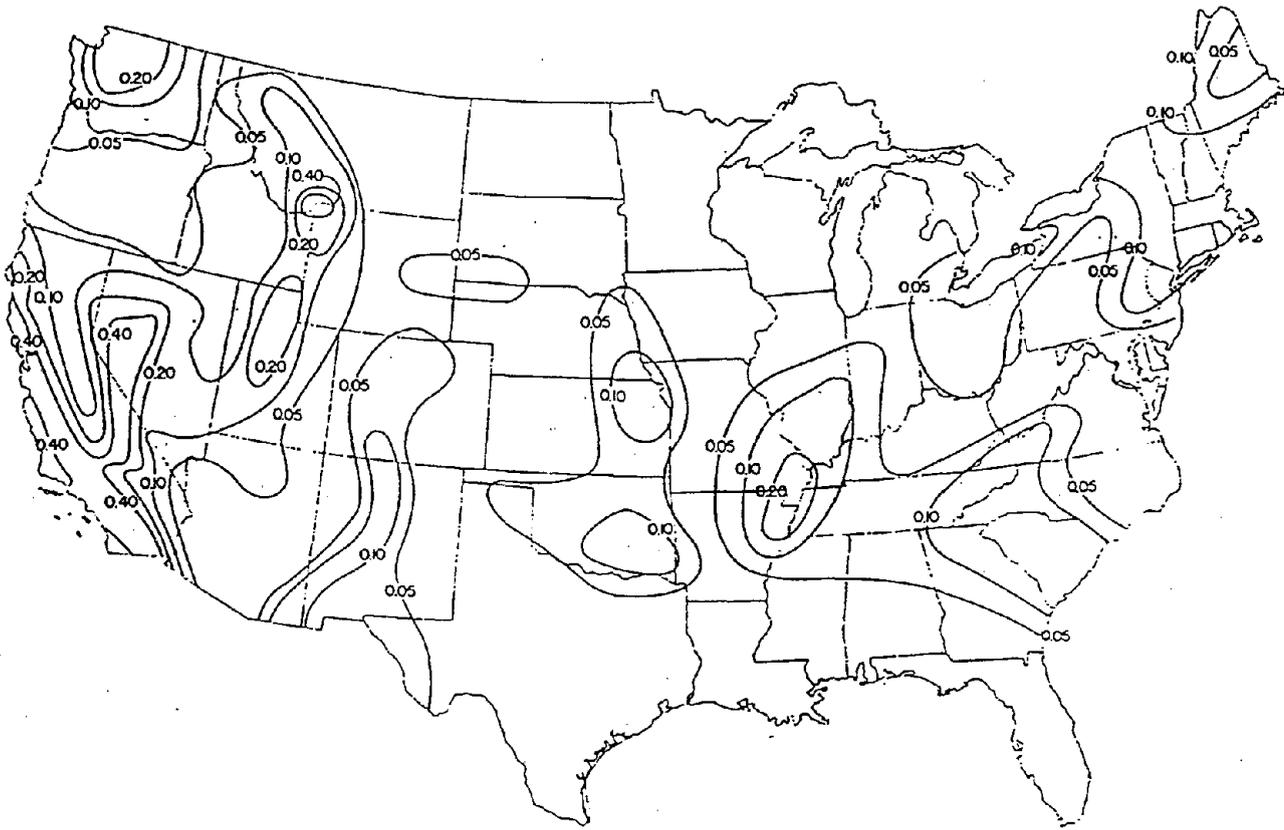
**Figure 5-1**  
**NEHRP Ground Acceleration Map**  
(Adopted from Building Seismic Safety Council, 1994)

Note that the numbers on the contours are values of EPA in units of acceleration gravity. They were used to prepare Map 1 in Chapter 1 of the *Provisions*.

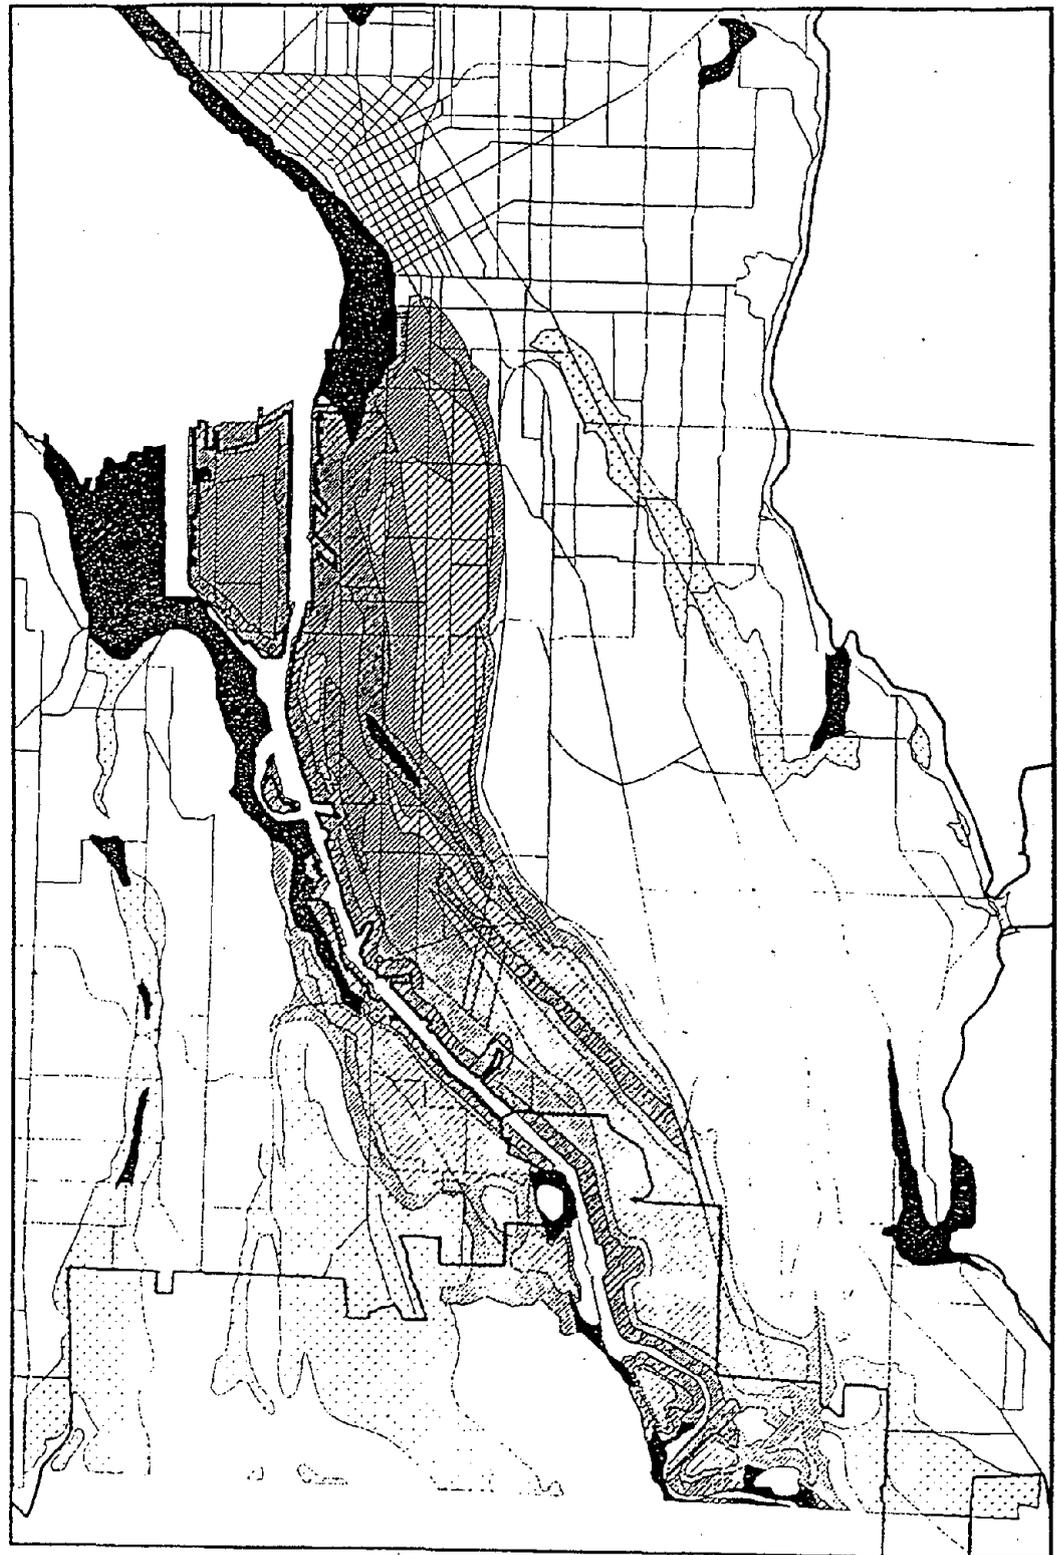
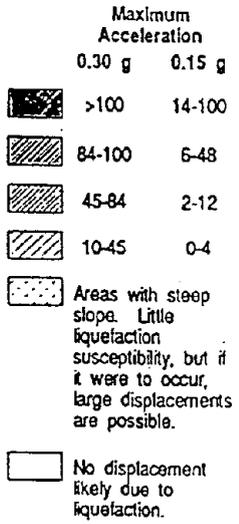
Figure 5-2  
Lateral Spread Displacement for the South Seattle Quadrangle  
(Adopted from Mabey and Youd, 1991)

MAXIMUM LATERAL SPREAD DISPLACEMENT HAZARD FOR SOUTH SEATTLE

DISPLACEMENT  
(IN INCHES)  
FOR A MAGNITUDE  
7.3 EARTHQUAKE

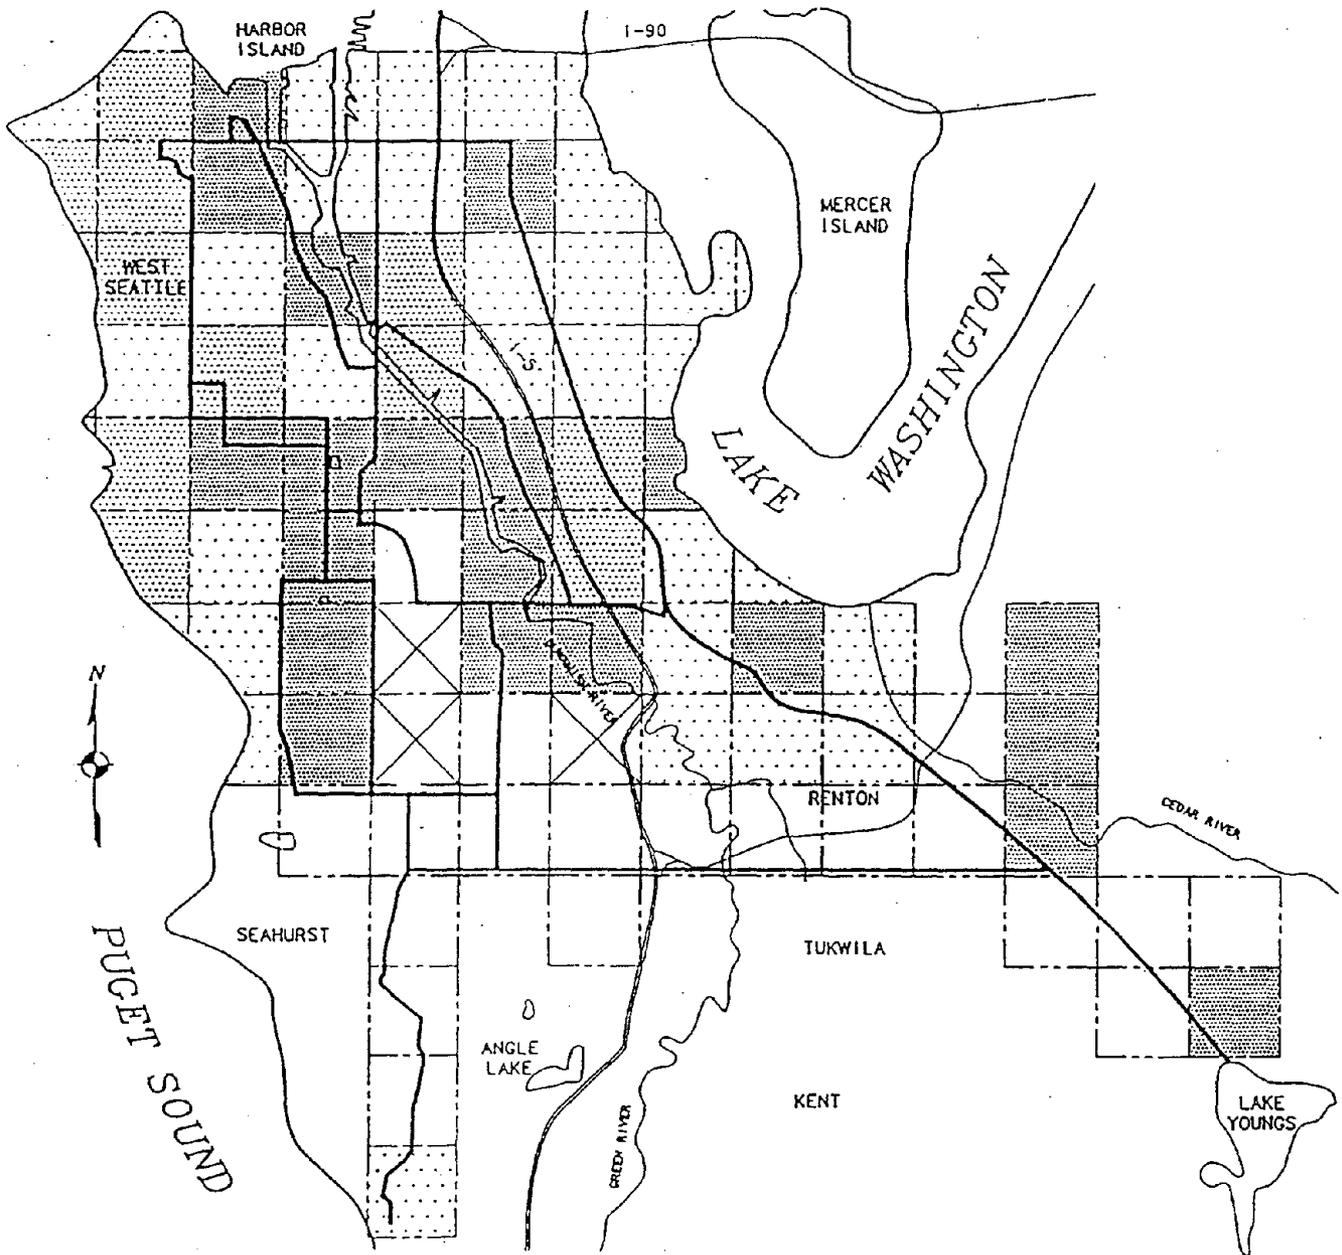
Figure 5-3  
Seattle Water System Pressure Following a Hypothetical Earthquake  
(Adopted from Kennedy/Jenks/Chilton, 1990)

SYSTEM PRESSURE			
	LOW PRESSURE		MICROZONE WITH NO DISTRIBUTION PIPING
	NO WATER		ADEQUATE PRESSURE
			MICROZONE NOT INCLUDED IN MODEL

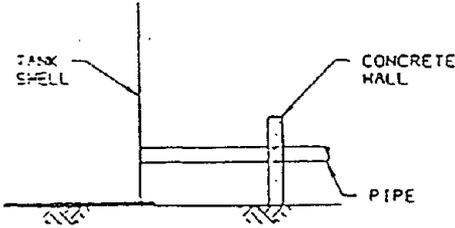
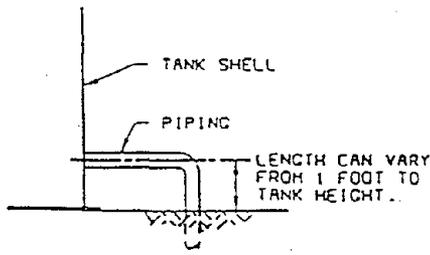
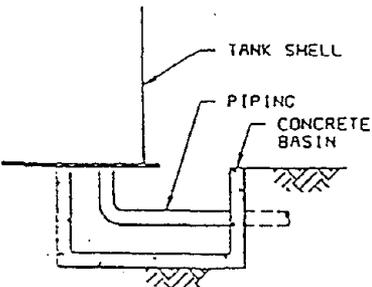
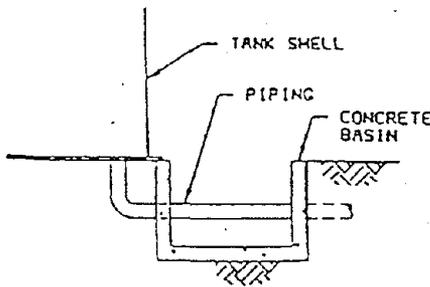
Figure 6-4 Typical Poor Details at Unanchored Tanks and Retrofit Recommendations (Adapted from Dowling and Summers, 1993)

Poor Details	Retrofit Recommendations
<p>(a)</p>

<ul style="list-style-type: none"> <li>• Add flexibility to pipe</li> </ul>
<p>(b)</p>

<ul style="list-style-type: none"> <li>• Add flexibility to pipe</li> </ul>
<p>(c)</p>

<ul style="list-style-type: none"> <li>• Add flexibility to pipe</li> </ul>
<p>(c')</p>

<ul style="list-style-type: none"> <li>• Reroute piping to center of tank or extend concrete basin beyond pipe/tank connection</li> </ul>

The most frequently encountered hazardous details are listed below, together with appropriate retrofit recommendations, and illustrated in Figure 6-4.

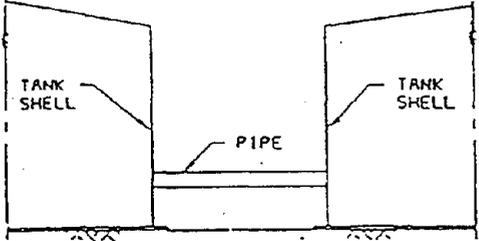
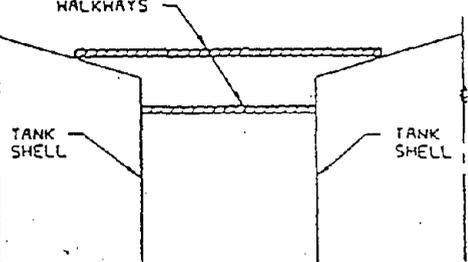
Figure 6-4(Cont.) Typical Poor Details at Unanchored Tanks and Retrofit Recommendations (Adapted from Dowling and Summers, 1993)

Poor Details	Retrofit Recommendations
<p>(e)</p>

<ul style="list-style-type: none"> <li>• Increase flexibility by providing horizontal or vertical bends</li> </ul>
<p>(f)</p>

<ul style="list-style-type: none"> <li>• Anchor pipe at shell roof connection</li> </ul>
<p>(g)</p>

<ul style="list-style-type: none"> <li>• Increase walkway flexibility to accommodate relative displacements</li> </ul>
<p>(h)</p>

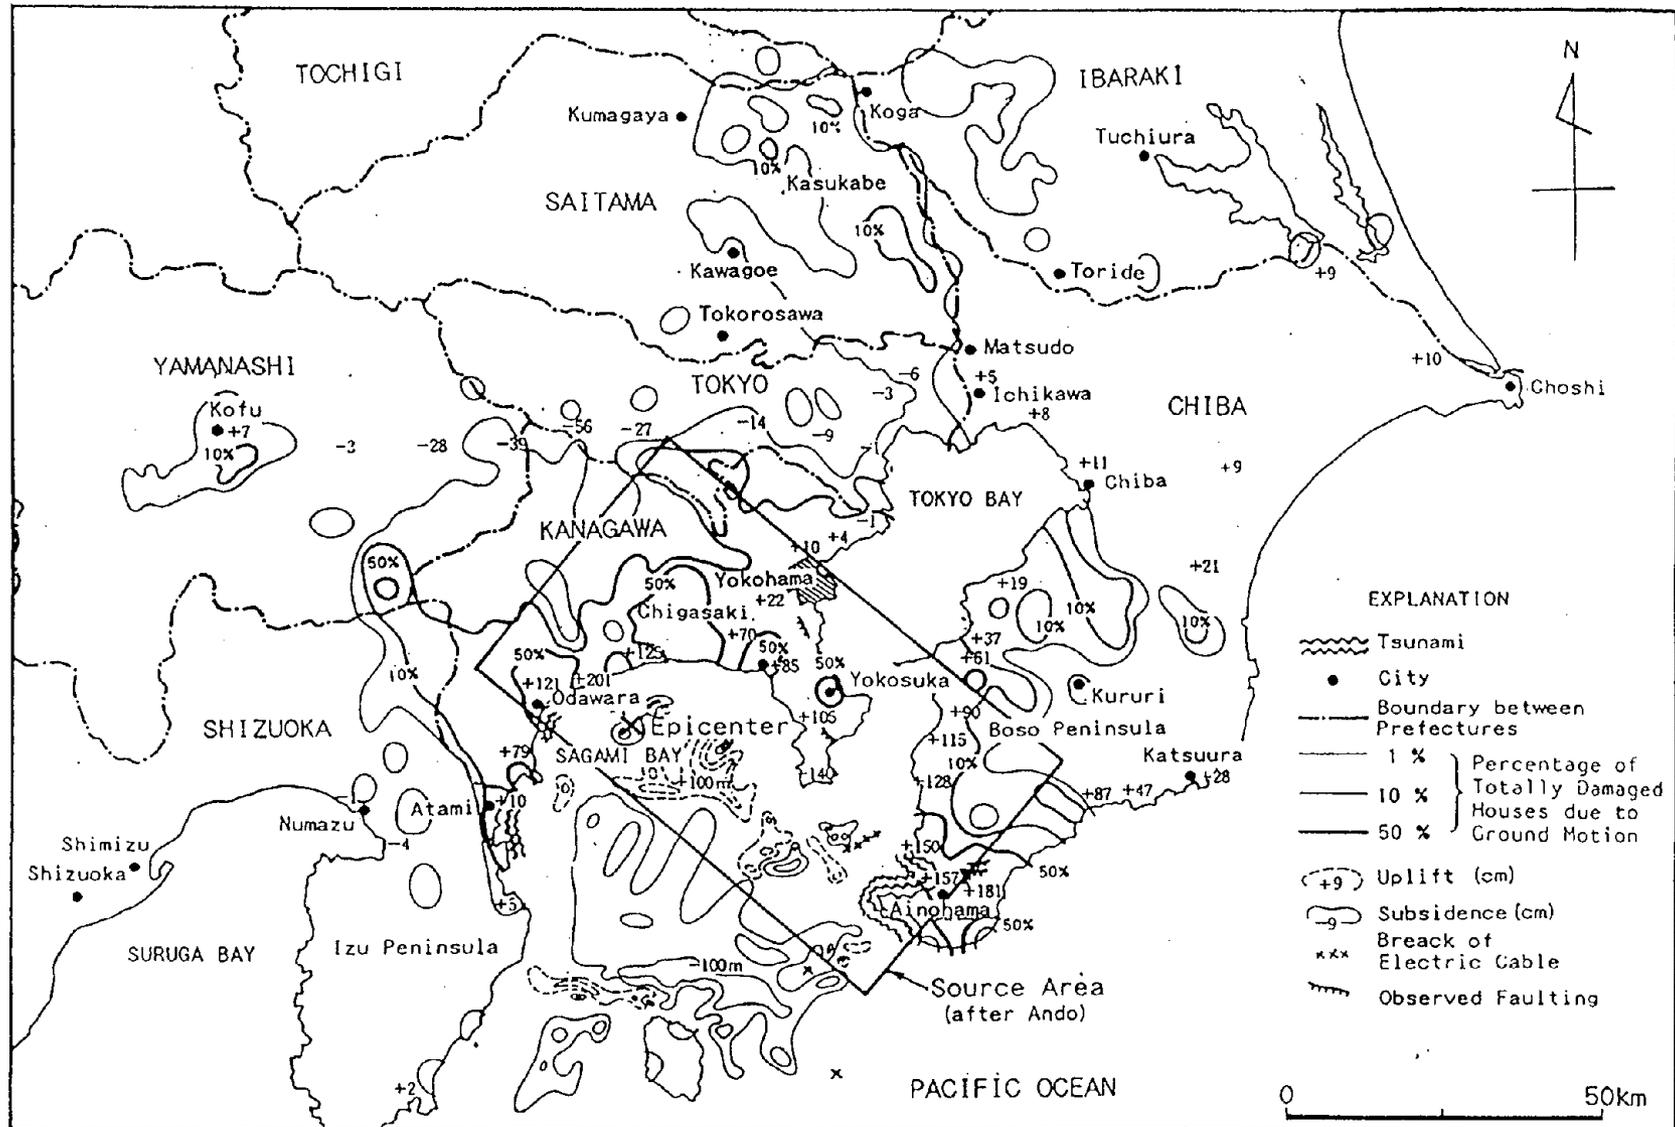
Figure A-7.1 - Map of Kanto and Chubu Districts Showing Distribution of Seismic Damage Caused by the 1923 Kanto Earthquake (from Hamada et al, 1992, as modified by Usami, 1987).

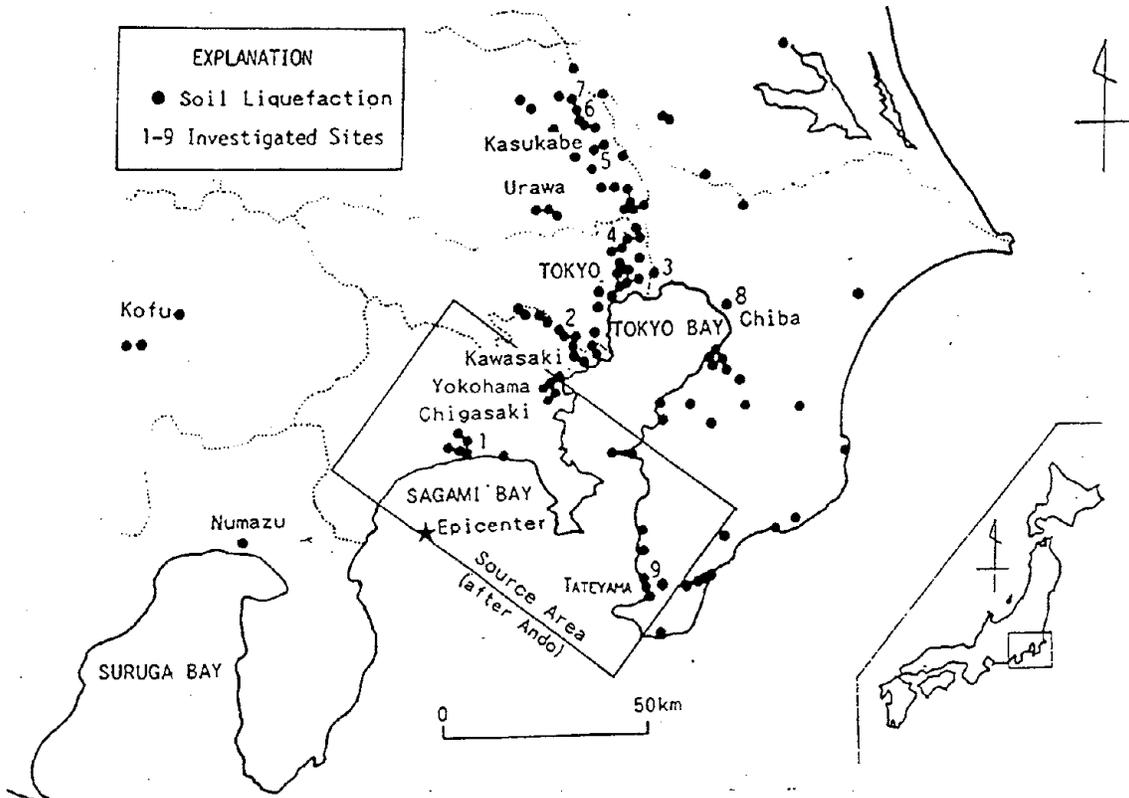
Figure A-7.2 - Map of Kanto and Chubu Districts Showing Principal Areas Affected by Liquefaction during the 1923 Kanto Earthquake (from Hamada et al 1992).

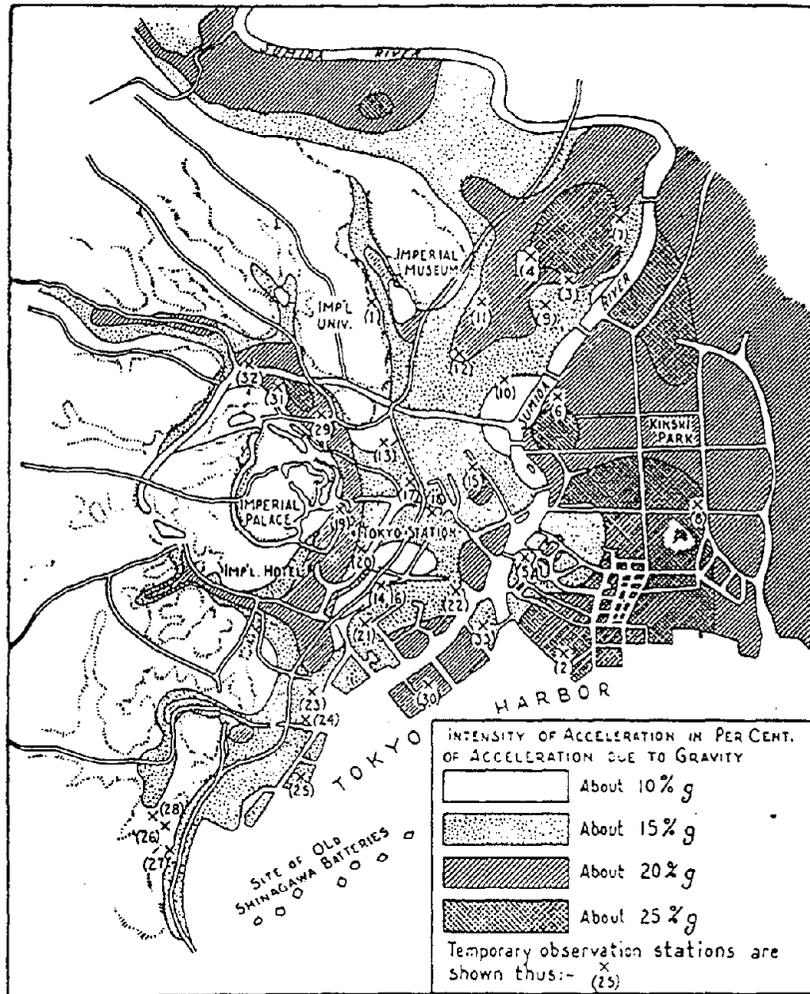
Figure A-7.3 - Distribution of Earthquake Intensity in Tokyo, September 1, 1923 (from Freeman 1932).

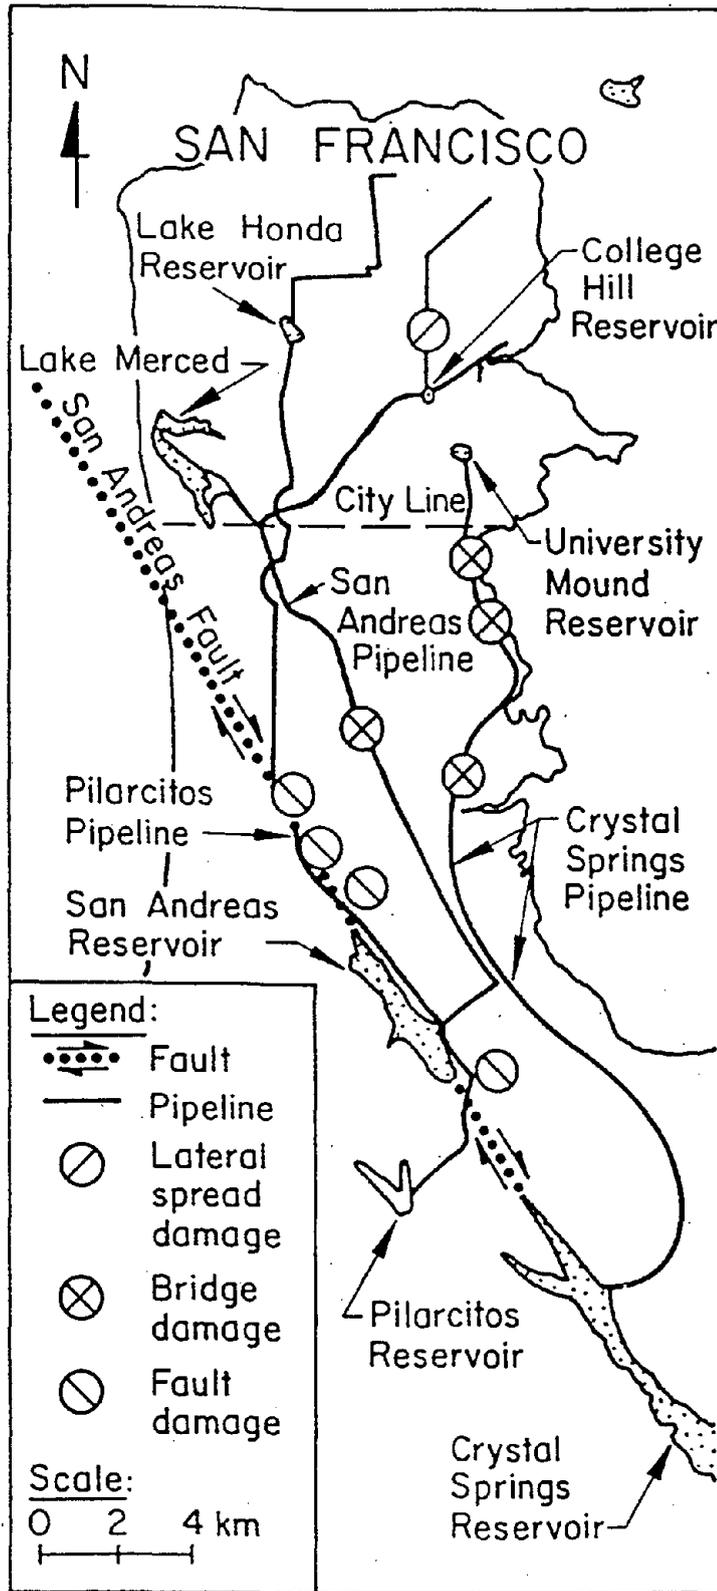
FIGURE A-8.1 Approximate Locations of Transmission Pipeline Damage, 1906 San Francisco Earthquake

Superimposed on Figure A-8.1 are the approximate locations of transmission pipeline damage caused by the earthquake. Flow from all transmission pipelines stopped shortly after the earthquake. Because telephone service was out, emergency control information had to be obtained by dispatching personnel into the field where maintenance crews reported on the damage.

Right lateral strike-slip movement along the San Andreas fault ruptured a 750 mm diameter wrought iron pipeline conveying water from the Pilarcitos to Lake Honda Reservoir. Over 29 breaks were reported north of the San Andreas Reservoir, where the pipeline was constructed parallel to the San Andreas fault. Fault movement near the San Andreas Reservoir was measured as 3.6 to 5.6 m (Lawson, 1908). Pipeline ruptures were caused by tensile and compressive deformation of the line. Over three months were required to reconstruct the pipeline.

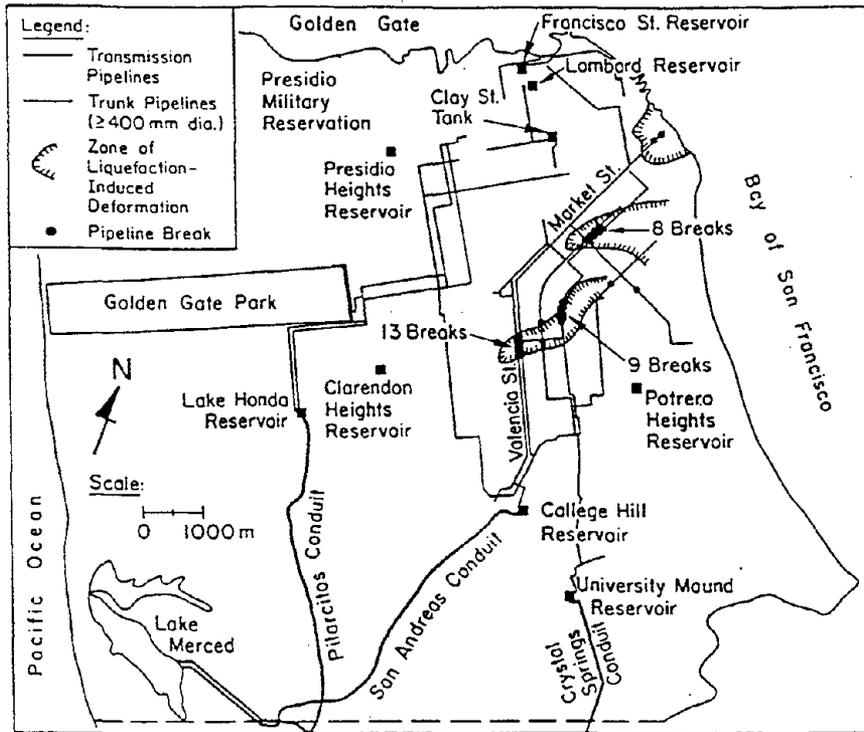
**FIGURE A-8.2 1906 Water Supply Within San Francisco City Limits, Trunk Lines, 400 mm or Larger**

Superimposed on the Figure A-8.2 are the zones of lateral spreading caused by soil liquefaction, as delineated by Youd and Hoose (1978). Breaks in the pipeline trunk system crossing these zones are plotted from records provided by Schussler (1906) and Manson (1908). It can be seen that multiple ruptures of the pipeline trunk systems from the College Hill and University Mound Reservoirs occurred in the zones of large ground deformation, thereby cutting off supply of over 56% of the total stored water to the Mission and downtown districts of San Francisco.

Two pipelines, 400 and 500 mm in diameter were broken by liquefaction-induced lateral spreading and settlement across Valencia Street north of the College Hill Reservoir. These broken pipes emptied the reservoir of 53 million liters, thereby depriving fire fighters of water for the burning Mission District of San Francisco. As indicated in previous studies (O'Rourke and Lane, 1986), this local deformation ranks as one of the most devastating events of the 1906 earthquake.

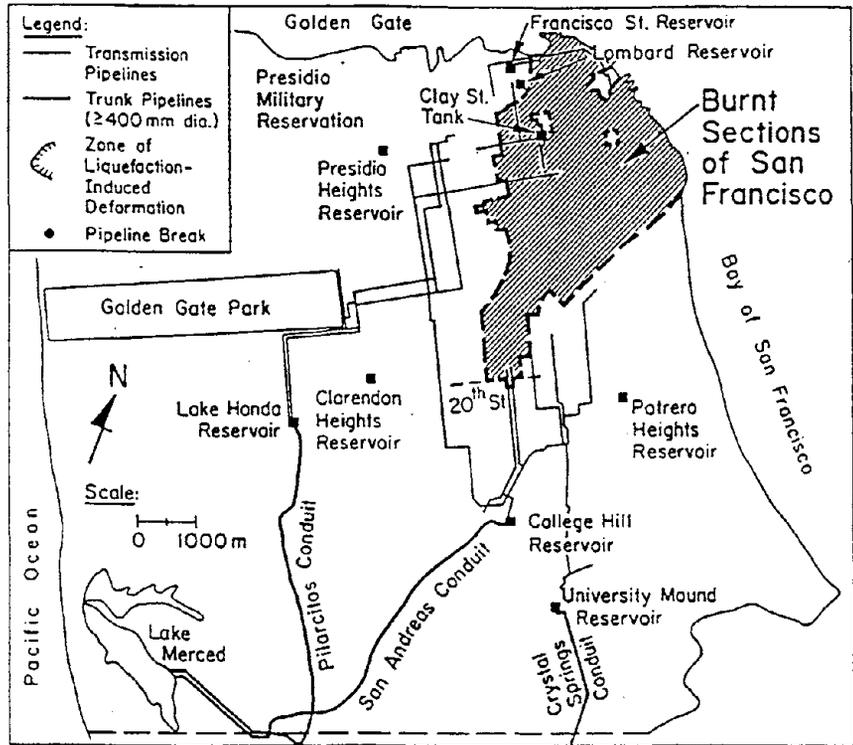
FIGURE A-8.3 San Francisco Water Supply and Area Burned During Earthquake

As a result of the earthquake, over fifty ignitions occurred within a relatively short time, and quickly developed in several conflagrations, which burned for three days (Scawthorn and O'Rourke, 1989). Figure A-8.3 shows a map of the San Francisco water supply and the burnt area. All trunk lines of the College Hill and University Mound Reservoirs downstream of the pipeline ruptures are removed from Figure A-8.3 to show the impact and lack of hydraulic conductivity caused by severing these conduits.

As is evident in Figure A-8.3, the Lake Honda Reservoir was able to provide a continuous supply of water to the western portion of the city. The fire eventually was stopped along a line roughly parallel to Van Ness Avenue, a wide street where water still was available from the Lake Honda Reservoir. Moreover, the southern and southeastern extent of the fire is bounded by areas south and southeast of the trunk system ruptures. It is likely that these unburned areas had water from the University Mound Reservoir. Figure A-8.5 presents a bar graph showing the reservoir storage in San Francisco as a function of time after the earthquake. The amounts of water corresponding to day 0 represent the quantities available roughly two hours after the earthquake struck. After four days, less than one tenth of the initial capacity of the College Hill, University Mound, and Lake Honda Reservoirs still was available. Two factors were critically important in preserving flow. Sixteen hours after the earthquake, water was pumped from Lake Merced into the Pilarcitos Conduit to supply Lake Honda. This action provided an additional 25 million liters/day, thereby maintaining capacity in Lake Honda for distribution to the western parts of the city. After repairs of the San Andreas Conduit over three days, approximately 30 million liters/day were conveyed to the College Hill Reservoir for distribution in the South Mission area of the city. By the fourth day, approximately 55 million liters of water were flowing into the city, in addition to the 25 million liters still available in the reservoirs.

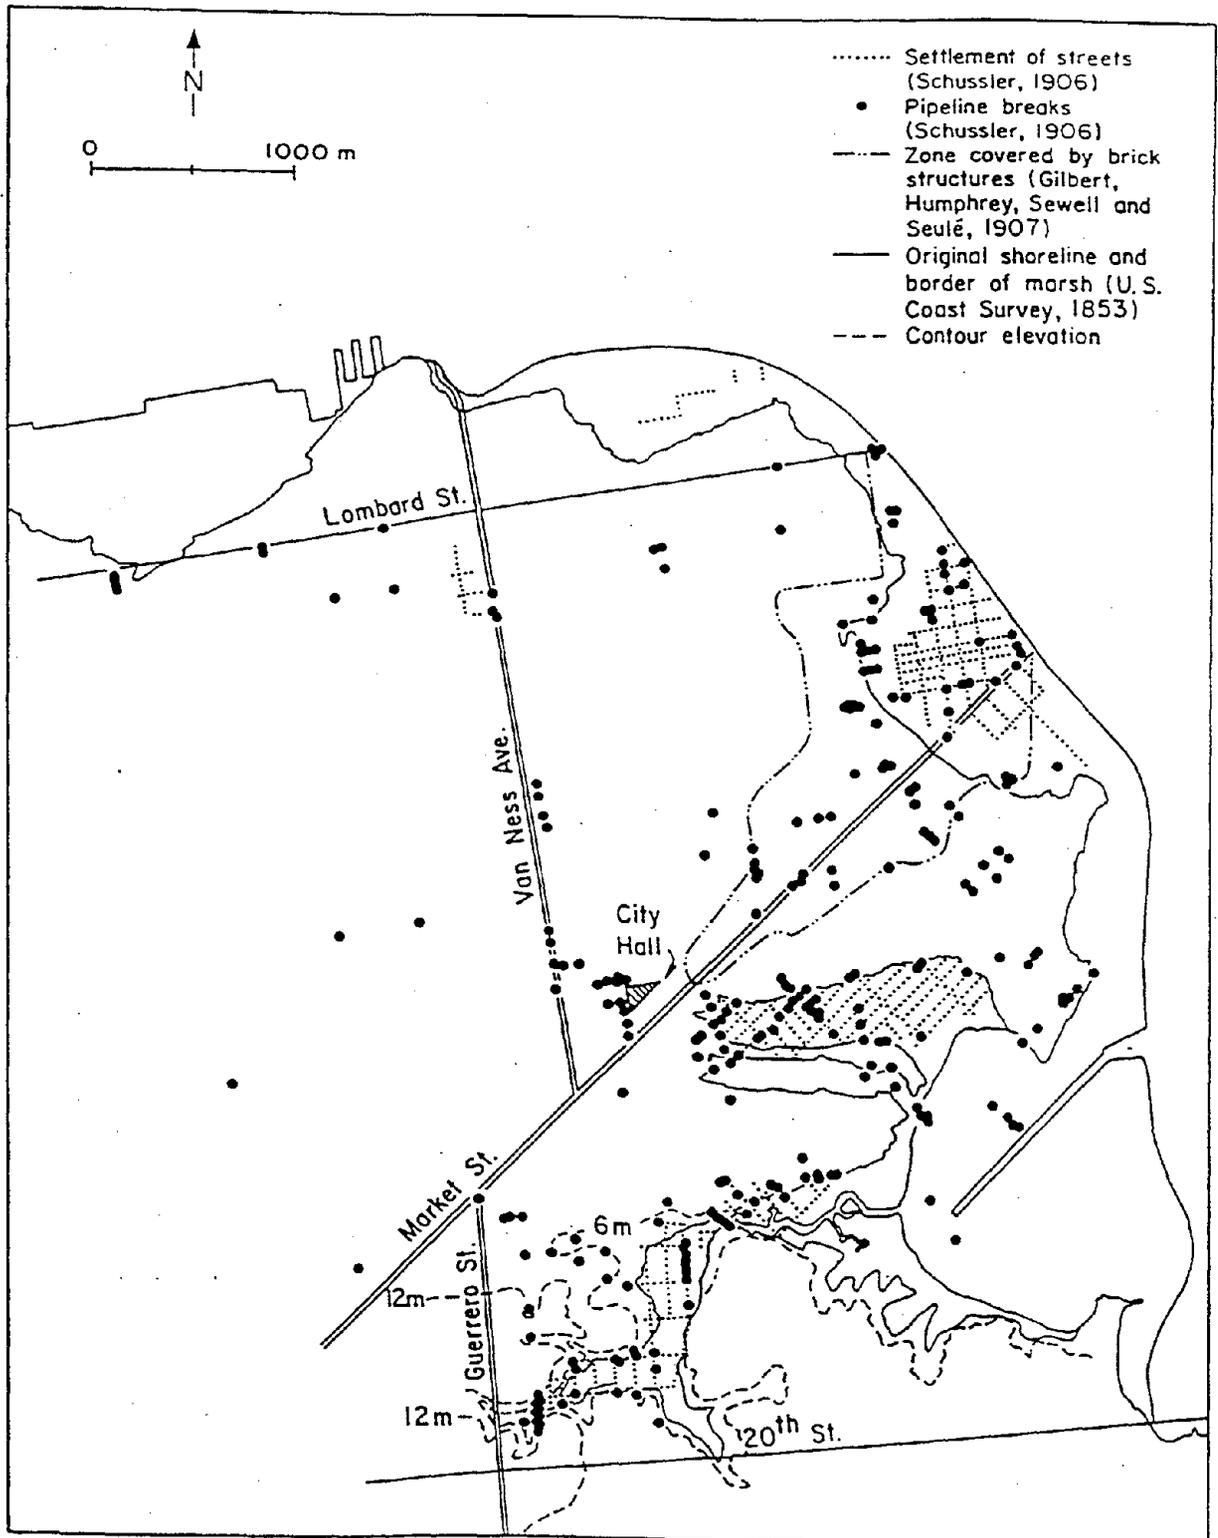
FIGURE A-8.4 Pipeline Breaks and Street Settlements in San Francisco after 1906 Earthquake (after Schussler, 1906; Manson, 1906)

source of lost pressure and water. There were roughly 23,200 breaks in service lines, between 15 and 100 mm in diameter, (Figure A-8.4). Fallen rubble and collapsed structures often prevented firemen from closing valves on distribution mains to diminish water and pressure losses in areas of broken mains and services.

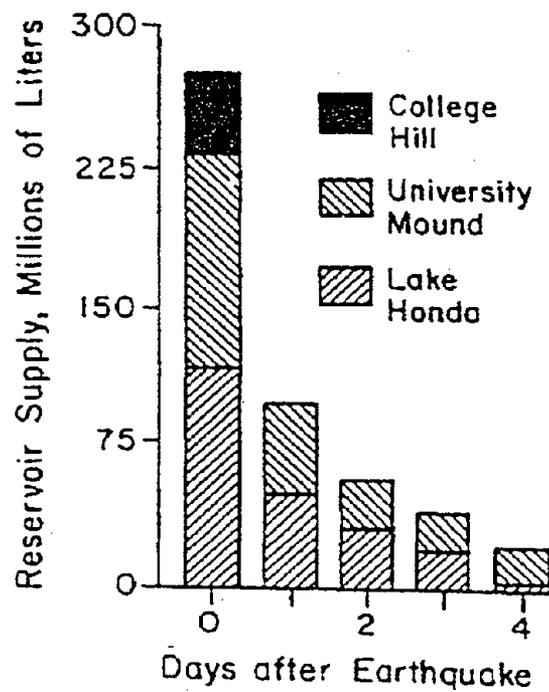
FIGURE A-8.5 Reservoir Storage in San Francisco, as a Function of Time after the Earthquake

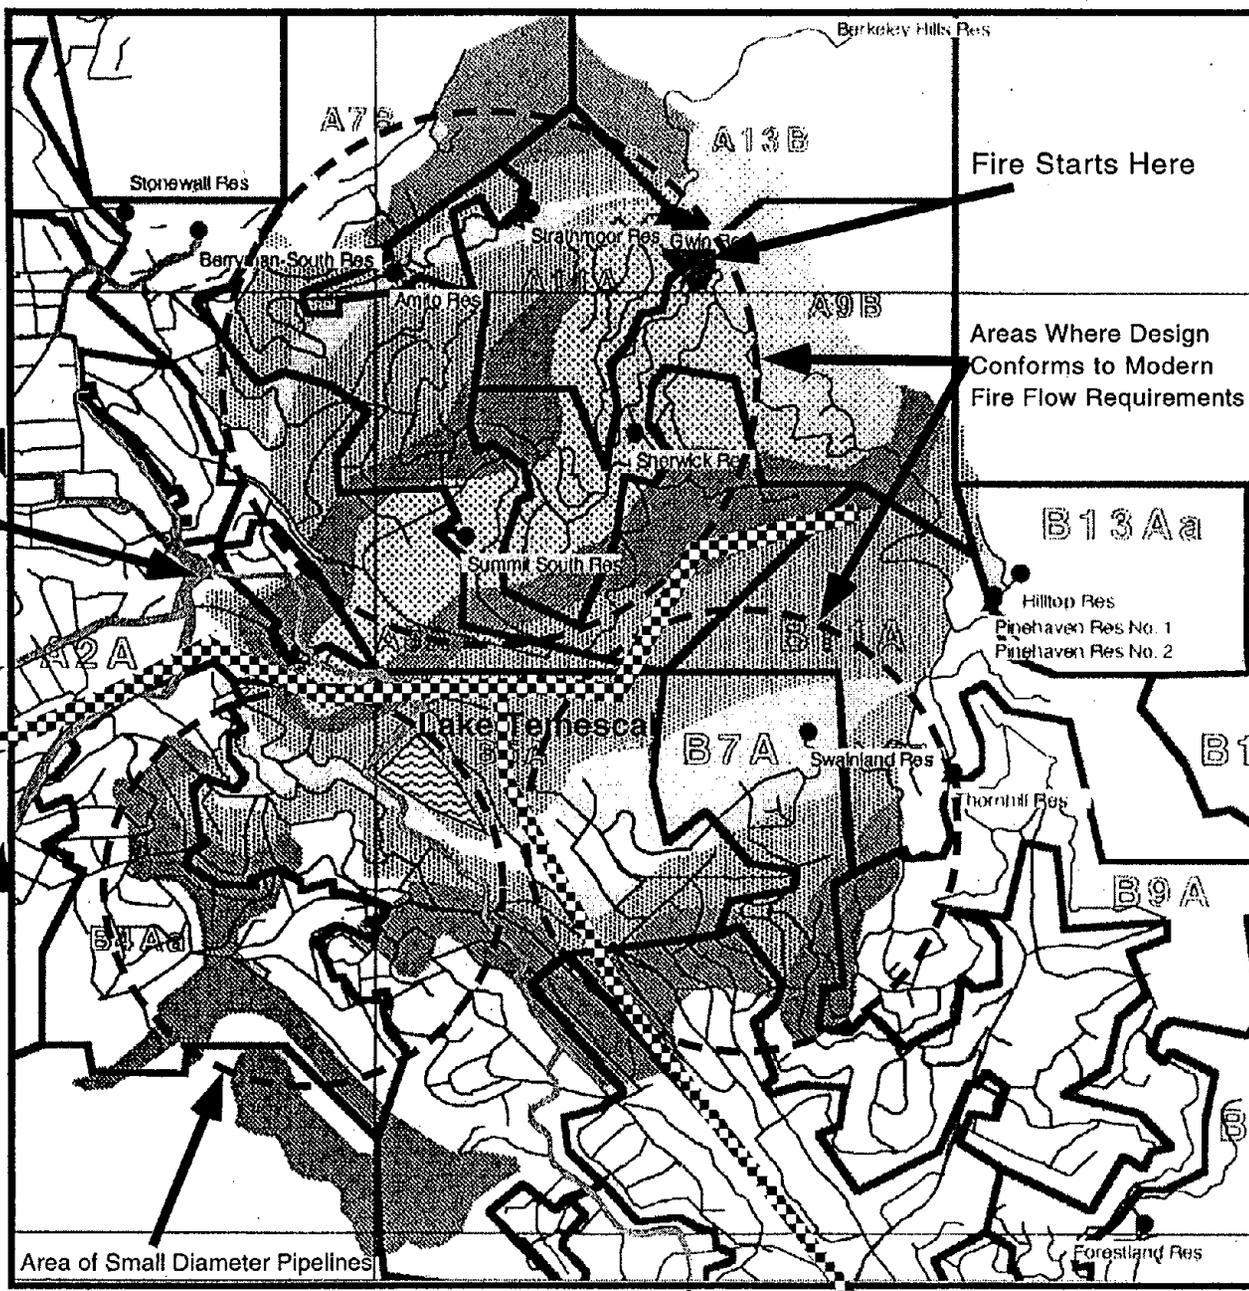
FIRE PRESSURE ZONES
