EARTHQUAKE RECORDINGS ON AND NEAR DAMS

Paul Morrison, Richard Maley, Gerald Brady
and Ronald Porcella

USCOLD

Committee on Earthquakes
Panel on Instrumental Recordings at
Dams

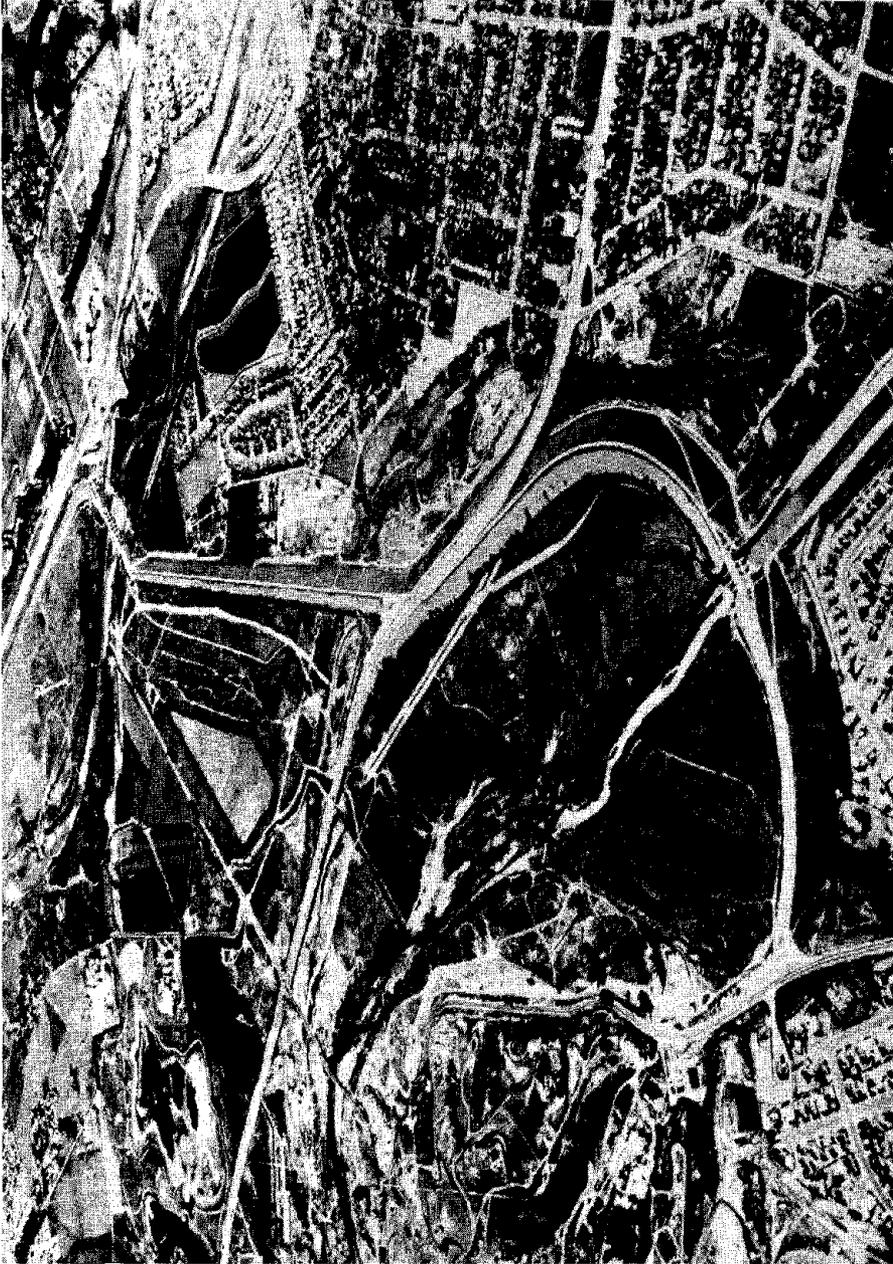
FIGURE 1. Whittier Narrows Dam.

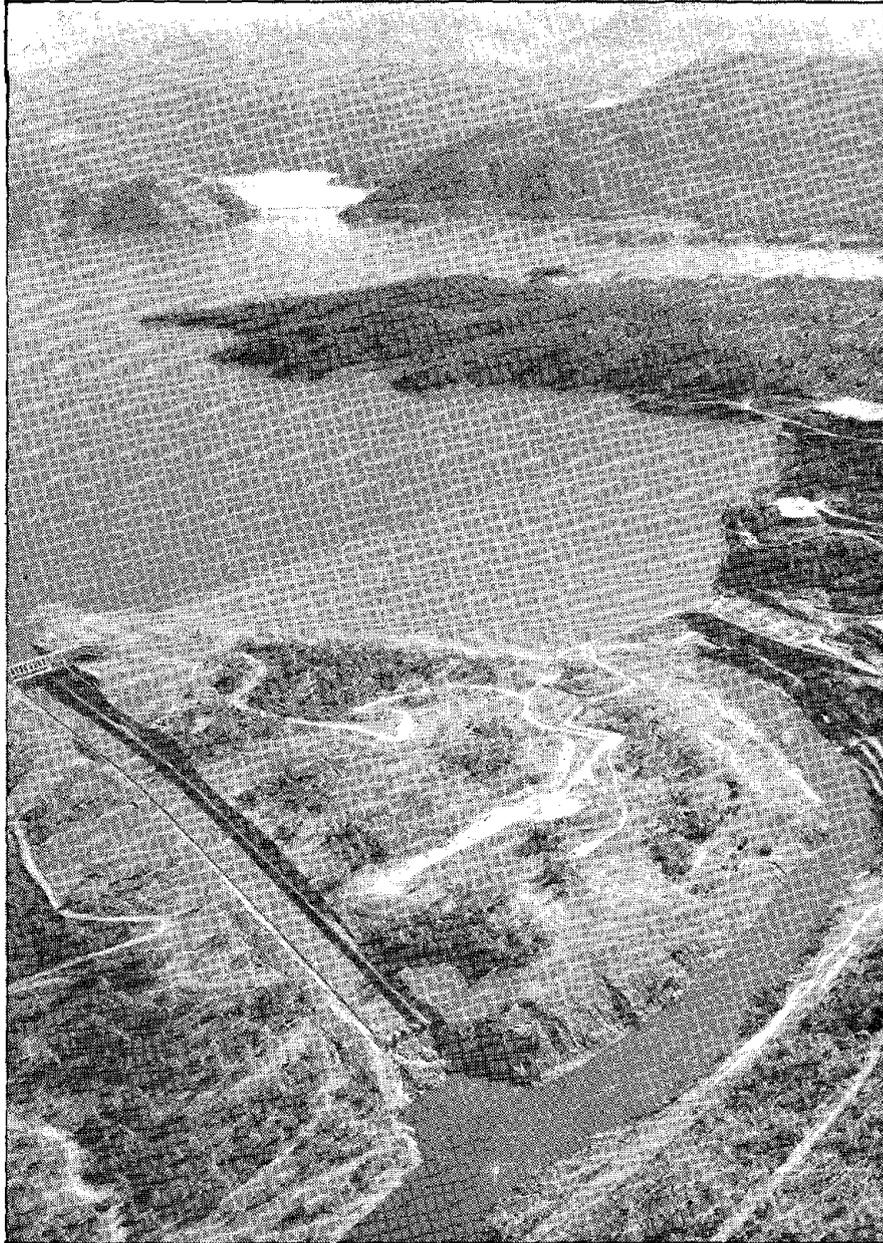
Figure 1. Oroville Dam and Spillway.

Oroville Dam, 39.53°N, 121.48°W, (Figure 1) is the keystone of the California State Water Project. The reservoir (Lake Oroville) is the source of water transported down the 644 km long California Aqueduct to Southern California. Dam construction was completed in mid-1968. On August 1, 1975 an earthquake ($M_L=5.7$) occurred within 12 km of the dam, resulting in no significant damage to the dam.
