THE USE OF STRUCTURAL FOAMS
TO IMPROVE EARTHQUAKE RESISTANCE
OF BUILDINGS

prepared for
National Science Foundation

B.L. Gabrielsen & R. Lindskog

Scientific Service, Inc.
1536 Maple Street
Redwood City, CA 94063
(415) 368-2931

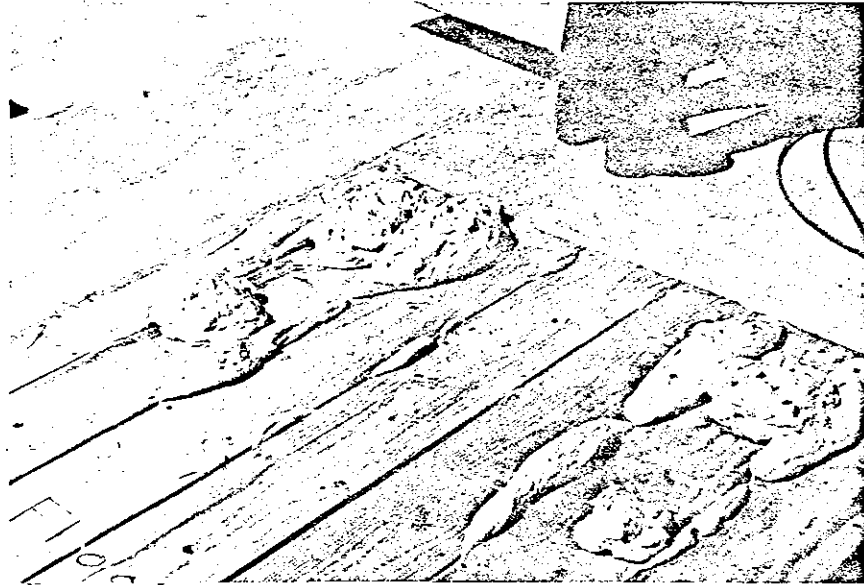
Fig. 2-3. Floor Number 1—Top View.

The next structural element foamed in Phase 1 was a floor specimen. The floor specimens were basically 4 x 8 ft, representing the second floor of a small apartment building or similar type of construction with 2 x 6 in. joists at 16-in. centers running in the four-foot direction, 1 x 8 sheathing running in the eight-foot direction and sheetrock on the bottom representing the ceiling of the room below. In Floor No. 1 three holes were drilled in each of the cells. These holes were drilled in the center of the cell and 16 in. in from either side—that is, each hole was in the center of a 16 in. x 16 in. area. It was noted in the ceiling trial discussed above that, in spite of the full appearance, some voids remained along the edges. Because of this it was decided in this floor to use approximately 5% more foam than the calculated requirement. The procedure was as follows: 17 sec or 1.7 lbs of foam was injected in the center hole of each cell, that is, the center row of holes between each floor joist. This quantity was approximately 5% more than 1/3 the total volume. Then 16 sec of foam was injected into the edge holes of each cell. As the foam began to rise, however, it started pouring through the cracks in the flooring (Fig. 2-3) and a few seconds later the sheetrock underneath cracked, as shown in Fig. 2-4. The maximum deflection of the sheetrock was 3/4 in. at one end.

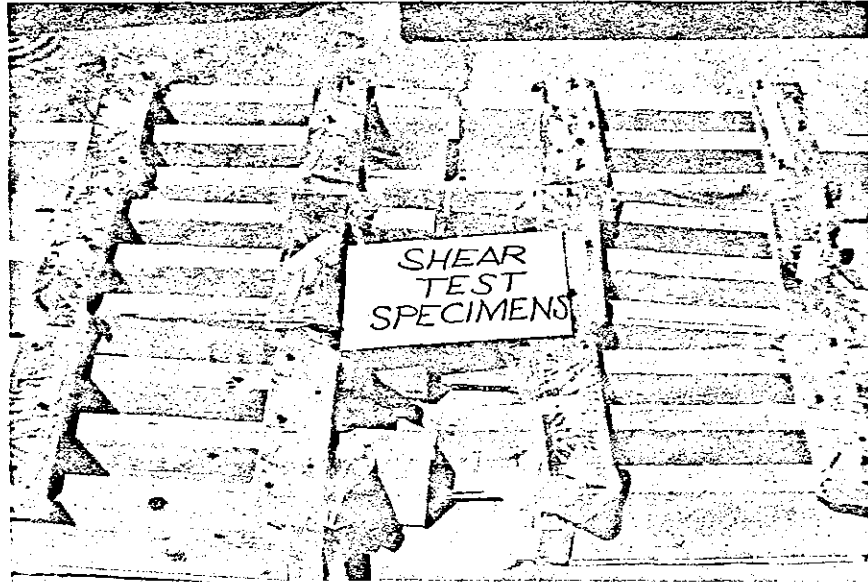
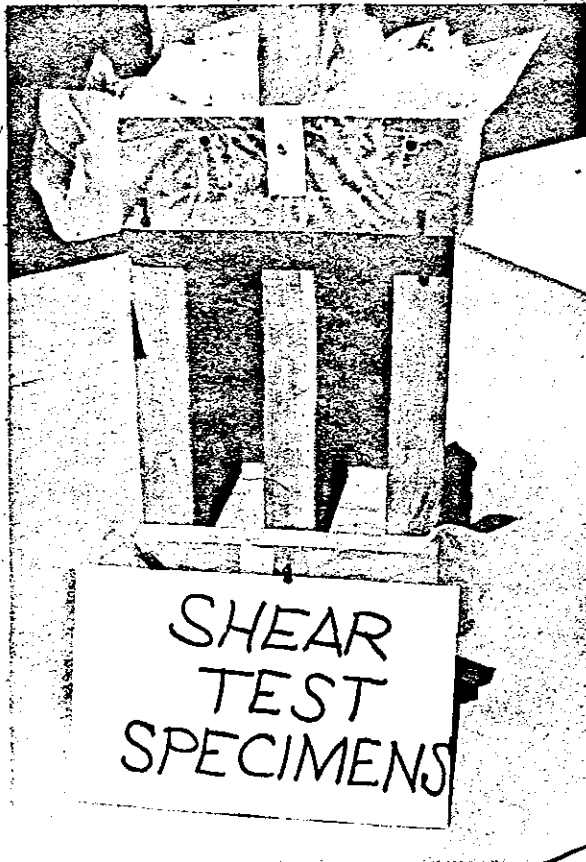
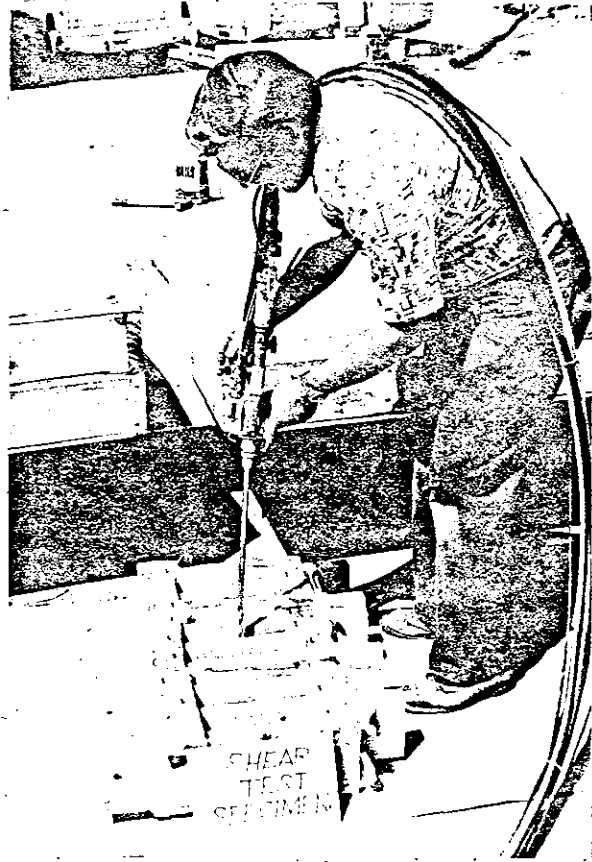
Fig. 2-30. Shear Test Specimens.

To gain additional data two sets of special test specimens were constructed and tested. Fig. 2-30 shows some special three-block shear specimens that were made in order to give a more accurate measurement of the shear strength and bonding capacity of foam to wood and the shear modulus. Another problem encountered in the earthquake area, or for that matter any lateral load area, is the connection of the floor system to the foundation. Some special short sections of 2 x 10 floor systems were bonded with foam, as shown in Fig. 2-31, to a concrete slab simulating a floor-to-foundation system. These were subjected to a shear test to demonstrate the bonding capability of the foam to the footing as well as to the floor system.

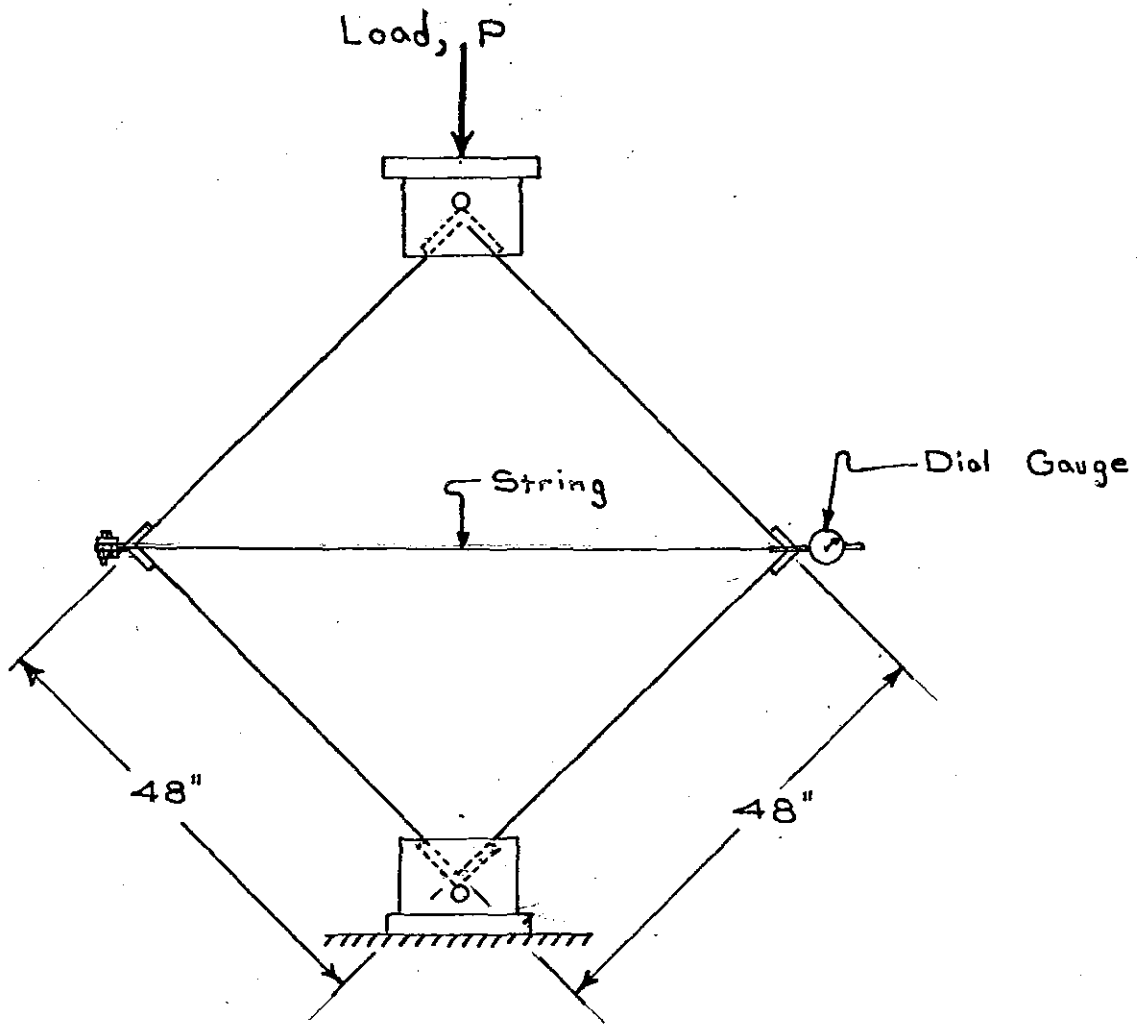
SHEAR TEST LOADING ARRANGEMENT

Fig. 3-12. Shear Test Arrangement.

This test was conducted using a universal testing machine in the compression mode with 4 ft x 4 ft wall panels. The panels were loaded diagonally causing pure shear along the panel's perimeter as shown in Fig. 3-12.

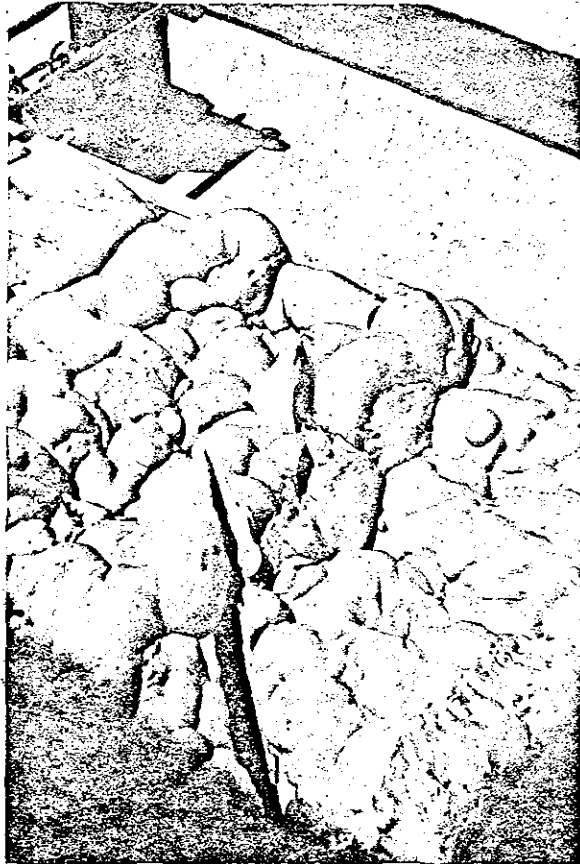
Fig. A-6. Ceiling No. 1 Tensile Cracks in End Cell.

The ceiling failed when the foam separated from the center joists and along the bond interface to the sheetrock. Separation also occurred along the base perimeter member simultaneously and sounded like a loud crack. Fig. A-6 shows the diagonal tensile failure at the end cells. Sections cut through the center portion show the foam separation from the sheetrock (Figs. A-7 and A-8) and from the perimeter cord (Fig. A-9).

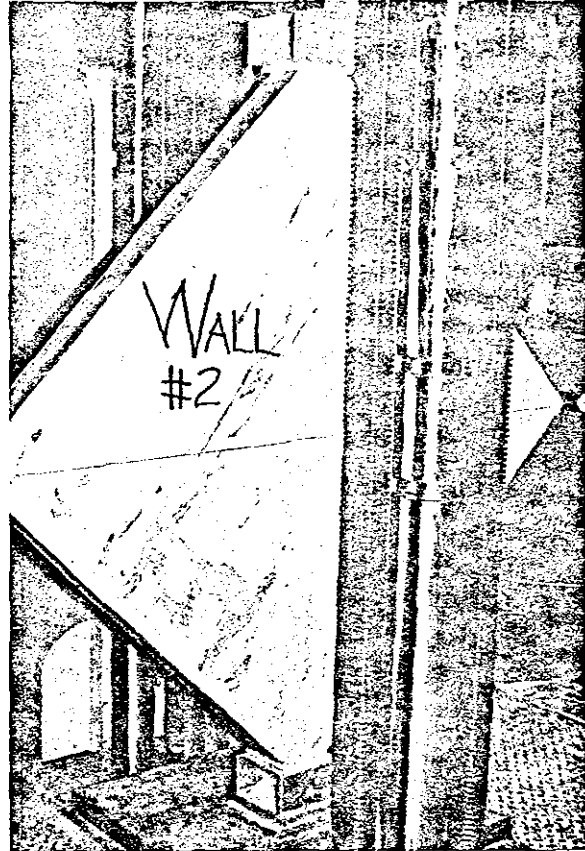
Fig. A-34. Test Arrangement for Wall Number 2.

Wall No. 2 was placed in the testing machine with one of its diagonals in the vertical position as shown in Fig. A-34. The wall was then loaded slowly to failure. The load versus vertical diagonal deflection was monitored by the testing machine plotter; the resulting plot is shown in Fig. A-35. The horizontal diagonal deflection was also recorded at various load increments; these data have been plotted and are presented in Fig. A-28.

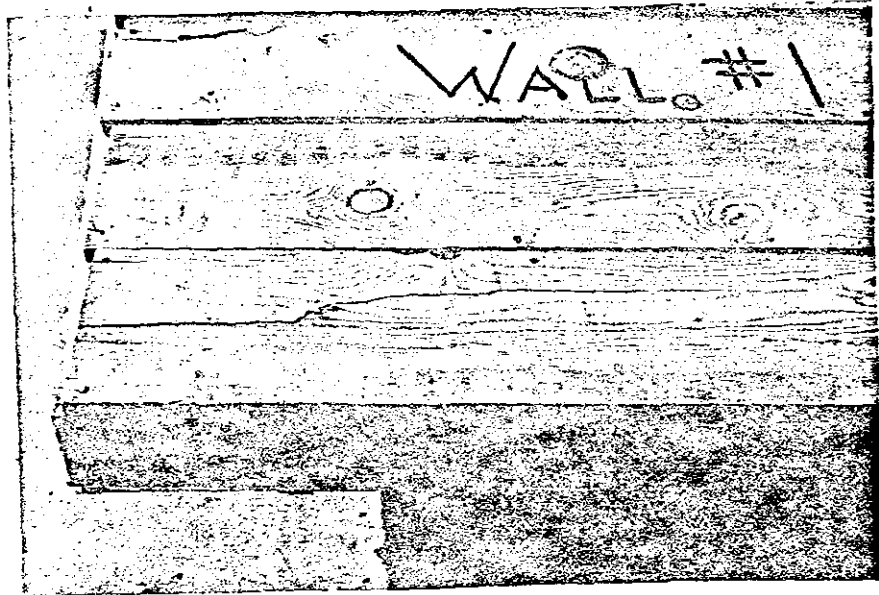
Fig. A-63. Cracks in Sheathing of Base Case 4 ft x 8 ft Wall After Test.

Fig. A-61 shows the deflected shape of the specimen at failure. From this photograph, you can see the sheetrock nails had torn the wallboard along both longitudinal edges and interior studs. Fig. A-62 shows the sheathing side where the relative dislocations of the 1 x 8 pieces are readily visible. Closer examination reveals cracks in various sheathing sections (Fig. A-63).

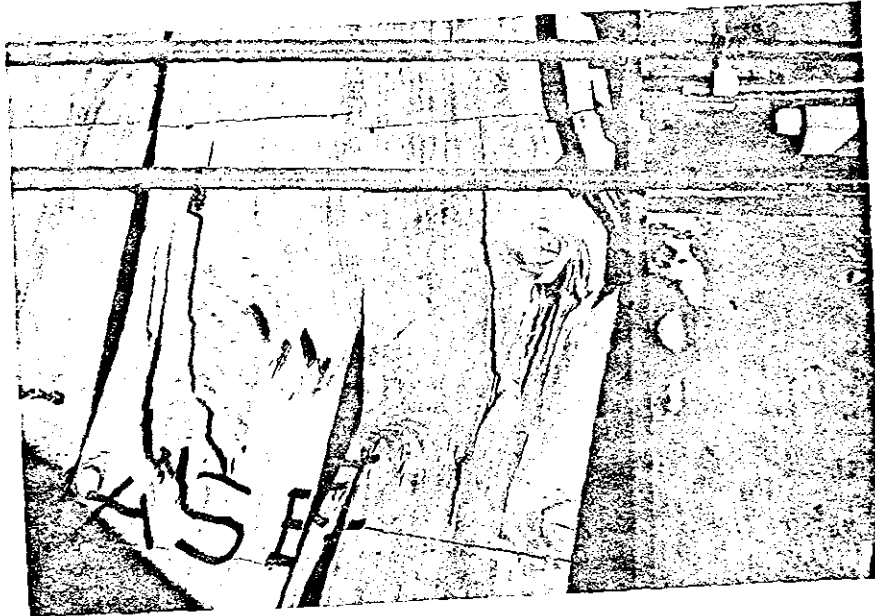
Fig. A-78. Sheathing Failure in Floor Base Case.

The test specimen after failure is shown in Fig. A-76. At the start of the test, the nails holding the sheetrock tore through along all four sides (Fig. A-77). As the deflection increased, more load was transferred to the sheathing at about 9,000 lbs and 1.5 inches of deflection bending failure occurred in the sheathing at the center of the panel (Fig. A-78).

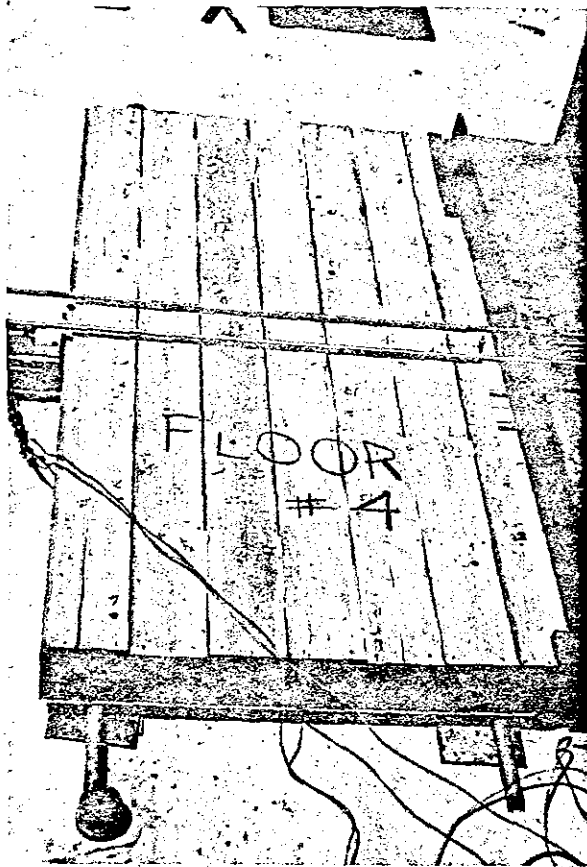
Fig. A. 92. Floor Number 4 in Horizontal Shear Test Frame.

This specimen was subjected to the horizontal shear test as shown in Fig. A-92. The applied load and resulting deflection was recorded on an x-y plotter. The load was increased slowly until failure occurred.

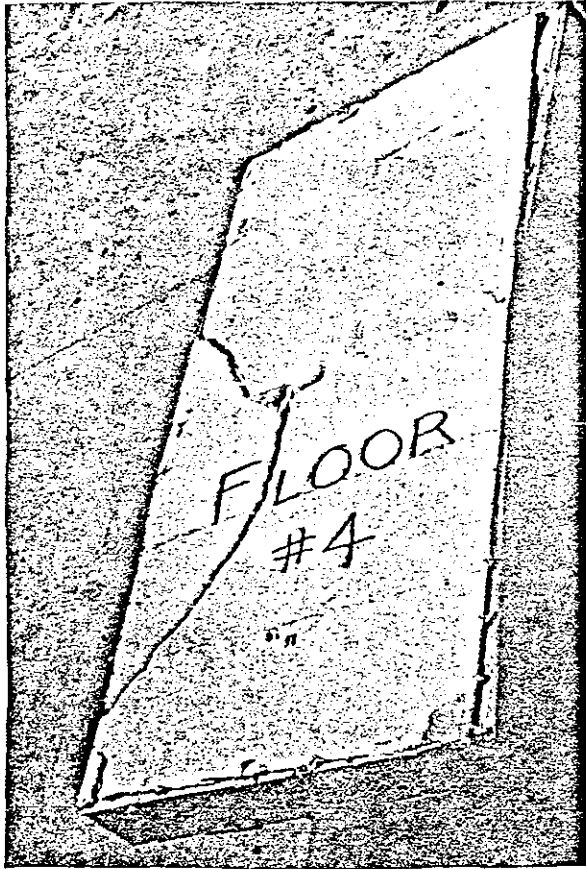
Fig. A-96. Gypsum Wallboard Side of Floor Number 4.

There was no distinct failure, just increasing signs of stress in the sheathing observed as cracking and splitting around nailing. Fig. A-94 shows the panel after testing. A closer examination revealed extensive cracking of the foam underneath the sheathing (Fig. A-95). The foam had also separated from center and perimeter frame members. Fig. A-96 shows a broken section of sheetrock and separation along the perimeter.

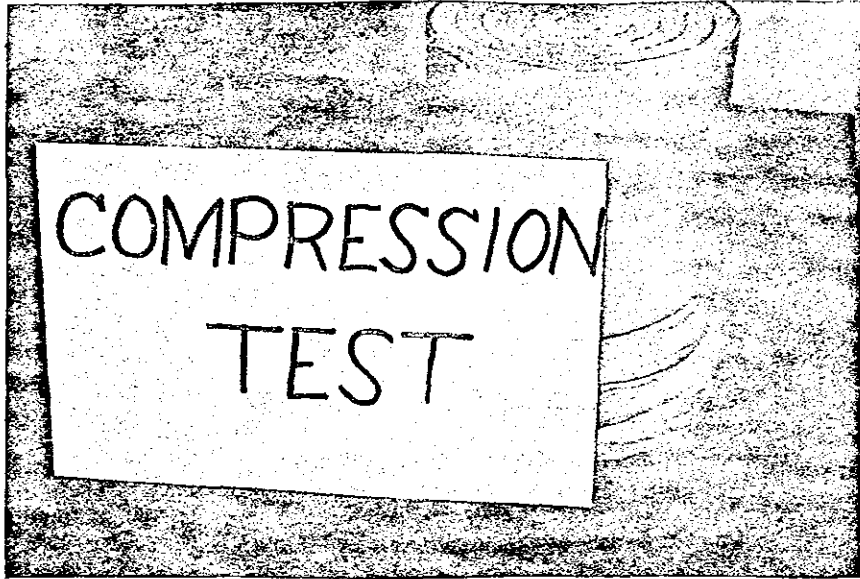
Fig. B-22. Compression Test. (Load Applied in Direction of Rise)

All six specimens ultimately failed due to localized buckling failures. For Specimens 1, 2, and 3, where the load was applied in the direction of rise of the foam, the specimens exhibited considerable symmetry in their buckling failures, as seen in Fig. 22, A and B.
