REPORT DOCUMENTATION PAGE	1. REPORT NO. NSF/RA-770702	2.	PB 291601	
4. Title and Subtitle State of the Art of Buried Lifeline Earthquake Engineering (Reprint Proceedings of Current State of Knowledge of Lifeline Earthquake Engineering, Los Angeles, California, August 1977)		5. Report Date 1977

STATE OF THE ART OF BURIED LIFELINE EARTHQUAKE ENGINEERING

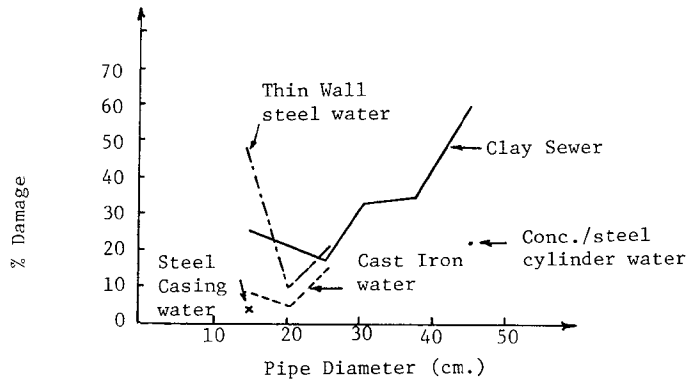
Fig. 1 % Damage vs Pipe Diameter
1971 San Fernando Earthquake

For example, using 1971 San Fernando earthquake data (19), the extent of water/sewer pipeline damages is given in Table 4. The percent of damage vs pipe diameter for data including all joint conditions is shown in Fig. 1. From this figure, one can not conclude what is the effect of pipe size for water pipes in the range of 15cm (6 in) to 46cm (18 in). Secondly, from the sewer pipeline information, there seems to

be a definite trend that larger pipes are more liable to fail, which contradicts Katayama's observation from the Kanto earthquake. One possible explanation is that the damage data in the two investigations are different. The number of joint loosening was used in Kanto earthquake investigation while the number of breaks was used in San Fernando earthquake.
