PROCEEDINGS OF THE
P. R. C. — U. S. A.

JOINT WORKSHOP ON EARTHQUAKE
DISASTER MITIGATION THROUGH ARCHITECTURE,
URBAN PLANNING AND ENGINEERING

ARCHITECTURAL DESIGN AND URBAN PLANNING FOR SEISMIC REGION

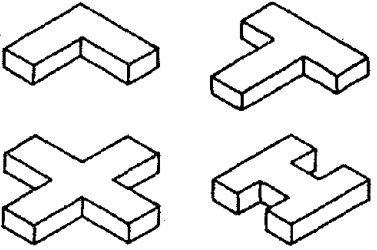
<p data-bbox="315 506 669 540">b. FALSE SYMMETRY</p>

<p data-bbox="315 889 571 953">2. RE-ENTRANT CORNERS</p>

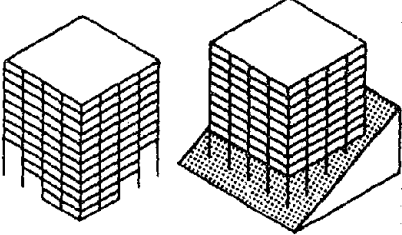
<p data-bbox="332 476 728 512">2. SOFT STORY - FRAME</p>	<p data-bbox="766 251 1281 306">causes abrupt change of strength and stiffness at point of discontinuity</p>

<p data-bbox="332 838 716 902">3. VARIATIONS IN COLUMN STIFFNESS</p>	<p data-bbox="766 612 1281 668">causes changes of stiffness and much higher forces in stiffer columns</p>

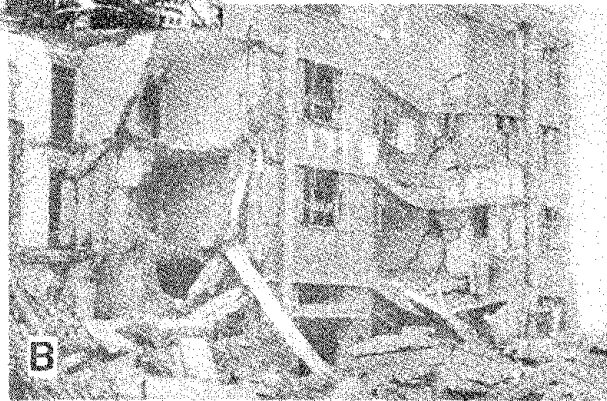
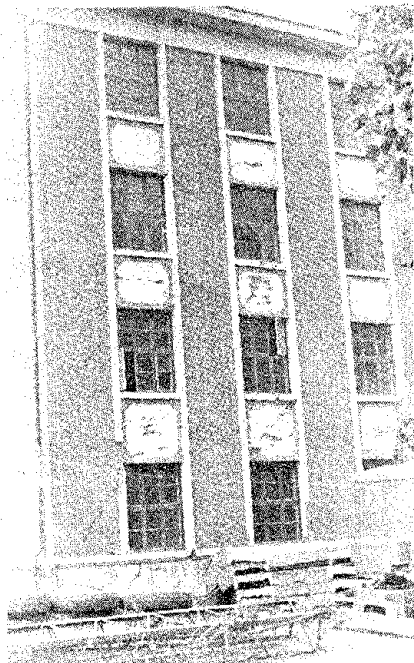
Fig. 6 Damage to building Having sunk spandrel wall during the Tangshan earthquake

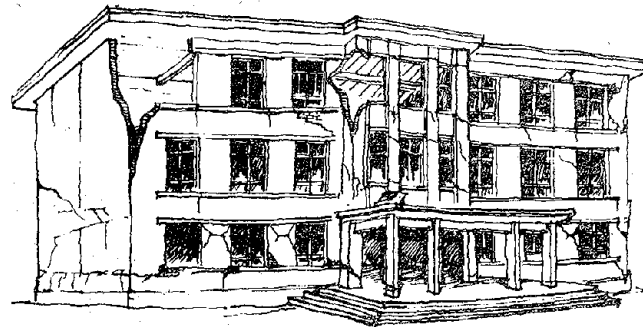
Figure 23 Damaged elevation of classroom bldg. of DXZ primary school

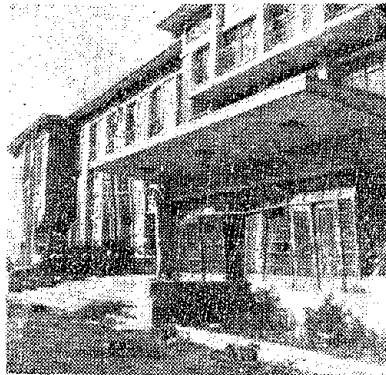
图13 10度区唐山第一瓷厂办公楼雨罩震后状态

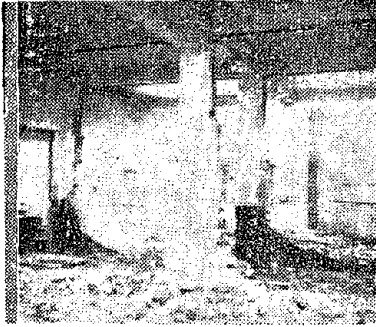
图22 电机馆的底层带有构造柱，楼板基本完好

The reinforced concrete structural columns, if securely attached to the girths and girders running in two directions, and rationally attached to the cross and vertical walls with careful construction, could produce good effect. They could prevent a three-storeyed house in brick-concrete structure, an eight-storeyed house with inside frame structure and a spacious house in brick load-bearing structure from collapse in presence of serious cracks. However the discontinuous reinforced concrete structural columns were ineffective for anti-seismic effect of the houses (see Figs 21, 22 and 23).

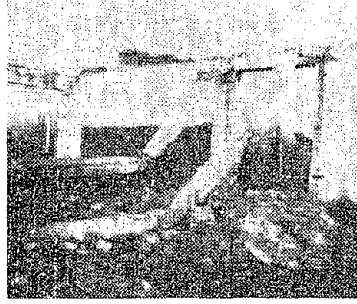
图23 电机馆的二层无构造柱。这是圈梁的破坏状态

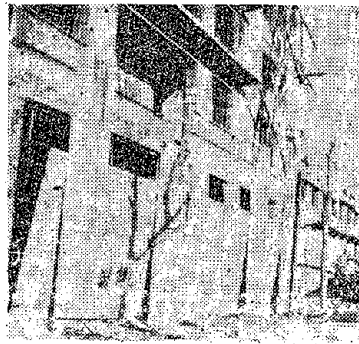
图27 新华旅馆门厅入口处雨棚倾复的状态

the superstructures, the colonnades and canopies also experienced, at the parts connected with the main structure, horizontal push and pull forces and vertical shearing effect. Therefore, they all suffered damage to a certain extent. These sensitive structural elements should have been separated from the main structure to avoid damage(see Fig 27).

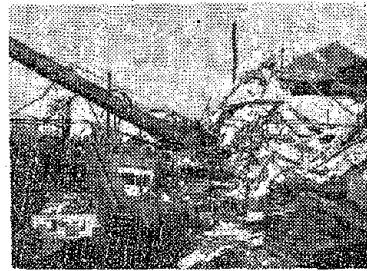
图31 11度区机车车辆厂机车厂房天车落地

Collapse of houses or collapse of wall in part posed great menace to various equipment. The combined high-tension switches, ventilators, porcelain machinery such as scrapers, generators and forming machines were destroyed, and coal hoisting was interrupted, resulting in the failure of production operations. Pumps, electrolyzers, liquid chlorine storage tanks were destroyed, causing corrosion of metals and hazards to lives by leakage of air and liquid. Damage of pipes and the fall of overhead travelling cranes rendered the production impossible to restore(see Fig 31).

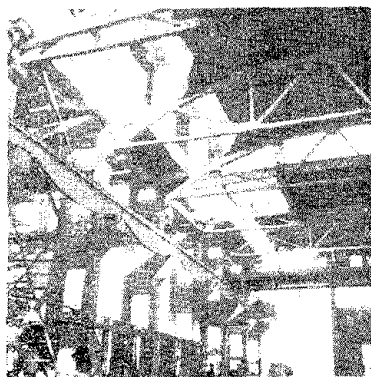
Fig. 2

Recently, the roof-light of the "sinking" type has been widely adopted. Because it is located below the roofing hence the entirety of the roof is strengthened and the seismic damage is not discovered. Fig.2 shows the roof-light of a turbine shop of the Xingang Shipyard in Tang-gu. Its roof-light of the "sinking" type is not damaged.

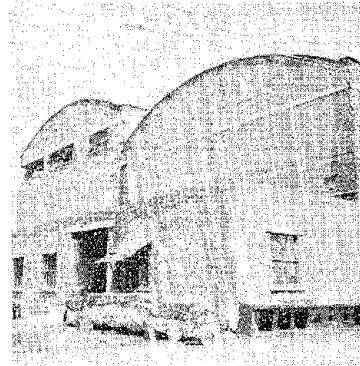
Fig. 11

(2) Gable cracked diagonally and the parts of wall collapsed down, as shown by the machine shop of the Sixth Machine Factory in Fig.11. This case chiefly appears in the factory buildings with the roof of large rigidity, which can transmit the seismic force to the gable, so that it is easy to be destroyed by the shear force.

(3) Interfenestral wall and corner of gable produce cracking crack and are collapsed as shown in Fig.11, 29.

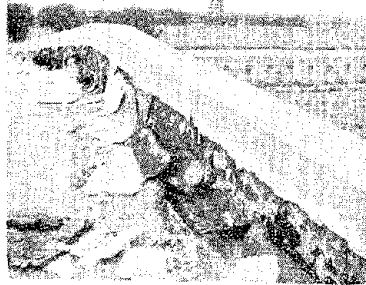
Fig. 12

(3) Gable inclines outwardly, so the roofing asphalt felt cracks. Fig.12 shows that the foundry gable of the grinding machine factory inclined outwardly about 10 CM. Fig.13 shows that the foundry gable of the Xinhe Shipyard seriously inclined outwardly and collapsed to the extent that the columns of resisting wind force ruptured just at the place where the section area changed. As everyone knows, when the seismic forces act on the factory building along its lengthwise direction, the stability of the whole factory building is guaranteed by column bracing. But the ability to resist seismic force by the gable itself is very weak, so the seismic force acting on the gable is mainly resisted by the column of resisting wind force. The above mentioned seismic damage will take place, if there is a bad bind between the gable and the column of resisting wind force.

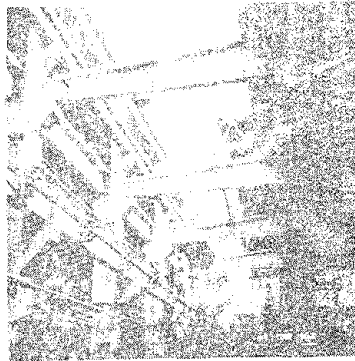
Fig. 16

as it fell down, as shown by the third foundry in Fig.16.

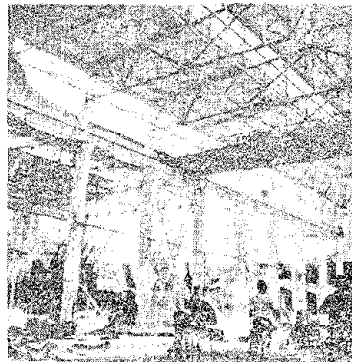
Fig. 17

The irregular plans with the spans being perpendicular to each other such as "L", "T" and "n" etc. are unfavourable for transmission of seismic forces. Because the forces are twisting and turning, the strains will not be homogenous and will be easy to make concentration of stresses. If the strengths of elements and wall are not big enough, it is easy to make seismic damages as shown by the foundry shop of the Tianjin Tractor Factory and the machine shop of the Tianjin Forging Press Factory in Fig.17 and 18. For this reason the plans should

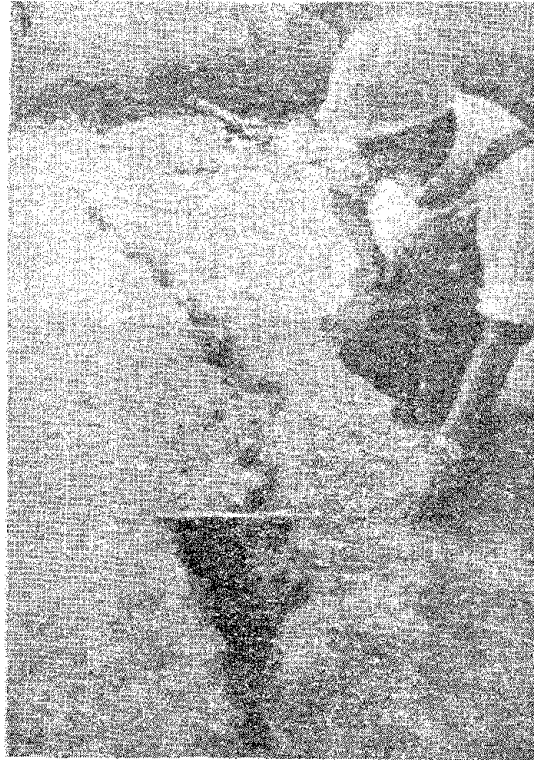
Mainly be distributed in the areas of Heping and Hexi, The fissure width being 1-2 generally, Max. had 30, fissure direction had two: mainly be NE (20, 40, 60,) and NW (20, 40,) they are perpendicular each other in crisscross distance had 3-60, In addition trace phenomenon for horizontal movement is existance about the horizontal displacement had 3-20, the fissure length had several-tens to the one hundred meters, Some fissure had 400-1000 meters length. see Fig. 6.

Fig. 6. Ground surface fissure, Chen-Dui-Zi.

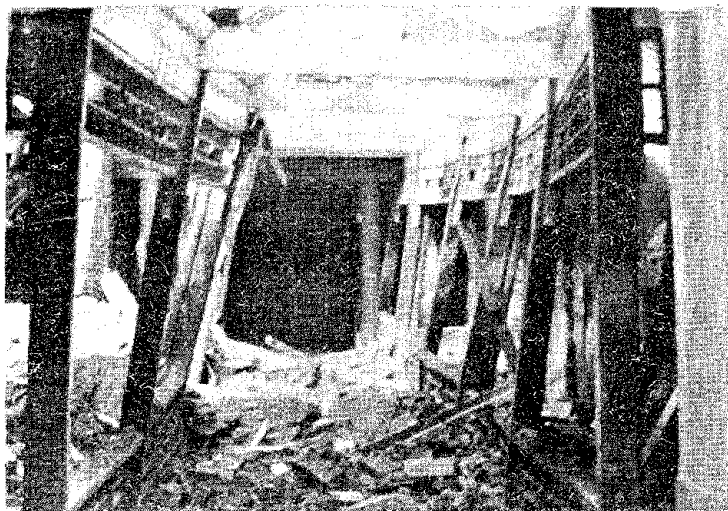
Fig. 10. Destructive building seriously,
Tianjin-Hotel.

b) Destructive building seriously, mainly to contributed at the two banks of Hai-river. see Fig. 10.

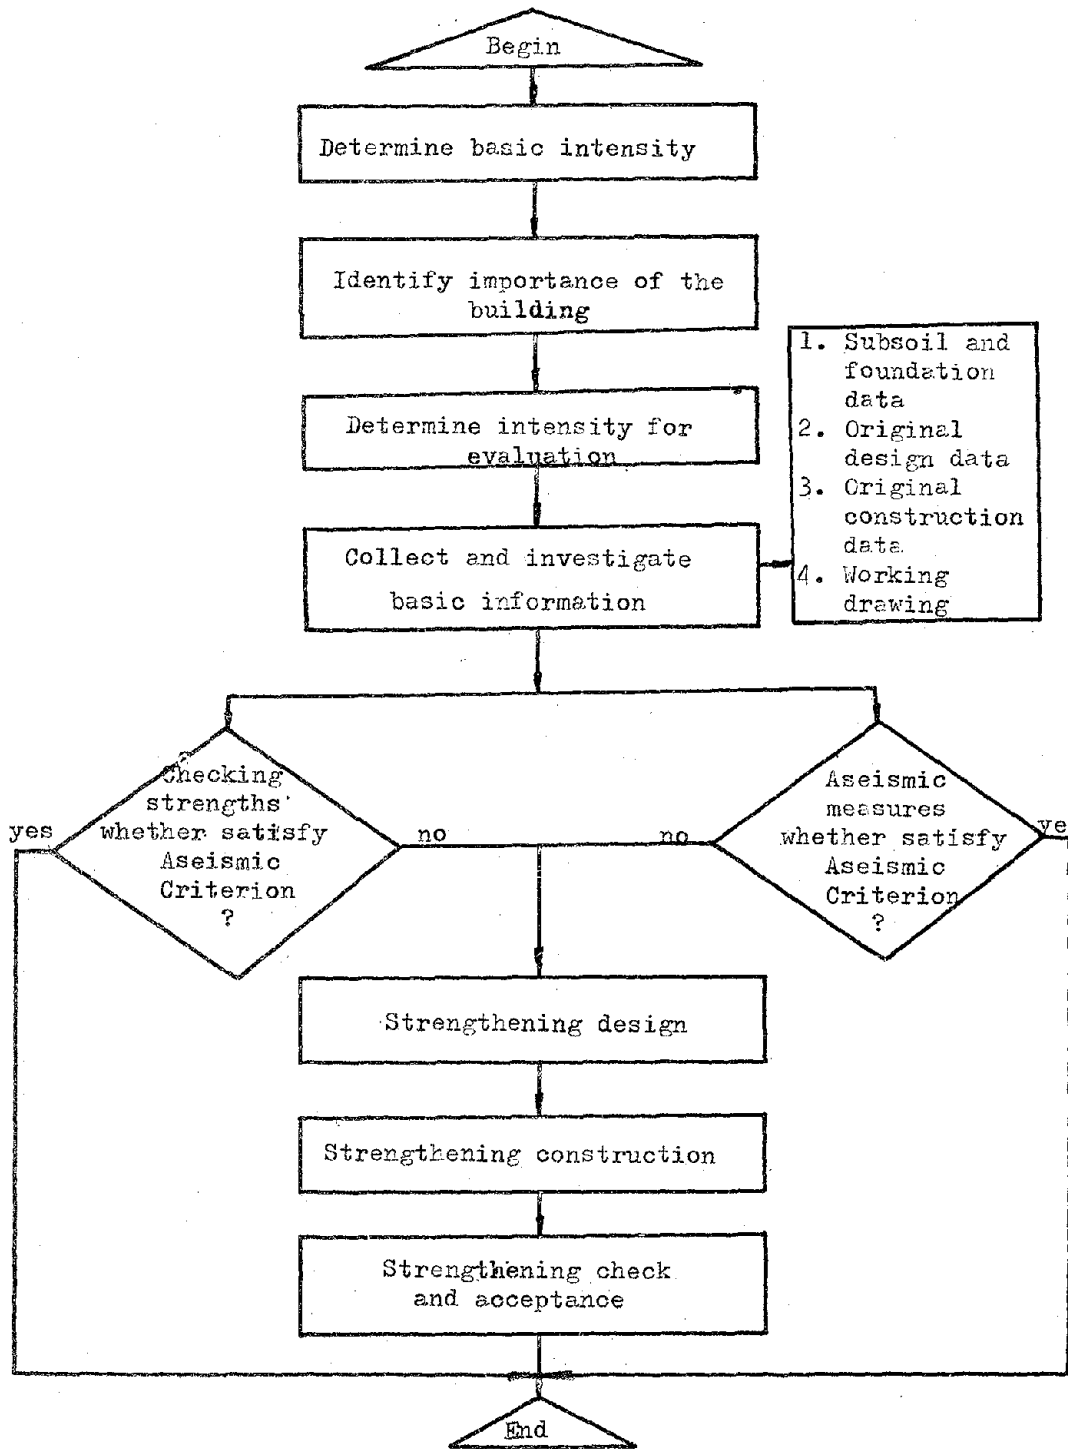
Figure 1. Flow chart for Aseismic Evaluation
