PROCEEDINGS OF THE FIRST SEMINAR
ON
REPAIR AND RETROFIT OF STRUCTURES

US/JAPAN COOPERATIVE EARTHQUAKE ENGINEERING RESEARCH PROGRAM SPONSORED BY
THE NATIONAL SCIENCE FOUNDATION THROUGH GRANT NUMBER CEE-7816730

MAY 1980

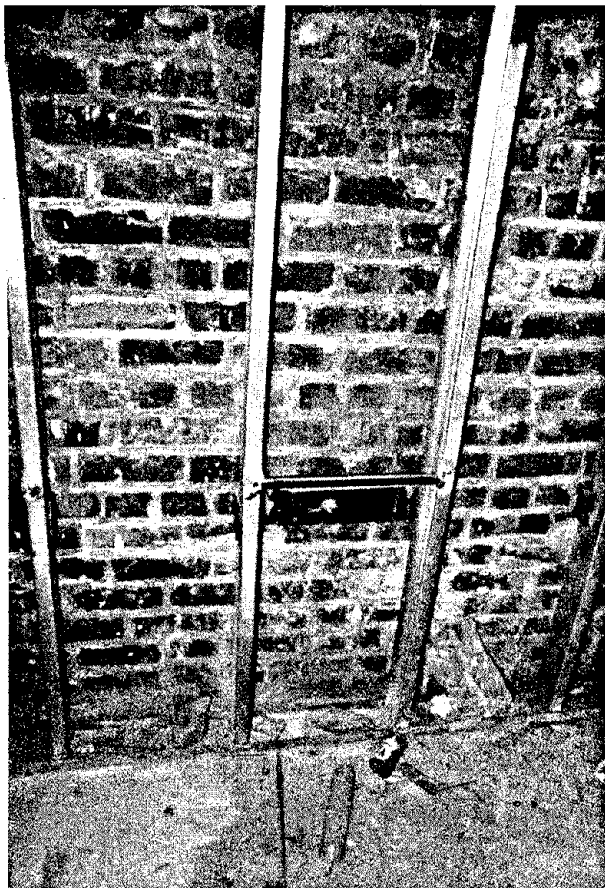
Figure 2. Bracing of unreinforced brick on typical floor of Hotel Oakland restoration. Epoxy bolt in brick connected to heavy duty furring studs which spanned between floors.

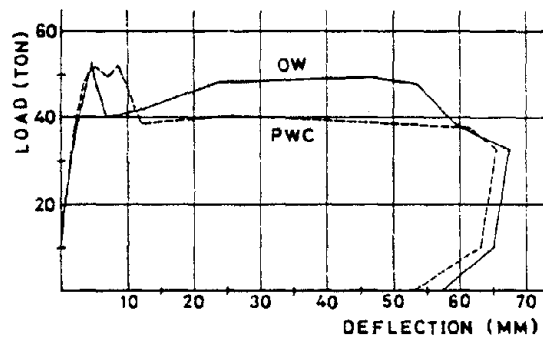
(a) Test Specimens and Results (1)

(b) Test Specimens and Results (2)

- W-1 : Unstrengthened Frame
- W-2 : Monolithic Wall
- W-3 : Epoxied Mortar Shear Key
- W-4 : Dowel with Wedge Anchor,
along Top Beam, Roughing
- W-5 : Dowel all around the Frame
- W-6 : Dowel all around the Frame
Roughing

(c) Test Results (3)

FIG. 7 TESTS OF INFILLED WALLS
(After Kokusho (12-14))

Infilled Concrete Walls - A series of tests by Kokusho for three types of infilled walls shown in Fig. 7 indicate that (1) infilled walls provide reasonable strength, however, dowels may simultaneously fail in shear at their screw parts, (2) it is effective to provide gaps along columns so that walls may behave in a ductile manner, and (3) chipped shear key may provide as much strength as that of monolithic wall. While it is indicated on the basis of the test by Yamaguchi and Sugano (Fig. 9) that infilled wall may have as much strength as that of a monolithic wall when adequate connections are provided, in addition, it is

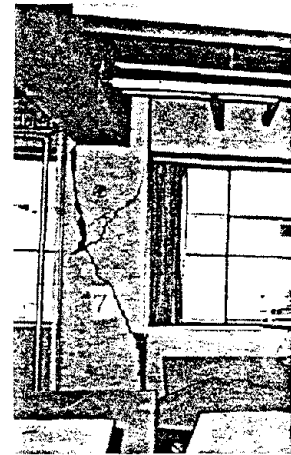
(c) Damage to a Column
(June, 1978)

School Building (1) [6,7] - A five-story college building shown in Fig. 12 (a) and (b) suffered severe damage to captive columns at the northside as shown in Fig. 12(c) during the Miyagikenoki Earthquake of June, 1978. Severely damaged columns were replaced with new concrete providing additional reinforcements. The transverse direction was strengthened through the stories by infilled walls. The existing walls were thickened. The longitudinal direction was also reinforced through the stories with diagonally configulated steel braces as shown in Fig. 12 (d). Braces were connected with the exterior side of existing beams by means of steel platforms. An experimental program was undertaken to investigate the behavior of braces. Spandrel walls were drilled along columns to reduce their contribution to columns. The microtremor measurement after the construction indicated that the building recovered the stiffness almost identical to that before the earthquake.

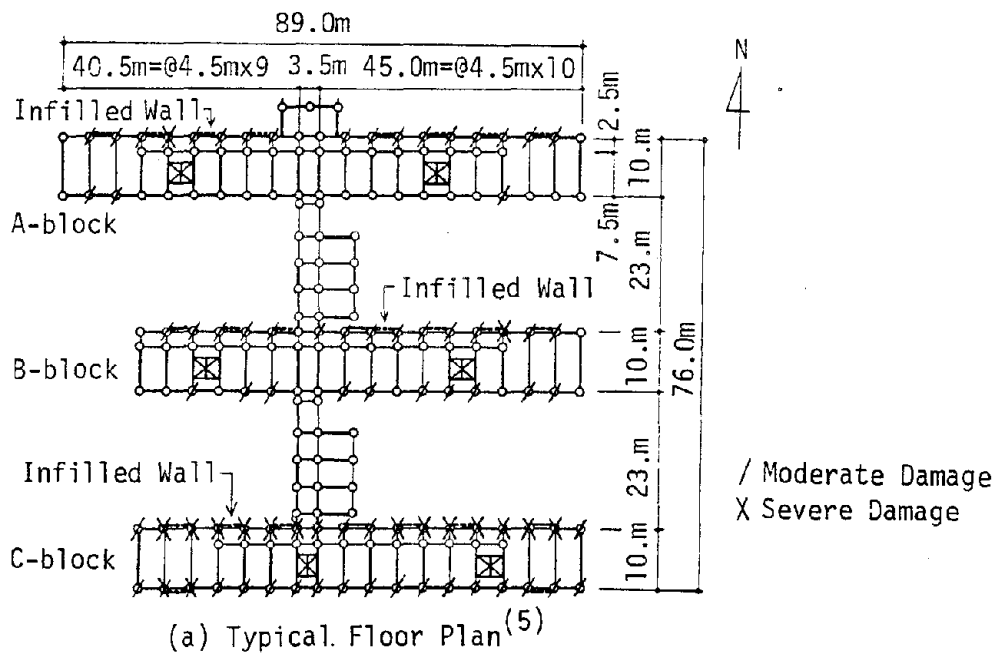
(b) Damage to Columns (June, 1978)

FIG. 13 A STRENGTHENED SCHOOL BUILDING

School Building (2) [5] - Three buildings in the school sustained severe or moderate damage, as shown in Fig. 13(a) and (b), mainly to captive columns at the north side during the earthquake of June, 1978. The damage oriented to the longitudinal direction. Severely damaged columns were replaced with new concrete providing additional reinforcements. Some of other columns were only epoxied or replaced at cover concrete. In each building, concrete walls were placed within northside longitudinal frames at every two spans in the lowest two stories and

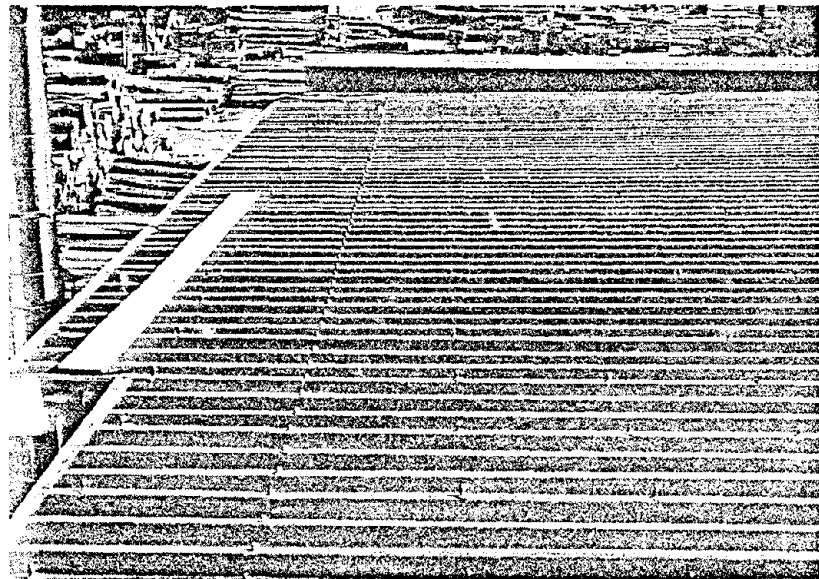
Fig.1 Repair for Improvement of Yield Shear Coefficient

Before the Miyagi-Ken-Okii Earthquake, this office building had a concrete flat slab as the roof. Because the braces were damaged due to the earthquake, the roof was replaced with light steel slates.

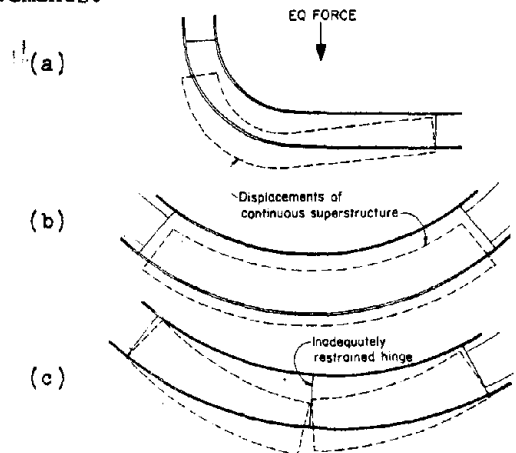
Figure 4

One of the more common seismic deficiencies is shown in Figure 4(c). Joints at the ends of simple spans and intermediate expansion joints in long continuous bridges permit the bridge to act as a number of individual units when shaken by an earthquake. Even moderate earthquakes may damage the bearings and joints in the decks, curbs, and railings of these structures. More severe or longer duration earthquakes can fail bearings and cause excessive forces and deflections in the columns, leading to collapse. If these

EFFECT OF EQ FORCES
ON CURVED BRIDGES

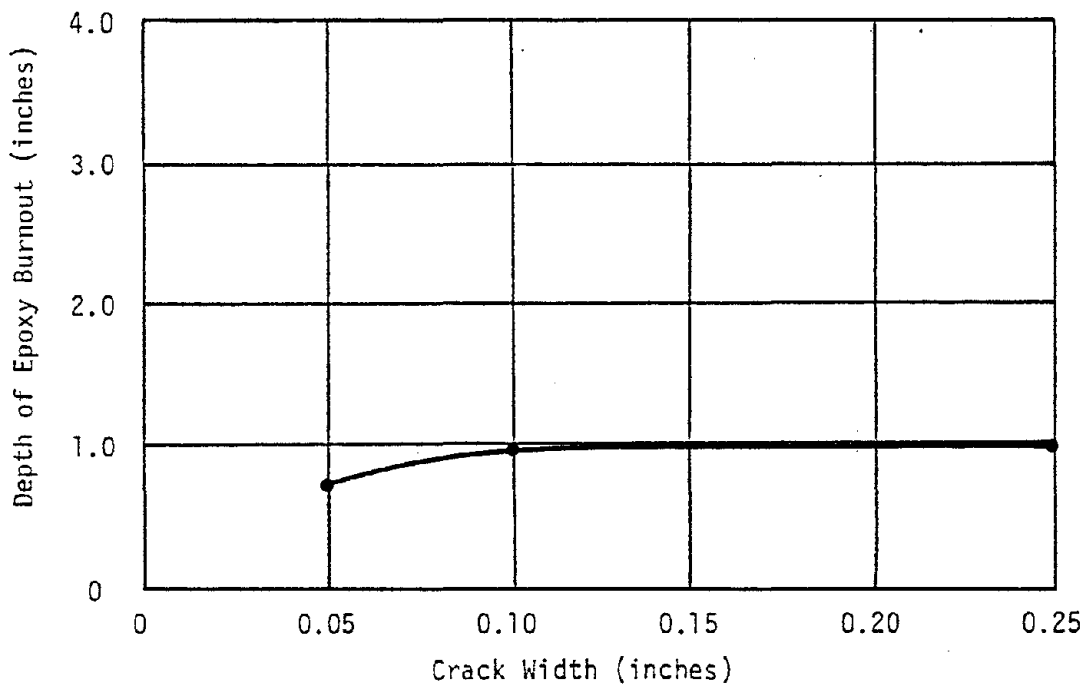
Fig. C-1b : Average Depth of Epoxy Burnout as a Function of Crack Width

Tables C-1, C-2, and C-3 provide the test data for each specimen including the ultimate compression strength and the depth of epoxy burnout. Figs. C-1, C-2, and C-3 provide the graphical summary of average test results including average ultimate compressive stress and depth of epoxy burnout as a function of crack width. Fig. C-4 provides a complete summary of test results for average ultimate compressive stress and average depth of epoxy burnout as a function of wall thickness. Fig. C-5 provides a pictorial view of a typical failure pattern for specimens tested in this chapter. Ultimate compressive stress is a function of crack width due to the development of higher frictional forces between concrete surfaces in the case of smaller crack widths. Depth of epoxy burnout is not significantly affected by crack width. The failure pattern for the 6 in. thick wall specimens consisted of shear failure in the epoxy since the temperatures within the specimens during the compression tests were above the heat distortion temperature. The failure pattern for most 8 in. and 10 in. shear wall specimens generally consisted of shear failure within concrete in regions where the epoxy was not burned out.

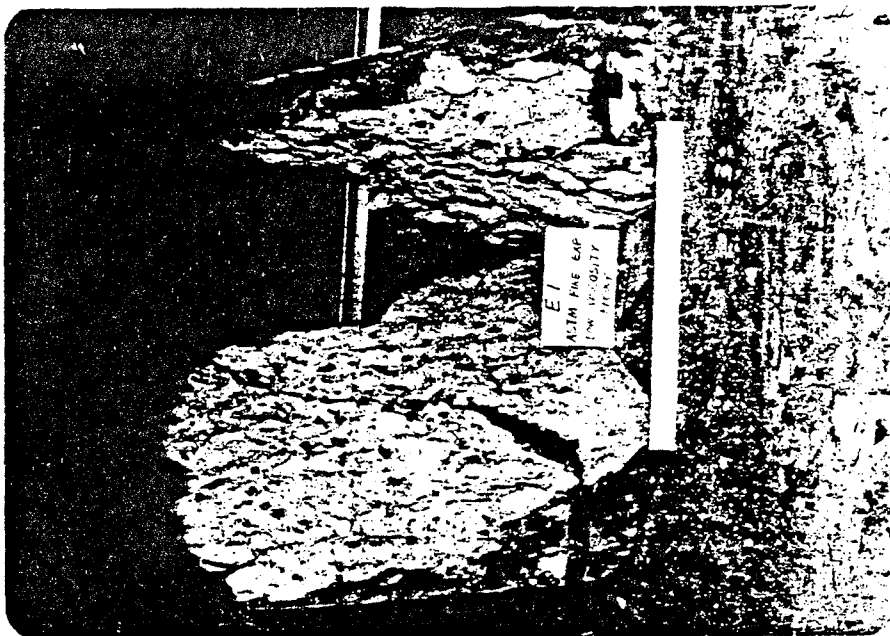
Fig. D-5b : Failure pattern for 8 in Thick Specimen. Note the Shear failure through Concrete not through Epoxy.
