**PMFSEL REPORT NO. 86-5
MAY 1986**

**SEISMIC STRENGTHENING OF A
REINFORCED CONCRETE FRAME
USING STRUCTURAL STEEL BRACING**

**Elizabeth A. Jones
James O. Jirsa**

**PHIL M. FERGUSON STRUCTURAL ENGINEERING LABORATORY
Department of Civil Engineering / Bureau of Engineering Research
The University of Texas at Austin**

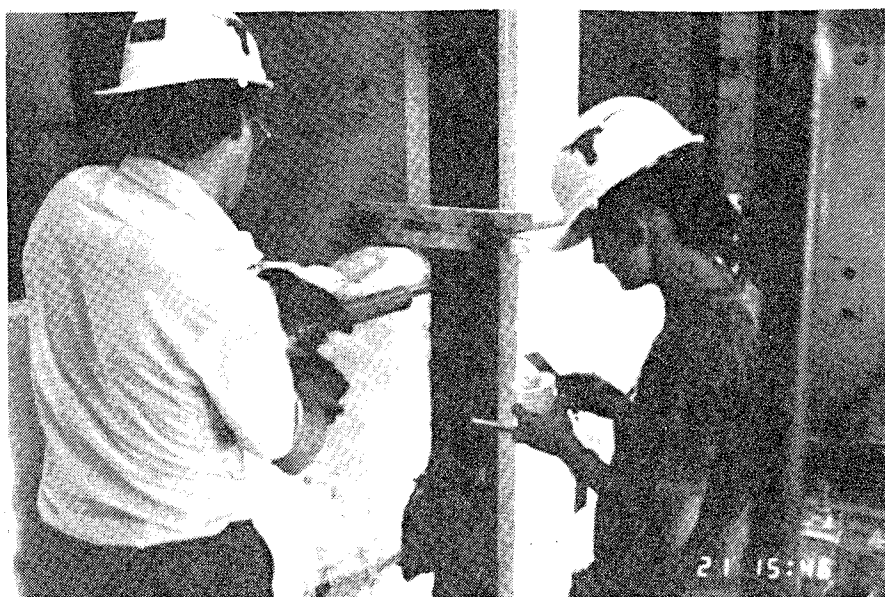
Fig. 3.23 Epoxy application procedure

Figure 3.23 shows the epoxy application procedure. A caulk gun was used to apply epoxy directly to the rear of the hole. As the hole filled, the caulk gun was gradually backed out until about 60 percent of the hole was full. The dowel was pushed into the hole and rotated one turn until it bottomed out. Extra epoxy was forced out of the hole and into the annulus between the bolt and hole in the steel section. Where the steel element was not flat against the concrete, extra epoxy was forced into the gap. Any additional epoxy was removed with a spatula.

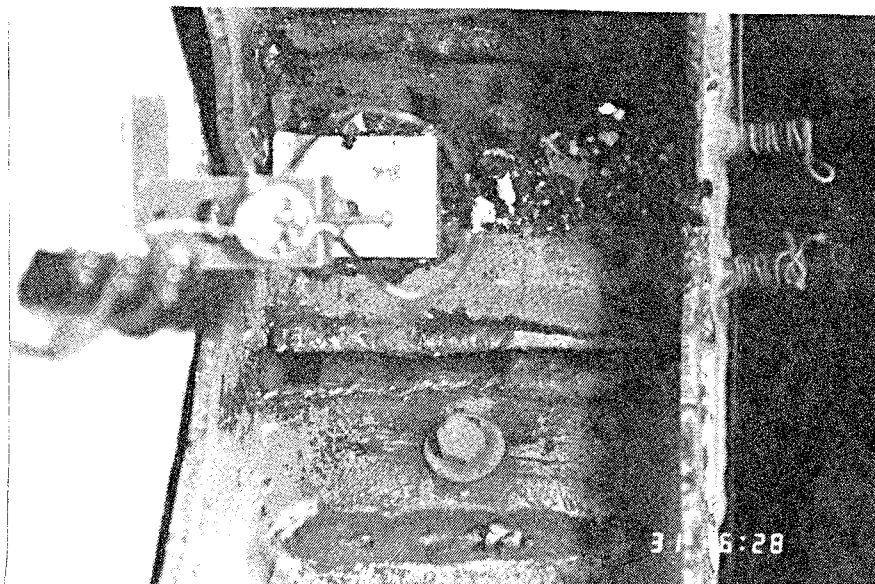
Fig. 4.14 Weld failure at bottom of brace T2

Figure 4.14 shows the weld failure at the bottom of brace T2. The local buckling caused by high strains at the ends may be seen in the top left corner of the photo.

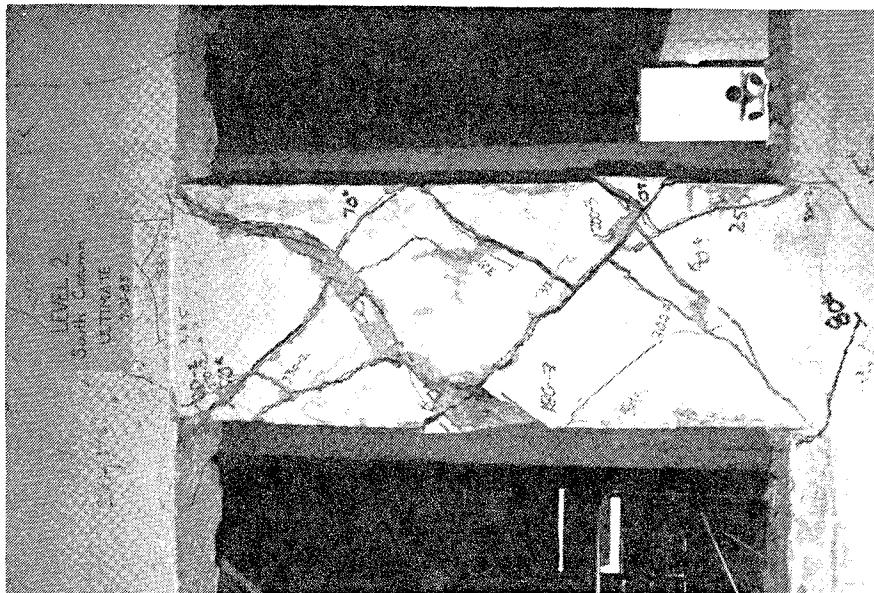
Fig. 4.15 Second level columns at ultimate

Load was applied for the final time reaching 220 kips before dropping to 125 kips when the bottom welds of both tension braces, T1 and T3, fractured completely. At point 17, the second level interstory drift was 1.3 percent. Around this time, the columns at the second level failed in shear in the south direction. Figure 4.15 shows the wide cracks and exposed reinforcement in the columns at the end of the test.

(a) South column

(b) North column

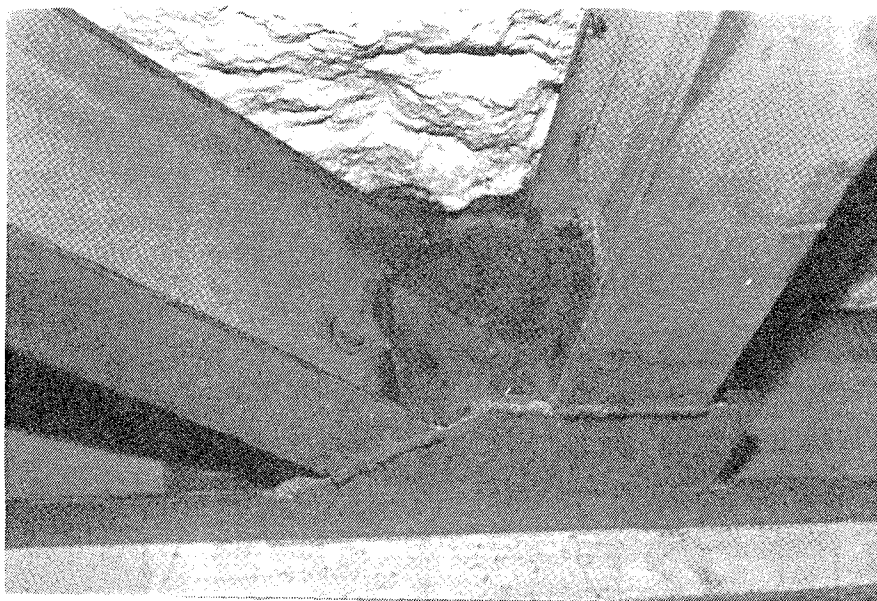
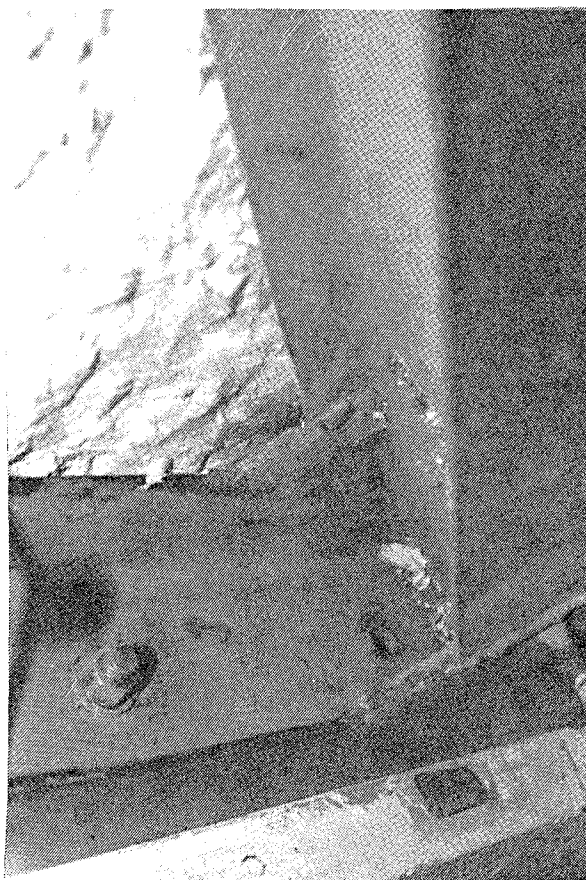
Fig. 4.23 Close-up of welded connection

Unless the brace flanges and webs were aligned almost perfectly with the gusset plates, it was impossible to build up a weld connecting the entire end surface of the brace to the gusset plates without clamps. This was especially true for the middle connection where the braces were welded to 1/4 in. web gusset plates and 1/4 in. thick tee flanges. The two-thirds scale braces (flange and web thicknesses of 3/16 in.) magnified the problem of aligning two thin plates and increased the probability of local buckling. Figure 4.23 shows two close-up views of the brace-to-channel connection. Note the very thin brace and collector tee flanges framing into the 1/2 in. gusset plates.
