DEVELOPMENT OF METHODOLOGY FOR
RETROFITTING WATER LIFELINES FOR
IMPROVED SEISMIC RESISTANCE

March 1985

Environmental Quality Systems, Inc.
1160 Rockville Pike
Rockville, MD 20852

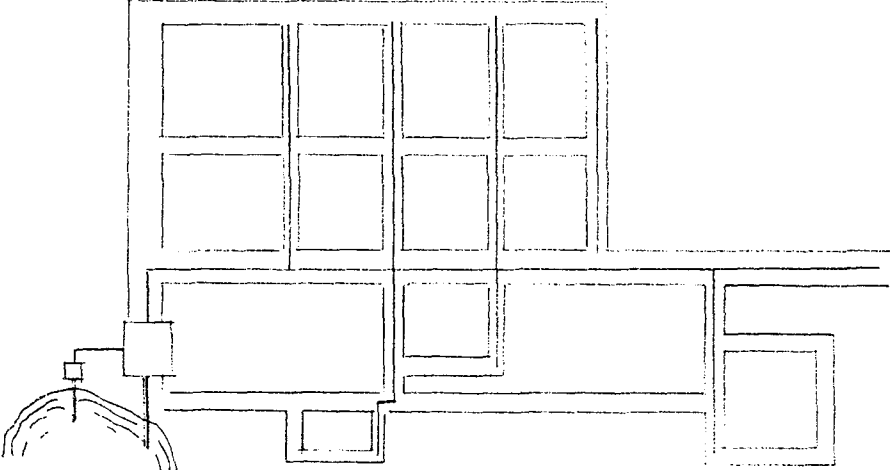
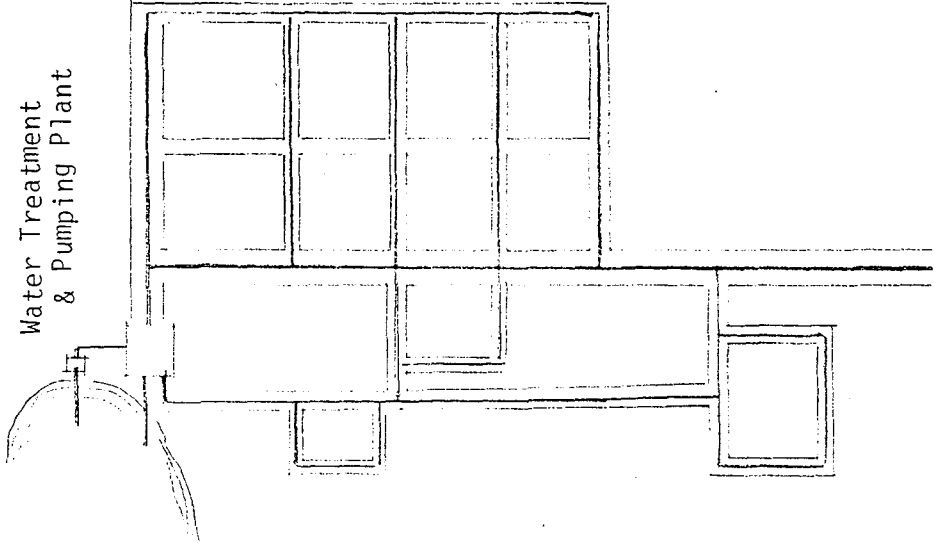
Figure V-1 Water Distribution Network for Municipal Size Facility (56)

Comments	b) Poor Practice	a) Good Practice
<p>Use grid system when laying out municipal size water distribution facilities. The grid system promotes maximum flexibility in water distribution.</p> <p>The good practice distribution system cannot be put out of service by a break in any one line.</p>	<p>b) Poor Practice</p>

<p>a) Good Practice</p> <p>Water Treatment & Pumping Plant</p>

Redundancy in a distribution network can be measured by the number of paths available from the treatment facility or storage facility to a given location. Older systems and systems in sparsely populated areas may have feeder lines with branches or dead ends as shown in Figure V-1. Increased redundancy within the system can be achieved by reducing the number of dead end lines by looping as shown in Figure V-1a (56).

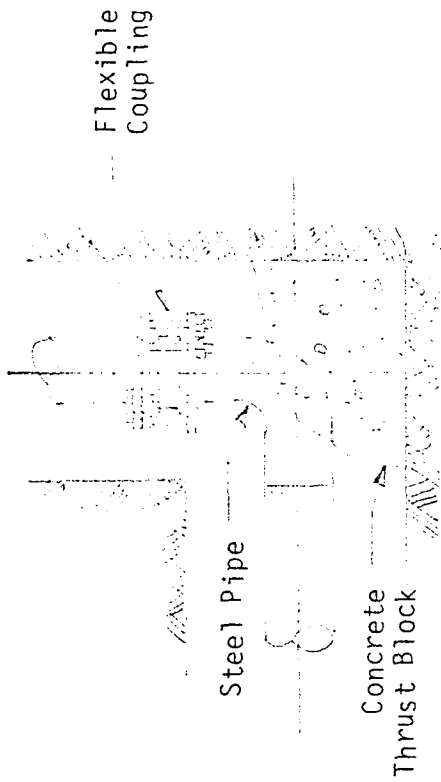
Figure V-10 Flexible coupling installation for bends with thrust block (60, 61)

(a) Good Practice

(b) Poor Practice

Comment: For steel pipe, a flexible joint can be achieved by using flexible couplings. Proper inspection requires the thrust block not interfere with the action of the flexible coupling.

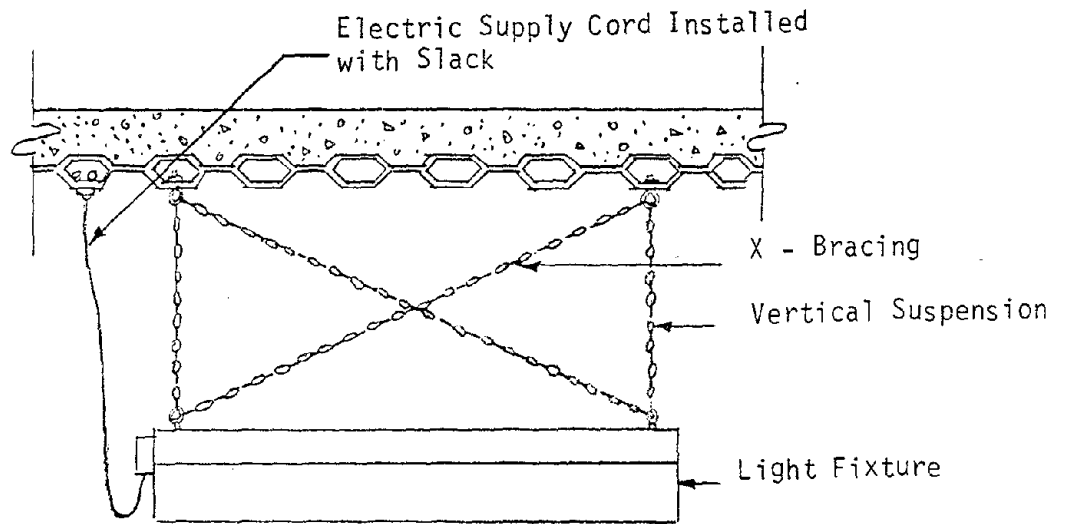
Figure V-31 Suspended Light Fixture (71)

To prevent this, the lower nut should be removed or loosened from the hanger, thus, allowing the fixtures to pivot at the top of the hanger and swing freely. The upper nut must be provided with a locking device, such as a double nut, to prevent loosening. In addition, an arrangement of safety chains should be provided which is capable of supporting the fixture weight, attached from the light to the ceiling support system. Care must be exercised to be sure chain connections are independent from existing hanger rods. Individual fluorescent fixtures should be provided with a minimum of 2 safety chains located symmetrically with the center of fixture mass and attached with eye bolts to the fixture and ceiling. Typical existing fixtures with recommended seismic modifications are shown in Figures V-30 and V-31.

in any direction. Modification of the fixed connection by the loosening of the bottom nut at the top of the rod connection should be performed. Again, the upper nut should have locking device to prevent loosening. To prevent the fixture from falling, the addition of safety chains are recommended.
