REPORT NO.  
UCB/EERC-91/12  
OCTOBER 1991

EARTHQUAKE ENGINEERING RESEARCH CENTER

# PERFORMANCE OF IMPROVED GROUND DURING THE LOMA PRIETA EARTHQUAKE

Report No. UCB/EERC-91/12  
Earthquake Engineering Research Center  
College of Engineering  
University of California at Berkeley

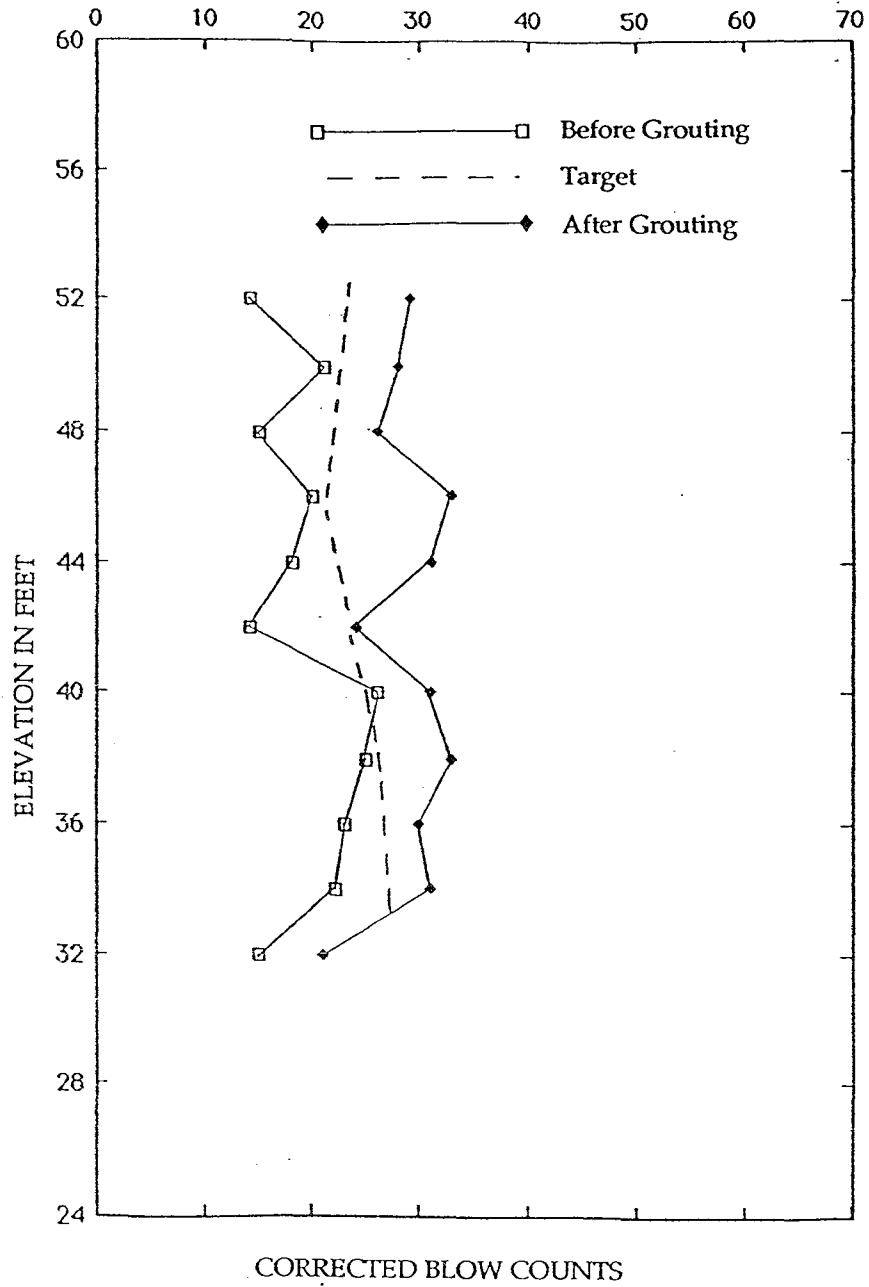
Fig. 30 Mean Corrected Blow Count Values in Test Section Before and After Compaction Grouting, Kaiser Hospital, South San Francisco (N. C. Donovan, 1978)

To evaluate the effectiveness of the procedure in densifying the fill layer, CPTs and SPTs were performed before and after the grouting. The CPT values were converted to equivalent SPT values as most available liquefaction potential relationships were based on SPT blow counts at the time. A comparison of the equivalent SPT blow counts before and after grouting in the test section using an eight-foot on center injection point spacing in a triangular grid pattern is shown on Fig. 30. This pattern was considered to be the optimum configuration to achieve the required relative density.
