Title: Feasibility Study of Replacement Procedures and Earthquake Performance Related to Gas Transmission Pipelines.

Authors: T. D. O'Rourke and M. C. Palmer.

Performing Organization: National Center for Earthquake Engineering Research, Buffalo, NY. **Cornell Univ., Ithaca, NY. School of Civil and Environmental Engineering.

Two transmission pipelines, Lines 121 and 123, were selected for a feasibility study. Both lines were constructed in 1930, and therefore represent older, more vulnerable portions of the system which are joined with oxy-acetylene welds. Emphasis in this work has been placed on characterizing the geotechnical and earthquake hazards to these pipelines, especially the potential for surface faulting and large ground deformation caused by liquefaction.

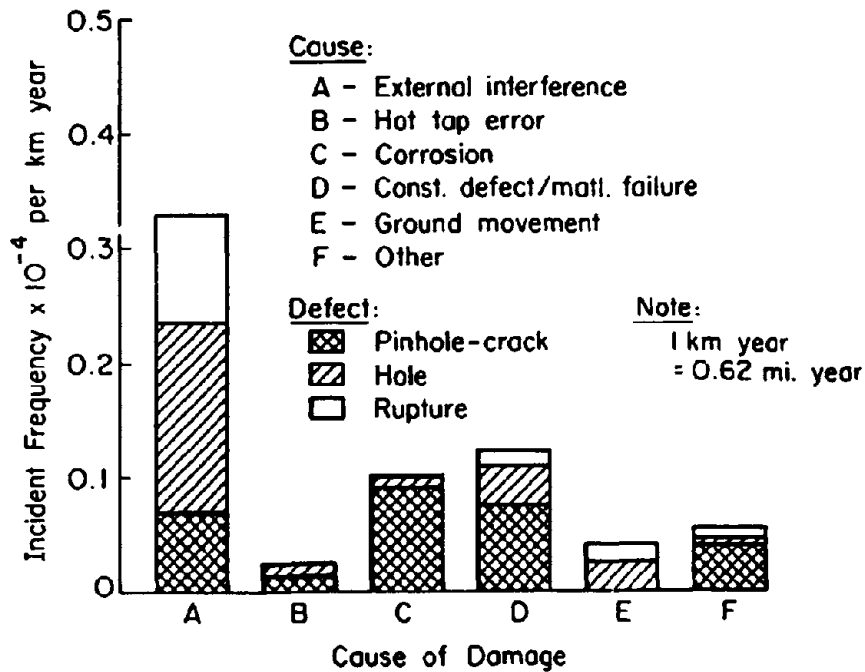
FIGURE 2-3. Incident Frequency According to Cause of Incident [after European Gas Pipeline Incident Group, 1988]

Figure 2-3 shows the frequency of incidents by cause, in which frequency is expressed per km/year. Mechanical interference by external force is the main cause of accidents and is responsible for the majority of incidents involving large losses of gas, including ruptures. Approximately 50% of all incidents were attributed to this cause. Construction defect/material failure and corrosion are the second and third principal causes of failure, respectively. No ruptures were attributed to corrosion.

Figure 2-5 shows the incident frequency for all pipelines damaged by external interference plotted as a function of pipe wall thickness. Please note that the incident frequency for pipe with wall thickness less than 5 mm (0.20 in.) exceeds the incident frequency for all external interference in Figure 2-3. There are a smaller number of thin wall pipes relative to others in the European systems. As a result, the km years associated with thin wall pipes are less than the 970,000 km years (603,000 mi. years) for the entire database, thereby yielding a higher frequency of incidents.

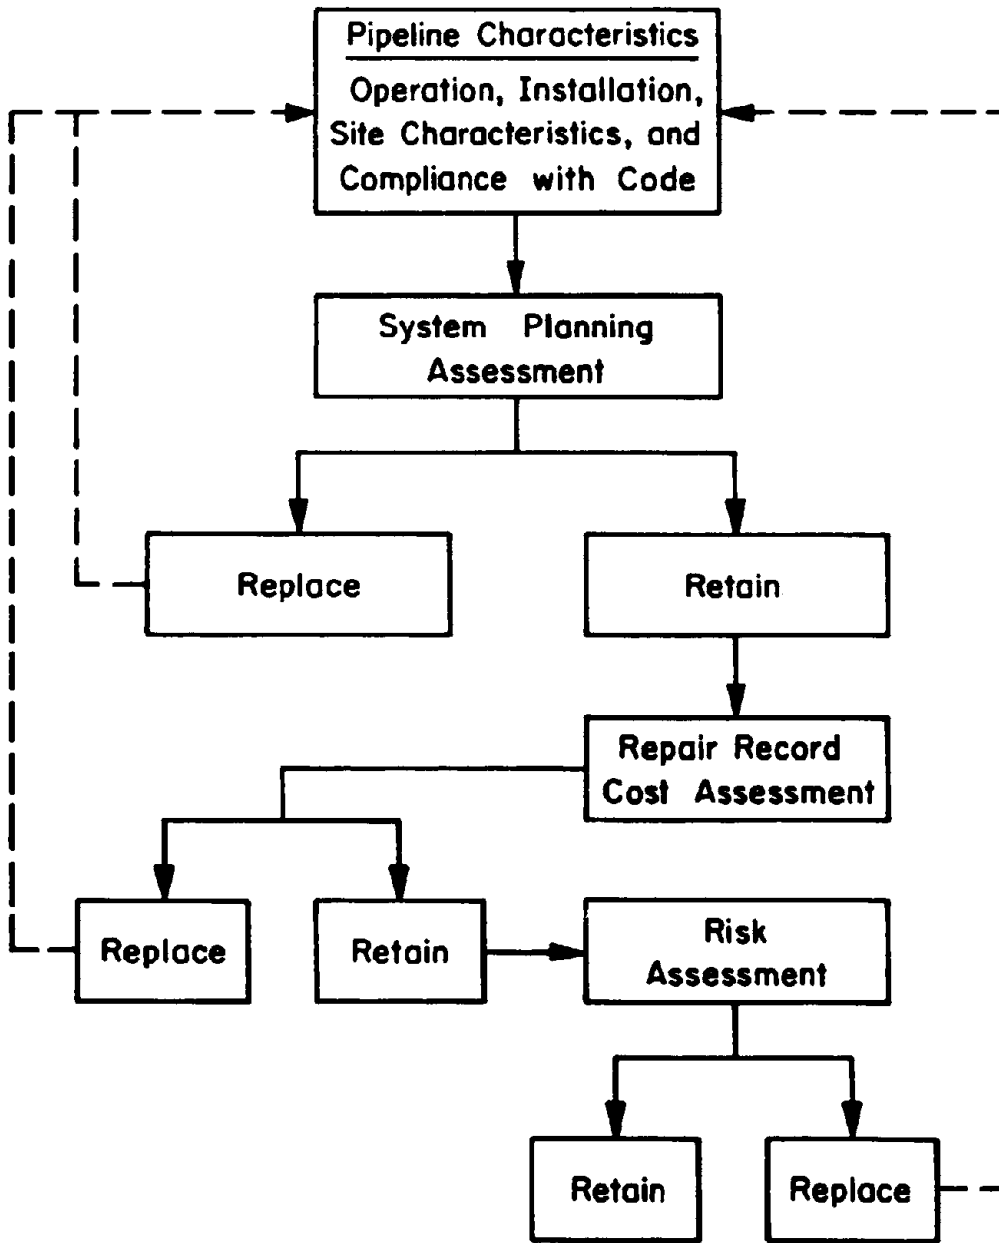
FIGURE 5-2. Flow Chart for Retention/Replacement Decisions About Steel Gas Pipelines

After considerable discussion with SoCalGas personnel and a thorough review of the VCA approach, a general replacement procedure is recommended in the form of the flow diagram in Figure 5-2. Although the flow chart has been developed so it is amenable to either transmission or distribution pipelines, its primary advantage for SoCalGas will be its application to the company's supply line system.

The flow chart shows a three-step process in which a system planning assessment is made, followed by a repair record cost assessment, with a risk assessment completing the evaluation. At each stage in the evaluation, a decision to replace or retain is made. If the pipeline is to be replaced at any of the three stages, the flow chart shows, by means of dashed lines, a return to specifying new pipeline characteristics and repeating the three tier decision process.

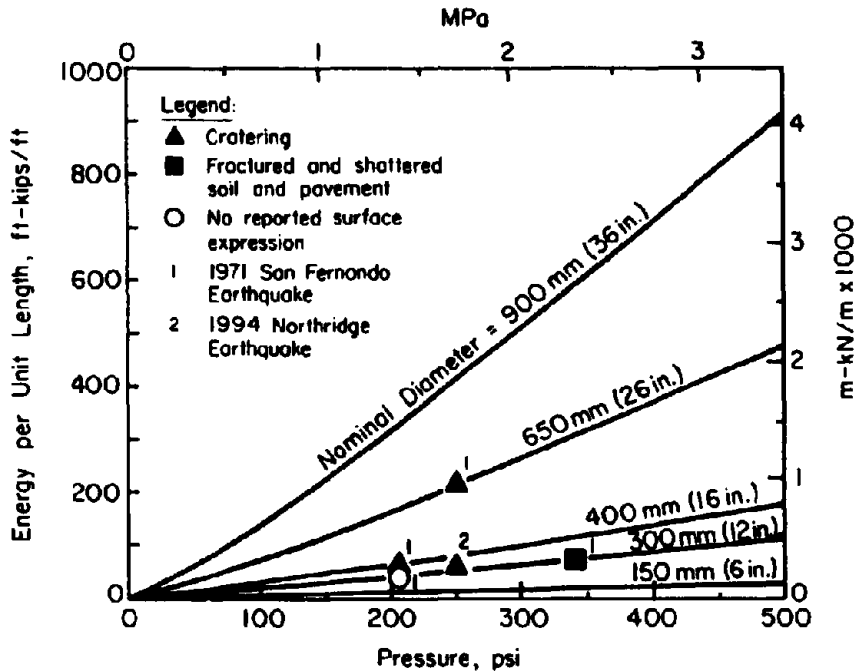
FIGURE 5-4. Energy per Unit Length of Pipeline as a Function of Pressure and Diameter

Figure 5-4 presents a family of curves developed from Equation 2-2 which show how the energy per unit pipeline length varies as a function of pressure for various nominal diameters. Five points are plotted on the figure, which represent pipeline diameters and operating pressures associated with the girth weld rupture of transmission and supply lines during the 1971 San Fernando and 1994 Northridge earthquakes. Cratering after the 1971 San Fernando earthquake was observed at locations of girth weld failure in Line 115 [400-mm- (16-in.)-diameter] and Line 85 [650-mm- (26-in.)-diameter], whereas heaved and shattered soil and pavement were observed at locations of failure in Line 1001 [300-mm- (12-in.)-diameter]. No surface manifestations of rupture were reported for Line 102.90 [300-mm- (12-in.)-diameter]. Records exist for the MAOP and actual operating pressures in 1971 and 1994, respectively. It is recognized that using the MAOP may result in a somewhat higher operating pressure than that at the time of the earthquake. This simplification, however, does not affect the conclusions drawn, nor the method proposed here for relative risk assessment. Cratering after the 1994 Northridge earthquake was observed at multiple locations of failed oxy-acetylene girth welds along Line 1001, including the large crater and ensuing fire at Highway 126 at the eastern outskirts of Fillmore. Evidence of cratering was not used for the rupture of Line 120 on Balboa Blvd. because it is not possible to determine the extent to which water trunk line failures at these locations contributed to soil and pavement disruption.

The figure allows for the superposition of energy associated with various pipelines and the occurrence of cratering or severe surface disturbance in the field. The onset of cratering and shattered soil correlates approximately with an energy of 276 m-kN/m (62.1 ft-kips/ft). This value is used as a reference energy, W_N , in Figure 5-5, which shows a family of dimensionless curves in which energy is normalized with respect to the reference value.

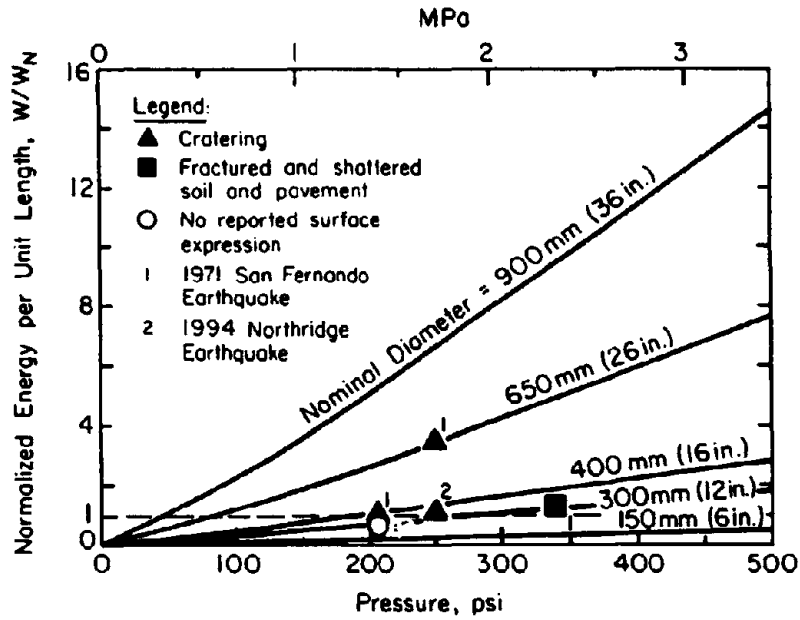
FIGURE 5-5. Normalized Energy per Unit Length of Pipeline as a Function of Pressure and Diameter

Figure 5-5 is expressed in a matrix format in Figure 5-6. This latter figure shows the normalized values of energy according to a row and column structure, organized with respect to nominal pipe diameter, as given by API 5L [API, 1987], and level of operating pressure. The matrix shows the energy levels for various pressures and diameters scaled according to the reference energy that correlates with cratering and severe surface disturbance in the field.

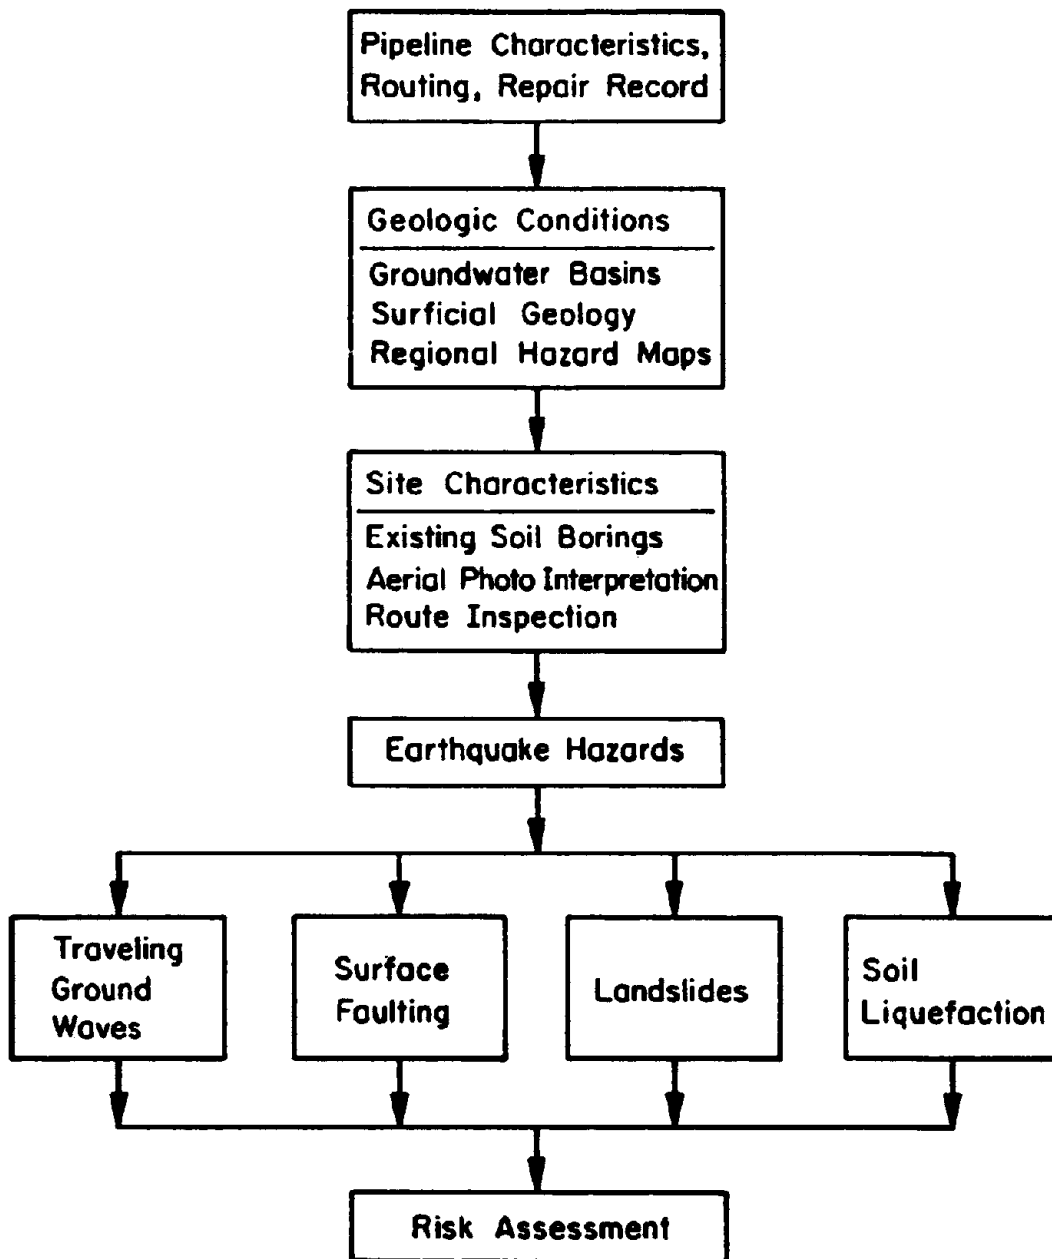
FIGURE 5-8. Flow Chart for Assessing the Relative Risk of Earthquake Hazards to Steel Pipelines

Figure 5-8 presents a flow chart of the methodology followed in this report to

assess earthquake hazard effects on steel pipelines. The use of the methodology is demonstrated in Section 6 by means of its application to two existing supply lines. It is recommended that the general approach outlined in Figure 5-8 be followed in assessing the relative seismic risk to other transmission and supply lines. The methodology is based largely on reconnaissance information. The synthesis and interpretation of such information should be performed by one who is experienced and qualified to make geotechnical engineering evaluations.

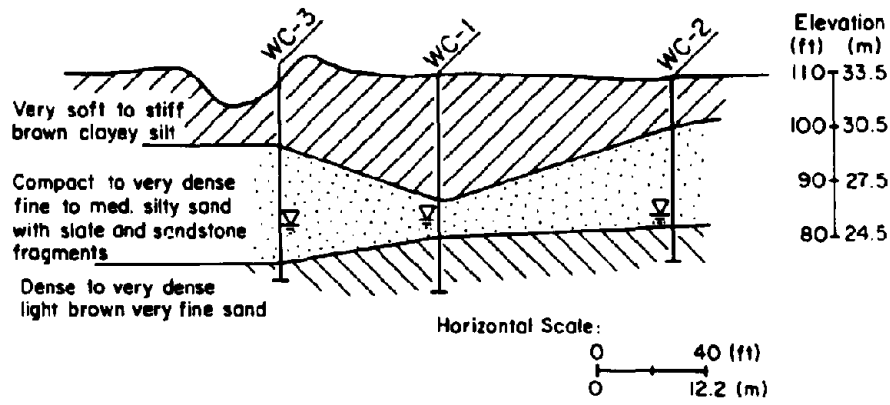
a) Sawtelle Plain

b) Ballona Gap

FIGURE 6-6. Soil Profiles Along Pipeline Route at Sawtelle Plain and Ballona Gap

Figure 6-6 shows simplified soil profiles representative of the soils encountered in the Sawtelle Plain and Ballona Gap. The borings used to draw the representative profile for Sawtelle Plain are located at the crossing of the San Diego Freeway and the Westwood Flood Control Channel near Palms Blvd. The soil profile in this area consists of an upper 3 to 4 m (10 to 12 ft) of clayey silt, with an underlying 4-m- (12-ft)-thick stiff clayey silt layer that contains slate and shale fragments. The bottom 5 m (15 ft) of the borings reveal a dense to very dense light brown very fine sand. Groundwater was encountered at depths of about 12 m (36 ft), with artesian pressures at a level of 8 to 9 m (25 to 27 ft) below the surface.

The borings used to draw the representative soil profile for Ballona Gap are located across Ballona Creek. The soil profile here consists of an upper 1- to 2-m (3- to 6-ft)-layer of compact clayey silt fill underlain by an 8- to 10-m-

The aerial photos were studied to identify landforms, soil types, vegetative patterns, variations in topography, and other features which would help in assessing the potential for liquefaction and associated large ground deformation. For example, aerial photo analysis of areas in the Sawtelle Plain disclosed a location along the pipeline route of potentially high water table, as evinced by surface drainage features and concentrations of vegetation. This area was very close to the location of the soil profile in Figure 6-6a, which shows soils that

Figure 6-8 presents a 1938 aerial photograph of the area where Line 123 crosses Ballona Creek and enters through a small canyon at the bottom right of the photo into the Baldwin Hills. The location of this photo is shown in Figure 6-5. The alluvial valley of Ballona Gap, the western boundary of the Baldwin Hills, the alluvial fan underlying the pipeline, and the alluvial fan of Centinela Creek are labeled in the figure. The surficial boundaries of the alluvial fans have been outlined, based on stereographic interpretation of the photos. The locations of Caltrans soil borings, denoted as Locations A and B, are marked. Location A pertains to the soil profile illustrated in Figure 6-6b.

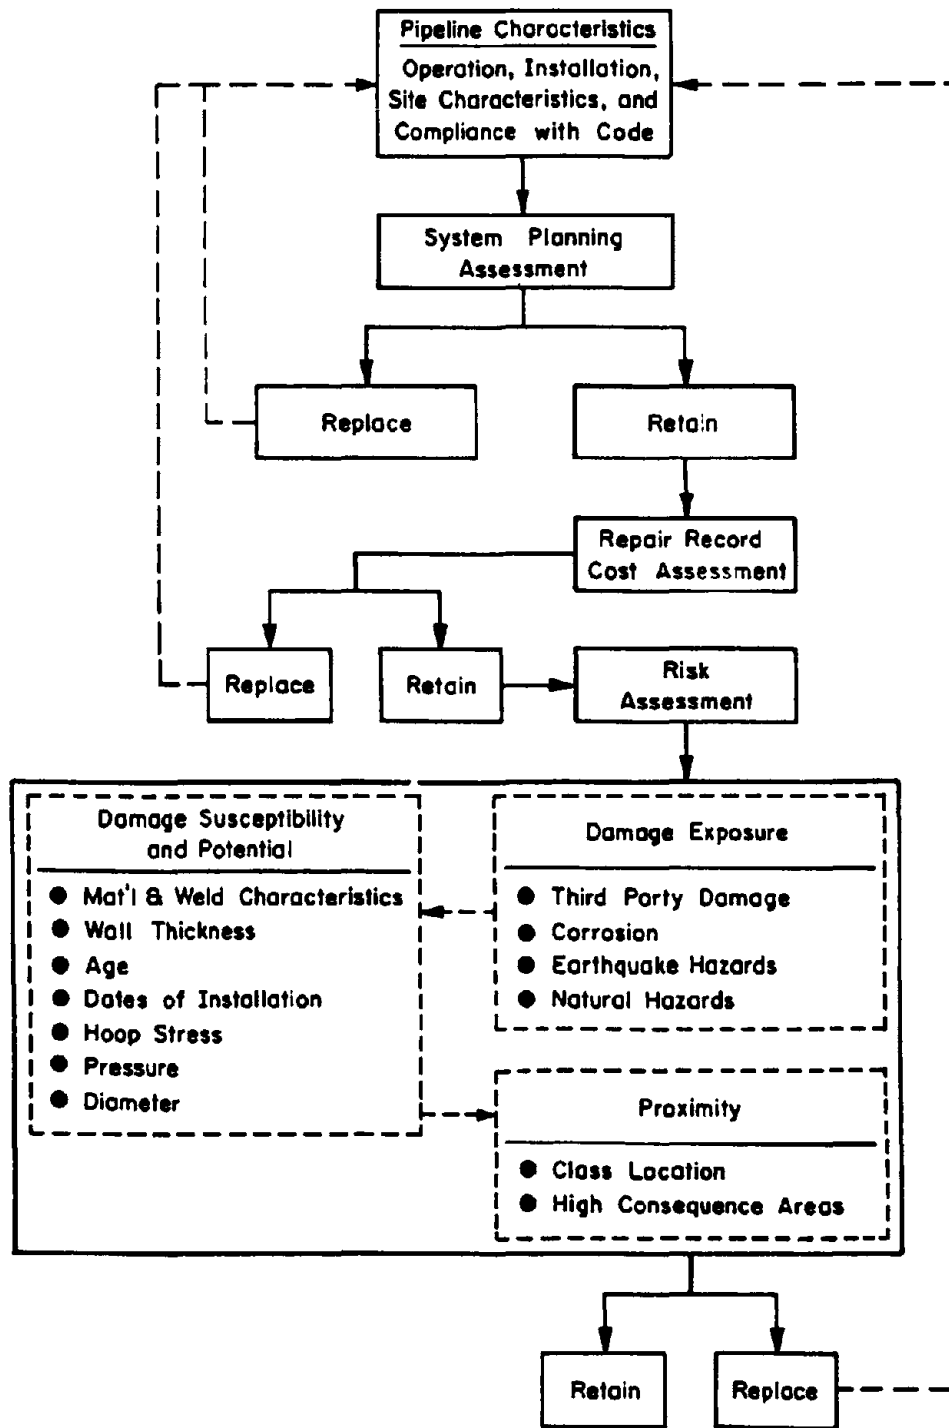
FIGURE 7-2. Flow Chart Showing General Replacement Procedure for Steel Pipelines

in Figure 7-2. Although the flow chart has been developed so it is amenable to either transmission or distribution pipelines, its primary advantage is likely to be realized for the distribution supply line system.

As illustrated in Figure 7-2, risk assessment is performed in a three-step process, similar to the procedure followed in the VCA approach. Damage exposure represents the major hazards which need to be considered, including third party damage, corrosion, earthquake hazards, and natural hazards, such as flooding and landslides. Third party damage is defined as damage compromising pipe wall, welds, coating, connections, attachments, and associated devices which is the result of forces and deformations imposed on the pipe by external activity, such as construction, agricultural work, subsurface exploration, and abnormally heavy surface loads. The procedure developed in this study for evaluating the relative risks from earthquake hazards should be used in this part of the risk assessment process.
