Recommended Postearthquake Evaluation and Repair Criteria for Welded Steel Moment-Frame Buildings

SAC Joint Venture

June, 2000

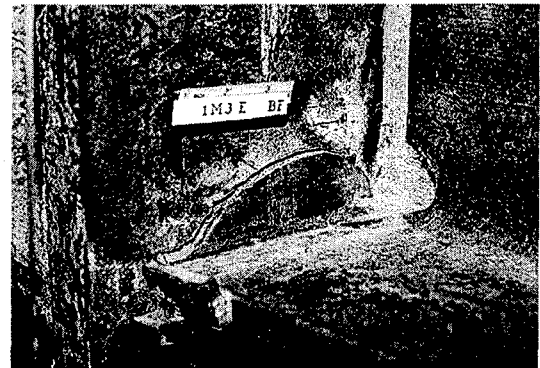
a. Fracture at Fused Zone

b. Column Flange "Divot" Fracture

Figure 1-3 Fractures of Beam to Column Joints

In some cases, the fractures progressed completely through the thickness of the weld, and when fire protective finishes were removed, the fractures were evident as a crack through exposed faces of the weld, or the metal just behind the weld (Figure 1-3a). Other fracture patterns also developed. In some cases, the fracture developed into a crack of the column flange material behind the CJP weld (Figure 1-3b). In these cases, a portion of the column flange remained bonded to the beam flange, but pulled free from the remainder of the column. This fracture pattern has sometimes been termed a “divot” or “nugget” failure.

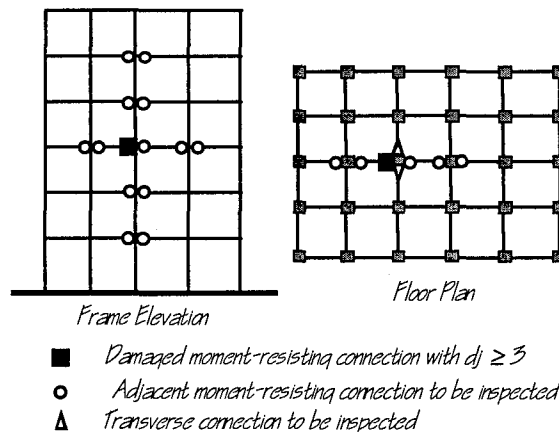
Figure 4-4 Inspection of Connections Adjacent to Damaged Connection ($d_j \geq 3$)

- When a connection is determined to have a damage index $d_j \geq 3$, inspect all of the moment-resisting connections in that line of framing on both sides of the affected column and of the column(s) adjacent to the affected column at that floor level and on the affected column at the two floor levels immediately above and below the damaged connection (See Figure 4-4). Also inspect any connections for beams framing into the column in the transverse direction at that floor level at the damaged connection.

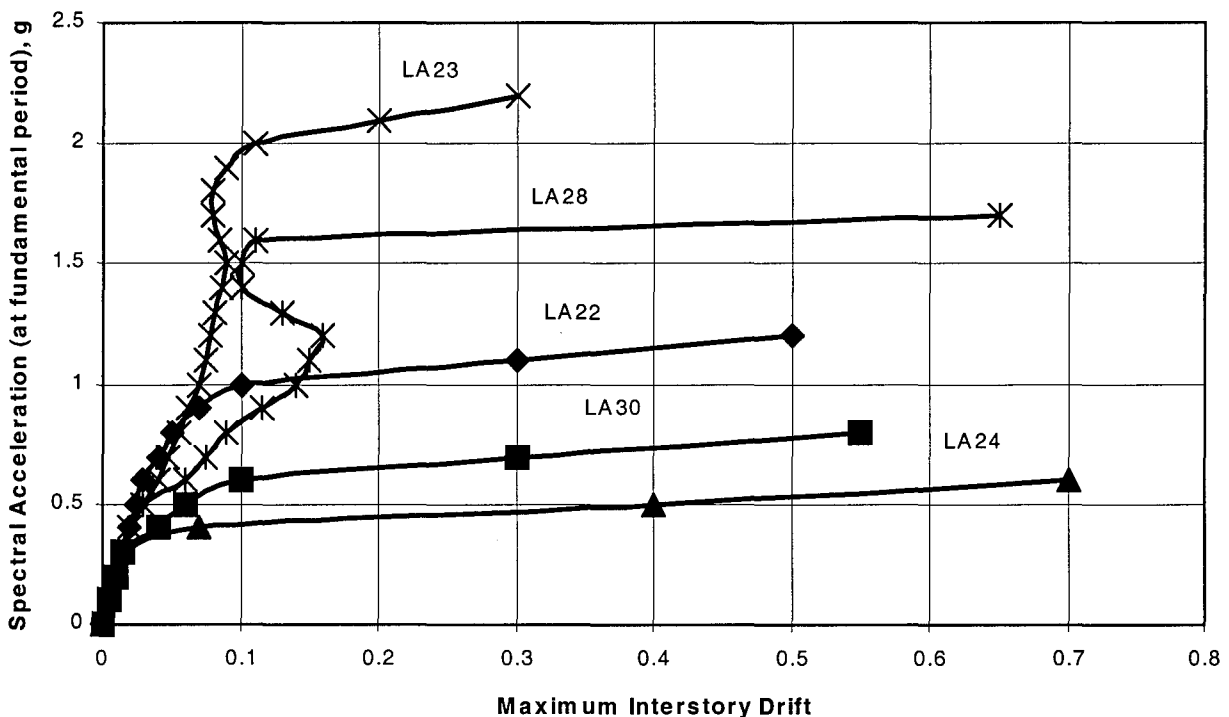
Figure A-1 Representative Incremental Dynamic Analysis Plots

7. Determine a median interstory drift capacity for global collapse C as the median value of the calculated set of interstory drift capacities, determined for each of the accelerograms. Note that the median value is that value exceeded by 50% of the accelerograms.
