Evaluation of Earthquake Damaged Concrete and Masonry Wall Buildings

FEMA 307

Technical Resources

The Applied Technology Council

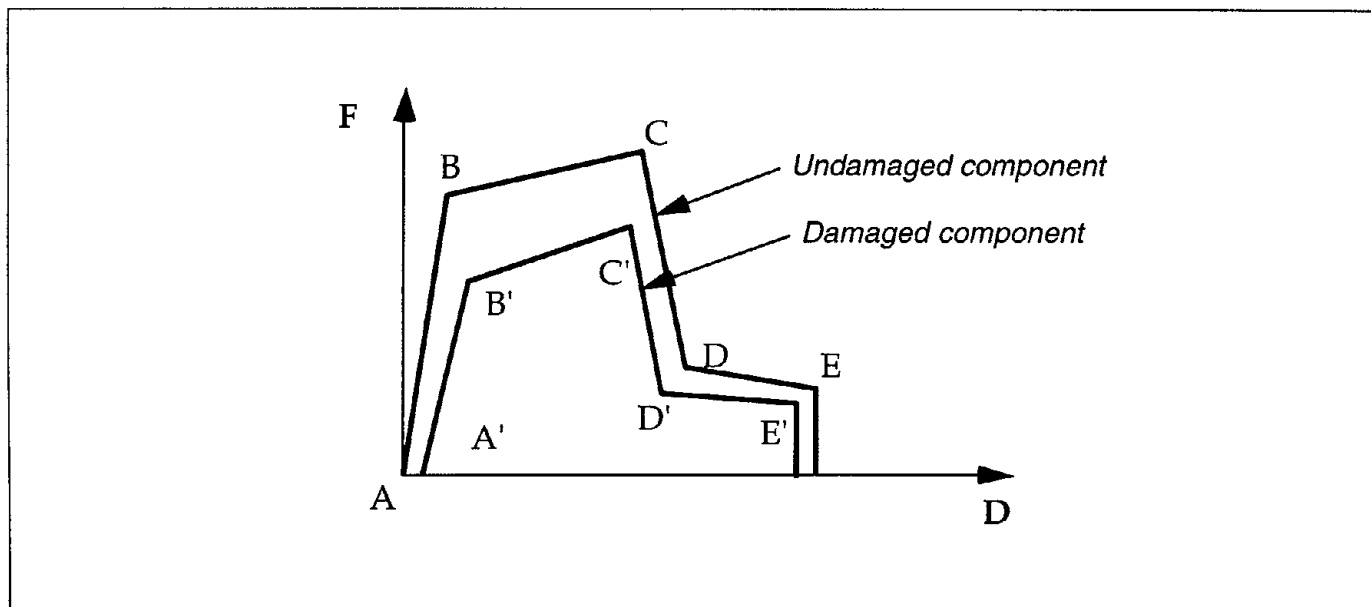
Figure 1-2 Generalized Undamaged and Damaged Component Curves

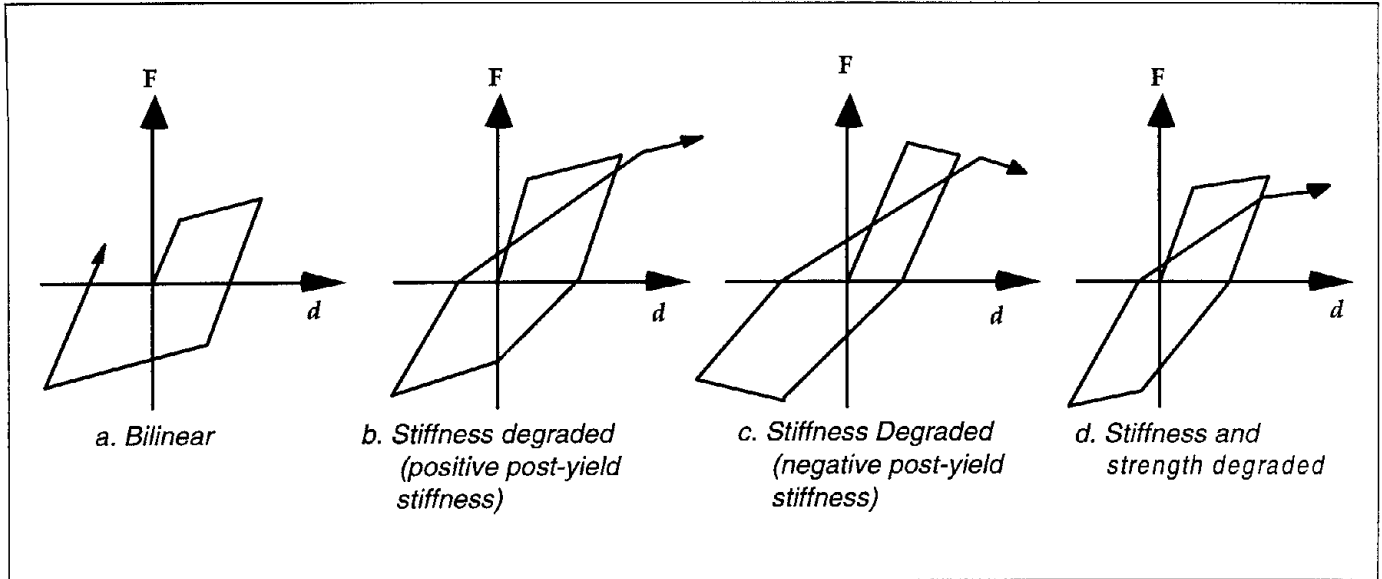
Figure 1-4 Global Load-Displacement Relationships

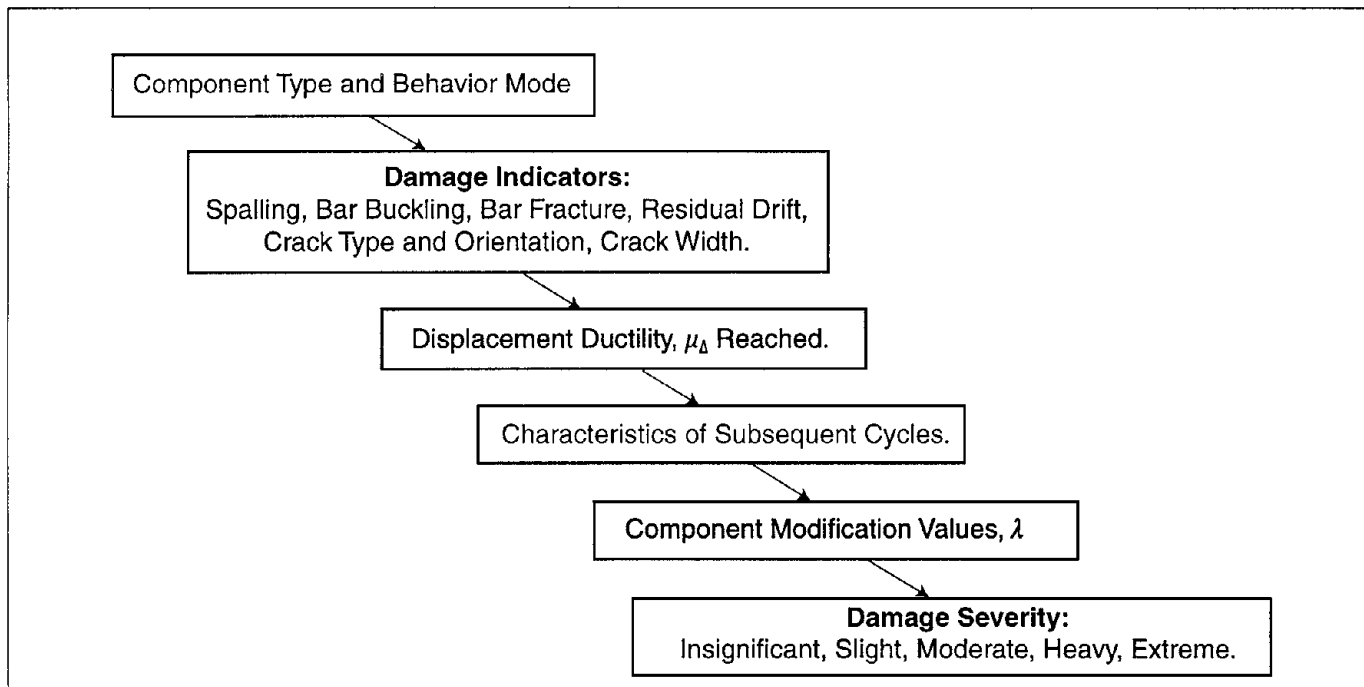
Figure 2-1 Diagram of process used to develop component guides and component modification factors.

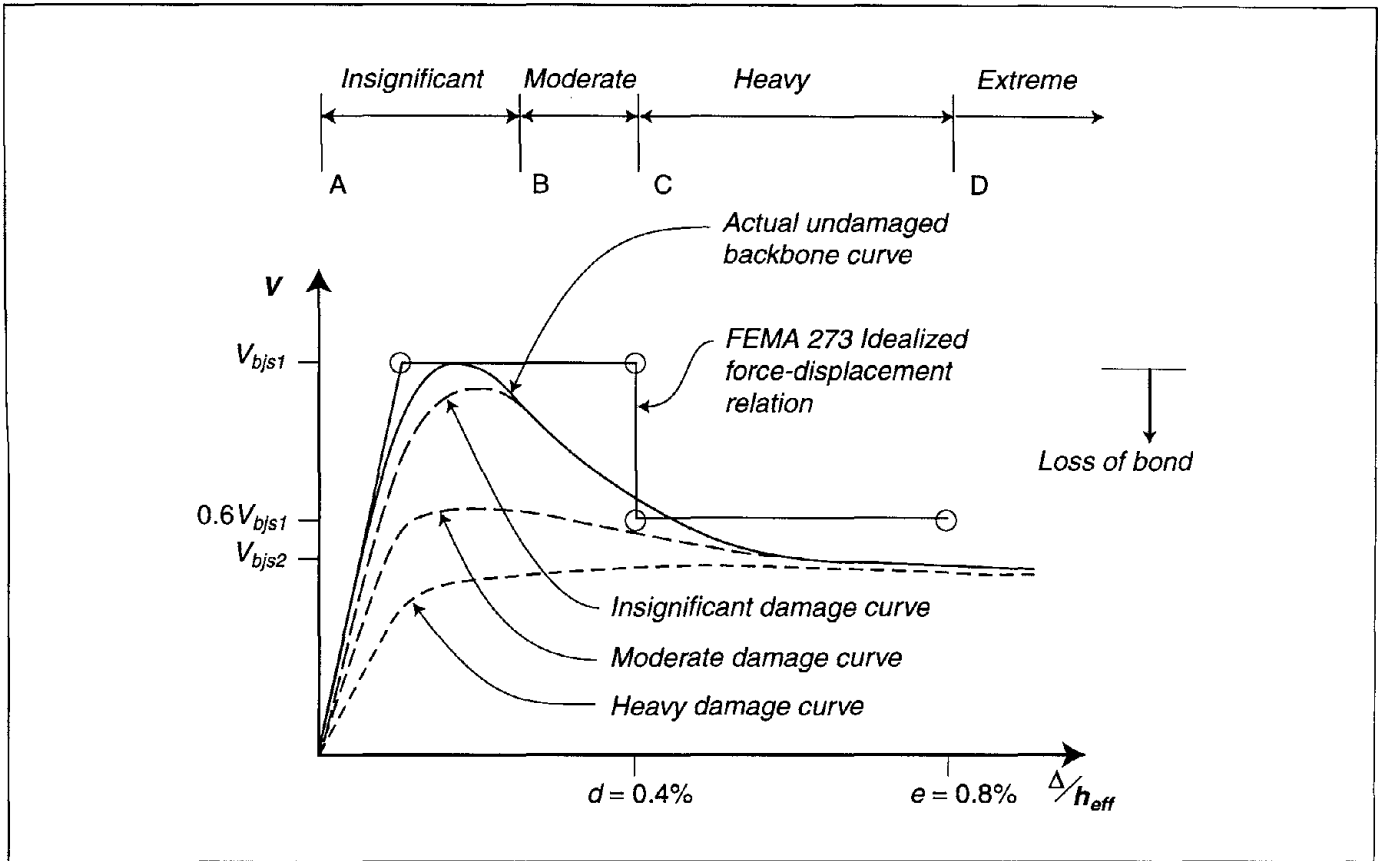
The model of bed-joint sliding used in this document is shown in Figure 4-1. For estimating the strength and deformation capacity of the undamaged bed-joint sliding mode, FEMA 273 was used. The idealized relationship has a plateau at the bed-joint capacity V_{bjs1} , which includes the bond and friction components. After bond is lost, the residual strength is limited to 60% of V_{bjs1} . The actual backbone curve is likely to be smoother than the idealized model, since the loss of bond does not occur all at once in the entire masonry section. Instead, more heavily stressed portions crack, and shear demand is redistributed to the remaining

Figure 4-1 Bed-joint sliding force/displacement relationship

For determining λ_Q , the approach shown in Figure 4-1 and discussed in the previous section is applied where appropriate to determine λ_Q , the ratio of strength at higher cycles to initial strength. The loss of strength is roughly equal to the capacity at high drift levels divided by the peak capacity. FEMA 273 describes both deformation-controlled and force-controlled modes. In a purely force-controlled mode, there is, by definition, little or no ductility. Deformation progresses until a brittle failure results. Thus, there are few, if any, damage states between *Insignificant* and *Extreme*, and there would be little, if any, post-cracking strength. Further, until a brittle mode occurs, the component would be expected to be minimally affected by previous displacement. Review of available hysteresis curves shows, though, that even modes defined as force-

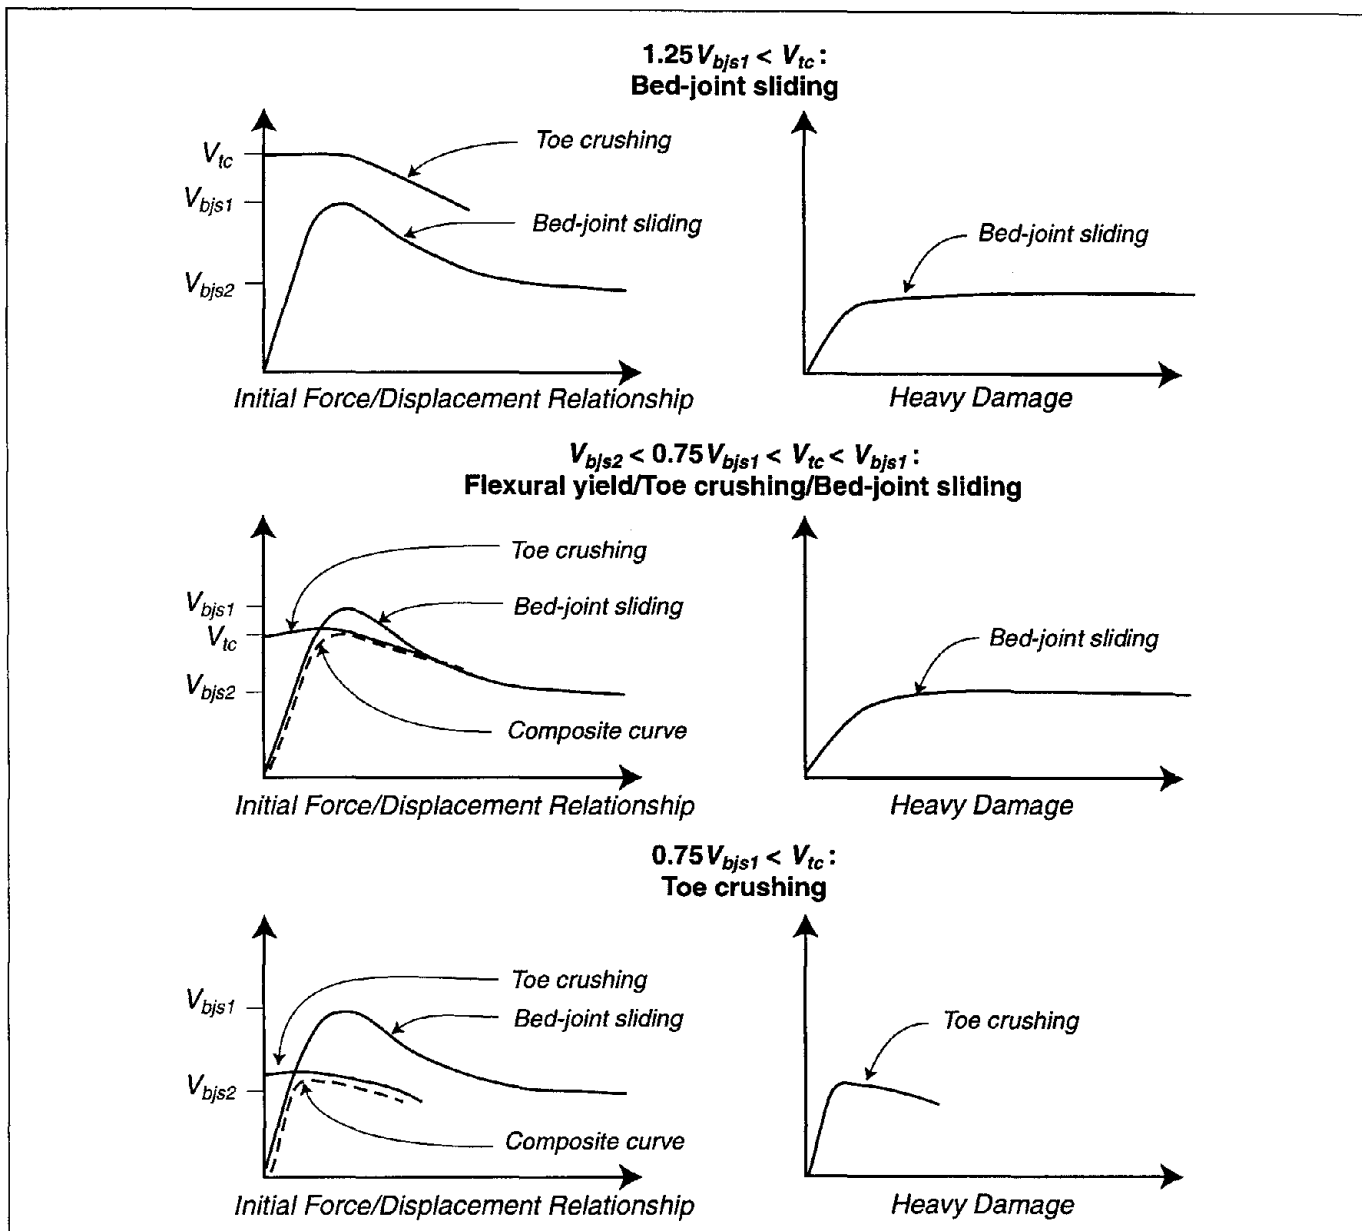
In the top set of curves, toe-crushing strength substantially exceeds the V_{bjs1} level. As displacement occurs, the bed-joint sliding capacity is reached first, and it becomes the limit state. If displacement is such that *heavy* damage occurs, then in subsequent cycles, the strength will be limited to the V_{bjs2} level.

Figure 4-2 Relationship Between Toe Crushing and Bed-Joint Sliding

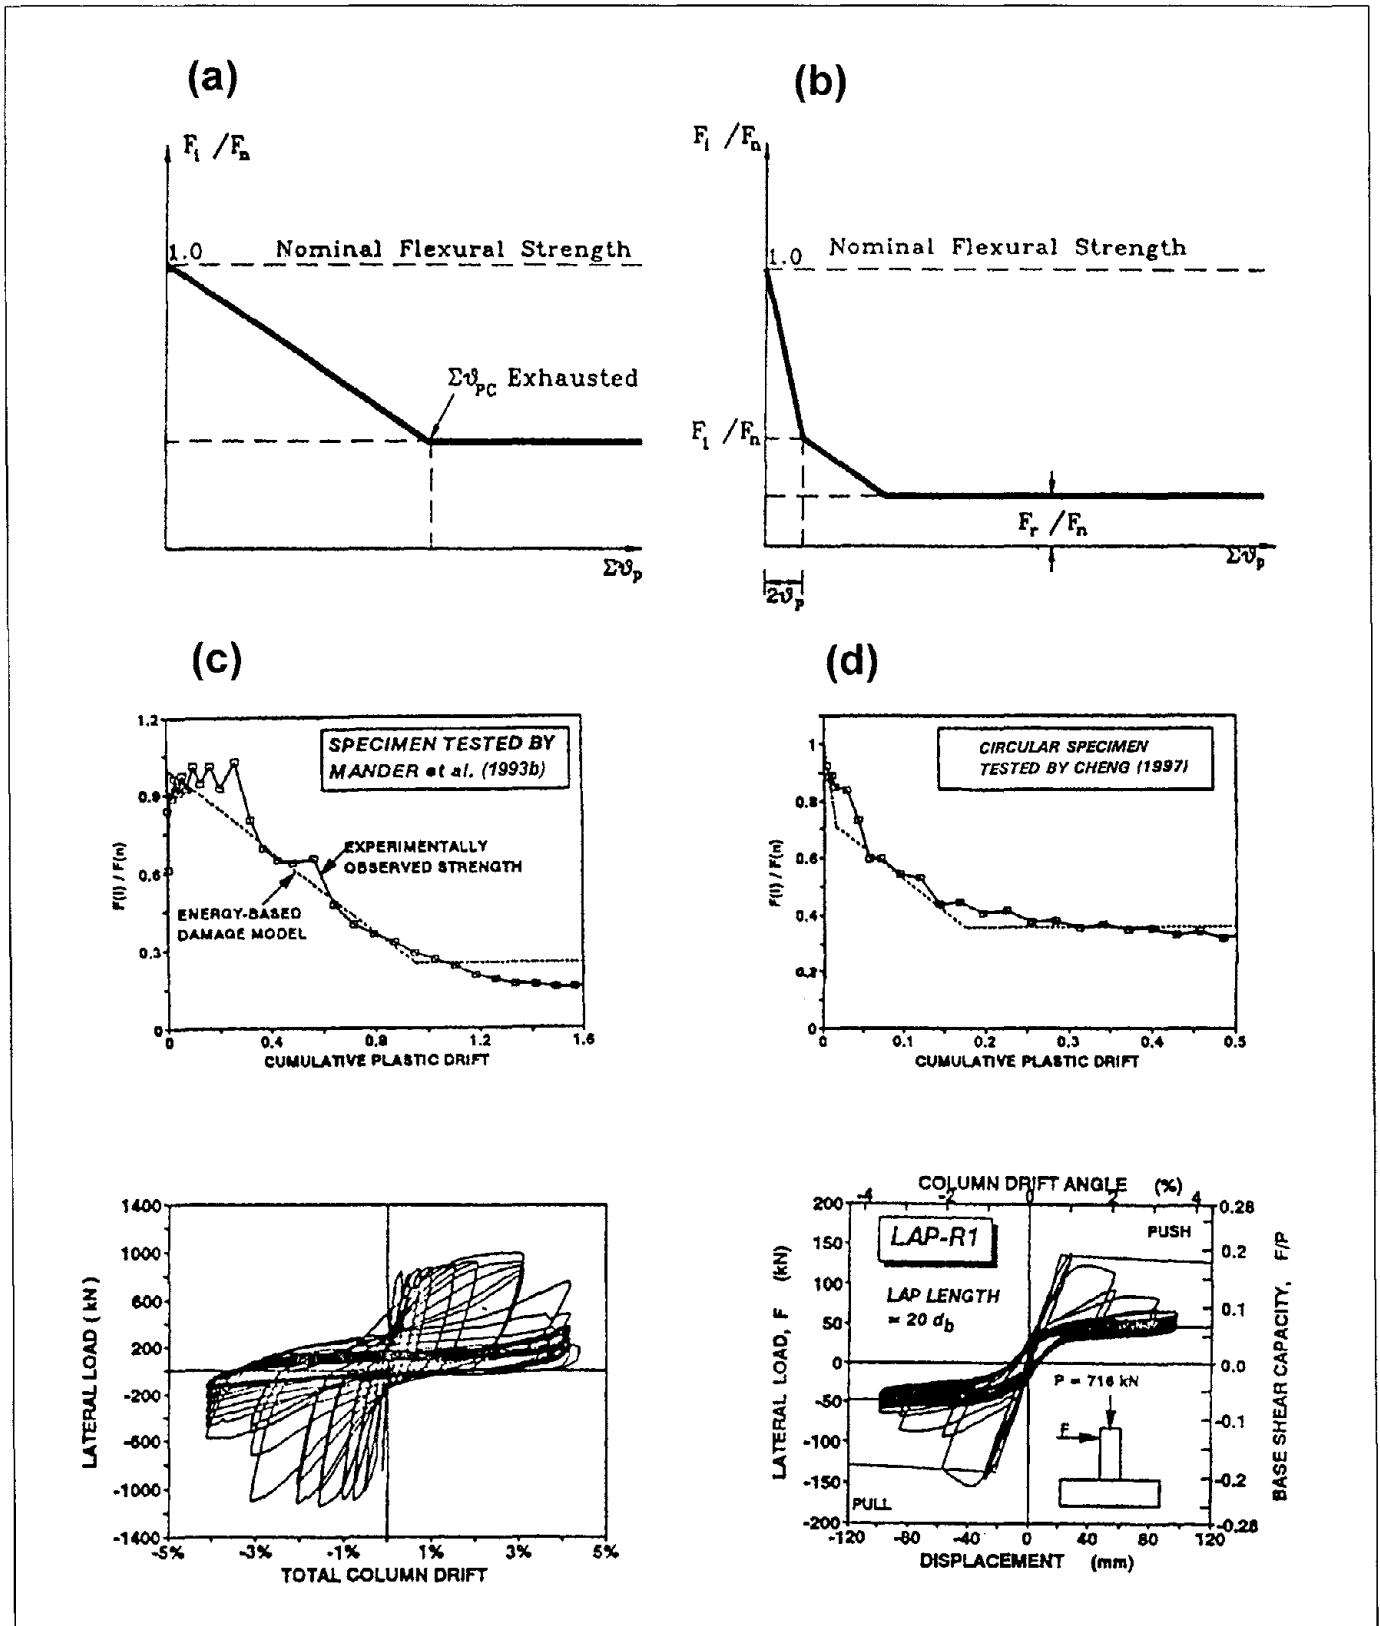
Figure 5-1 Energy-based damage analysis of strength reduction to define λ_Q

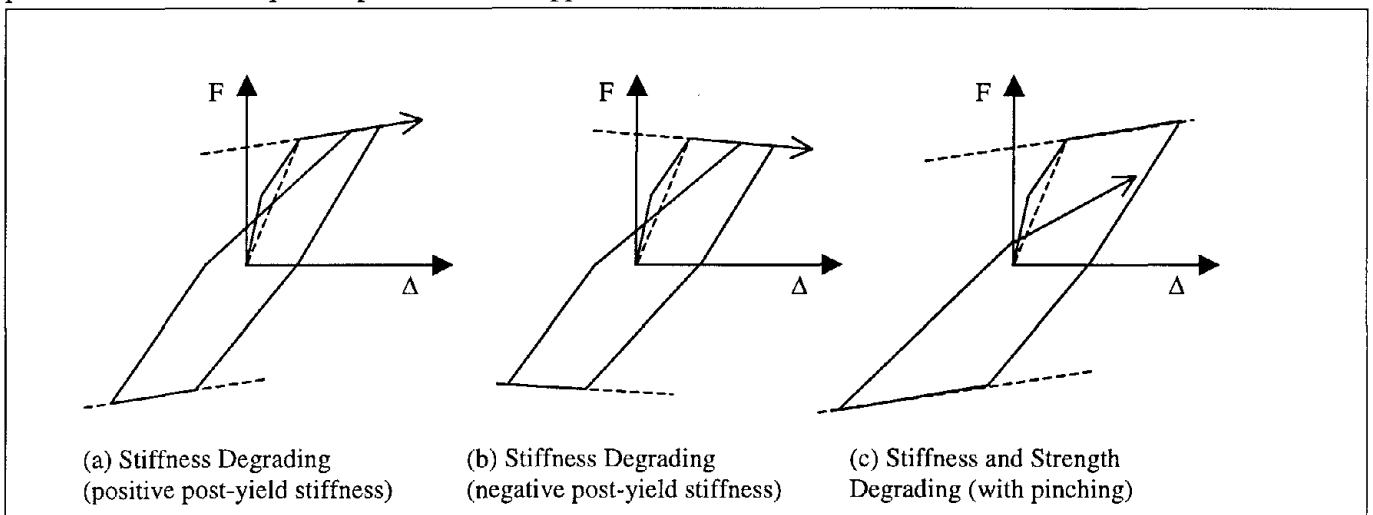
Figure 6-20 Force-Displacement Hysteretic Models

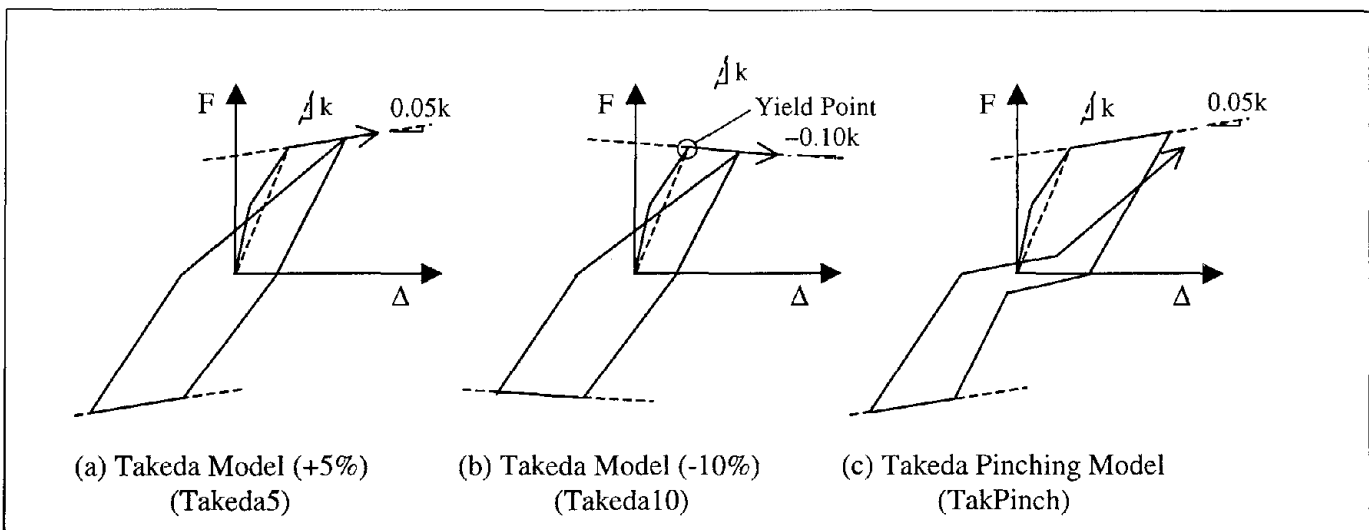
Figure 6-21 Degrading Models Used in the Analyses

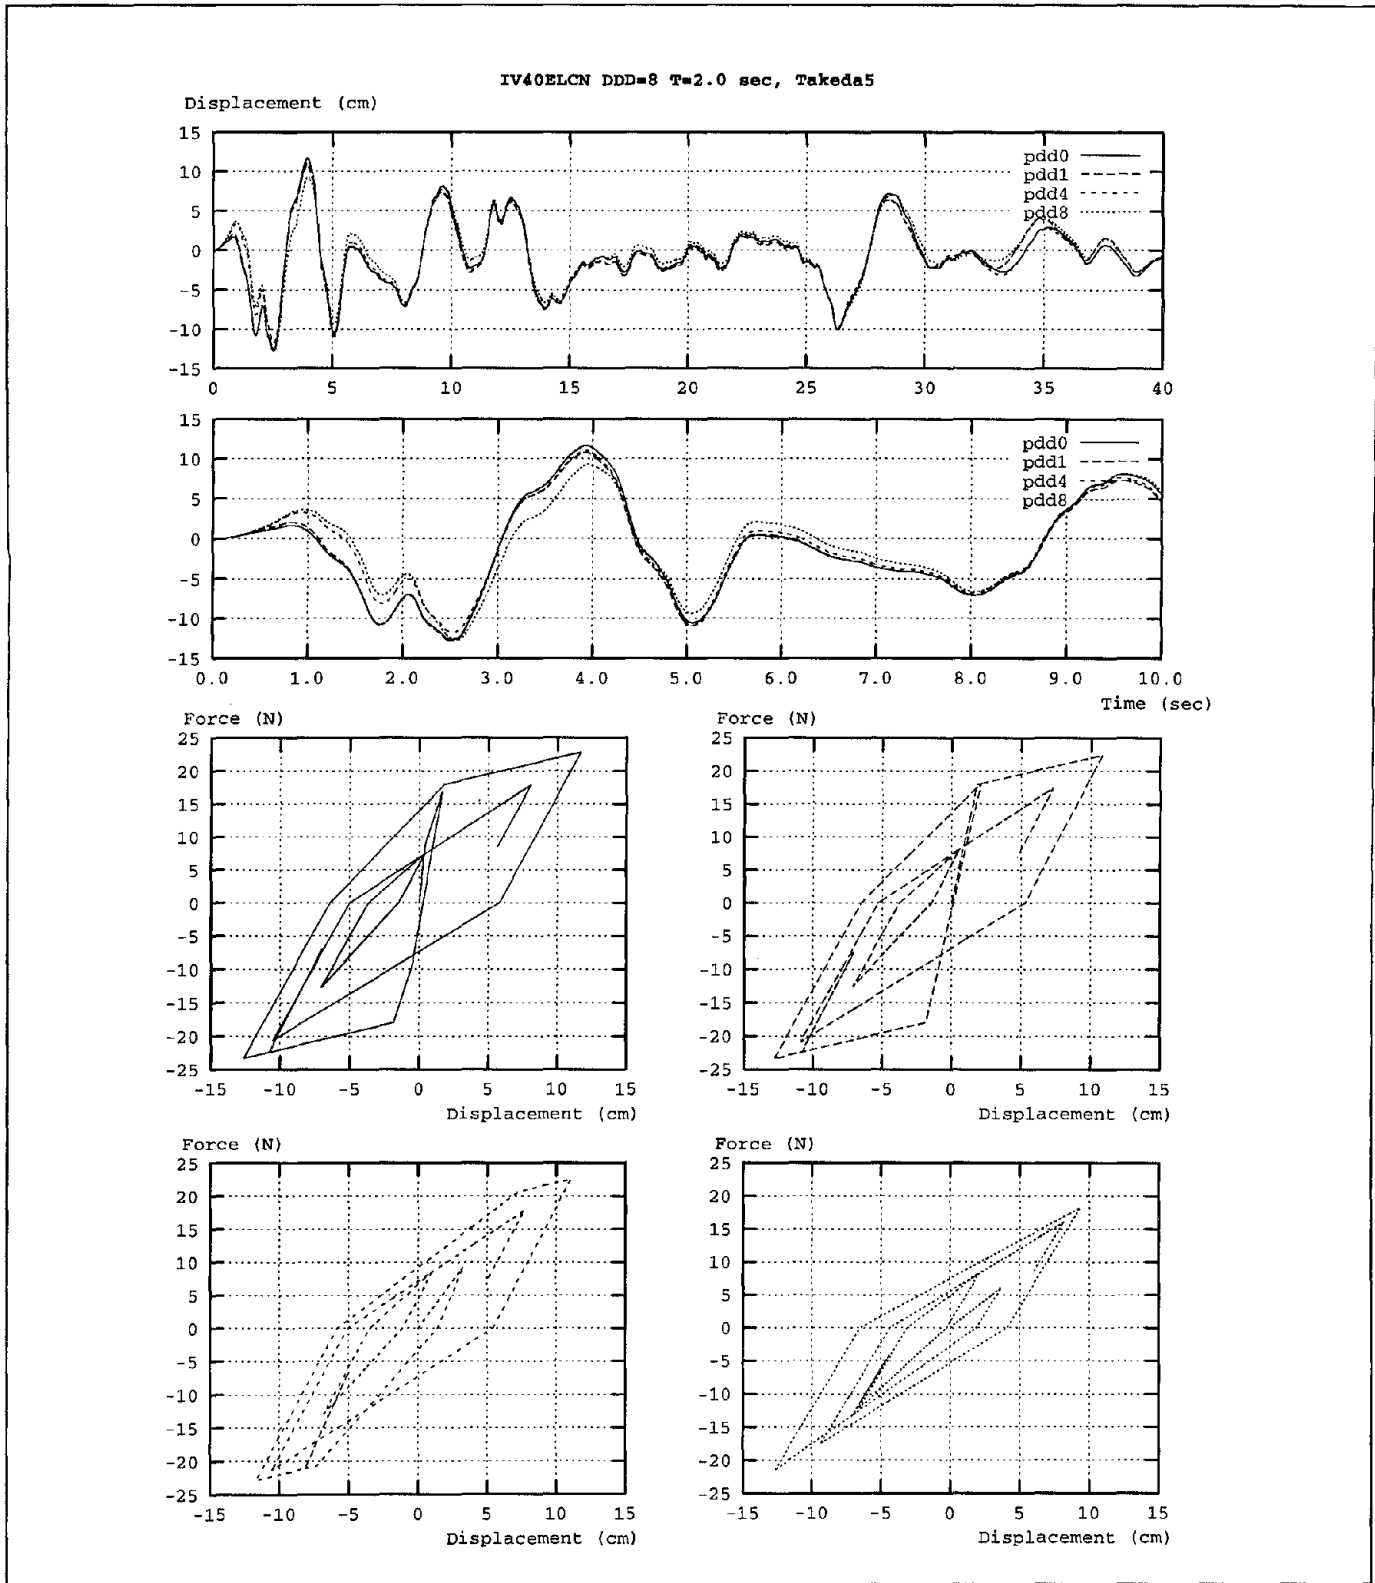
Figure 6-45 Effect of Damage on Response to El Centro (IV40ELCN.180) for Takeda5, $T=2.0$ sec ($DDD= 8$)
 $DDD =$ Design Displacement Ductility

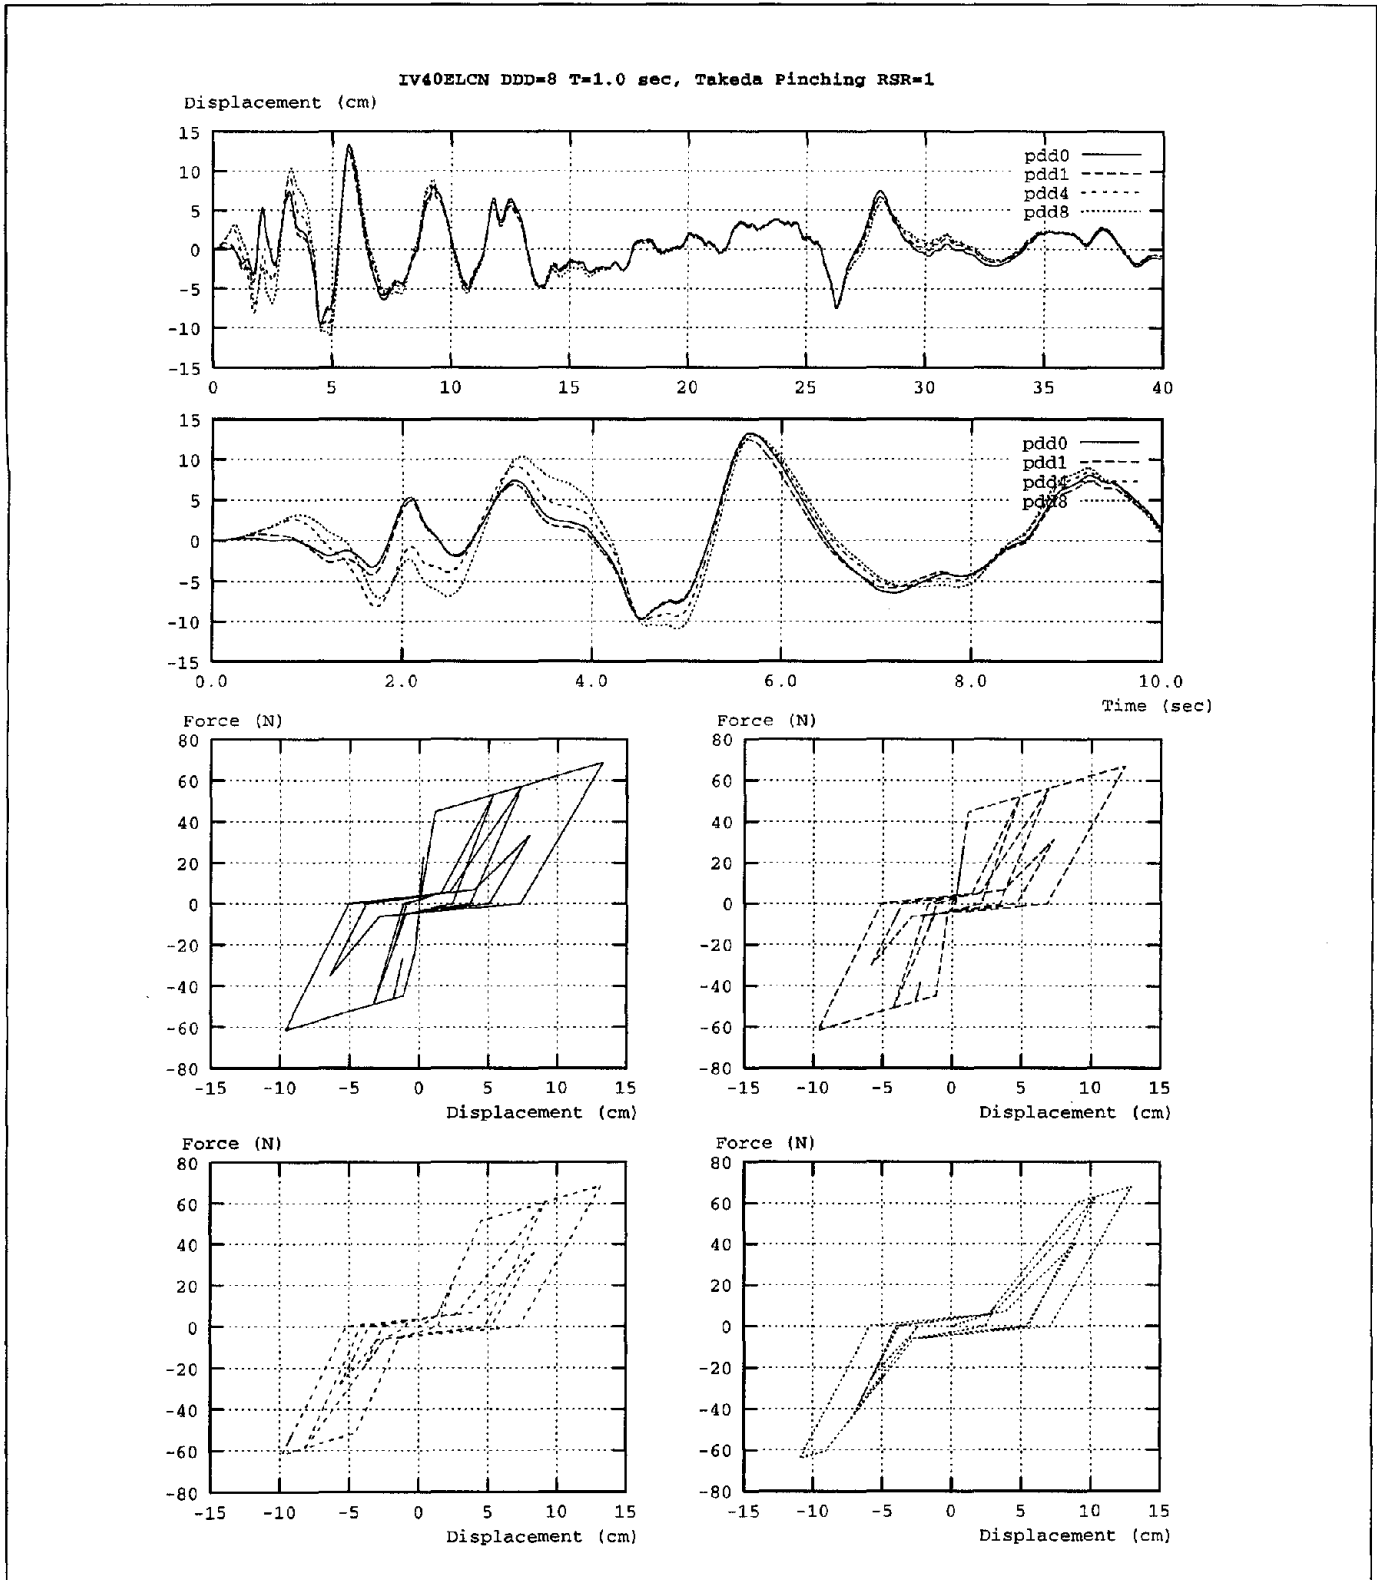
Figure 6-49 Effect of Damage on Response of TakPinch Model to El Centro (IV40ELCN.180) for T=1.0 sec and RSR= 1 (DDD= 8)
 DDD = Design Displacement Ductility

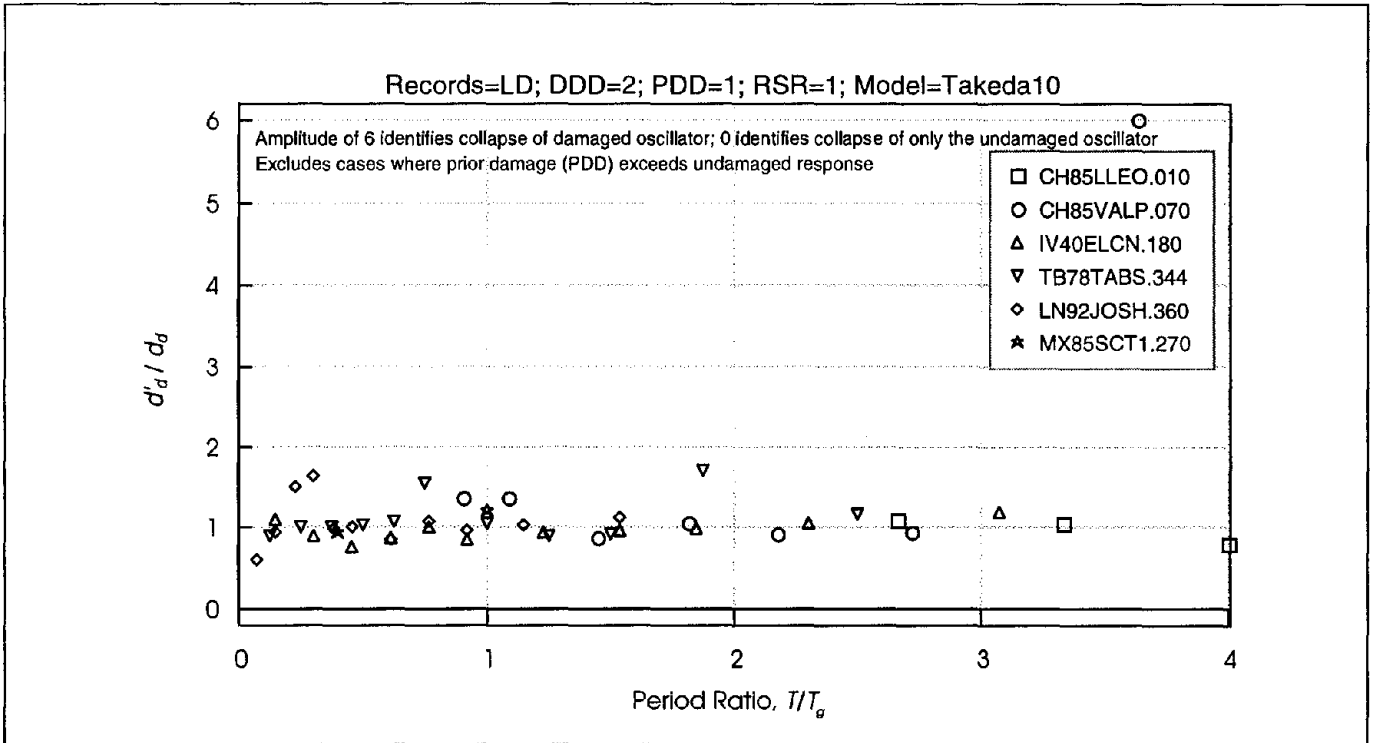
Figure 6-52 Effect of Cracking on Displacement Response of Takeda10 Model for Long-Duration Records (DDD= 8 and PDD=1)
 DDD = Design Displacement Ductility; PDD = Prior Ductility Demand; RSR = Reduced Strength Ratio

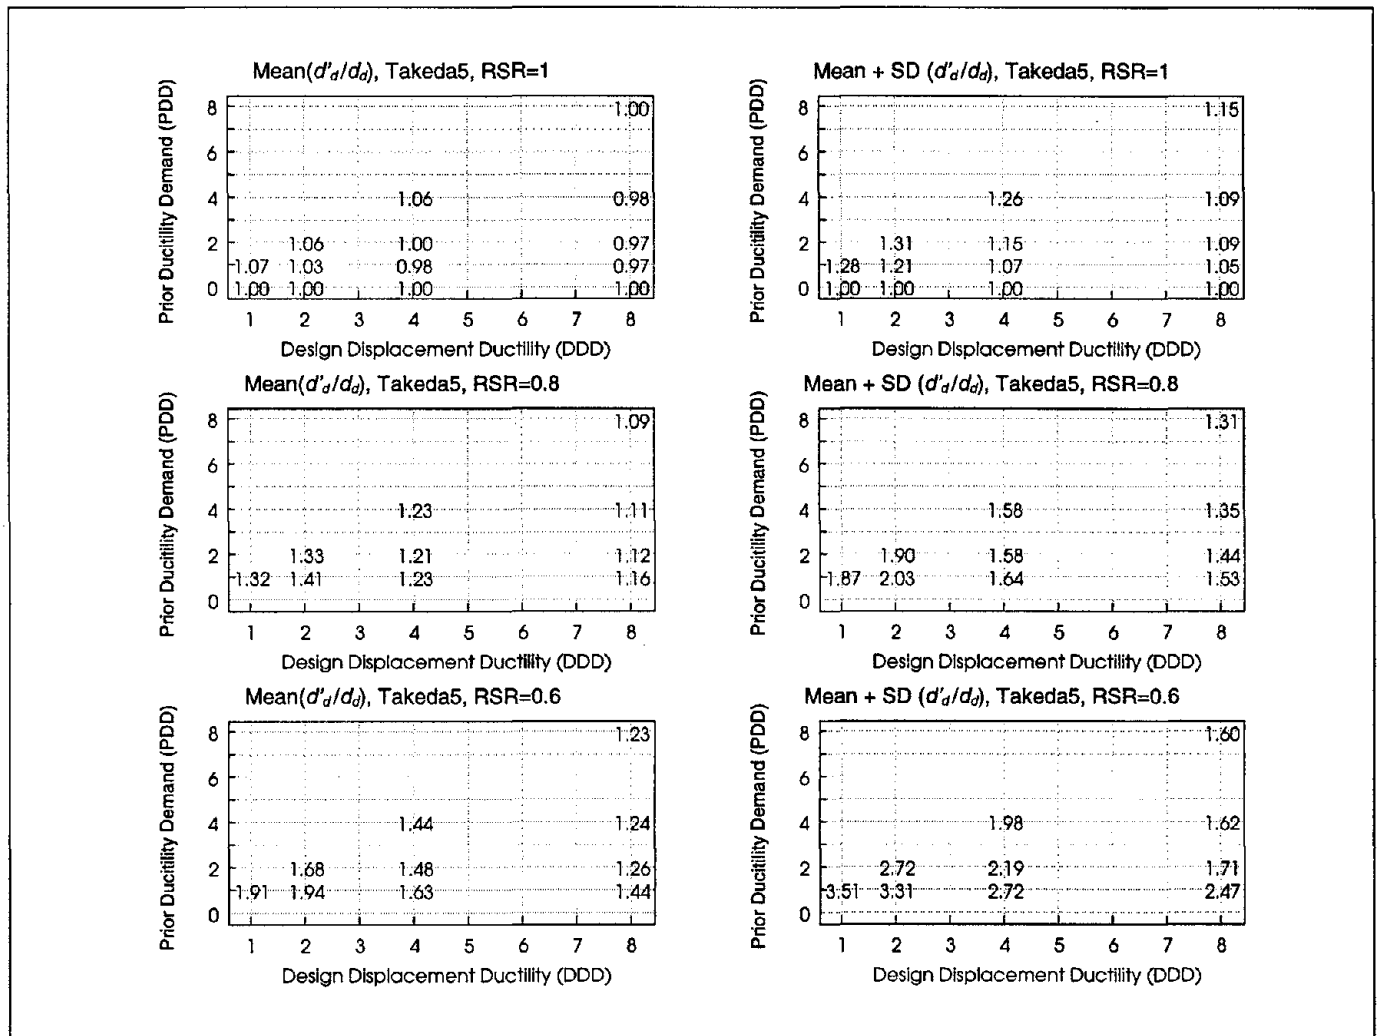
Figure 6-55 Mean and Standard Deviation Values of d'_d/d_d for Takeda5 Model.

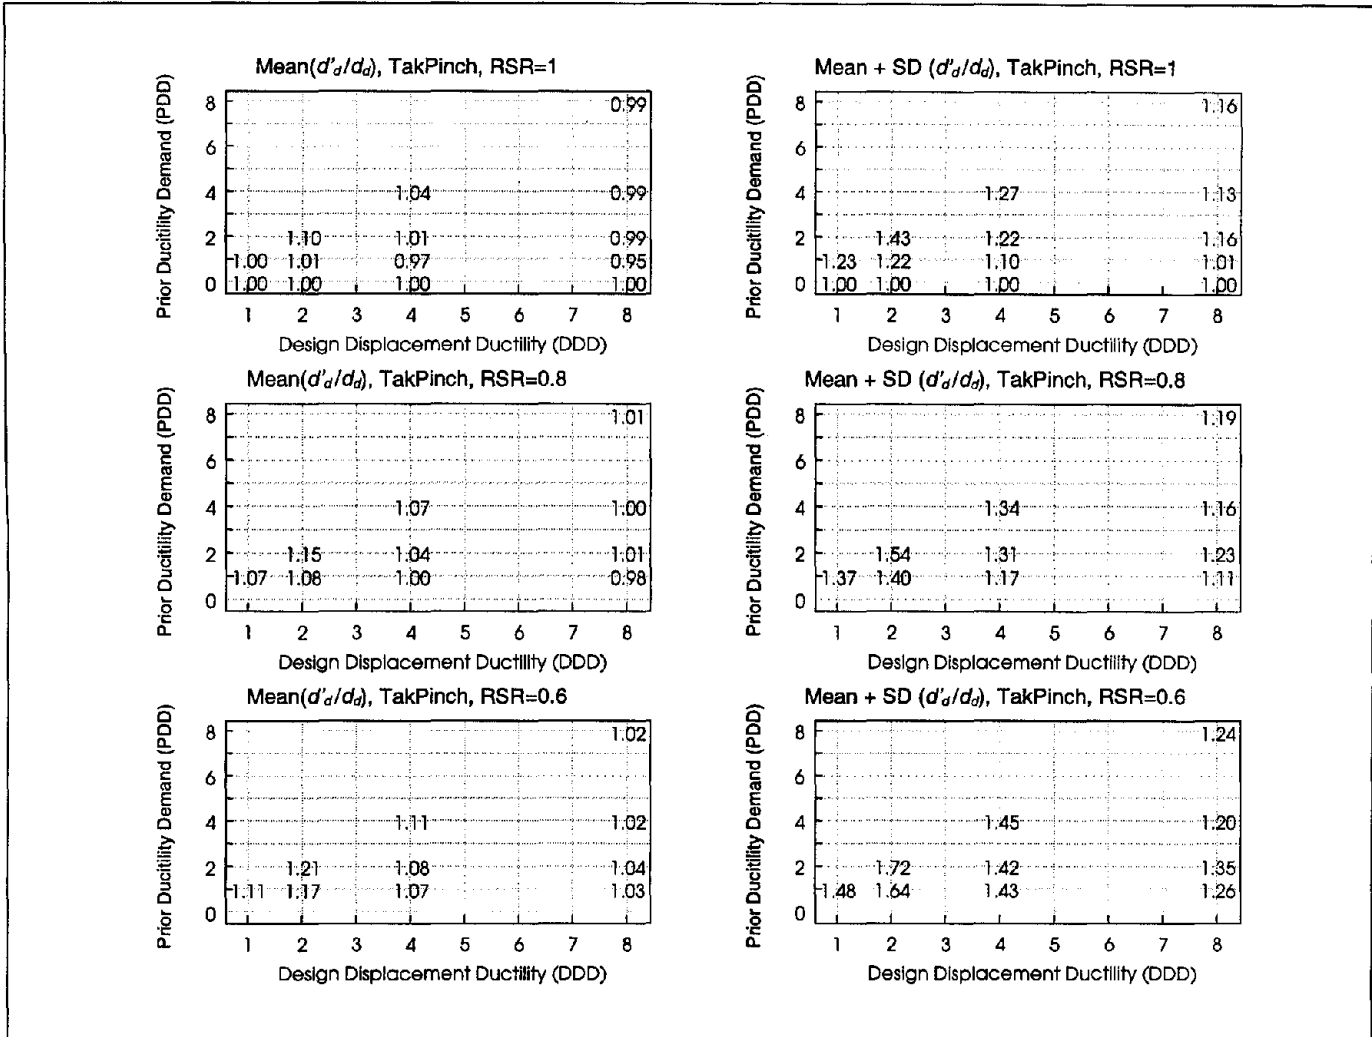
Figure 6-56 Mean and Standard Deviation Values of d'_d/d_d for TakPinch Model.

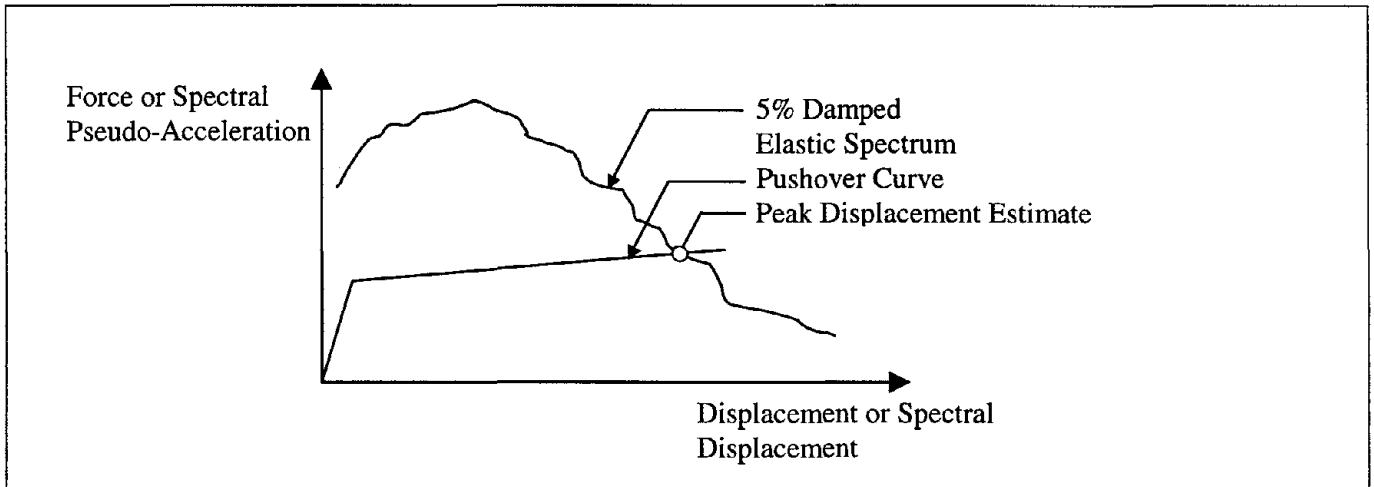
Figure 6-60 Schematic Depiction of Secant Method Displacement Estimation

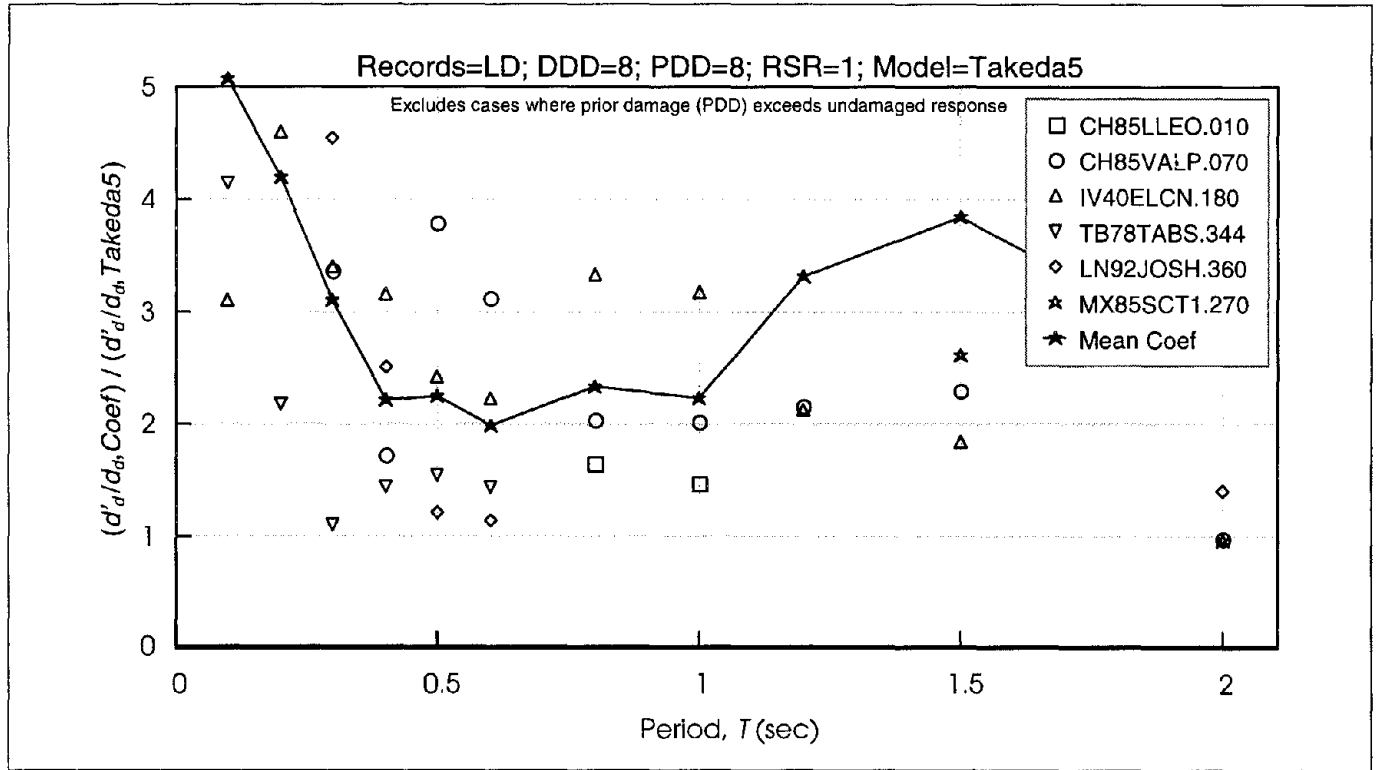
Figure 6-66 Coefficient Method Estimates of Ratio of Damaged and Undamaged Oscillator Displacement Normalized by Computed Ratio, for Long-Duration Records
 DDD = Design Displacement Ductility; PDD = Prior Ductility Demand; RSR = Reduced Strength Ratio

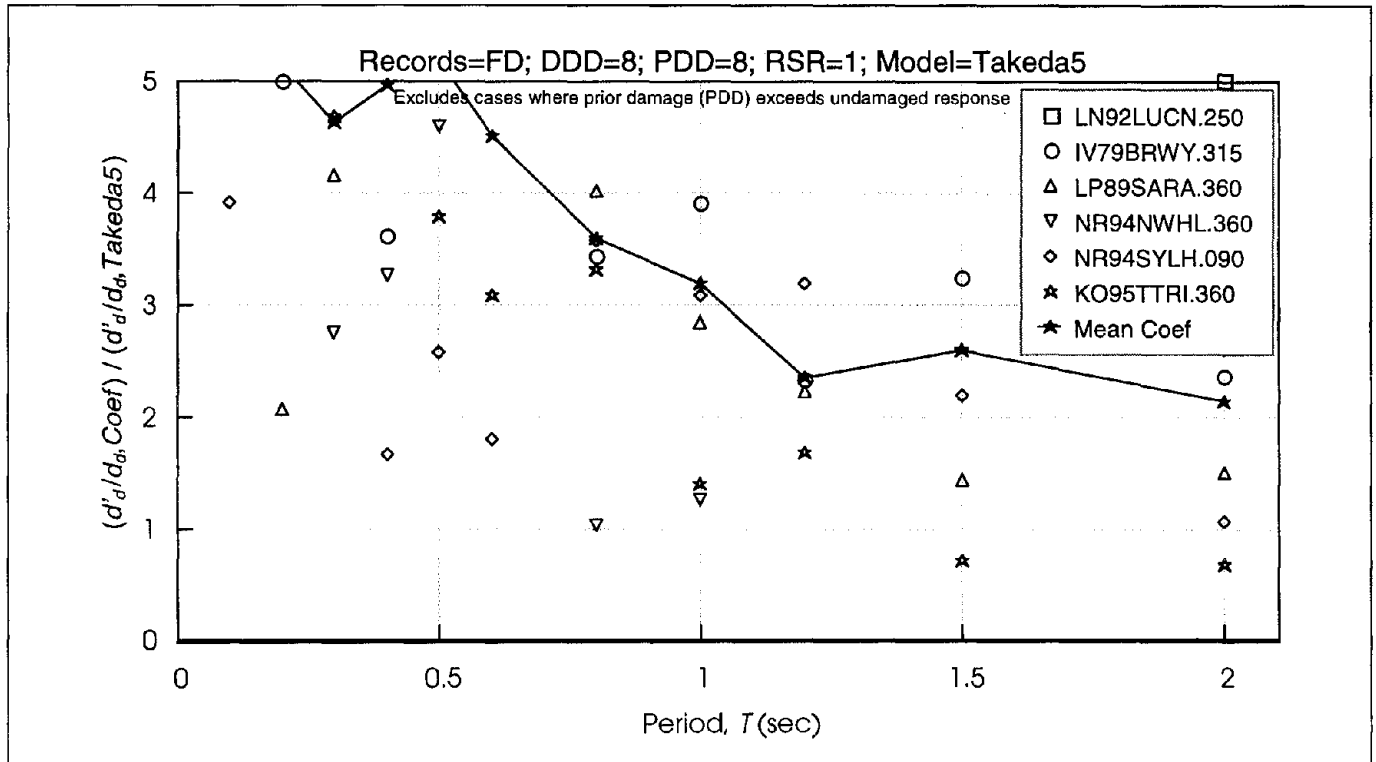
Figure 6-67 Coefficient Method Estimates of Ratio of Damaged and Undamaged Oscillator Displacement Normalized by Computed Ratio, for Forward Directive Records
 DDD = Design Displacement Ductility; PDD = Prior Ductility Demand; RSR = Reduced Strength Ratio

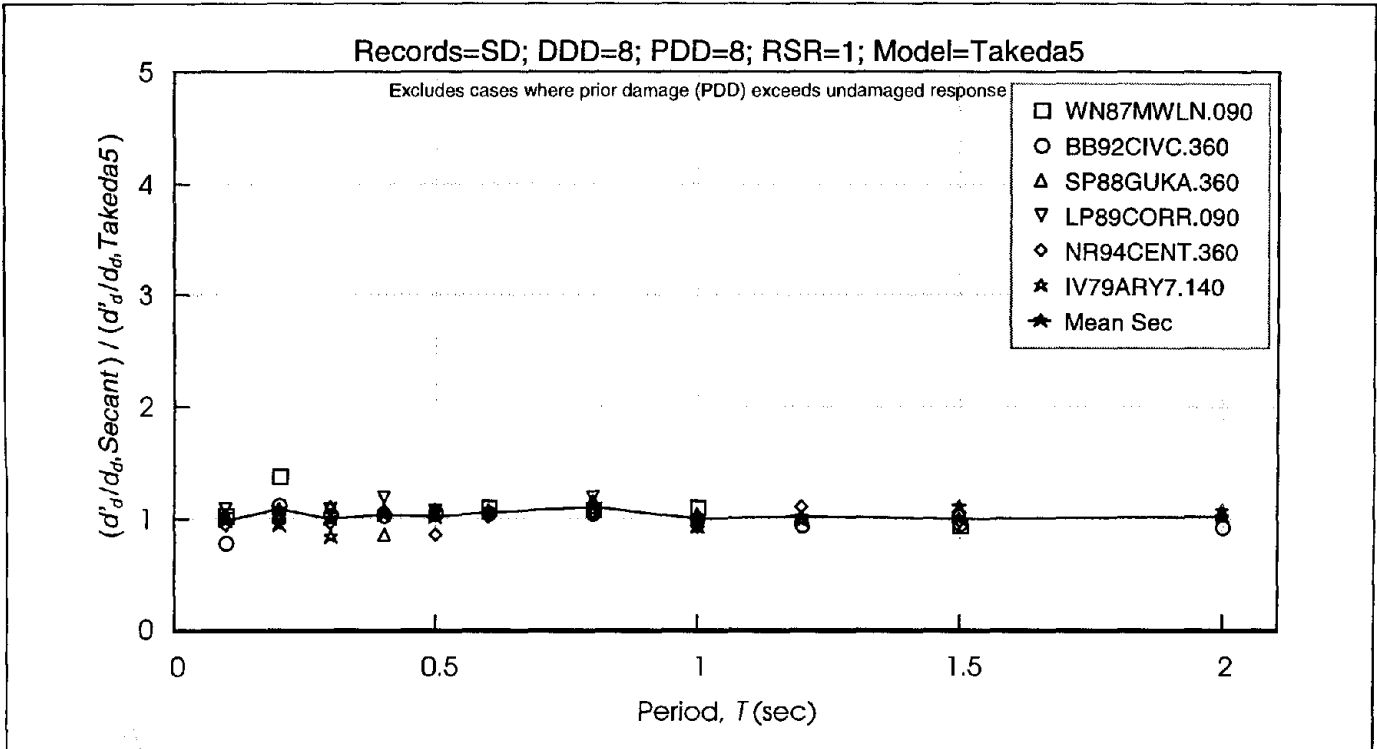
Figure 6-68 Secant Method Estimates of Ratio of Damaged and Undamaged Oscillator Displacement Normalized by Computed Ratio, for Short-Duration Records
 DDD = Design Displacement Ductility; PDD = Prior Ductility Demand; RSR = Reduced Strength Ratio

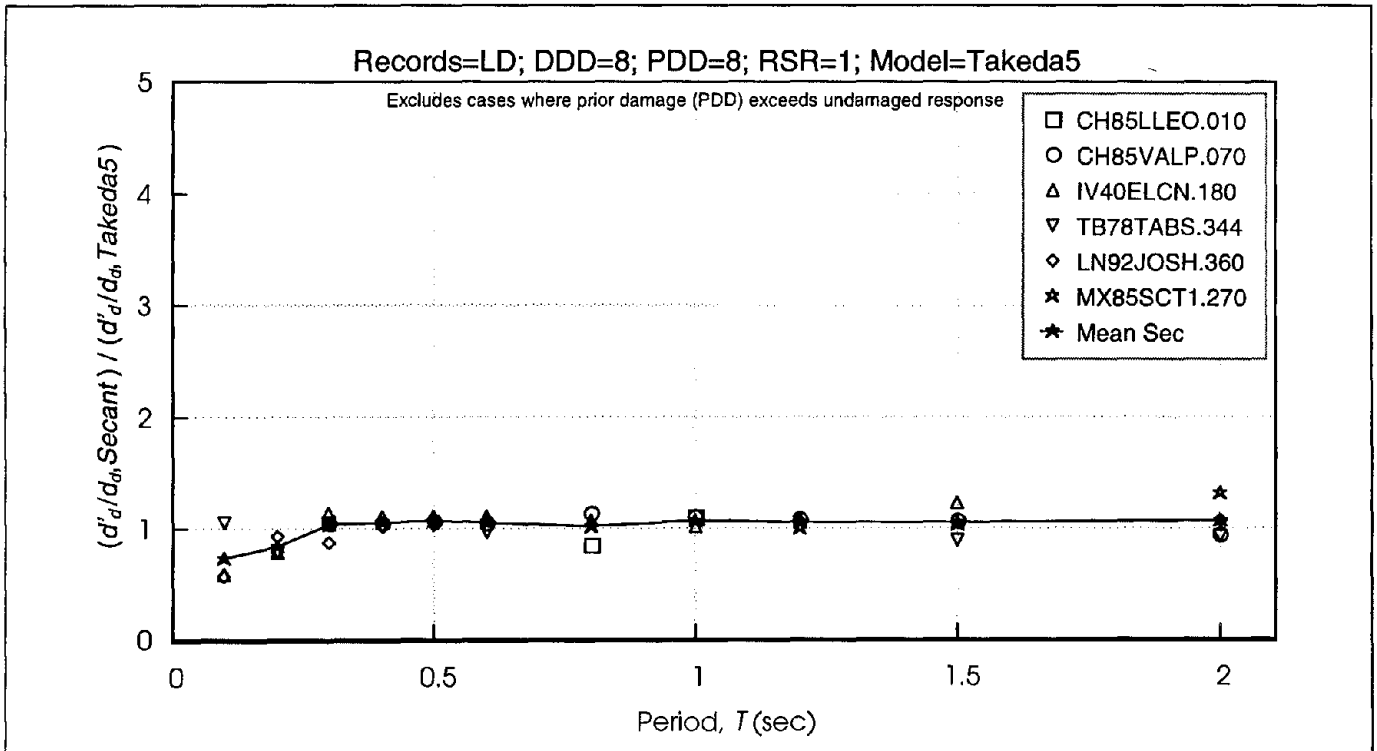
Figure 6-69 Secant Method Estimates of Ratio of Damaged and Undamaged Oscillator Displacement Normalized by Computed Ratio, for Long-Duration Records
 DDD = Design Displacement Ductility; PDD = Prior Ductility Demand; RSR = Reduced Strength Ratio
