Evaluation of Earthquake Damaged Concrete and Masonry Wall Buildings

FEMA 307

Technical Resources

The Applied Technology Council

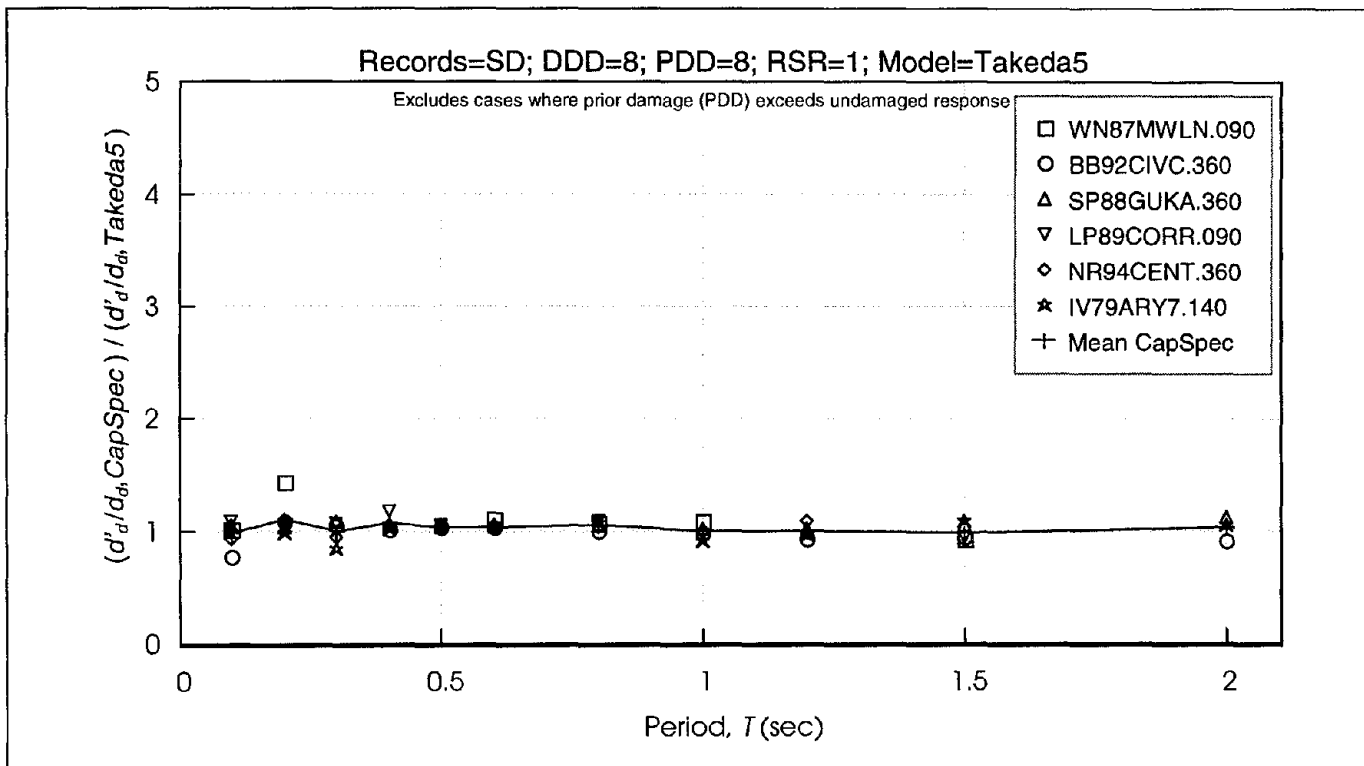
Figure 6-71 Capacity Spectrum Method Estimates of Ratio of Damaged and Undamaged Oscillator Displacement Normalized by Computed Ratio, for Short-Duration Records
DDD = Design Displacement Ductility; PDD = Prior Ductility Demand; RSR = Reduced Strength Ratio

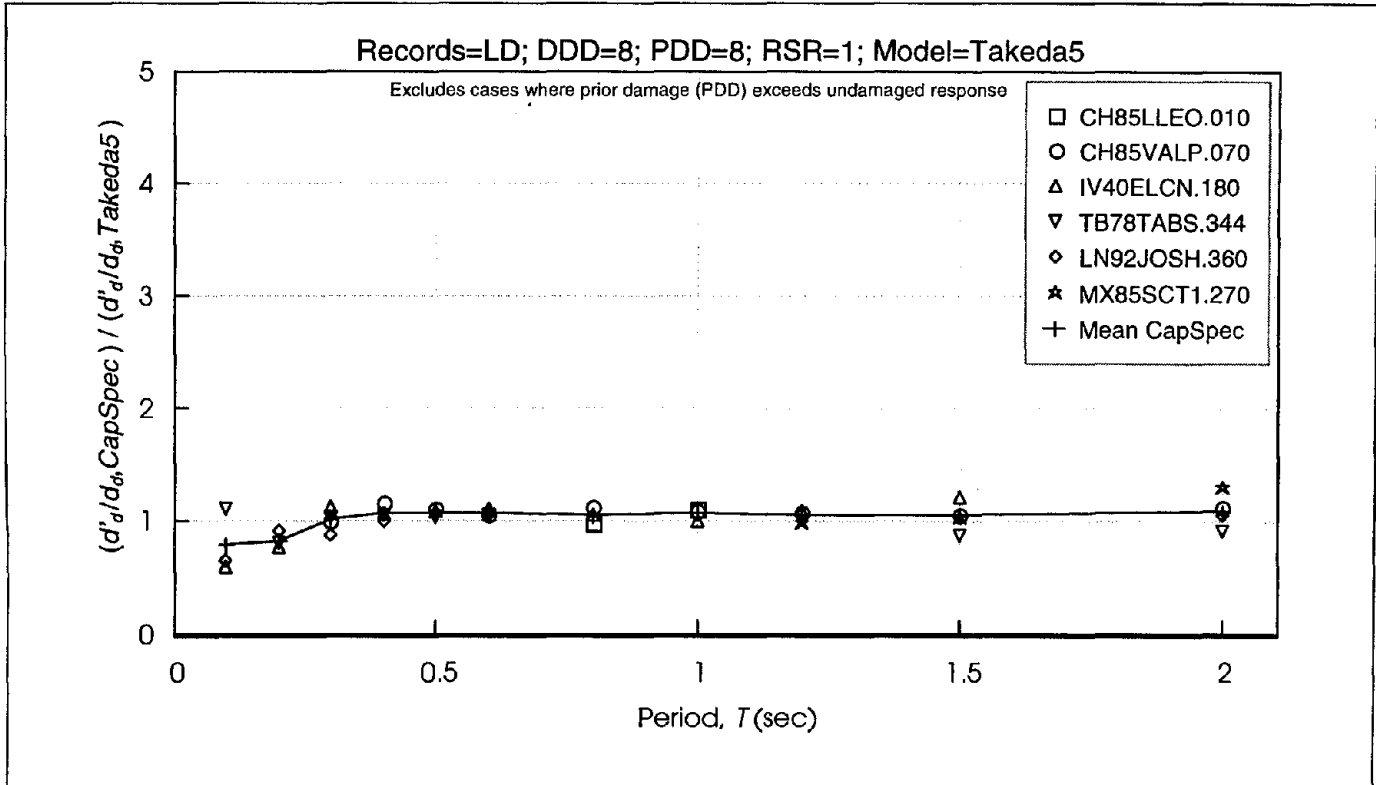
Figure 6-72 Capacity Spectrum Method Estimates of Ratio of Damaged and Undamaged Oscillator Displacement Normalized by Computed Ratio, for Long-Duration Records
DDD = Design Displacement Ductility; PDD = Prior Ductility Demand; RSR = Reduced Strength Ratio
