# Design Guide

for Improving School Safety in Earthquakes, Floods,  
and High Winds

*January 2004*

**FEMA**

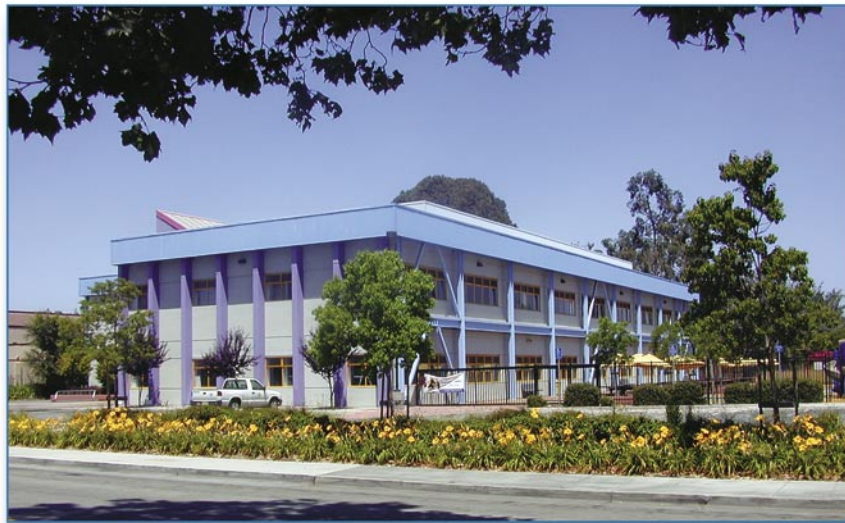
Figure 1-10  
Private high school, Palo Alto, CA, located in a remodeled industrial building. Note the exterior cross bracing; the building required extensive retrofitting to meet school seismic requirements.

Schools built in the 1980s and 1990s assumed a wide variety of forms, often combining classrooms into clusters and focusing on providing an attractive learning environment (see Figure 1-9). However, demographic needs, shortage of affordable land, and limited funding has also resulted in instances of the adaptation of existing non-educational buildings into schools (see Figure 1-10).

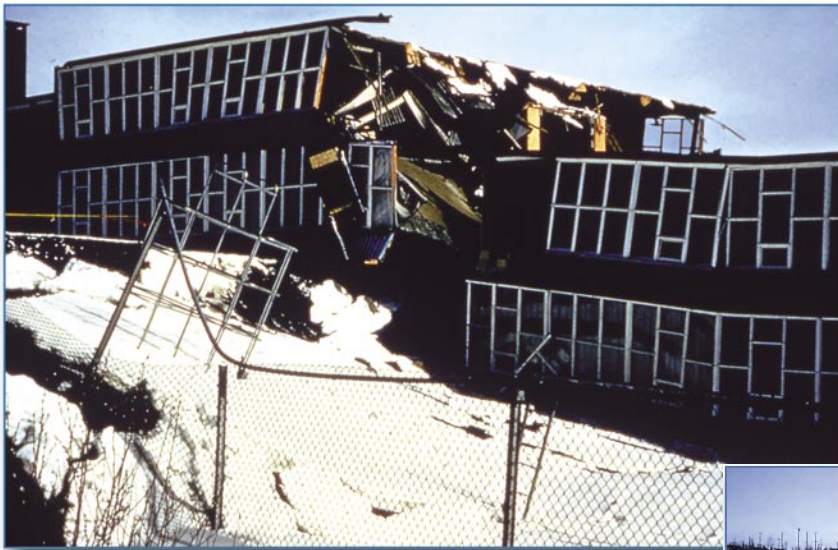
Figure 4-1  
School, Anchorage, AK,  
1964, severely damaged  
by earthquake-induced  
landslide

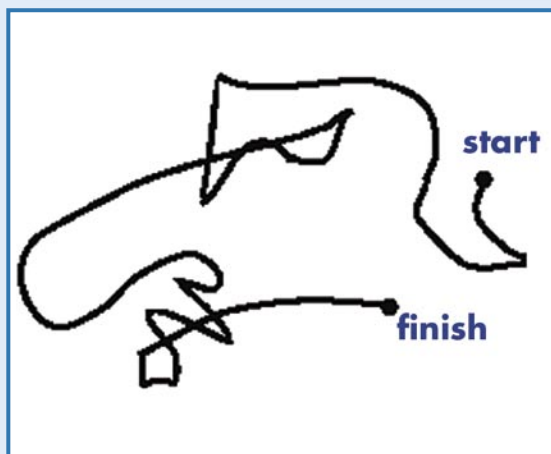
Scratch left on a floor by a kitchen range in the 1933 Long Beach earthquake that shows the random nature of earthquake motion.

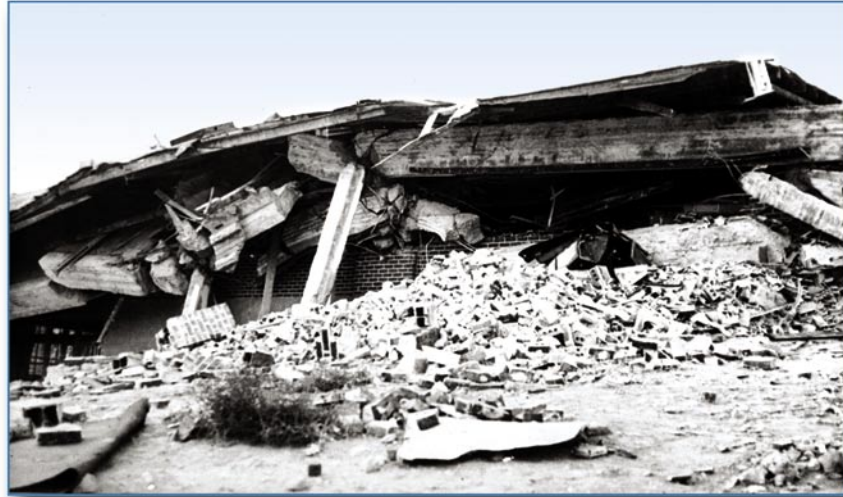
Figure 4-8  
Collapse of portion of  
nonductile concrete frame  
school structure, Helena,  
MT, 1935

Reinforced concrete frames are made ductile by introducing an appropriate, code-specified amount of specifically designed steel reinforcing; unfortunately, the need for this was not recognized in seismic codes until the mid-1970s and so a large inventory of these types of structure exists (see Figure 4-8).

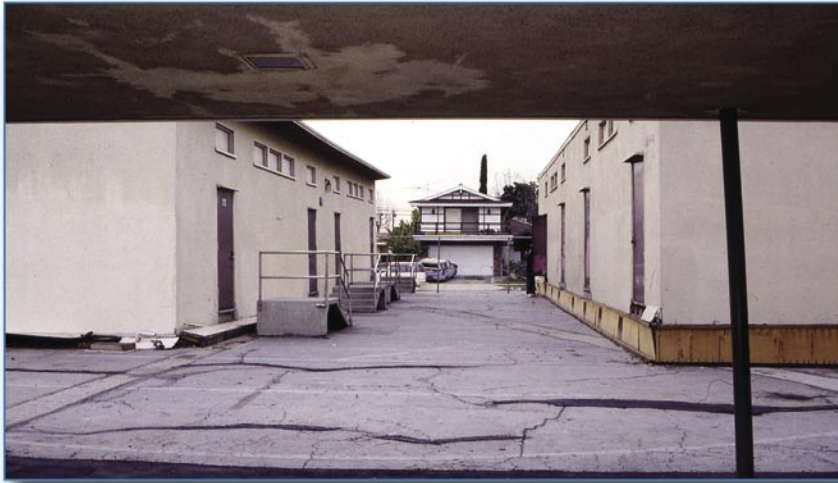
Figure 4-9  
Modular classrooms  
pushed off their  
foundations; note stairs  
at left, Northridge, CA,  
1994.

Modular classrooms are liable to topple off their foundations unless securely attached and braced. This damage is not life-threatening, but makes the building unusable; fractured power, gas, and waste lines may be a hazard (see Figure 4-9).

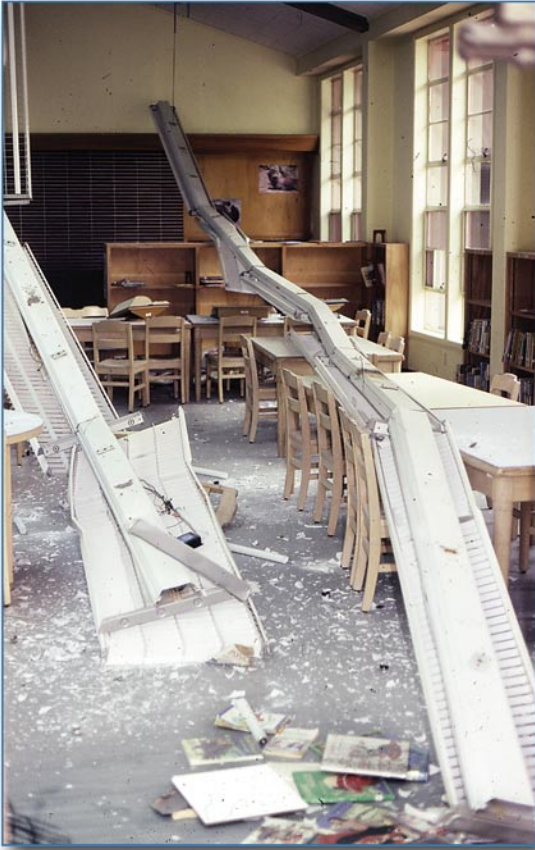
Figure 4-12  
Fallen light fixtures, library, Coalinga, CA, 1983  
SOURCE: GARY MCGAVIN, REDLANDS, CA

Pendant light fixtures have sometimes fallen if they are insecurely attached and not designed to swing freely (see Figure 4-12). Sudden breakage of large glass areas is a specific hazard because of the dense occupancy in many school rooms; design of glazing to resist wind-borne debris and physical attack may also assist in protecting it from earthquake motion. This kind of damage has been significant in California schools that have suffered recent earthquakes.

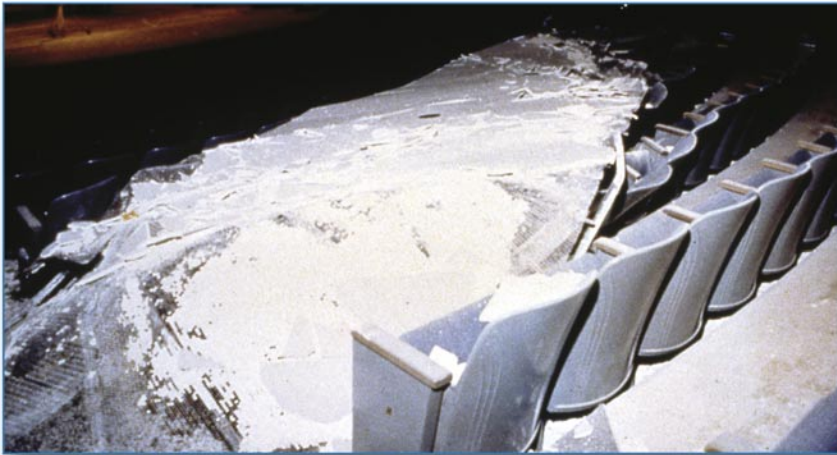
Figure 4-13  
Fallen heavy lath and  
plaster ceiling across  
auditorium seating,  
Northridge, CA, 1994  
SOURCE: GARY MCGAVIN,  
REDLANDS, CA

Heavy hung lath and plaster ceilings in older auditoriums (and assembly buildings) can be dangerous and need careful inspection of their attachment and materials. If deficient in safety, replacement is the only acceptable solution (see Figure 4-13).

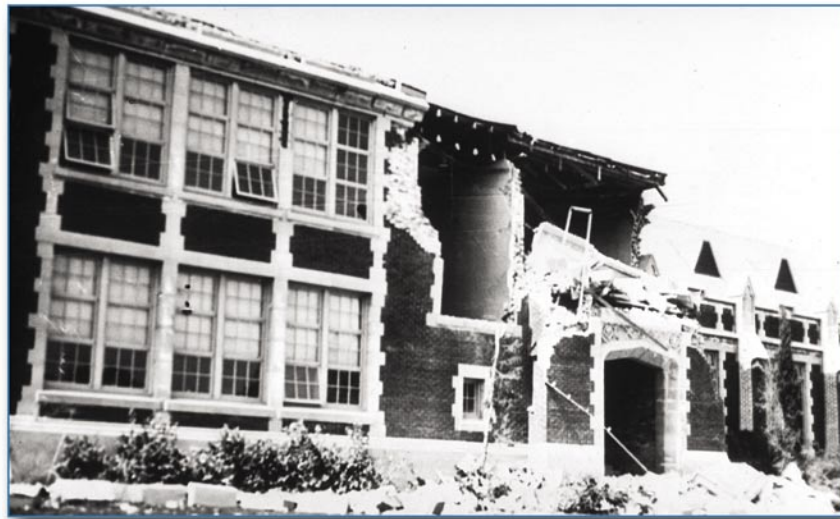
Figure 4-14  
Damage to the John Muir  
School, Long Beach, CA,  
1933

Considering the number of significant earthquakes in California since the early years of the 20th century, there has been remarkably little severe structural damage to schools, except in the Long Beach earthquake of 1933, and there have been very few casualties. In California, no school child has been killed or seriously injured since 1933. This good fortune has been primarily because all major California earthquakes since 1925 have occurred outside school hours (see Figure 4-14).

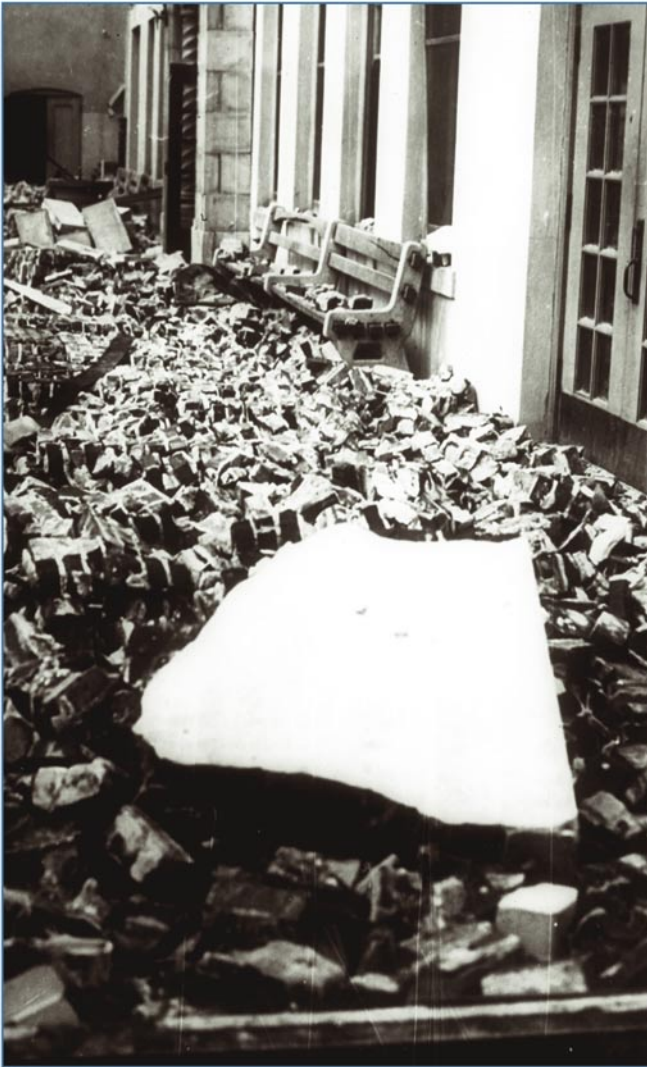
Figure 4-16  
A dangerous passage way between two  
buildings, Polytechnic High School, Long  
Beach, CA, 1933

In the Long Beach earthquake that occurred at 5:55 p.m. on March 10, 1933, damage to unreinforced masonry school buildings was so severe that there would have been many casualties had they been occupied. As a result, the state passed the Field Act within a month of the earthquake (see Figures 4-15 and 4-16).

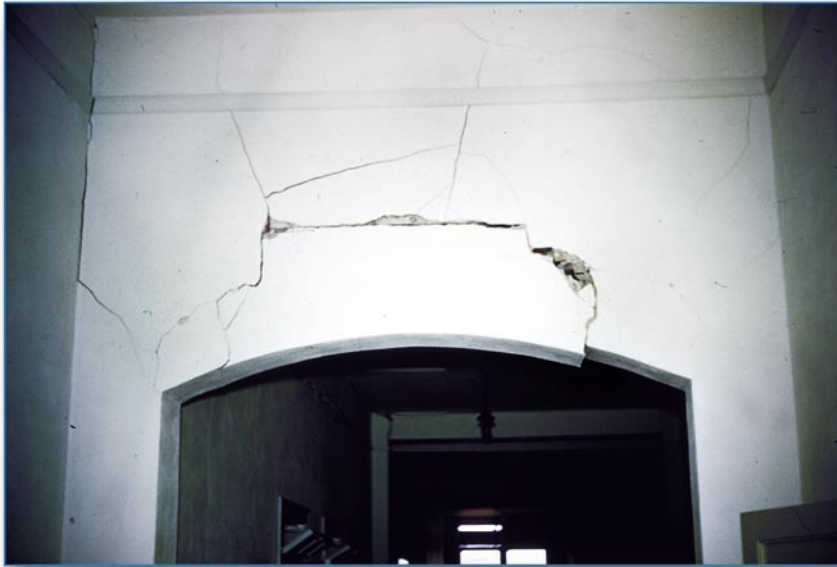
Figure 4-17  
A heavy corridor lintel  
ready to fall, Emerson  
School, Bakersfield, Kern  
County, CA, 1952

This earthquake was of particular interest because the incidence of school damage might represent that of comparable earthquakes striking in regions today where seismic codes have not been adopted and enforced due to the rarity of seismic events (see Figures 4-17, 4-18, and 4-19).

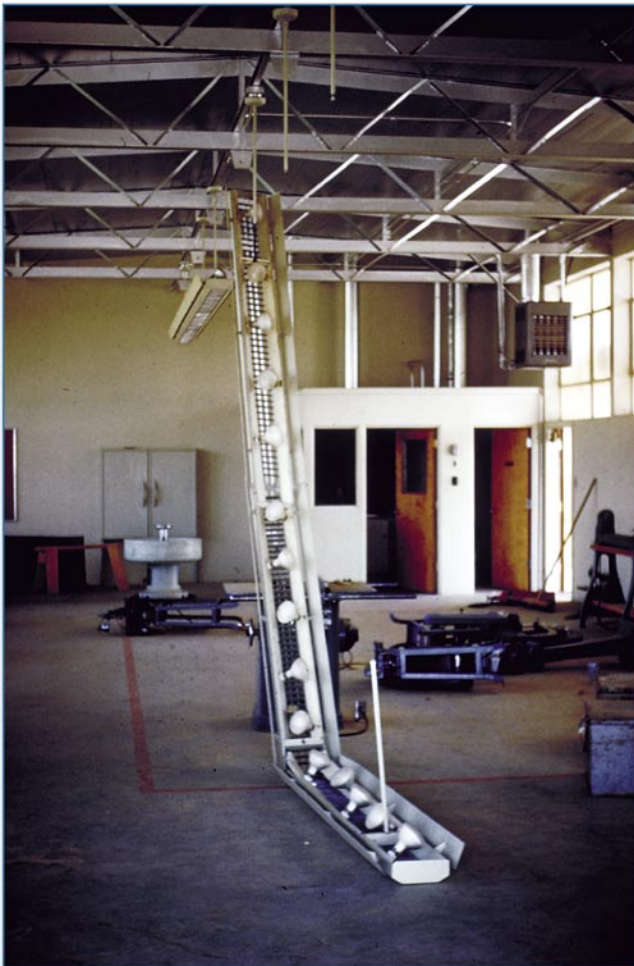
Figure 4-18  
Overturned shop equipment and failed  
light fixtures, Kern County, CA, 1952

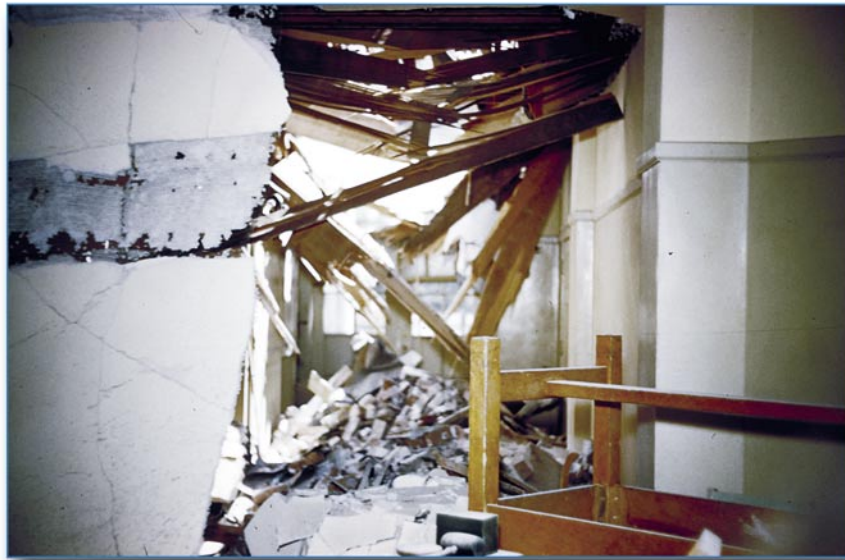
Figure 4-19  
Destroyed exit corridor,  
Bakersfield, Kern County,  
CA, 1952

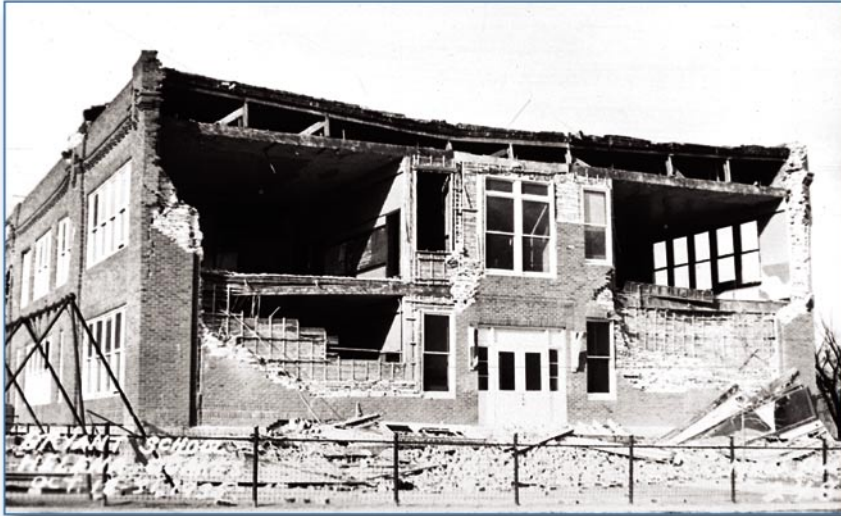
Figure 4-20  
Typical school damage,  
Helena, MT, 1935

In other states, similar damage to unreinforced masonry (URM) and early reinforced concrete structures occurred. Considerable damage to schools occurred in Helena, Montana, in 1935 (see Figure 4-20). In 1949, severe damage was inflicted on several URM schools, resulting in one fatality, in Seattle (see Figures 4-21 and 4-22). At Puyallup High School, three boys on the stage just managed to escape when the roof collapsed (see Figure 4-23). Widespread damage to furniture and contents also occurred (see Figure 4-24).

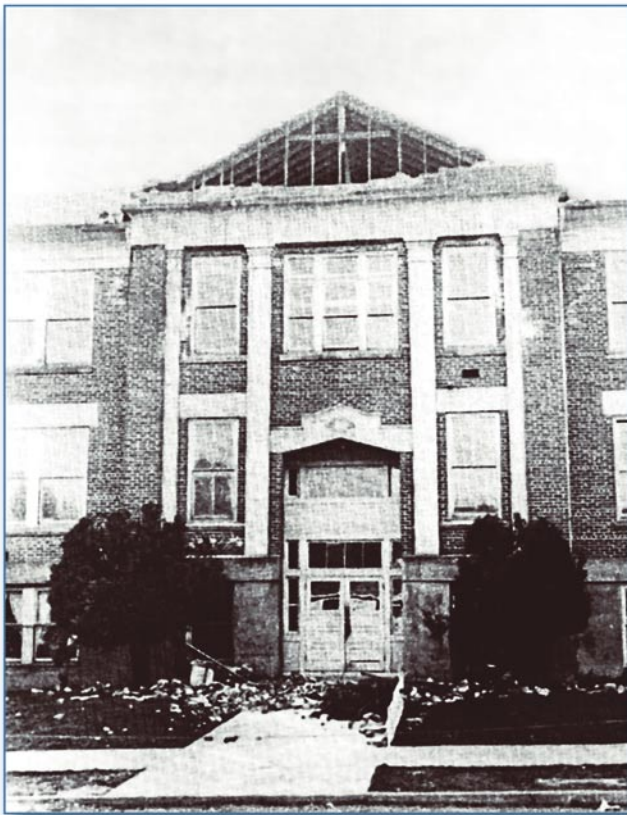
Figure 4-21  
The student body president was killed here by  
falling brickwork, Seattle, WA, 1949.

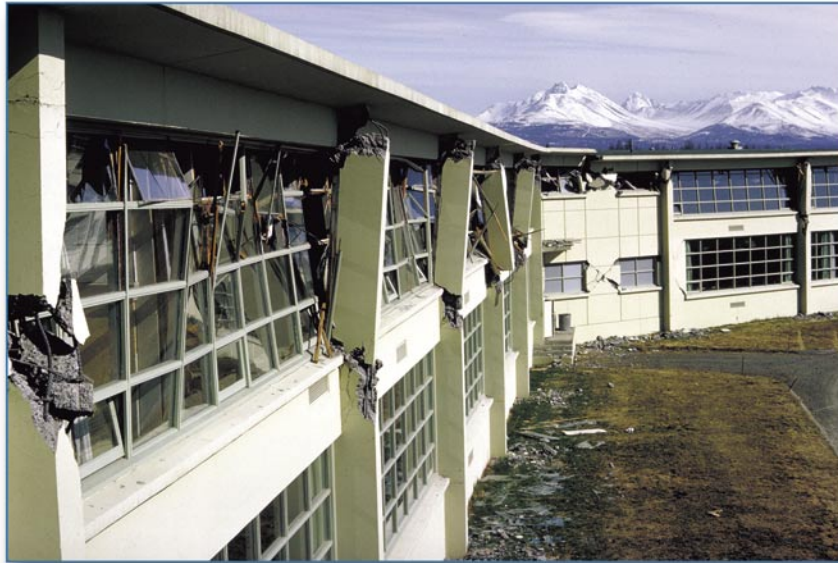
Figure 4-26  
Brittle failure at nonductile concrete column,  
West Anchorage High School, 1964

Figure 4-25	Severe structural damage to the West Anchorage High School, Anchorage, AK, 1964 .....	4-28
Figure 4-26	Brittle failure at nonductile concrete column, West Anchorage High School, 1964.....	4-28

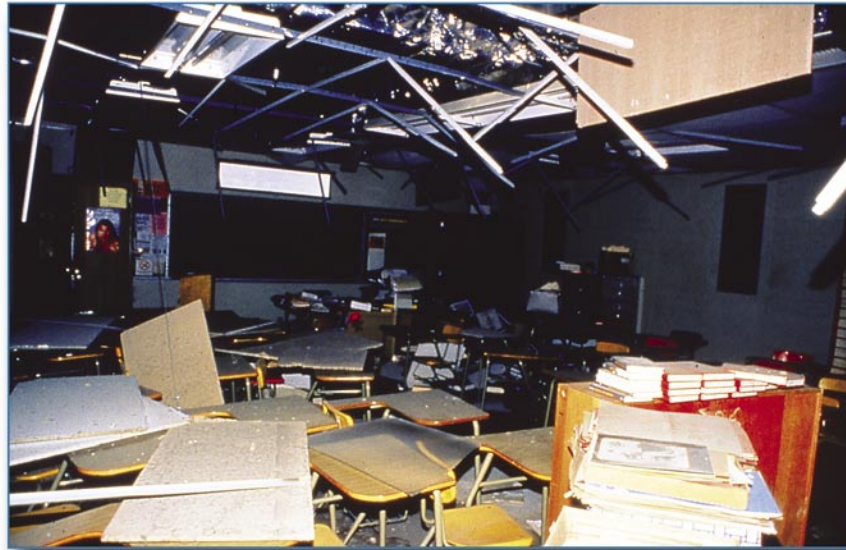
Figure 4-27  
Ceiling damage,  
Northridge, CA, 1994

over-conservative. No structural elements collapsed. There was, however, considerable nonstructural damage that was costly to repair, resulting in the closure of a number of schools and, if the schools had been in session, would have caused casualties. The Field Act focused on structural design and construction, and only recently were nonstructural elements included in the scope of the Act (see Figures 4-27, 4-28, and 4-29).

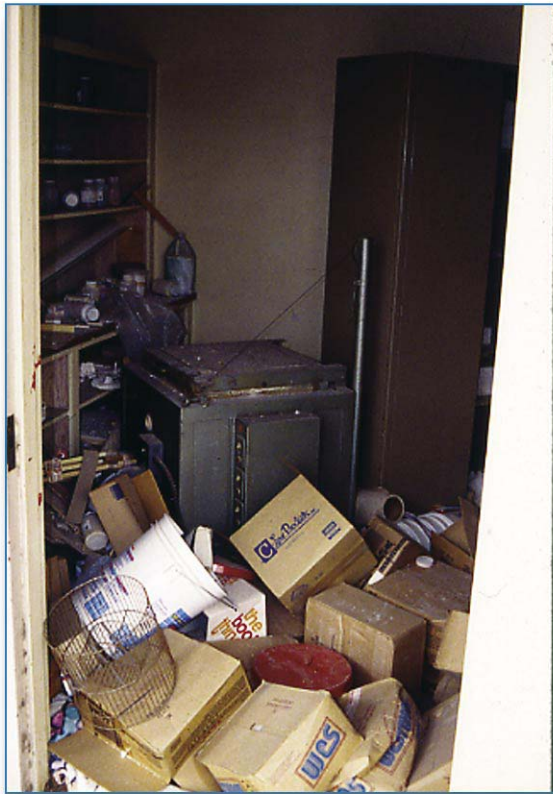
Figure 4-28  
Damage to ceramic kiln, including fractured gas  
line, Northridge, CA, 1994

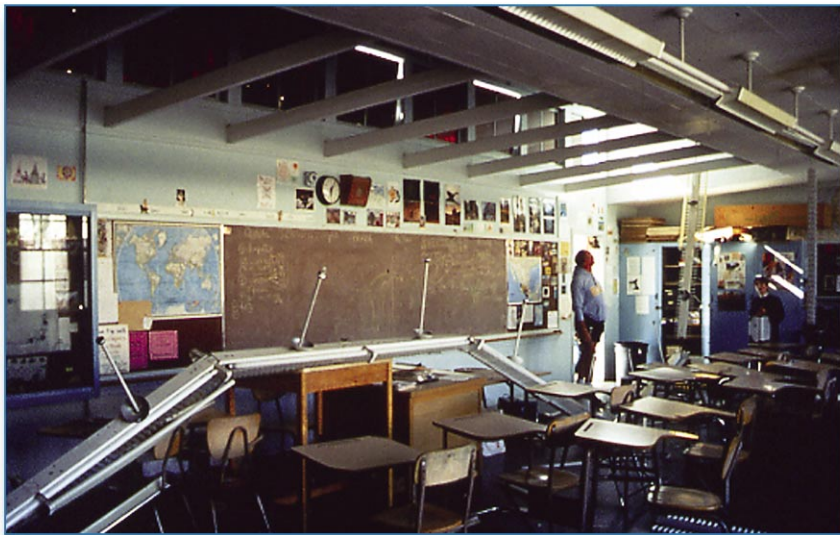
Figure 4-29  
Line of suspended light  
fixtures fallen on teacher's  
station, Northridge, CA,  
1994

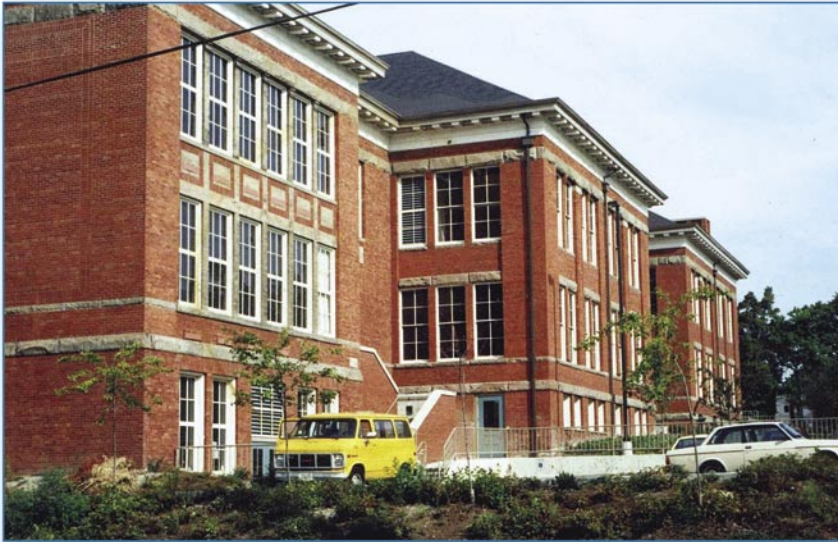
Figure 4-37  
Retrofit of B.F. Day  
Elementary School, Seattle,  
WA

Seismic retrofit at any large scale is expensive, both in design and construction, because of the more complex analyses that must be conducted and the construction constraints that must be overcome. In addition, closure of a school for an extended period (beyond that of the normal summer break) is usually unacceptable. Major seismic retrofit is rare, although some successful projects have been done, primarily with the goal of saving a building that is not only a place of learning, but a historic community resource as well. The retrofitting of the B.F. Day School in Seattle was one such project (see Figures 4-37 and 4-38).

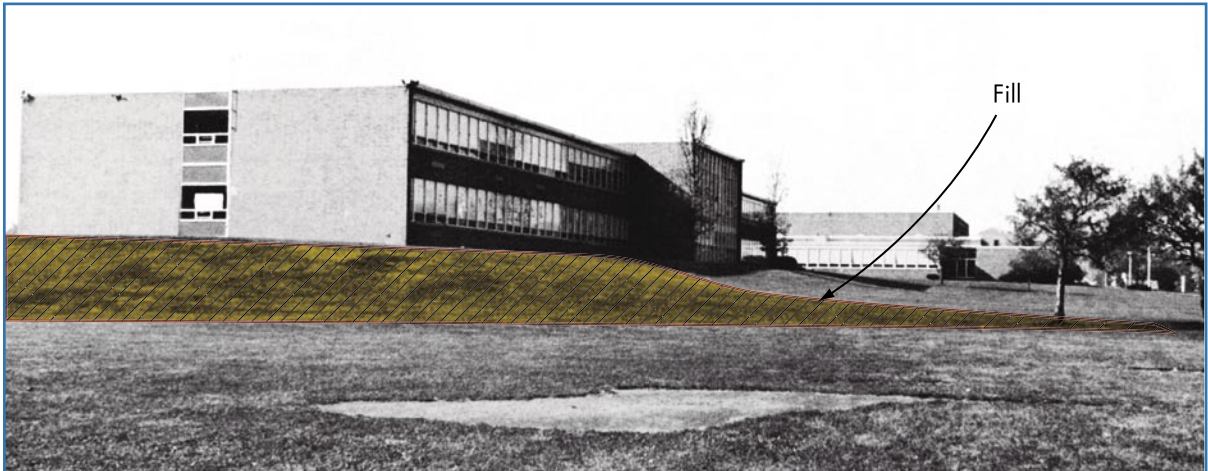
Figure 5-5 High school in Bloomsburg, PA, elevated on fill

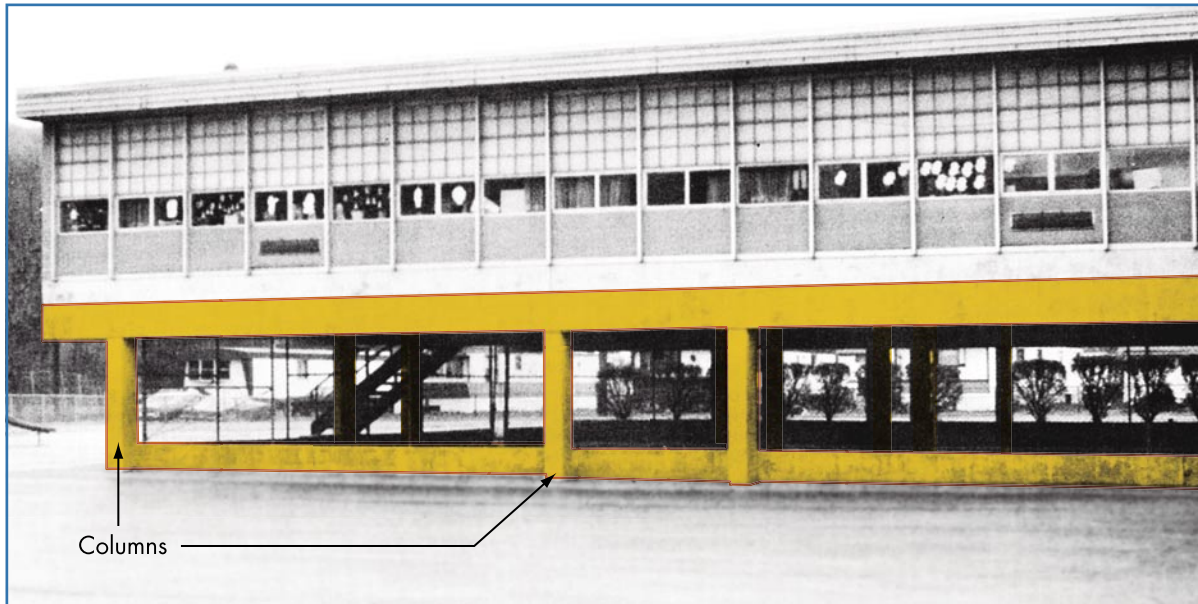
Figure 5-6 Elementary school in Jefferson County, OH, elevated on columns

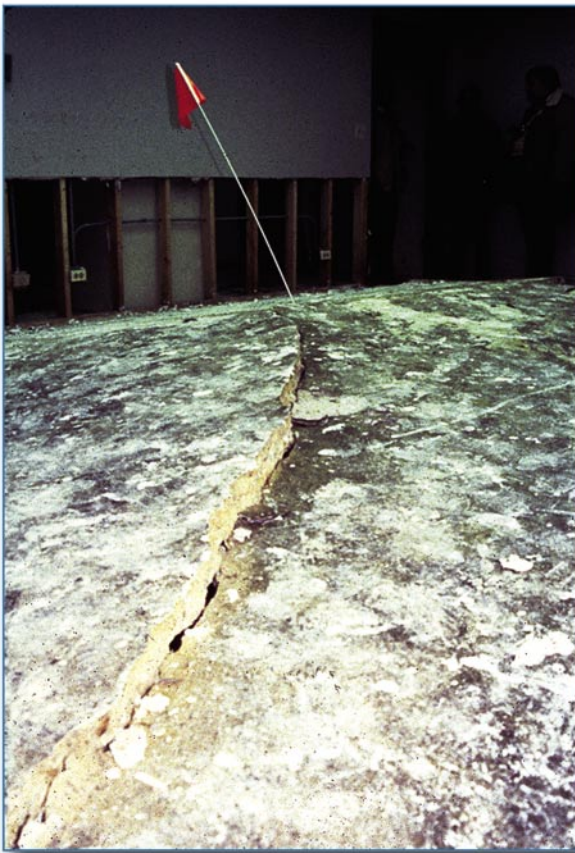
Figure 5-8  
Fractured concrete basement floor, Gurnee, IL,  
1986

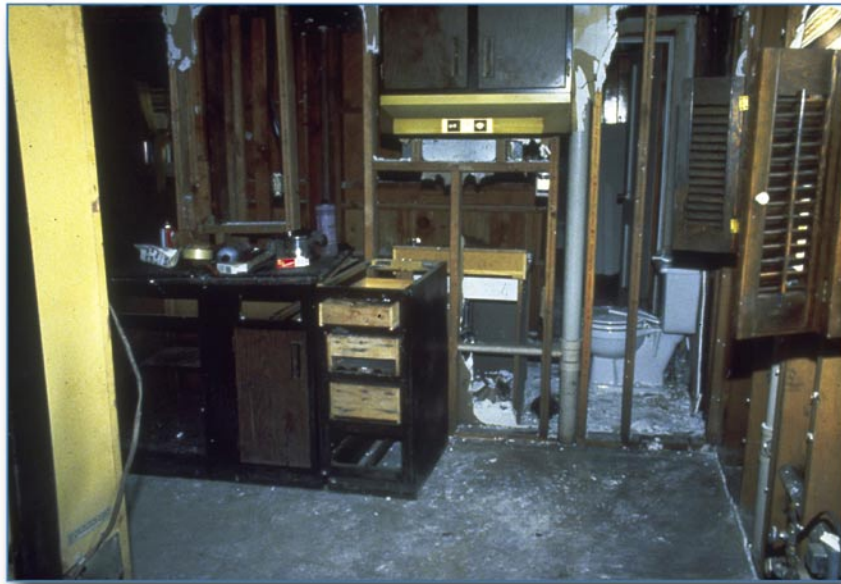
Figure 5-9  
Damaged walls and  
cabinets, Peoria County, IL

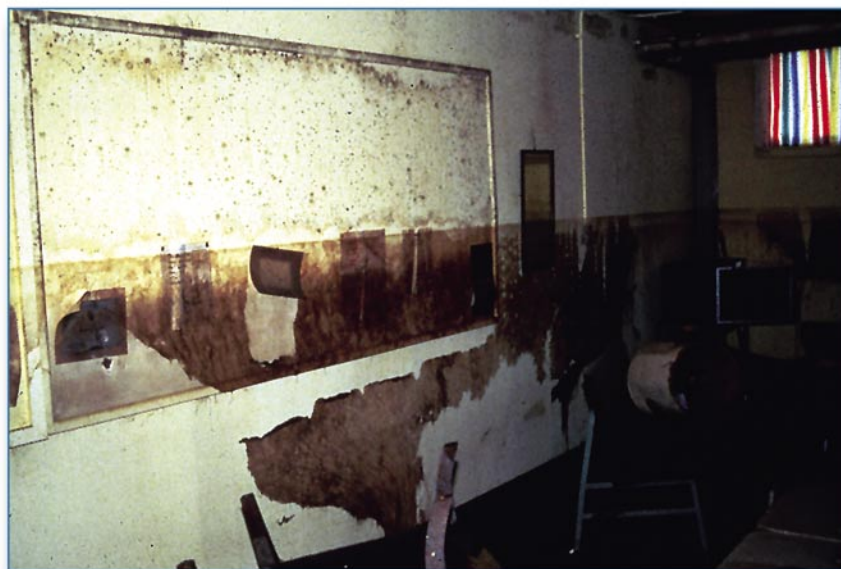
Figure 5-10  
Basement damage at a  
grade school in Gurnee,  
IL, 1986

- **Wall and wood components.** When soaked for long periods of time, some building components change composition or shape. Wet wood will swell and, if dried too quickly, will crack, split or warp. Plywood can delaminate and wood door and window frames may swell and become unstable. Gypsum wallboard, wood composition panels, other wall materials, and wood cabinetry not intended for wet locations can fall apart (see Figure 5-9). The longer these materials are wet, the more moisture, sediment, and pollutants they will absorb. Some wall materials such as the paper facing on gypsum wallboard, “wick” standing water, resulting in damage above the actual high-water line (see Figure 5-10).

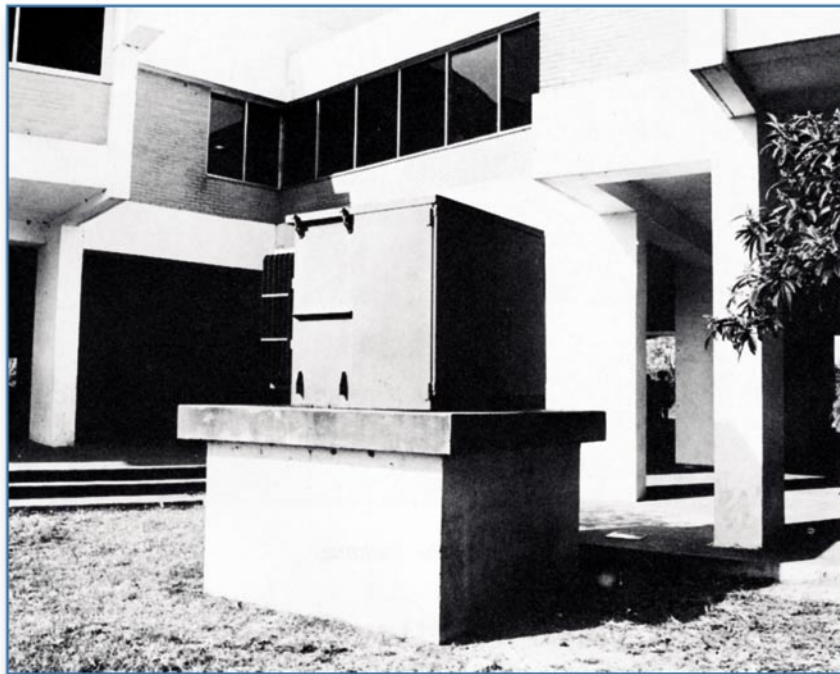
Figure 5-13  
Elevated electric  
transformer at an  
elementary school in  
Verret, LA

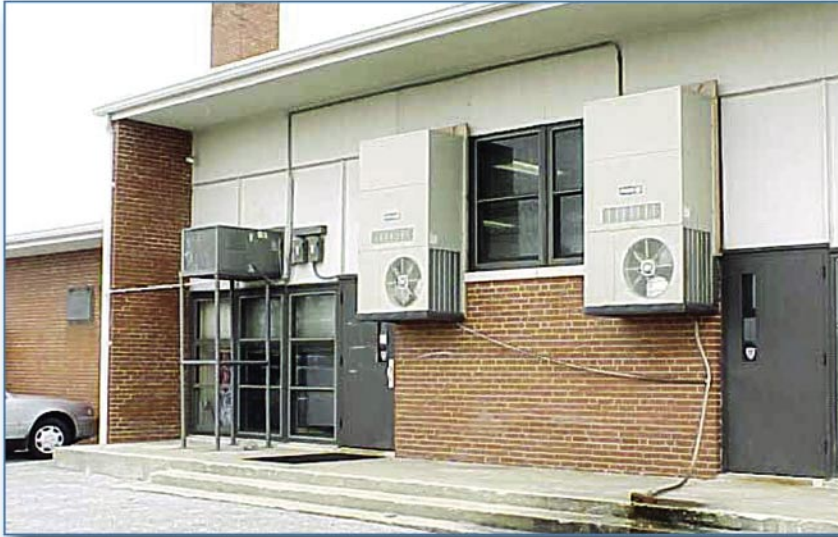
Figure 5-14  
Elevated utilities behind  
an elementary school in  
Wrightsville Beach, NC

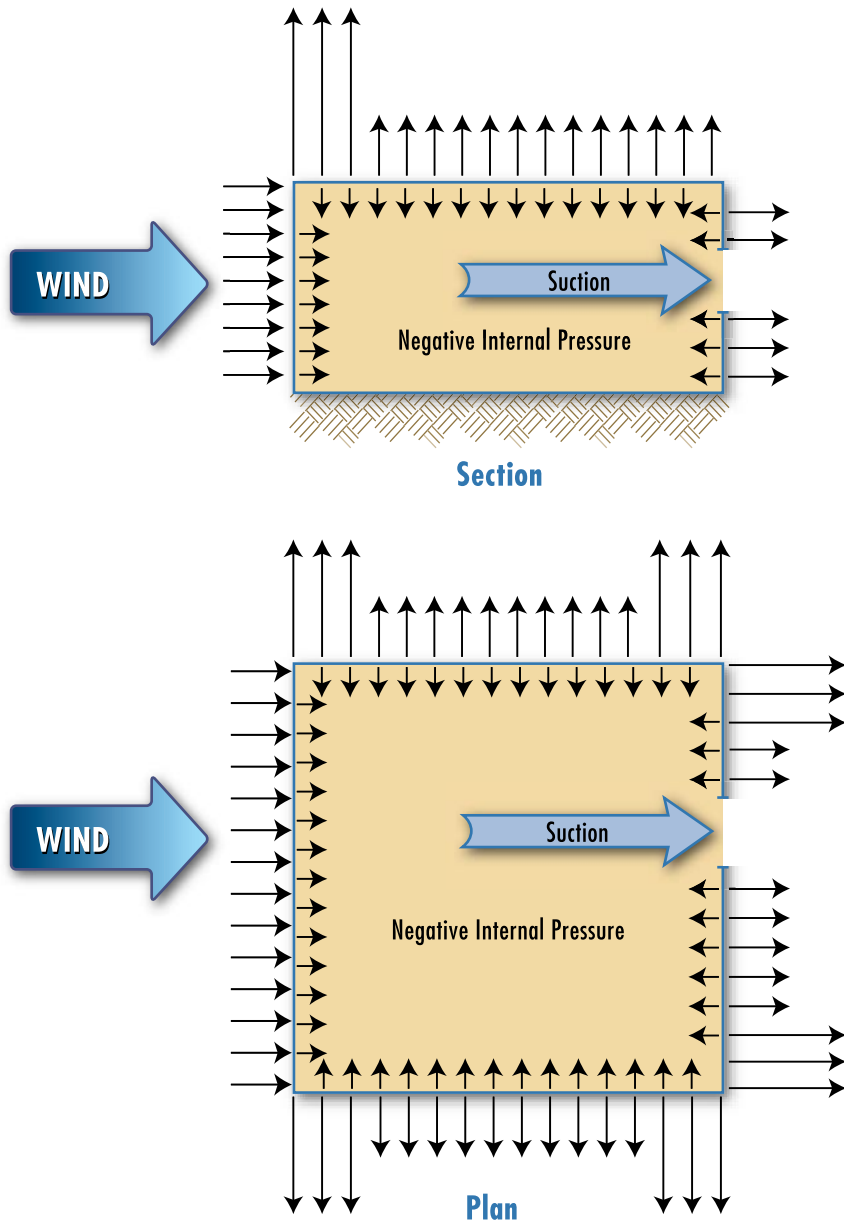
Figure 6-6  
Schematic of internal  
pressure condition  
when the dominant  
opening is in the  
leeward wall

Figure 6-6 Schematic of internal pressure condition when the dominant opening is in the leeward wall..... 6-11

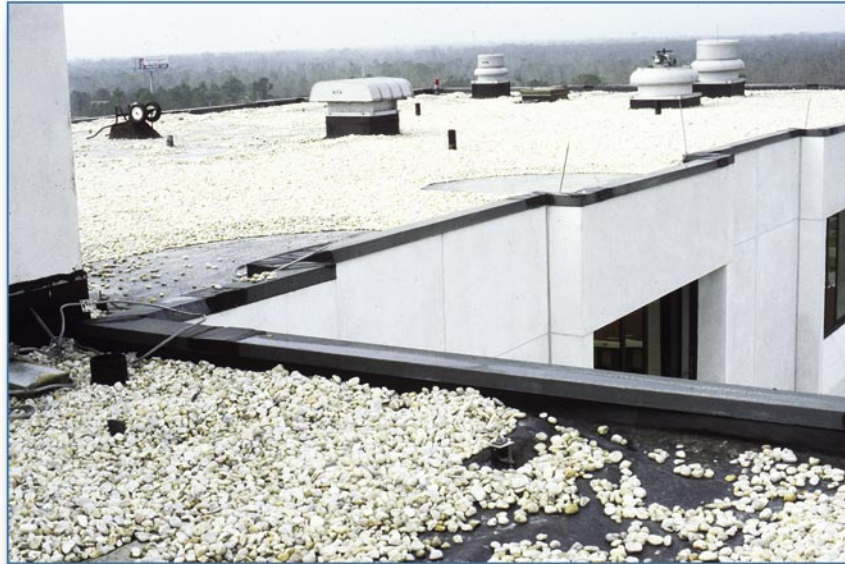
As shown in Figure 6-9, the built-up roof's base flashing was pulled out from underneath the coping and caused a large area of the membrane to lift and peel. Some of the wall covering on the stair tower was also blown away. Had the stair tower not existed, the built-up roof would not have been damaged.

Figure 6-9 The metal roof is over a stair tower. The irregularity created by the stair tower caused turbulence that resulted in wind speed-up..... 6-14

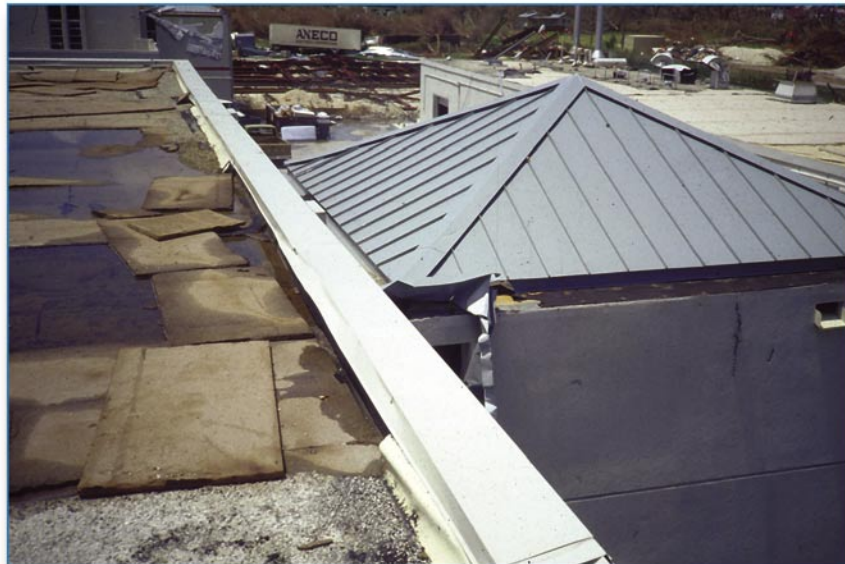
The metal roof is over a stair tower. The irregularity created by the stair tower caused turbulence that resulted in wind speed-up.

Building irregularities such as bay window projections, a stair tower projecting out from the main wall, dormers, chimneys, etc., can cause localized turbulence. Turbulence causes wind speed-up, which increases the wind loads in the vicinity of the building irregularity as shown in Figures 6-8 and 6-9.

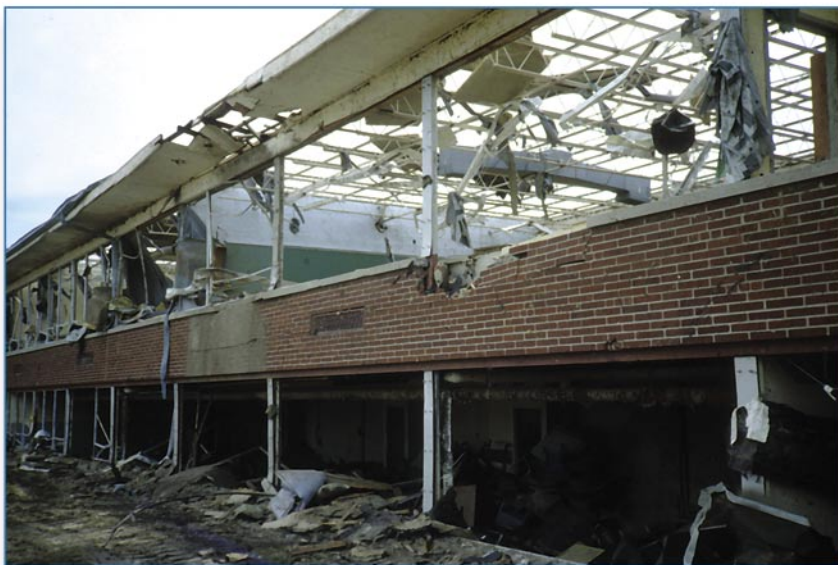
Figure 6-10  
This high school in northern Illinois was heavily damaged by a strong tornado.

Figure 6-10 This high school in northern Illinois was heavily damaged by a strong tornado ..... 6-17

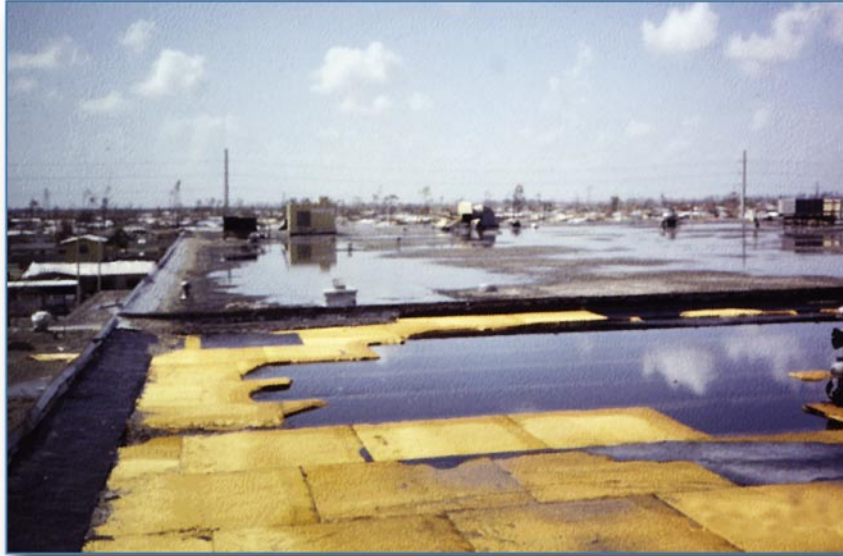
Figure 6-11

A portion of the built-up membrane at this school lifted and peeled after the metal edge flashing lifted. The cast-in-place concrete deck kept a lot of water from entering the school. Virtually all of the loose aggregate blew off the roof and broke many windows in nearby houses. This school was being used as a hurricane shelter at the time of the blow-off.

The traditional edge flashing/coping attachment method relies on concealed cleats that can deform under wind load and lead to disengagement of the flashing/coping (see Figure 6-38) and subsequent lifting and peeling of the roof membrane (as shown in Figure 6-11). When a vertical flange disengages and lifts up (as shown in Figure 6-38), the edge flashing and membrane are very susceptible to failure. Normally, when a flange lifts such as shown in Figure 6-38, the failure continues to propagate and the metal edge flashing and roof membrane blow off.

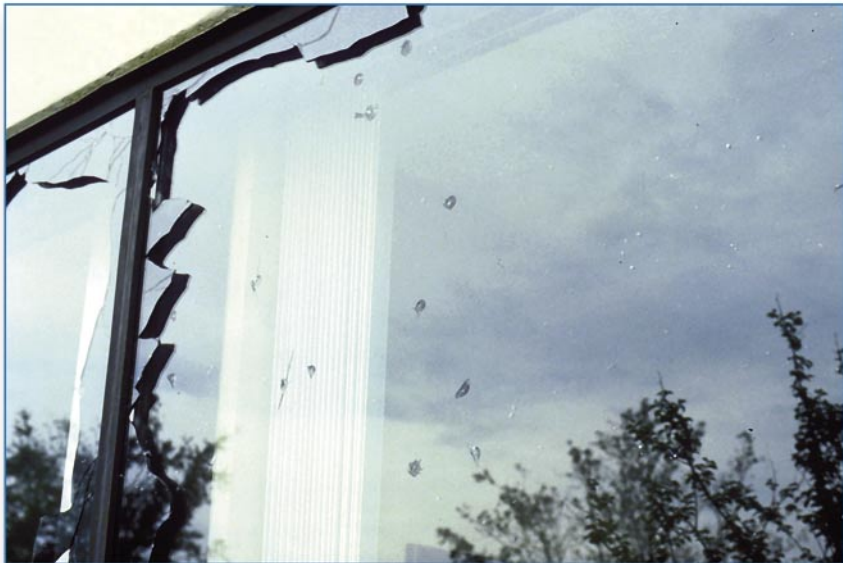
Figure 6-12

The outer panes of these windows were broken by aggregate from a built-up roof. The inner panes had several impact craters. In several of the adjacent windows, both the outer and inner panes were broken. The aggregate had a flight path in excess of 245 feet. The wind speed was less than the design wind speed.

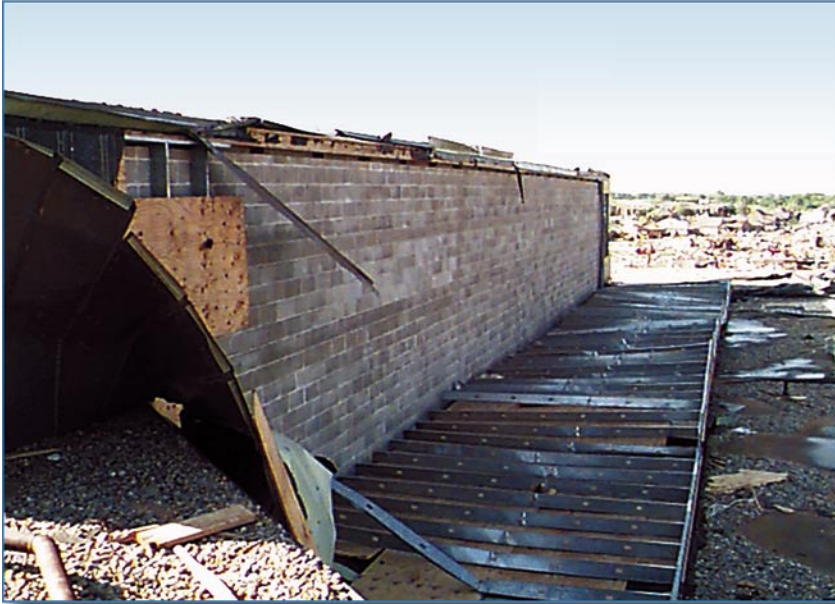
Figure 6-13  
The metal wall covering on this school was applied to plywood over metal studs. The metal stud wall collapsed in this area, but, in other areas, it was blown completely away. The CMU wall behind the studs did not appear to be damaged. This school was on the periphery of a violent tornado.

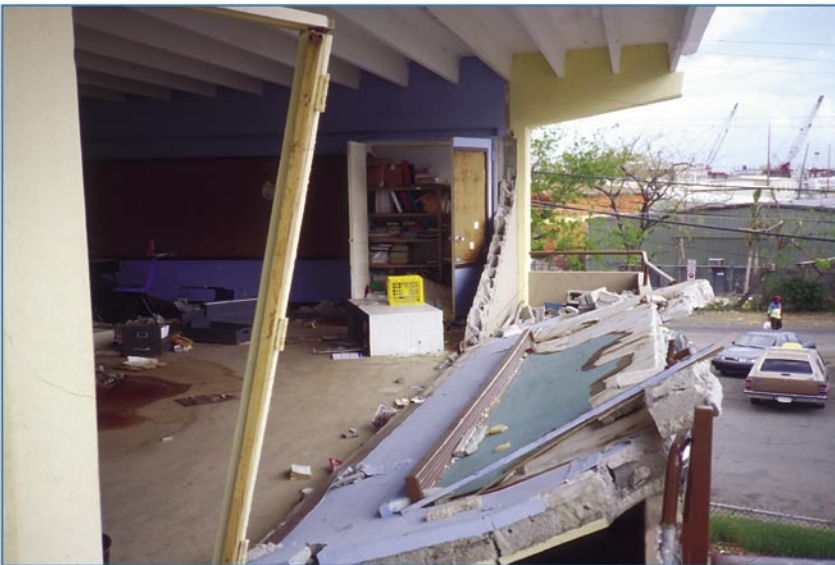
Figure 6-14  
The unreinforced CMU wall at this school collapsed during a storm that had wind speeds that were less than the design wind speed.

Particular care should be given to the design and construction of exterior non-load bearing walls constructed of masonry. Although these walls are not intended to carry gravity loads, they must be designed to resist the positive and negative wind loads in order to avoid collapse. Because of their great weight, when these types of walls collapse, they represent a severe risk to life as shown in Figure 6-14.

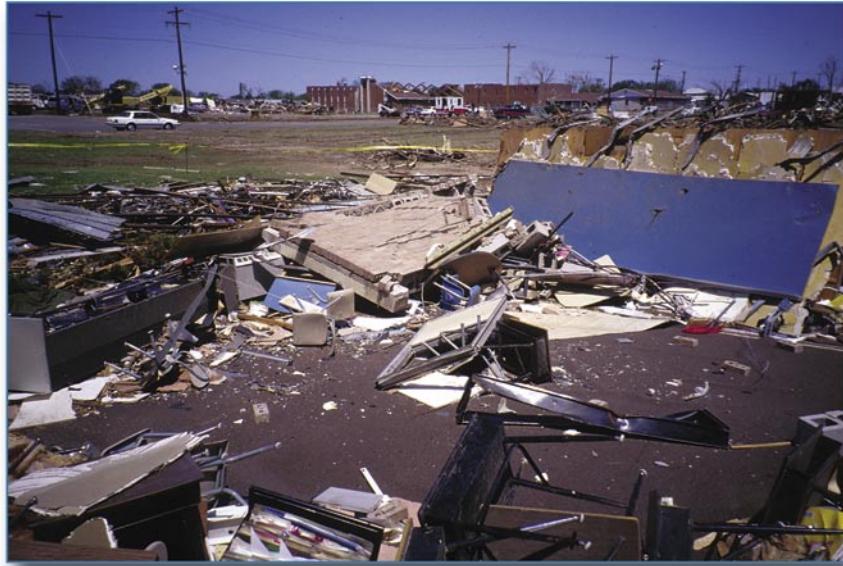
Figure 6-16  
This portable classroom was blown up against the main school building during a storm that had wind speeds that were less than the design wind speed. Depending upon the type of exterior wall, an impacting portable classroom may or may not cause wall collapse.

Figure 6-16 This portable classroom was blown up against the main school building during a storm that had wind speeds that were less than the design wind speed. Depending upon the type of exterior wall, an impacting portable classroom may or may not cause wall collapse. .... 6-20

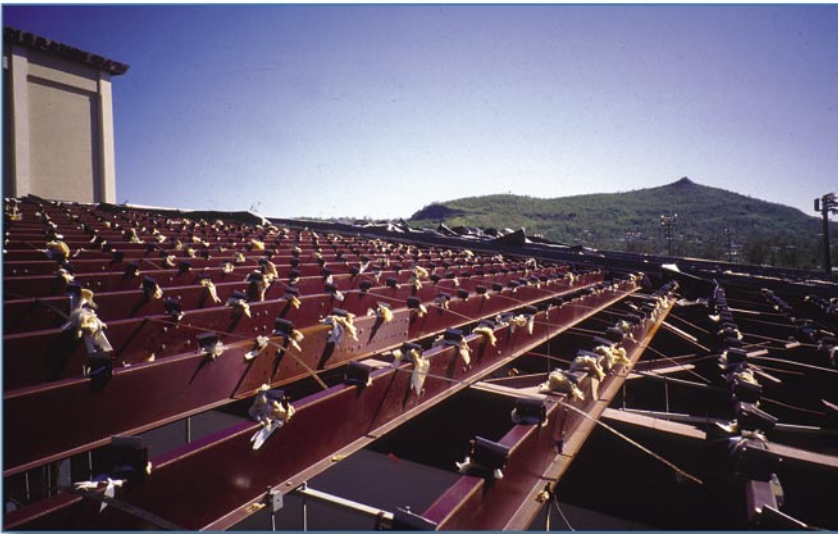
Figure 6-17  
This newly-constructed gymnasium had a structural metal roof panel (3-inch trapezoidal ribs at 24 inches on center) applied over metal purlins. The panels detached from their concealed clips. A massive quantity of water entered the school and buckled the wood gym floor.

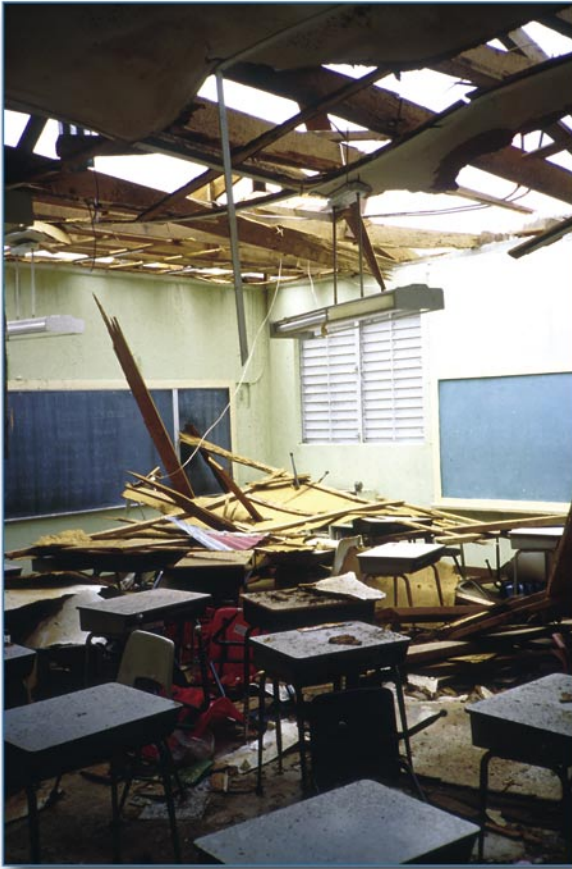
Figure 6-18

A portion of the roof structure blew off of this school, and a portion of it collapsed into classrooms. Because of extensive water damage, a school such as this can be out of operation for a considerable period of time.

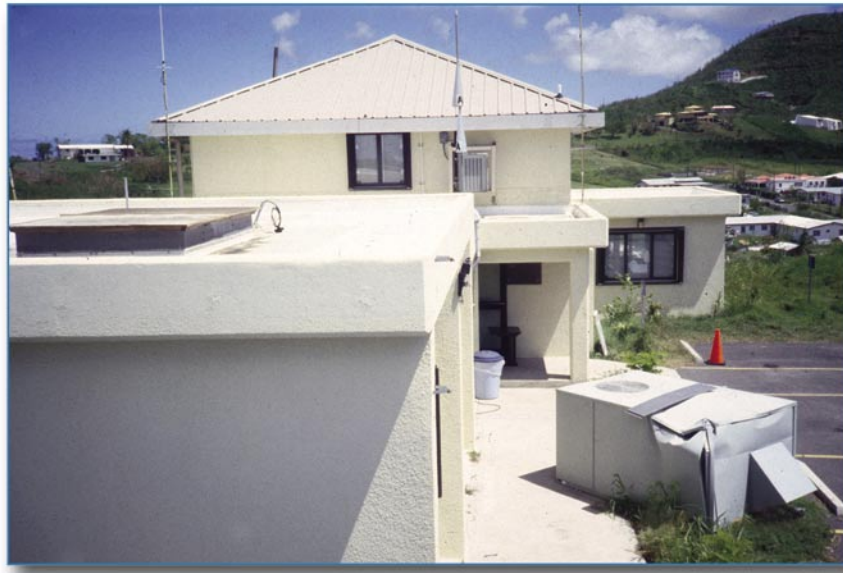
The HVAC unit in the parking lot in the photo's lower right corner blew off the curb during a storm that had wind speeds that were less than the design wind speed. A substantial amount of water entered the building before a temporary covering could be placed over the opening. The blow-off was caused by a load path discontinuity; no provisions had been made to anchor the unit to the curb. The insignificant cost of a few fasteners would have prevented repairs costing several thousand dollars and also prevented interrupted use of a portion of the building.

Fortunately, most of the enhancements pertaining to increased wind resistance are relatively inexpensive compared to the benefit that they provide. In evaluating what enhancements are prudent for a specific school, an enhancement that provides greater performance reliability at little cost is an enhancement worthy of consideration (see Figure 6-19).

As part of the detailed design effort, load path continuity should be clearly indicated in the contract documents. Load paths need to accommodate design uplift, racking, and overturning loads. Load path continuity obviously applies to MWFRS elements, but it also applies to building envelope elements. Figure 6-19 shows a load path discontinuity between a piece of HVAC equipment and its equipment curb. Figure 6-20 illustrates the load path concept.

Exterior-mounted mechanical (e.g., exhaust fans, HVAC units, relief air hoods, boiler stacks), electrical, and communications equipment (e.g., light fixtures, antennae, satellite dishes) are often damaged during high winds. Damaged equipment can impair the use of the school, the equipment can become missiles, and water can enter the facility where equipment was displaced (see Figures 6-19 and 6-48).
