# Design Guide

for Improving School Safety in Earthquakes, Floods,  
and High Winds

*January 2004*

**FEMA**

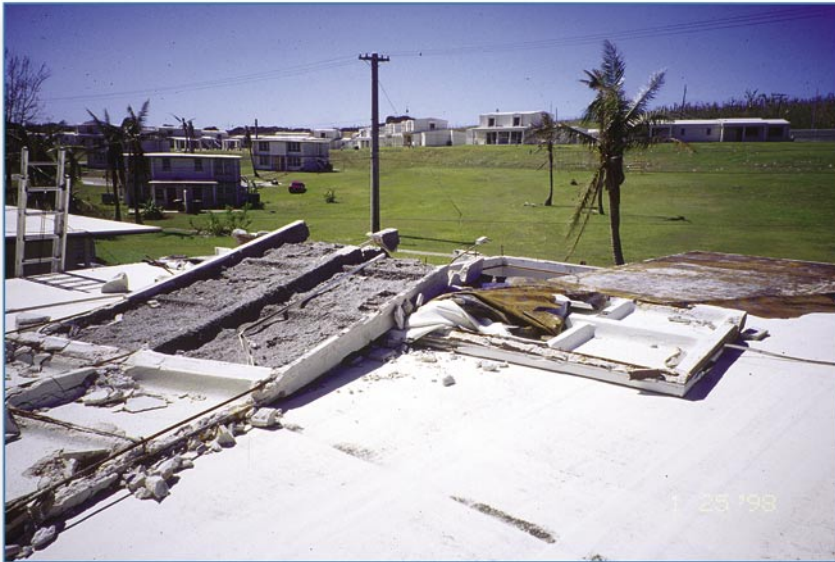
Figure 6-23  
Portions of this waffled precast concrete roof deck were blown off. Bolts had been installed to provide uplift resistance; however, anchor plates and nuts had not been installed. Without the anchor plates, the dead load of the deck was inadequate to resist the wind uplift load.

- For attachment of wood sheathed roof decks, specify screws, or ring-shank or screw-shank nails in the corner regions of the roof. Where the basic wind speed is greater than 90 mph, also specify these types of fasteners for the perimeter regions of the roof.
- For precast concrete decks, design the deck connections to resist the design uplift loads (the dead load of the deck itself is often inadequate to resist the uplift load; see Figure 6-23).

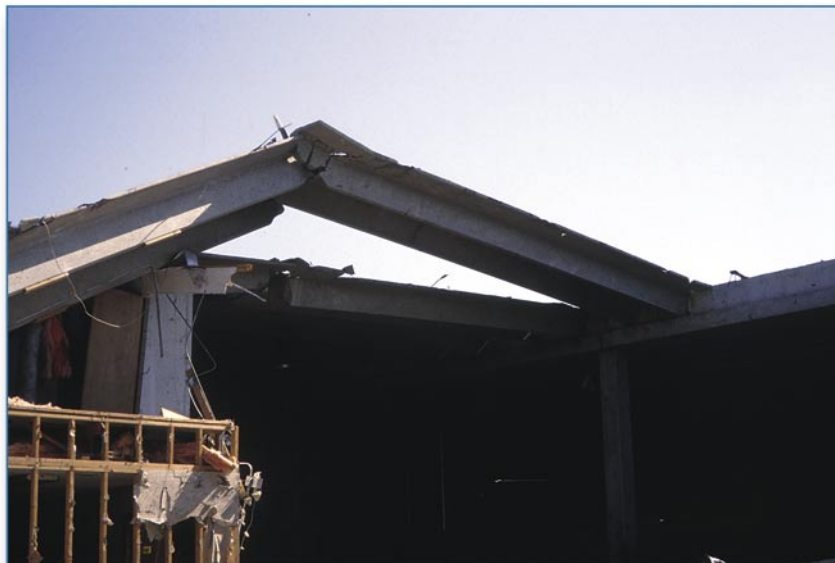
Figure 6-24  
Several of the precast twin-Tee roof and wall panels collapsed. The connection between the roof and wall panels provided very little uplift load resistance. This roof panel lifted because of combined effects of wind uplift and pretension.

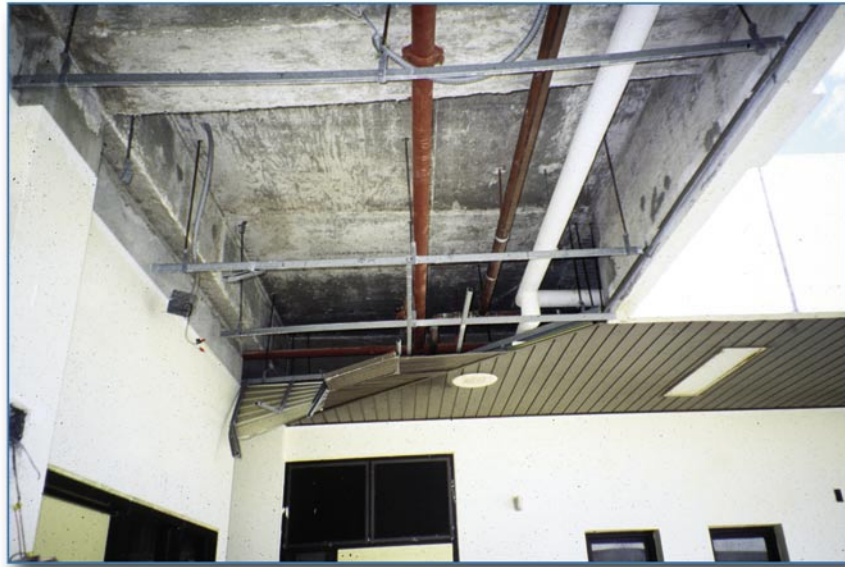
Figure 6-33  
This suspended metal soffit was not designed for upward-acting wind pressure.

The IBC requires that exterior non-load bearing walls, wall coverings, and soffits (see Figure 6-33) have sufficient strength to resist the positive and negative design wind pressure. Architects should specify that wall coverings and soffits comply with wind load testing in accordance with ASTM E 1233.

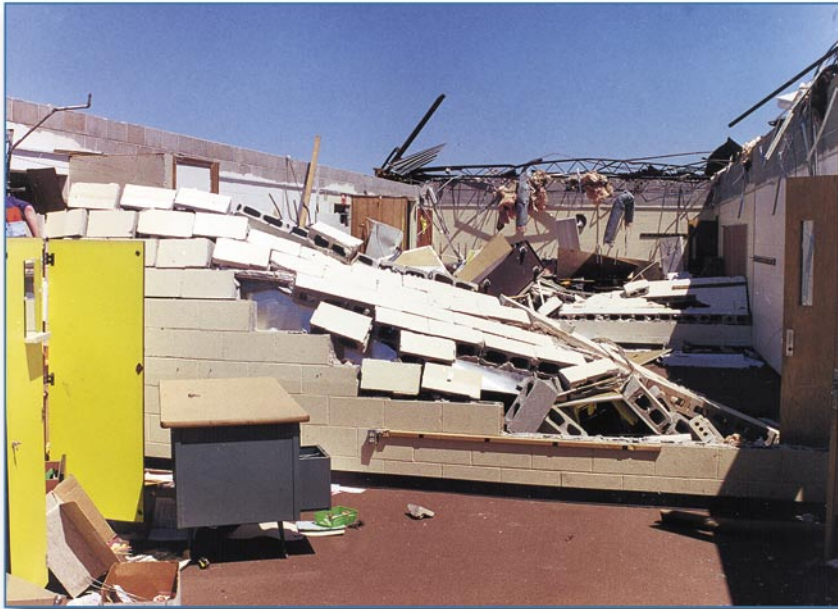
Figure 6-34  
The interior walls of this classroom wing were constructed of unreinforced CMU.

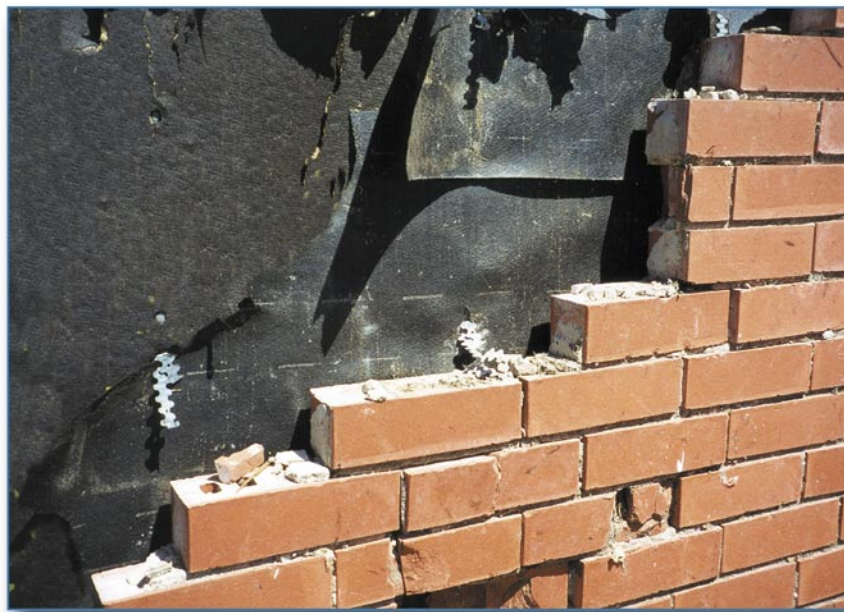
Figure 6-35 shows brick veneer that was blown off. The bricks were attached to the back-up wall with corrugated metal ties. All of the following failure modes are commonly found in the vicinity of this type of common failure: 1) The nails pull out of the studs (smooth shank nails are typically used, hence they have limited withdrawal resistance; 2) The ties do not extend far enough into the mortar joint (i.e., the tie is not long enough); 3) Although the ties make contact with the mortar, they are not well-bonded to it; 4) The ties are spaced too far apart; and 5) The ties provide essentially no resistance to compression. Hence, when a great amount of positive pressure is applied to the bricks, the brick joints flex. This flexing weakens the mortar joint. Walls that have not had bricks blown away have been found to be capable of being deflected with hand pressure. Although they look sound, in this condition they are very vulnerable to failure. Good reliable wind performance of brick veneer is very demanding on the designer and applicator.

Figure 6-35  
Failure of brick veneer

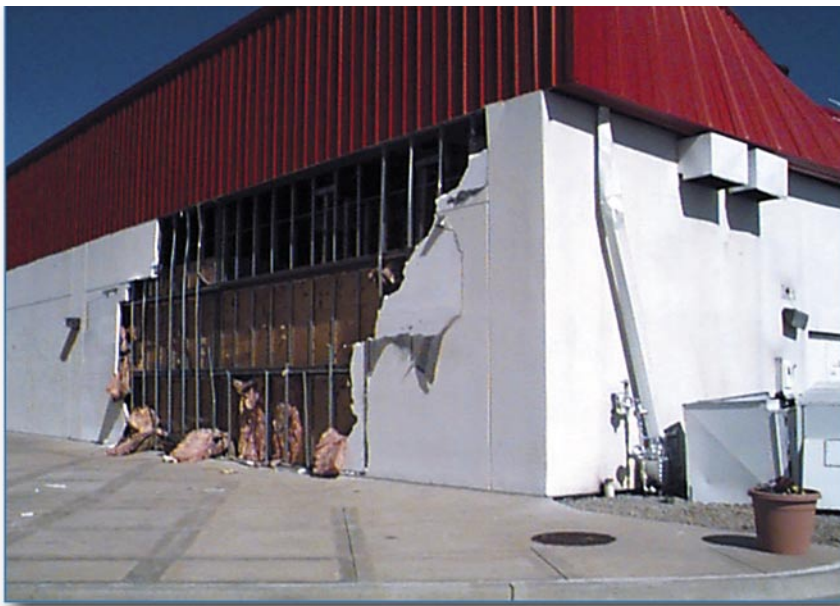
Figure 6-36 shows EIFS blow-off. In this case, the expanded polystyrene (EPS) was attached to gypsum board, which was attached to metal studs. The gypsum board detached from the studs, which is a common EIFS failure mode. When the gypsum board on the exterior side of the studs is blown away, it is common for gypsum board on the interior side to also be blown off. This then allows the school to become fully pressurized and allows entrance of wind-driven rain. Other common failure modes include separation of the EPS from its substrate and separation of the synthetic stucco from the EPS. Good reliable wind performance of EIFS is very demanding on the designer and applicator. Maintenance of EIFS and associated sealant joints is also demanding in order to minimize reduction of EIFS' wind resistance due to water infiltration.

Figure 6-36  
EIFS blow-off near a wall corner. At one area, the metal fascia was also blown in.

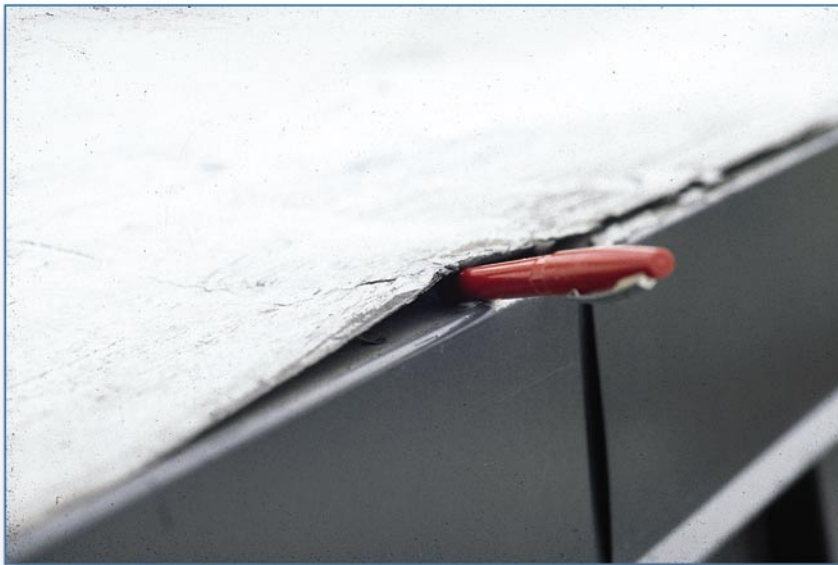
Figure 6-37  
The metal edge flashing on this modified bitumen membrane roof was installed underneath the membrane, rather than on top of it and then stripped in. In this location, the edge flashing is unable to clamp the membrane down. At one area, the membrane was not sealed to the flashing (an ink pen was inserted into the opening prior to photographing). Wind can catch the opening and lift and peel the membrane.

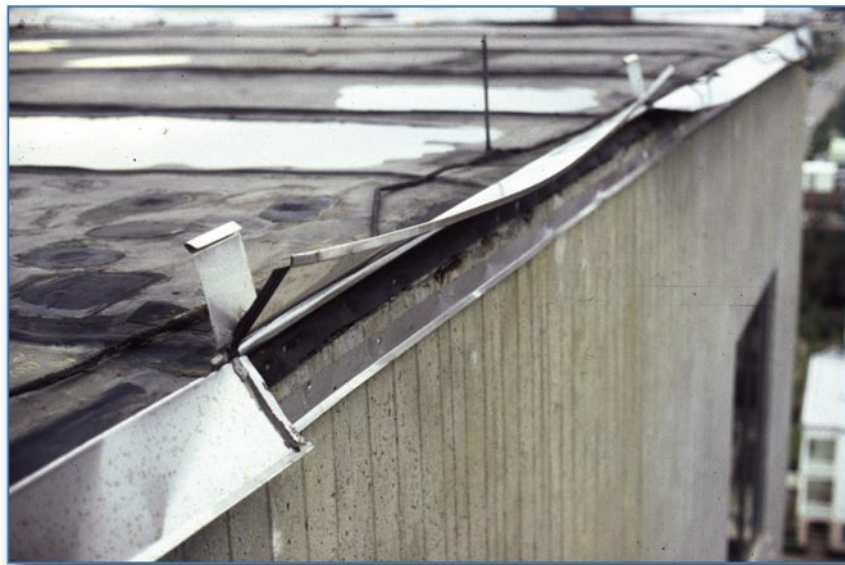
Figure 6-38  
This metal edge flashing had a continuous cleat, but the flashing disengaged from the cleat and the vertical flange lifted up. However, the horizontal flange of the flashing did not lift.

The traditional edge flashing/coping attachment method relies on concealed cleats that can deform under wind load and lead to disengagement of the flashing/coping (see Figure 6-38) and subsequent lifting and peeling of the roof membrane (as shown in Figure 6-11). When a vertical flange disengages and lifts up (as shown in Figure 6-38), the edge flashing and membrane are very susceptible to failure. Normally, when a flange lifts such as shown in Figure 6-38, the failure continues to propagate and the metal edge flashing and roof membrane blow off.

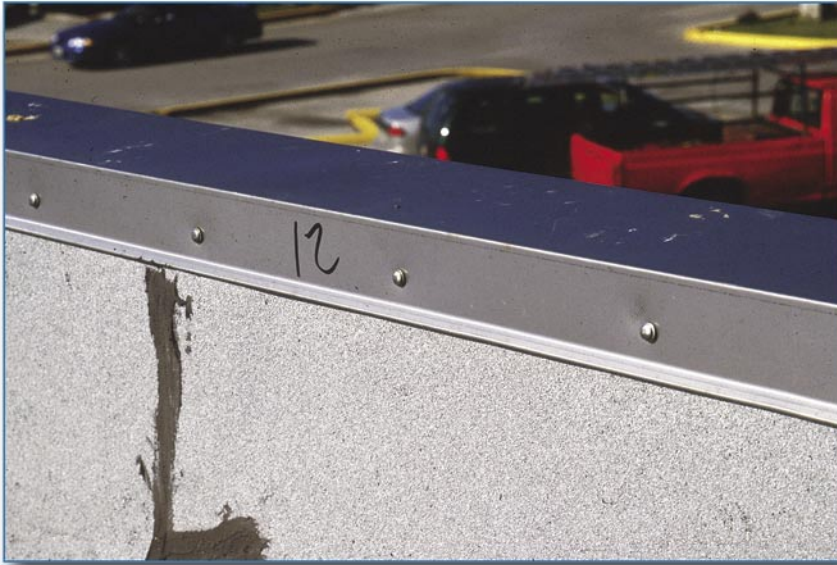
Figure 6-39  
 This coping was attached with ¼-inch diameter stainless steel concrete spikes at 12 inches on center. When the fastener is placed in wood, #14 stainless steel screws with stainless steel washers are recommended. Also, in the corner areas, the fasteners should be more closely spaced (the spacing will depend upon the design wind loads). ANSI/SPRI ES-1 provides guidance on fastener spacing and thickness of the coping/edge flashing.

Storm-damage research has revealed that, in lieu of cleat attachment, use of exposed fasteners to attach the vertical flanges of copings and edge flashings has been found to be a very effective and reliable attachment method (see Figure 6-39).

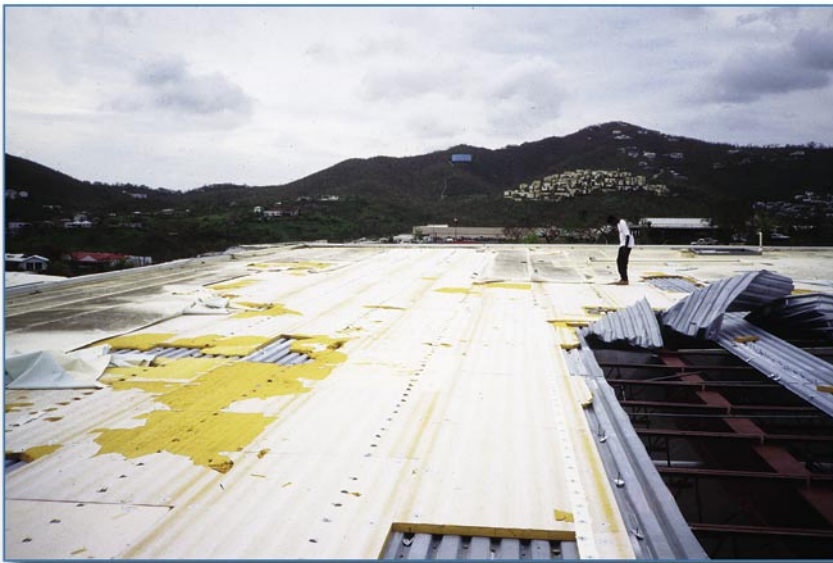
Figure 6-41  
On this school, the fastener rows of the mechanically attached single-ply membrane ran parallel to the top flange of the steel deck. Hence, essentially all of the row's uplift load was transmitted to only two deck fasteners at each joist (as illustrated in Figure 6-42). Because the deck fasteners were overstressed, a portion of the deck blew off and the membrane progressively tore.

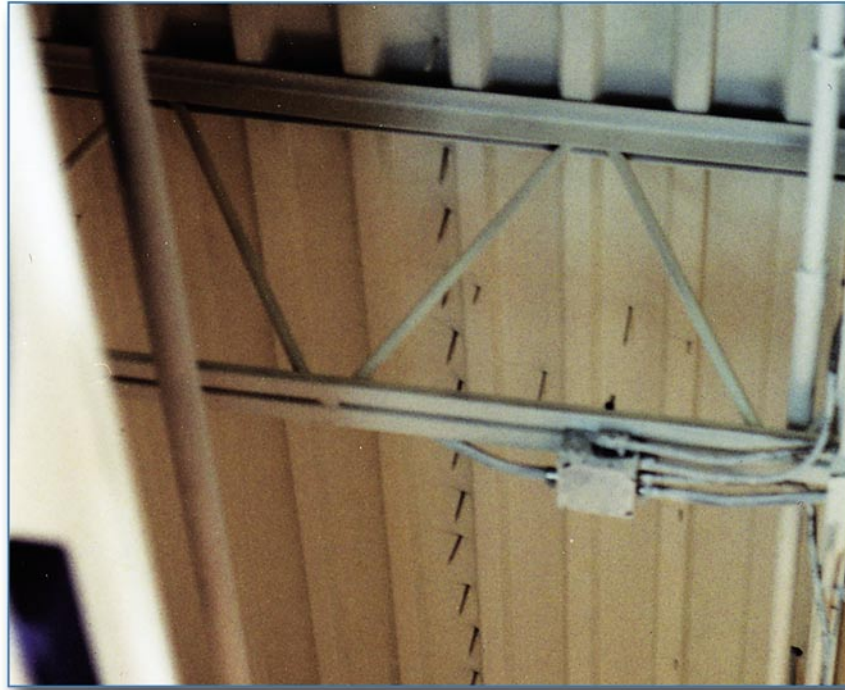
Figure 6-42  
View of the underside  
of a steel deck. The  
mechanically attached  
single-ply membrane  
fastener rows ran parallel  
to the top flange of the steel  
deck.

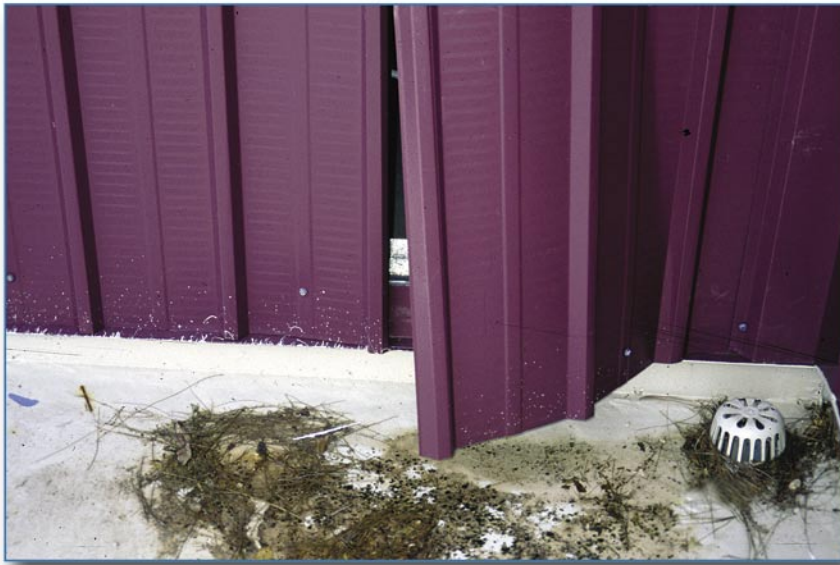
Figure 6-43  
The parapet on this school was sheathed with metal wall panels. The panels were fastened at 2 feet on center along their bottom edge, which was inadequate to resist the wind load.

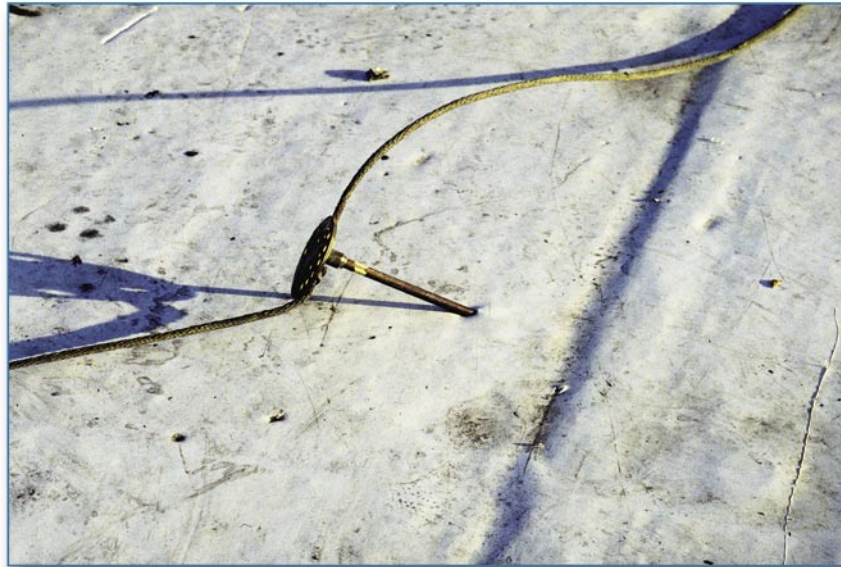
This air terminal (“lightning rod”) was dislodged and whipped around during a windstorm. The single-ply membrane was punctured by the sharp tip in several locations.

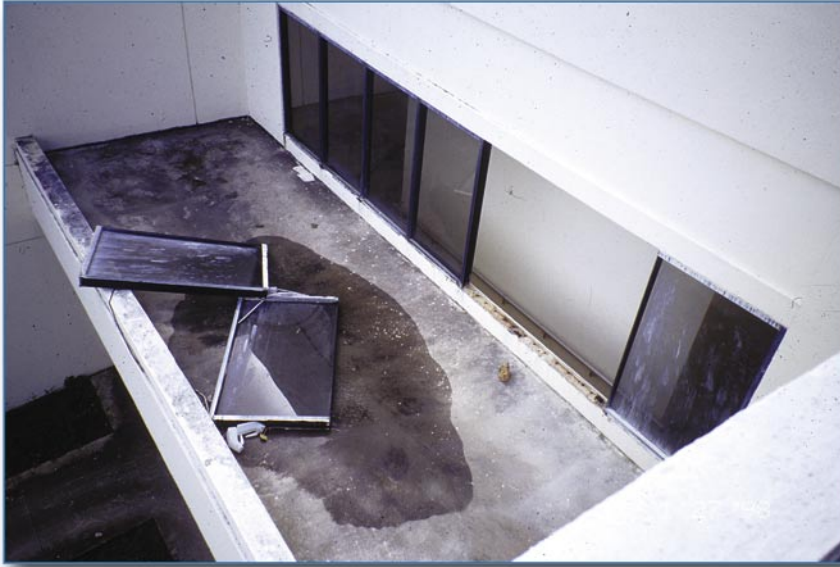
Figure 6-45  
Two complete windows, including their frames, blew out. The frames were attached with an inadequate number of fasteners, which were somewhat corroded.

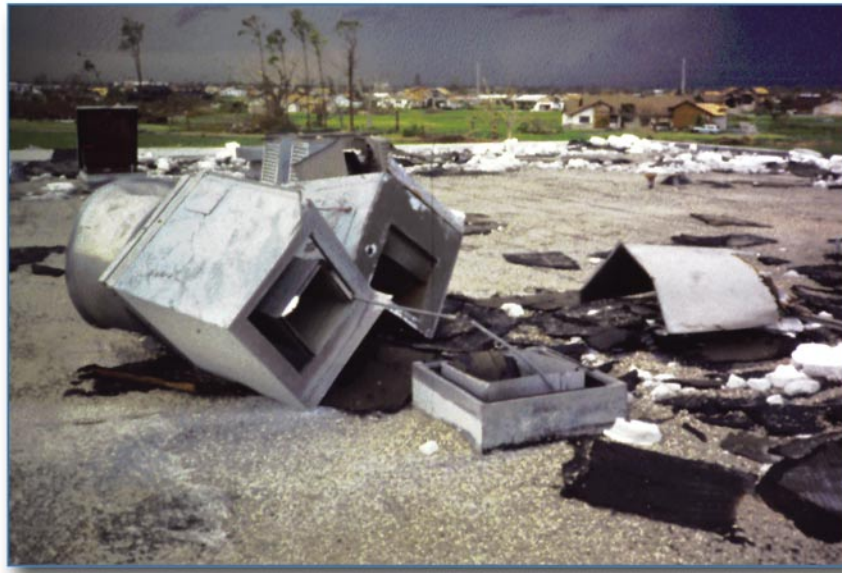
Figure 6-48

The rooftop mechanical equipment on this school was blown over. The displaced equipment can puncture the roof membrane and, as in this case, rain can enter the school through the large opening that is no longer protected by the equipment.

Exterior-mounted mechanical (e.g., exhaust fans, HVAC units, relief air hoods, boiler stacks), electrical, and communications equipment (e.g., light fixtures, antennae, satellite dishes) are often damaged during high winds. Damaged equipment can impair the use of the school, the equipment can become missiles, and water can enter the facility where equipment was displaced (see Figures 6-19 and 6-48).

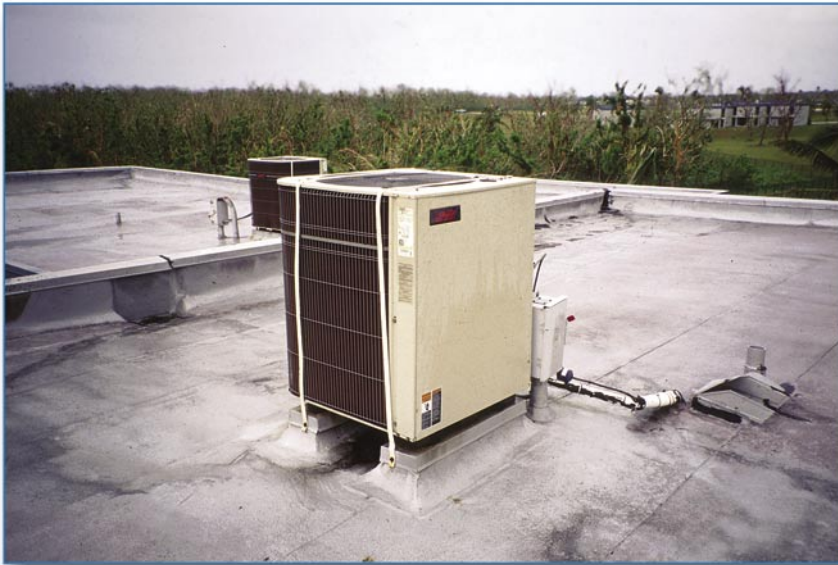
Figure 6-49  
This HVAC equipment had two supplemental securement straps. Both straps are still on this unit, but some of the other units on the roof had broken straps.

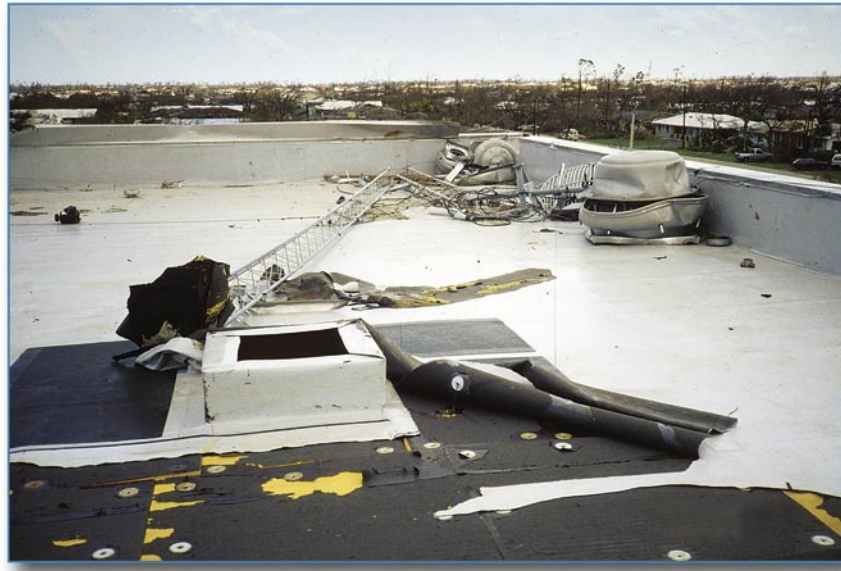
The communications mast on this school was pulled out of the deck, resulting in a progressive peeling failure of the fully adhered single-ply membrane. There are several exhaust fans in the background that were blown off their curbs, but were retained on the roof by the parapet.

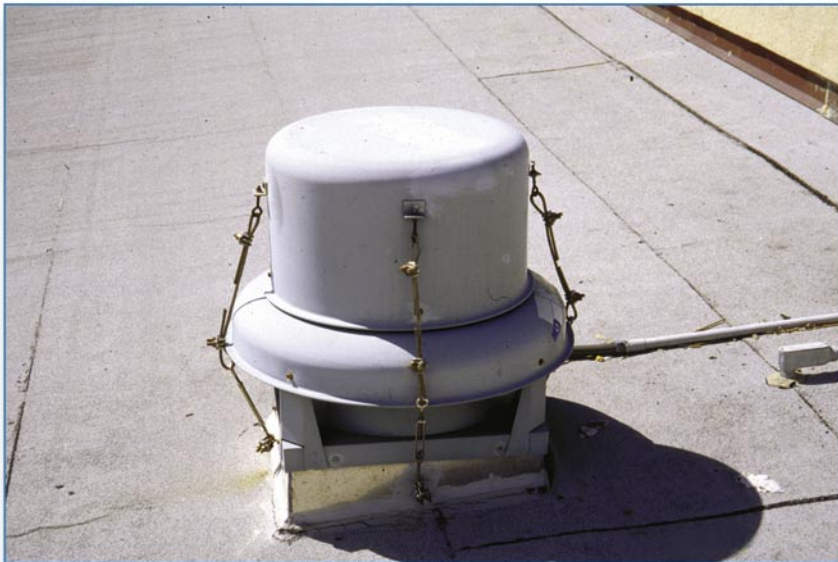
Figure 6-51  
To overcome blow-off of the fan cowling, which is a common problem, this cowling was attached to the curb with cables. The curb needs to be adequately attached to carry the wind load exerted on the fan.

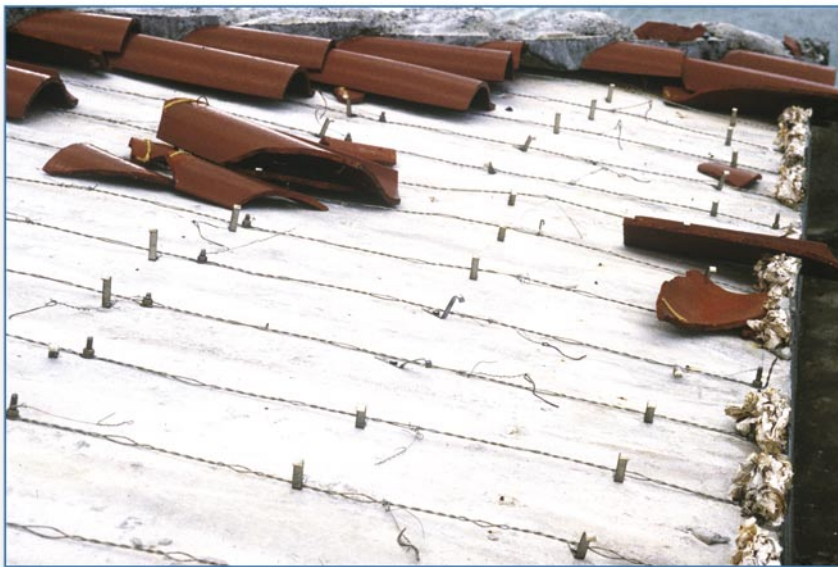
Figure 6-52  
These wire-tied tiles were installed over a concrete deck. They were attached with stainless steel clips at the perimeter rows and all of the tiles had tail hooks. Adhesive was also used between the tail and head of the tiles.

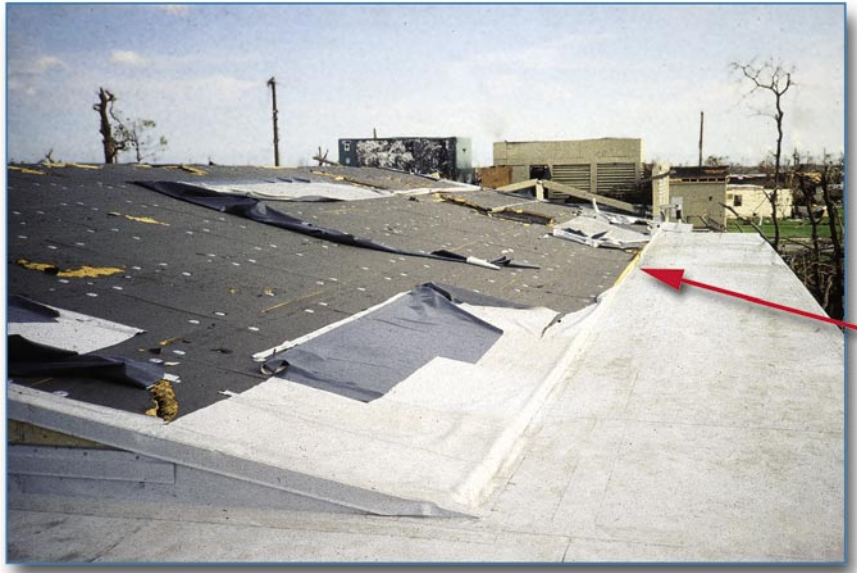
Figure 6-53

At this school, a missile struck the fully adhered low-sloped roof (see arrow) and slid into the steep-sloped reinforced mechanically attached single-ply membrane. A large area of the mechanically attached membrane was blown away due to progressive membrane tearing.

Because mechanically attached and air-pressure equalized single-ply membrane systems are susceptible to massive progressive failure after missile impact (see Figure 6-53), these systems are not recommended on schools in hurricane-prone regions. Fully adhered single-ply membranes are also very vulnerable to missiles (see Figure 6-54); therefore, they also are not recommended unless they are ballasted with pavers.

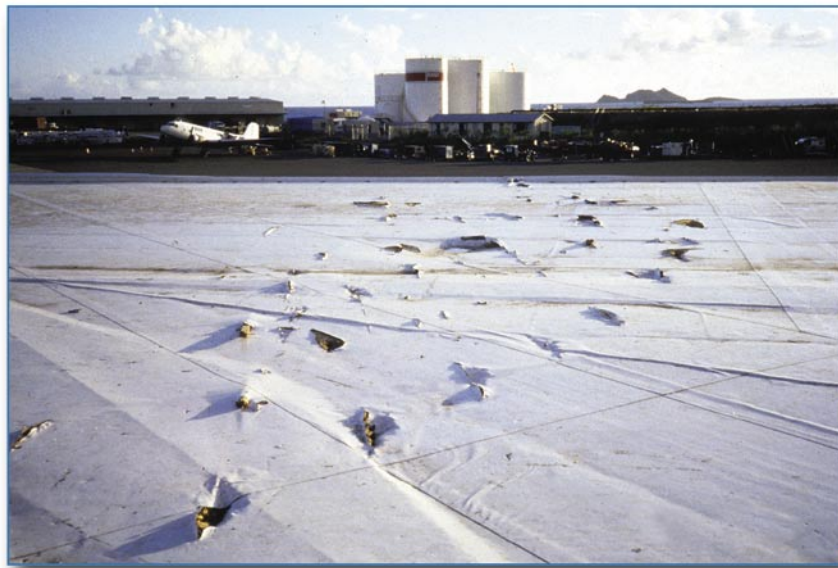
Figure 6-54

This fully adhered single-ply membrane was struck by a large number of missiles during a hurricane.

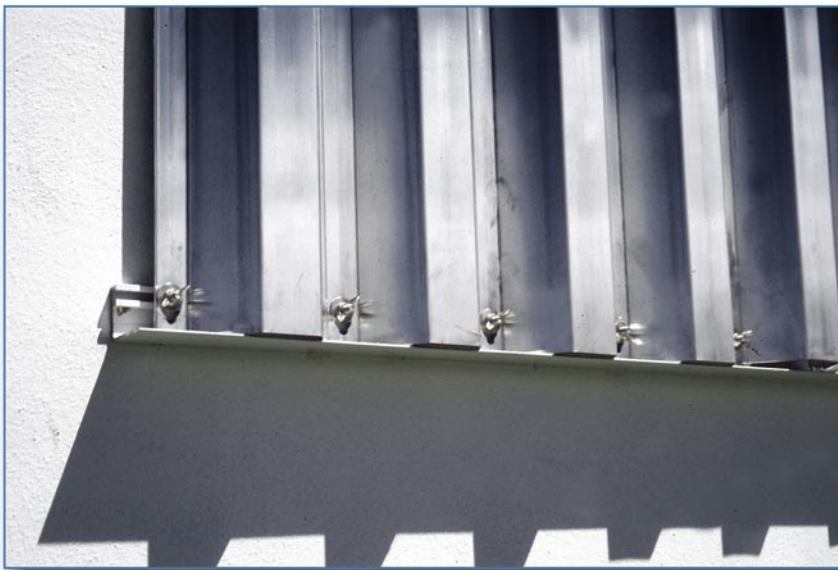
Figure 6-55  
View of a metal shutter  
designed to provide missile  
protection for windows

With the advent of building codes requiring glazing protection in wind-borne debris regions, a variety of shutter designs have entered the market. Figure 6-55 illustrates an effective shutter. A metal track was permanently mounted to the wall above and below the window frame. Upon notification of an approaching hurricane, the metal shutter panels were inserted into the frame and locked into position with wing nuts.

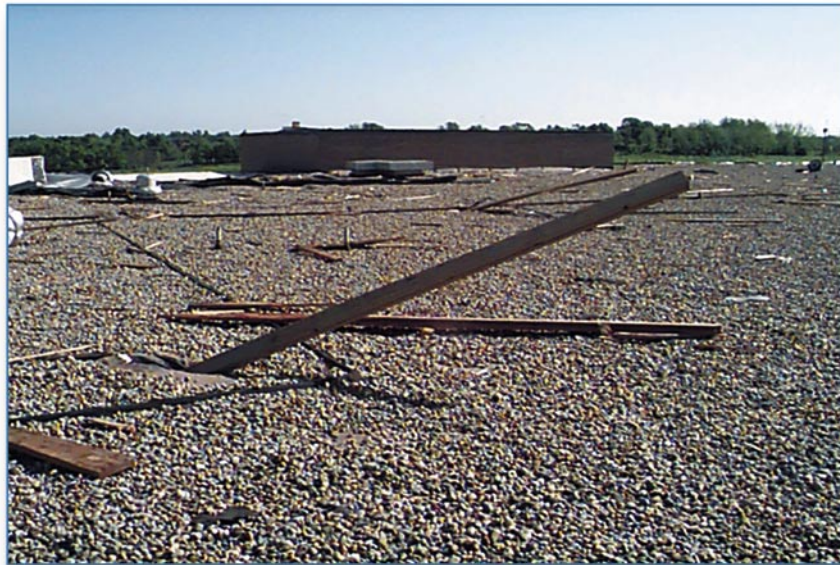
A violent tornado passed by this high school and showered the roof with missiles.

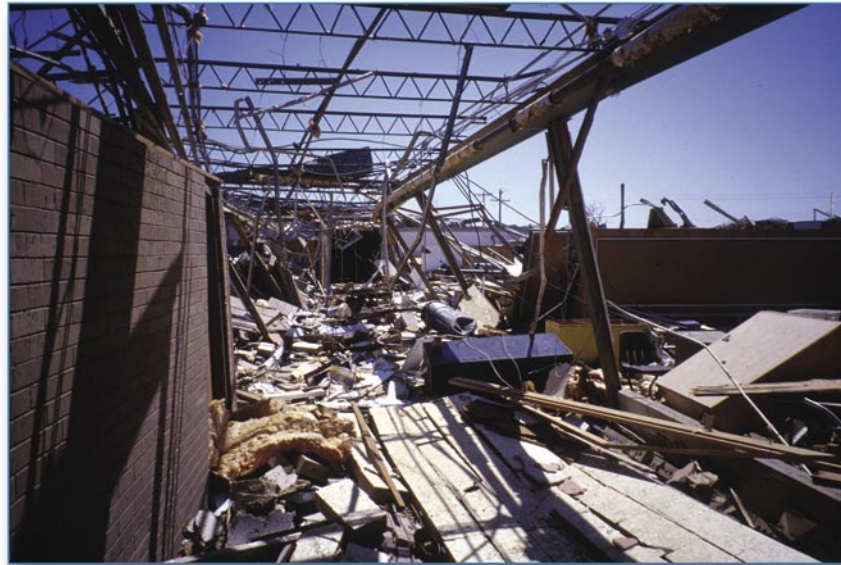
View of an elementary school corridor after passage of a violent tornado. Although corridors sometimes offer protection, they can be death traps as illustrated in this figure (fortunately the school was not occupied when it was struck).

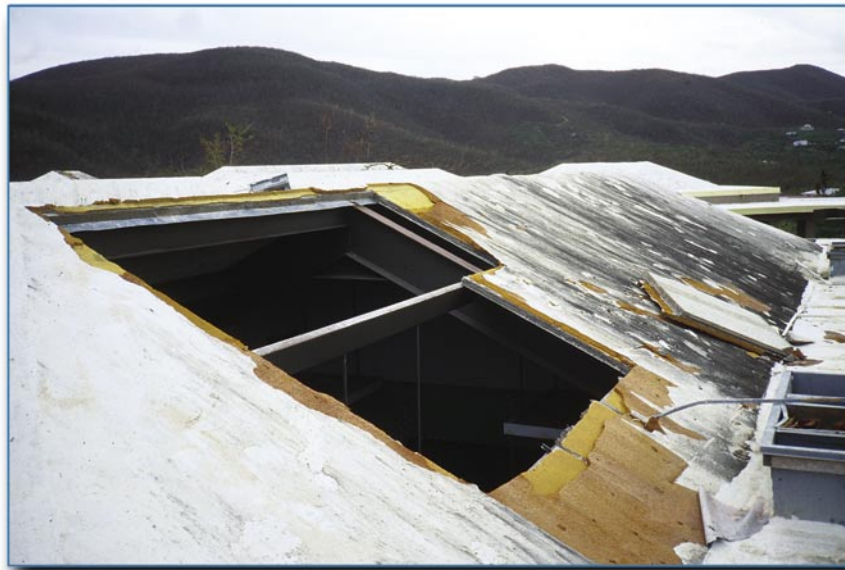
Figure 6-58  
This school had a cementitious wood-fiber deck (commonly referred to by the proprietary name “Tectum”).

During planned roof covering replacement, by tearing off the existing roof covering rather than re-covering, there is the opportunity to evaluate the structural integrity of the deck and deck attachment and upgrade its attachment if necessary. Many older decks are poorly attached (Figure 6-58); hence, if their attachment is not upgraded, blow-off of the deck and the new roof covering could occur. The two deck panels shown in Figure 6-58 blew away because their attachment to the roof structure was inadequate. An SPF roof covering was over the deck panels that blew away because of the characteristics of this type of covering, membrane propagation failure did not occur, as would have been the case with built-up, modified bitumen, or single-ply roof membranes. Cementitious wood-fiber decks were commonly used on schools built in the 1950s and 1960s. Decks constructed during that era typically had very limited uplift resistance due to weak connections to the support structure.
