Risk Management Series

Primer for Design Professionals

Communicating with Owners and Managers of New Buildings on Earthquake Risk

January 2004

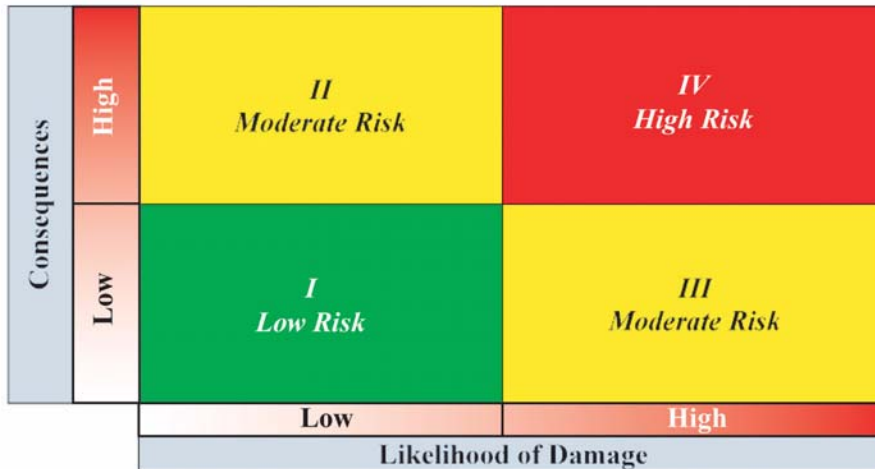
Figure 2-1 Seismic risk, expressed graphically as a function of likelihood of damage and consequences given the occurrence of the damage.

The concept of seismic risk, expressed as a function of the likelihood of damage and the expected consequences, is illustrated in Figure 2-1. The likelihood of damage is shown along the horizontal axis, increasing from left to right. As mentioned above, the likelihood of damage is a function of the seismic hazard level (expected earthquake occurrences and severity of ground shaking) and the seismic vulnerability (earthquake resisting capacity of the building). The consequences or losses resulting from the earthquake damage (or “consequence” in the more general risk term) are depicted on the vertical axis, increasing from bottom to top. The quantification of seismic risk is not a simple task; however, the graph shown in Figure 2-1 is simplified qualitatively as four distinct quadrants, each of which is described below with example scenarios.

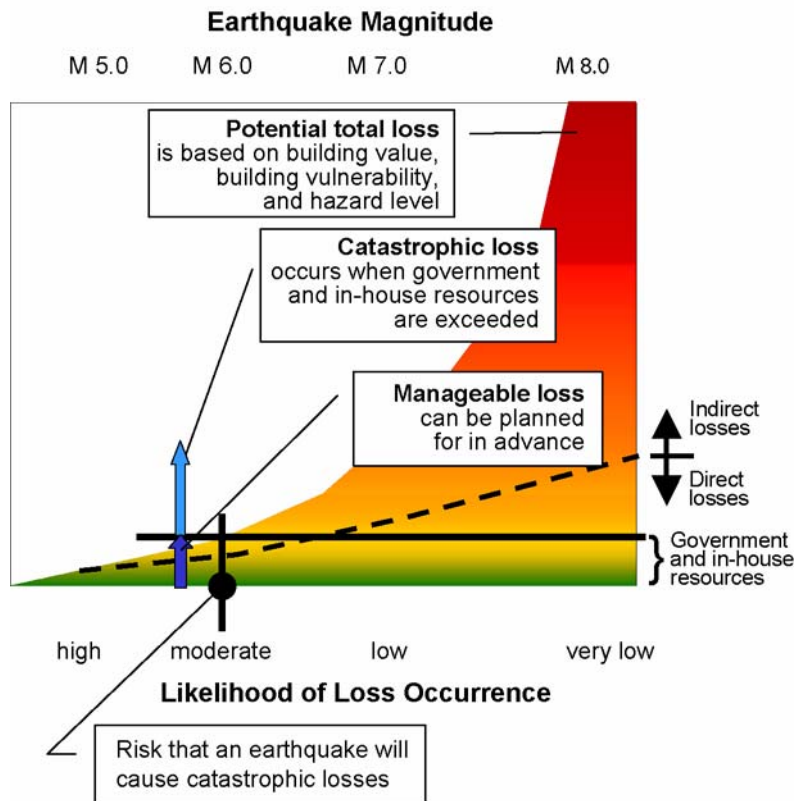
Figure 2-2 Illustration of risk of experiencing catastrophic earthquake losses. Concept assumes building, or inventory of buildings, is located close to earthquake source region.

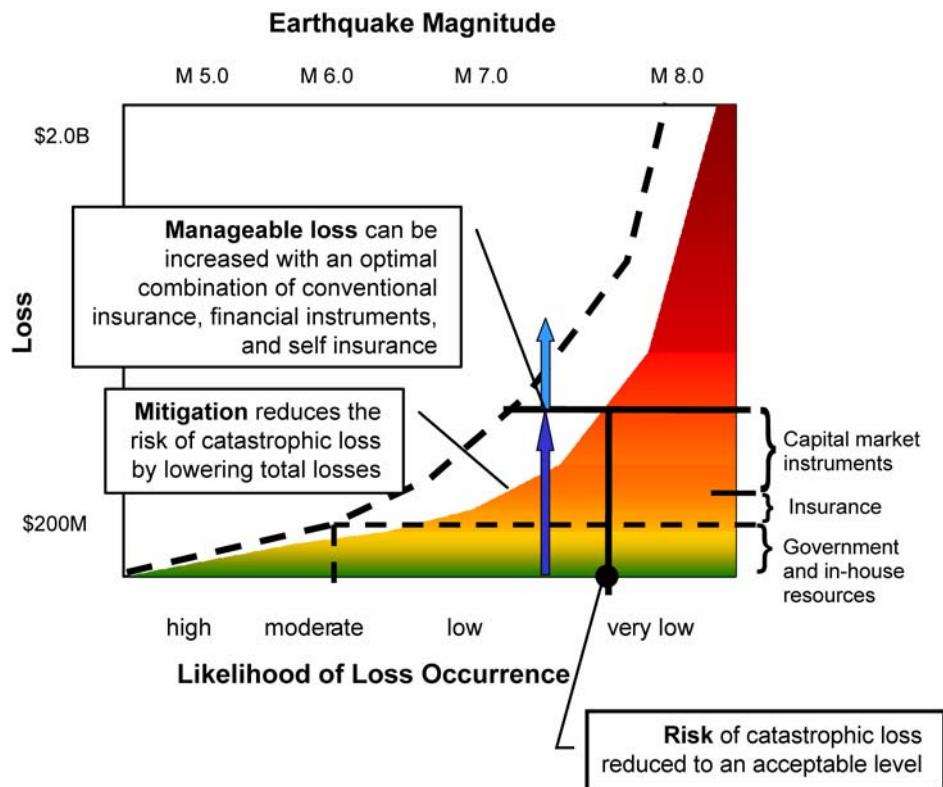
Figure 2-3 Illustration of reduction in risk of catastrophic earthquake losses.

optimal combination of these alternatives depends on insurance market conditions, interest rates, bonding capacity of the building owner, and other factors. Increasing the manageable loss level reduces the risk of catastrophic loss by elevating the horizontal loss limit line as illustrated in Figure 2-3.

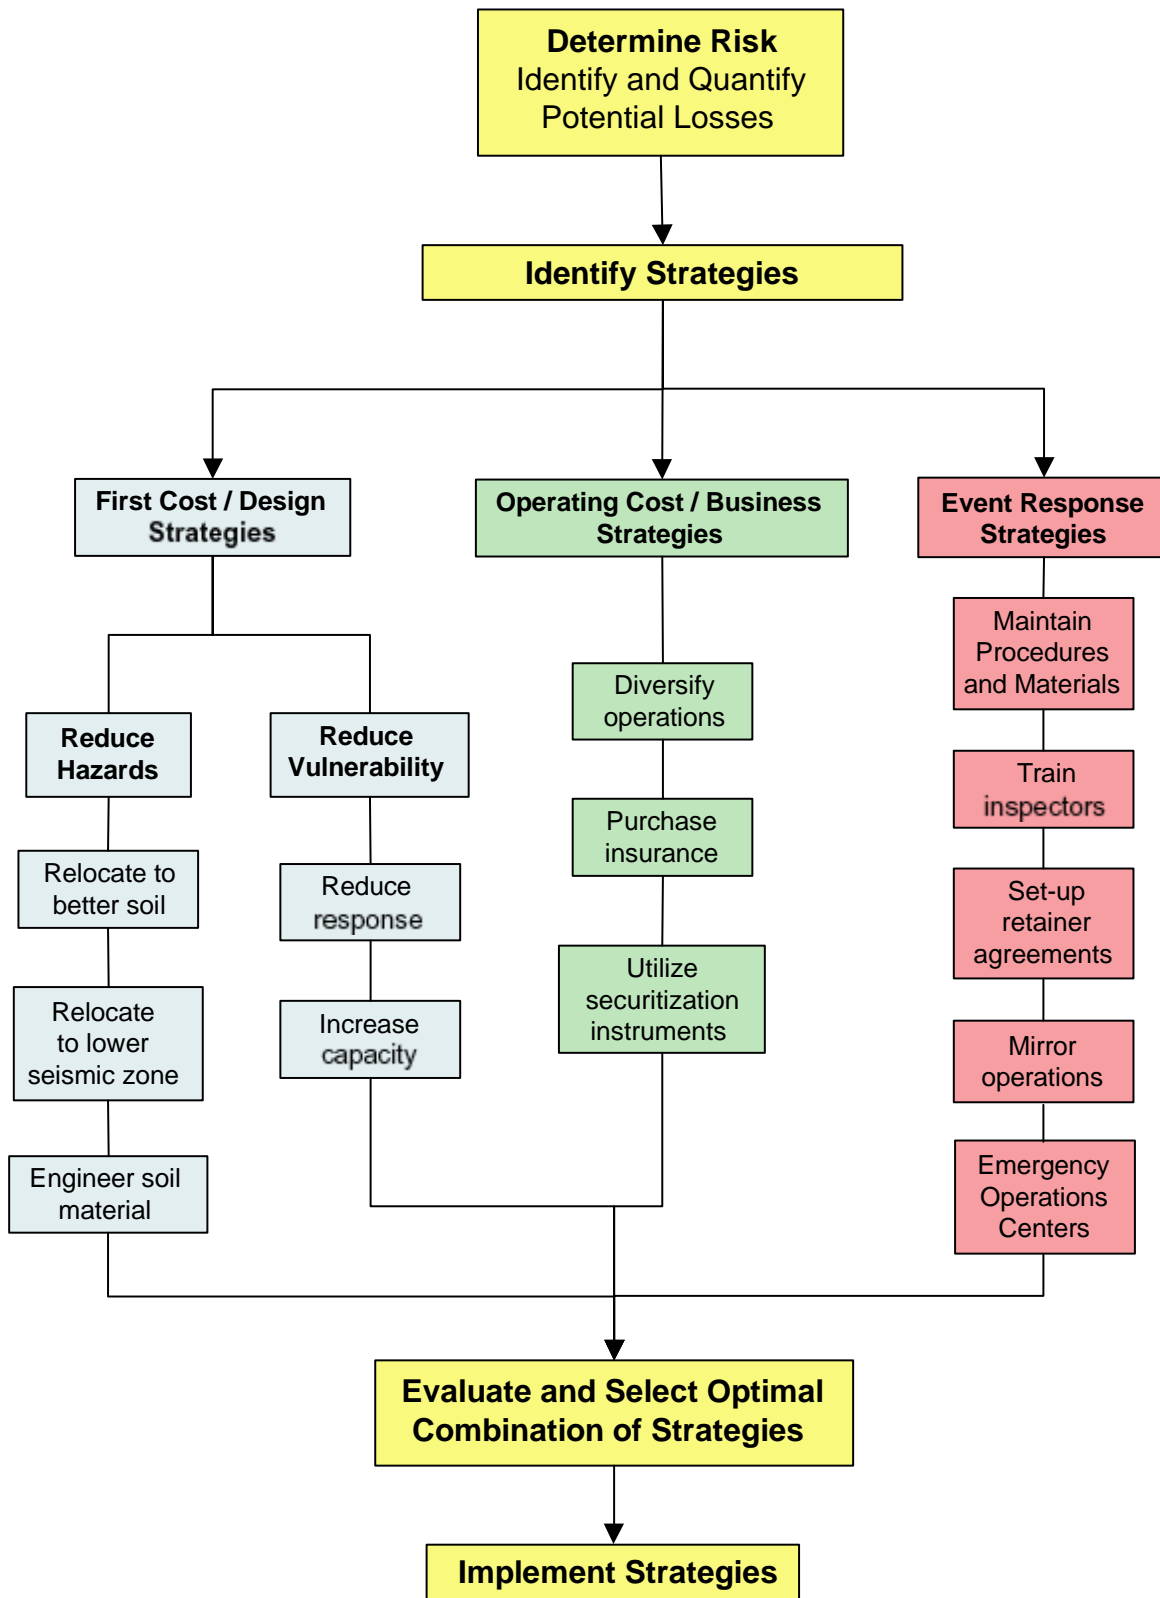
Figure 2-4 Flow chart for identifying, evaluating, and selecting risk-reduction strategies to develop a risk management plan.

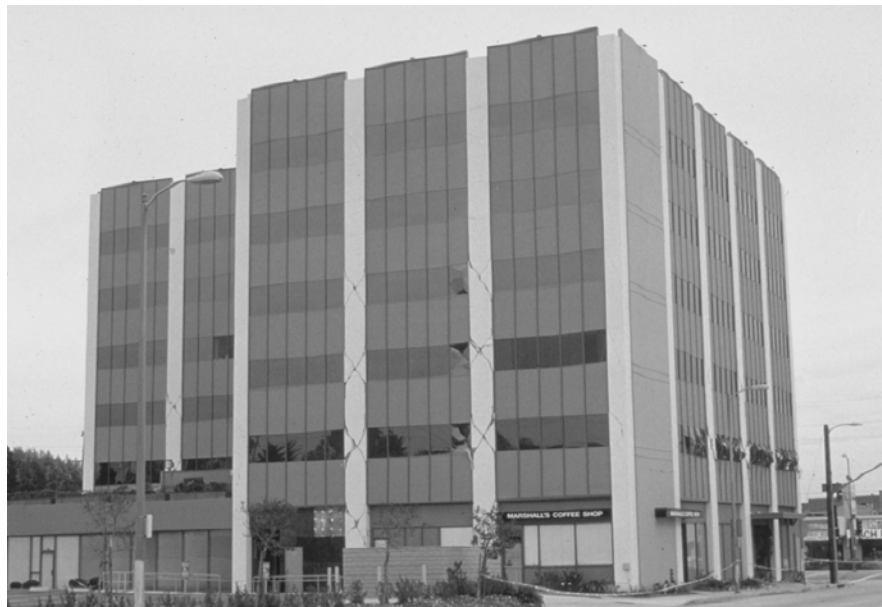
Figure 3-1 Six-story concrete-moment-frame medical building that was severely damaged by the magnitude-6.8 Northridge, California, earthquake of January 17, 1994. The building was subsequently demolished without removing contents. (photo courtesy of the Earthquake Engineering Research Center, University of California at Berkeley)

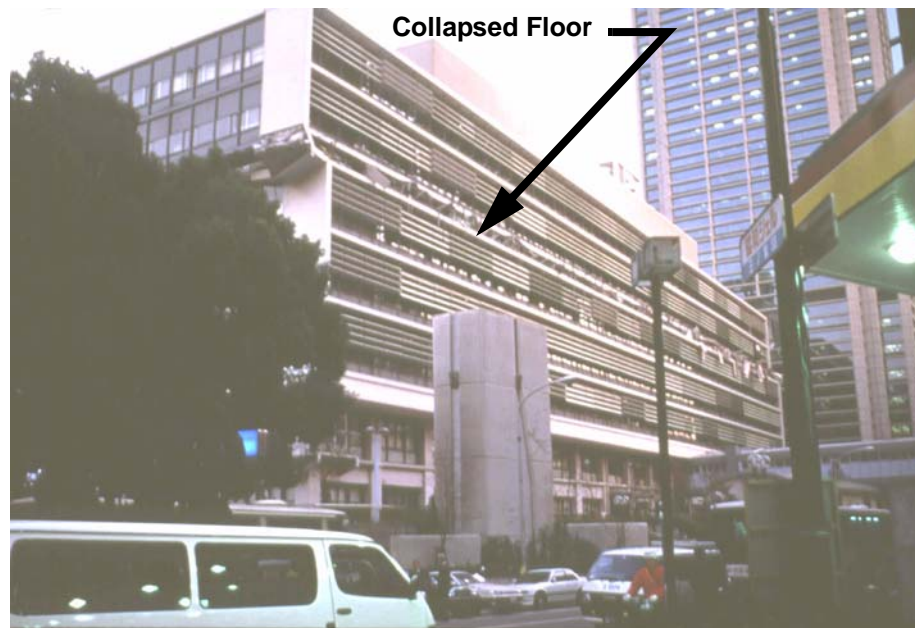
Figure 3-2 Eight-story reinforced-concrete-frame office building in Kobe, Japan that partially collapsed during the magnitude-7.8 earthquake of January 17, 1995. Note that the sixth floor is missing, due to collapsed columns at that level. Seismic codes in Japan are essentially equivalent to those in the United States. (photo courtesy of C. Rojahn)

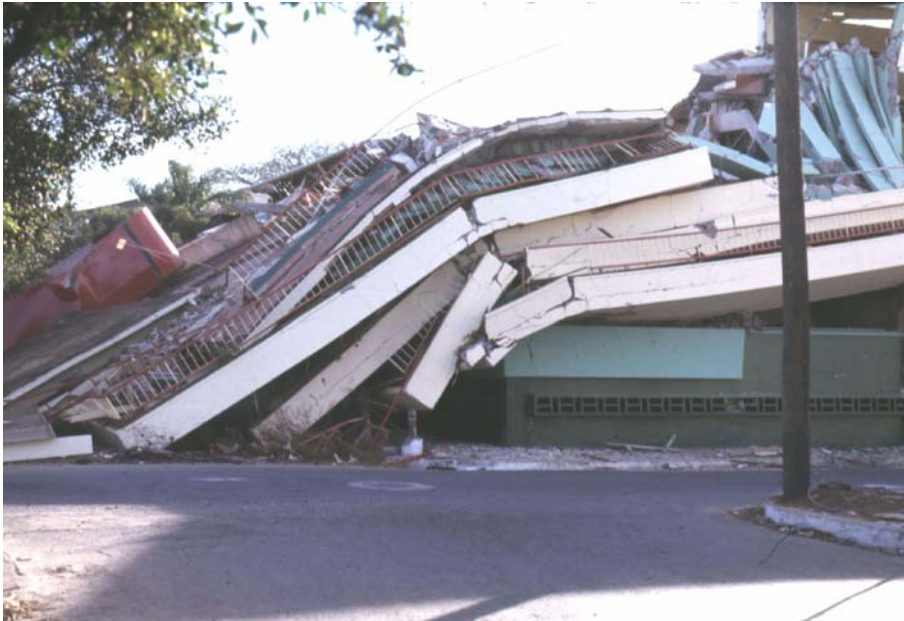
Figure 3-3 Older five-story reinforced concrete frame building in Managua, Nicaragua, that had inadequate seismic resistance and collapsed during the magnitude-6.2 earthquake of December 23, 1972. (photo courtesy of C. Rojahn)

The effects of ground shaking on building response are well known and extensively documented. Severe ground shaking can significantly damage buildings designed in accordance with seismic codes (Figures 3-1 and 3-2) and cause the collapse of buildings with inadequate seismic resistance (Figures 3-3 and 3-4).

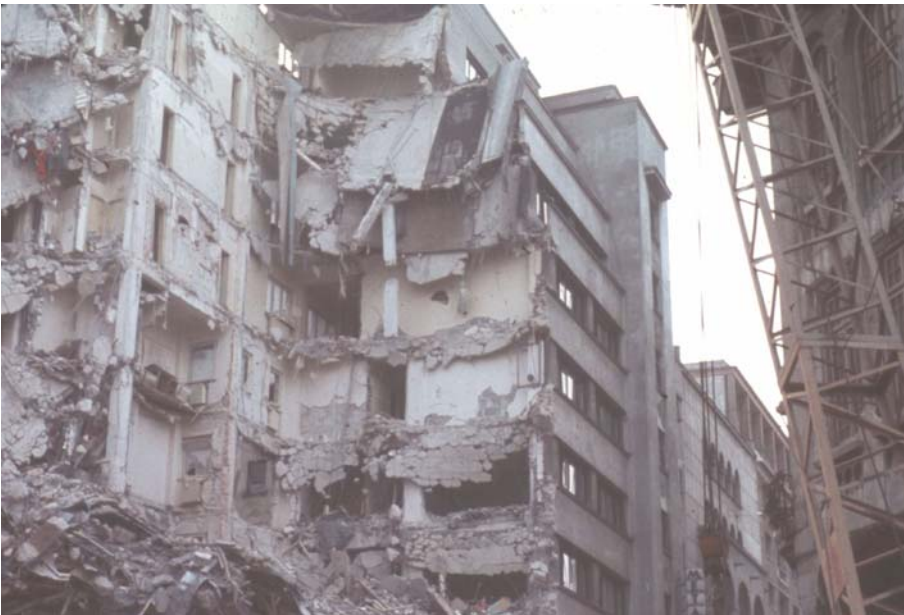
Figure 3-4 Preseismic-code ten-story reinforced-concrete-frame building in Bucharest, Romania, that partially collapsed during the 1977 magnitude-7.2 earthquake approximately 65 miles north of Bucharest. (photo courtesy of C. Rojahn)

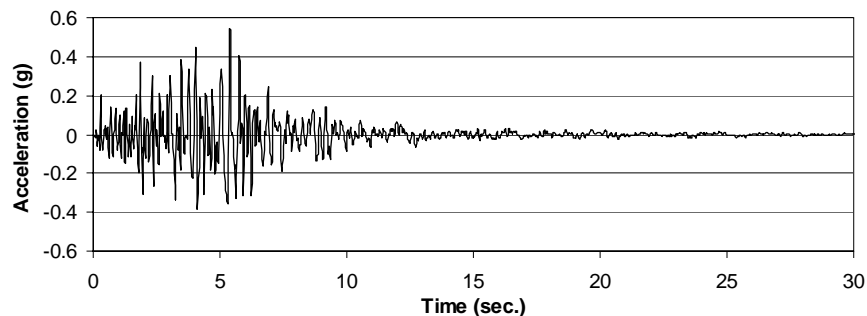
Figure 3-5 Typical acceleration time history of strong ground shaking.

Seismic shaking is typically quantified using a parameter of motion, such as acceleration, velocity, or displacement. In current seismic codes, seismic design forces are defined in terms that relate to acceleration in the horizontal direction. A typical acceleration time-history of strong ground shaking is shown in Figure 3-5.

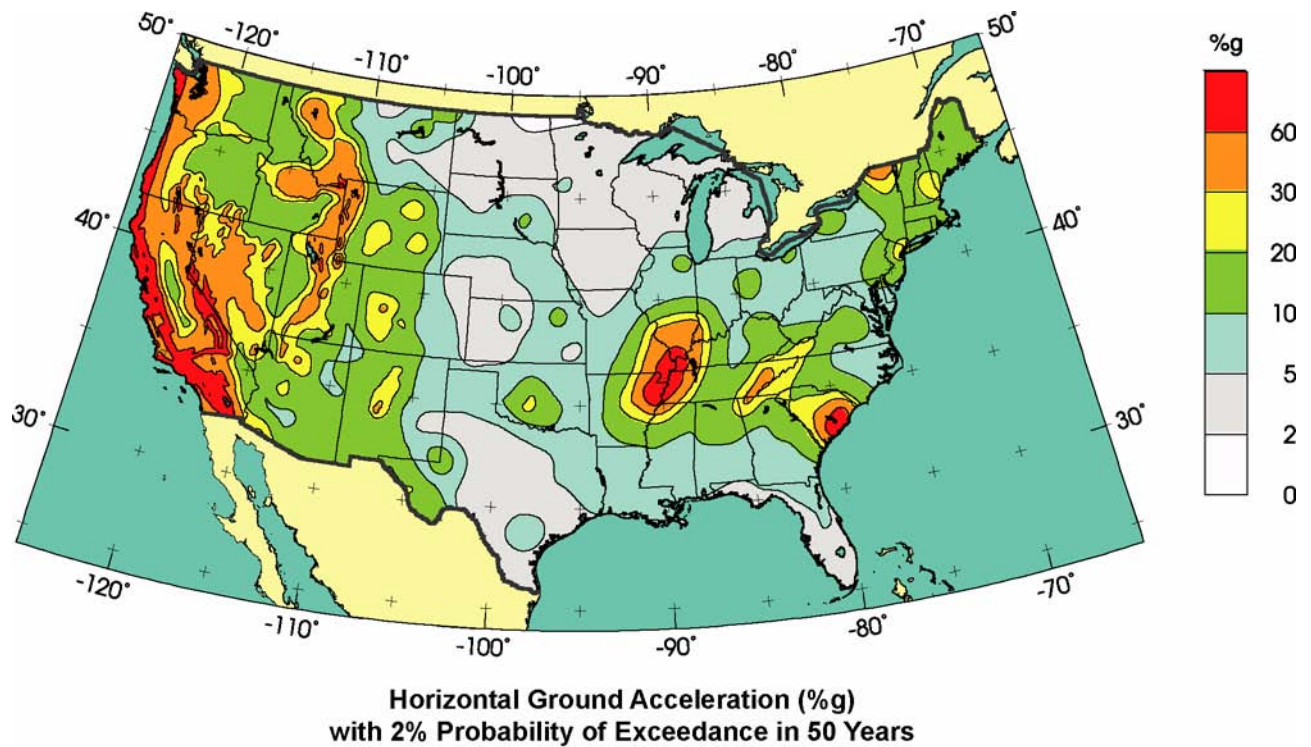
Figure 3-6 Probabilistic seismic hazard maps showing ground shaking hazard zones in the contiguous United States. (from USGS National Seismic Hazard Mapping Project website: geohazards.cr.usgs.gov).

maps include those showing expected peak ground acceleration and those showing expected peak spectral acceleration response at different building periods of vibration. Figure 3-6, which was prepared by the U.S. Geological Survey National Seismic Hazard Mapping Project, illustrates a probabilistic seismic hazard map showing the regional variation of ground shaking hazard in the contiguous United States.

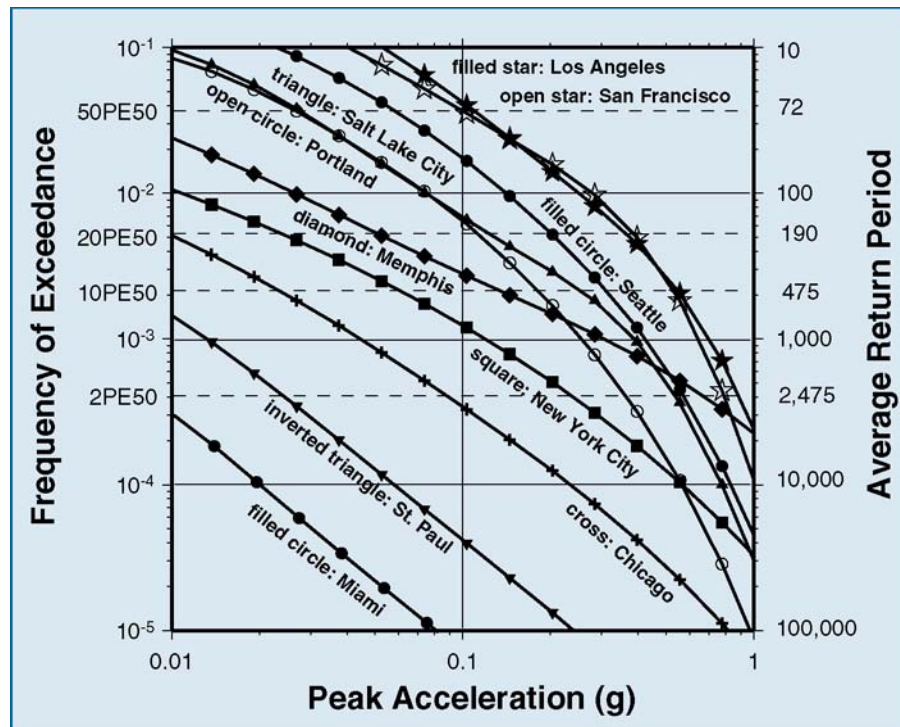
Figure 3-7 Hazard curves for selected U.S. cities.

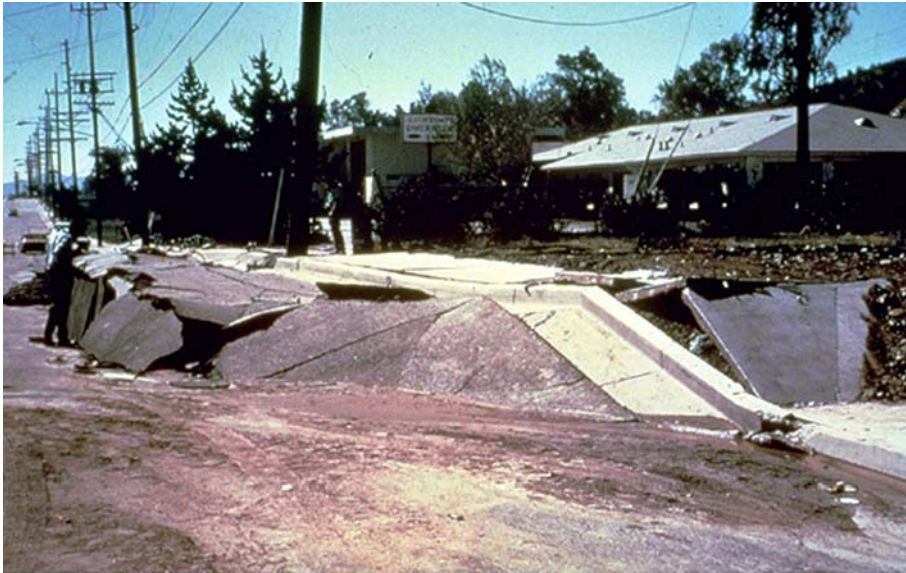
Figure 3-8 Example of surface fault rupture; 1971 San Fernando, California, earthquake (a thrust fault earthquake). (Photo courtesy of the Earthquake Engineering Research Institute.)

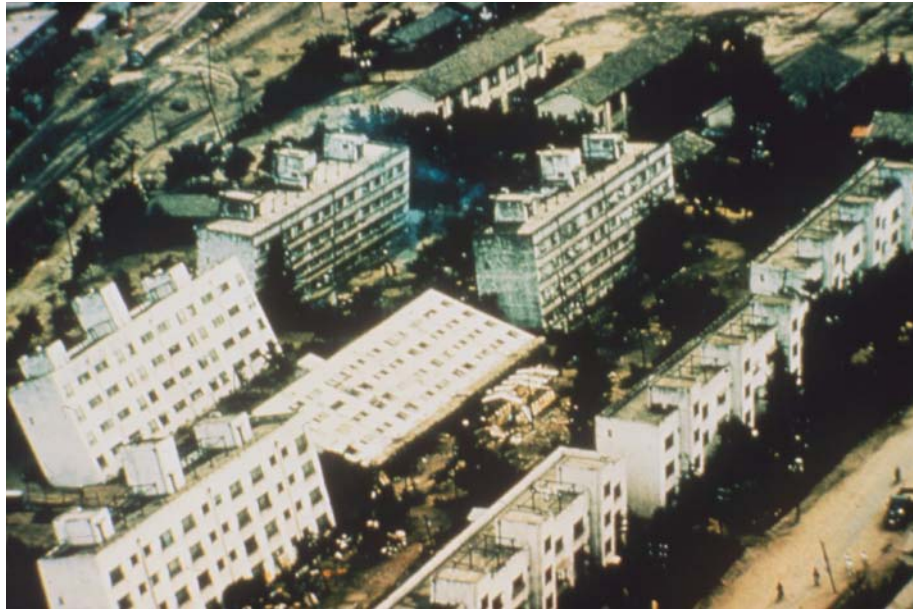
Figure 3-9 Aerial view of leaning apartment houses resulting from soil liquefaction and the behavior of liquefiable soil foundations, Niigata, Japan, earthquake of June 16, 1964. (Photo courtesy of National Oceanic and Atmospheric Administration, National Data Service).

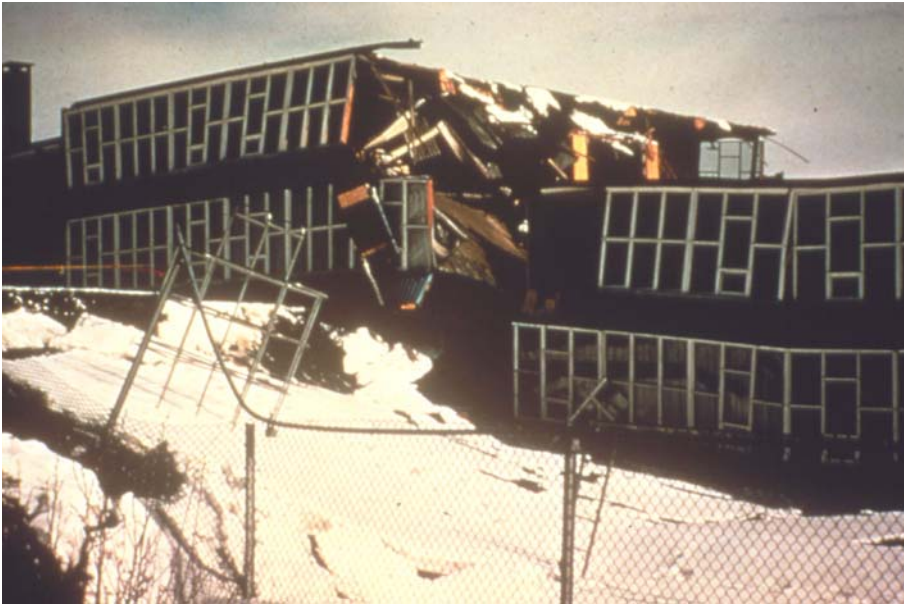
Figure 3-10 Government Hill School, Anchorage, destroyed by landslide during the magnitude-8.4 Alaska earthquake of 1964. (Photo courtesy of National Oceanic and Atmospheric Administration, National Data Service).

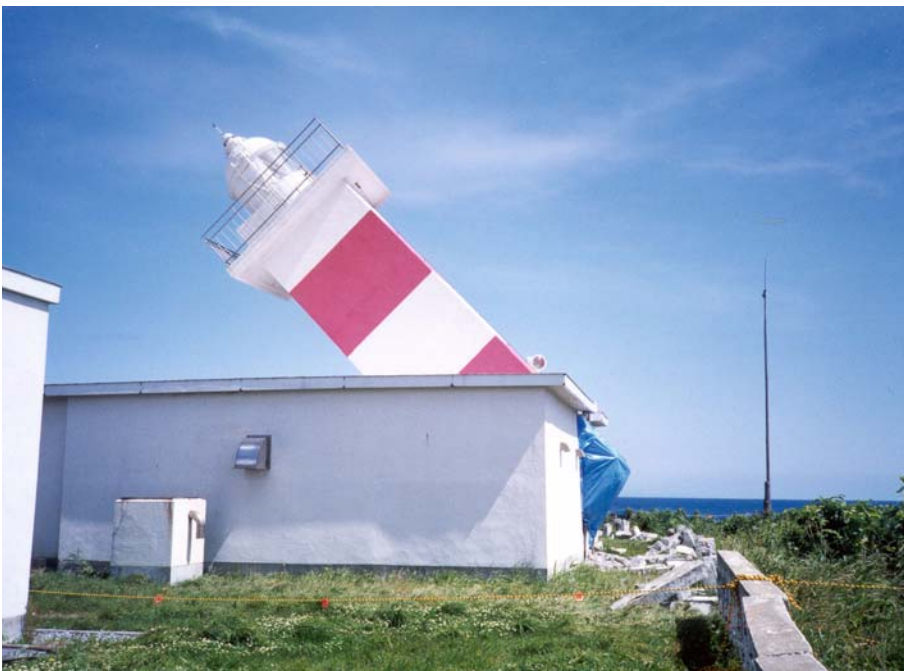
Figure 3-11 Overturned lighthouse at Aonae, Okushiri, from the tsunami following the 1993 Hokkaido-Nansei-Oki earthquake. (Photo courtesy of Yuji Ishiyama, Hokkaido University, Sapporo, Japan)

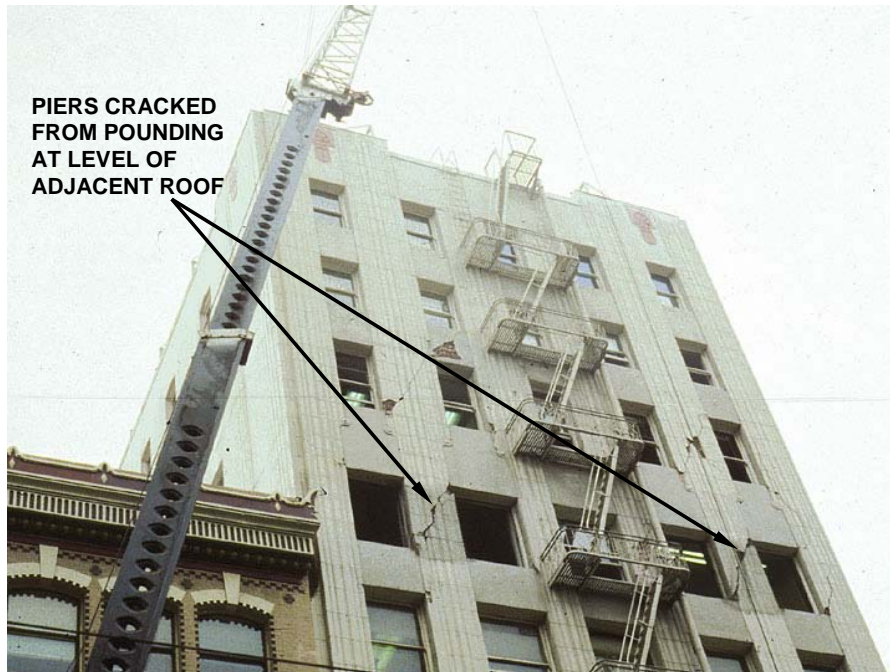
Figure 3-12 Photo showing damage caused by the pounding of a 10-story steel-frame building (with masonry infill walls) against a seven-story building. Most of the cracking damage to the piers of the taller building was at the roof line of the shorter building (Most of the cracking damage to the piers of the taller building was at the roof line of the shorter building. ATC-20 Training Slide Set photo)

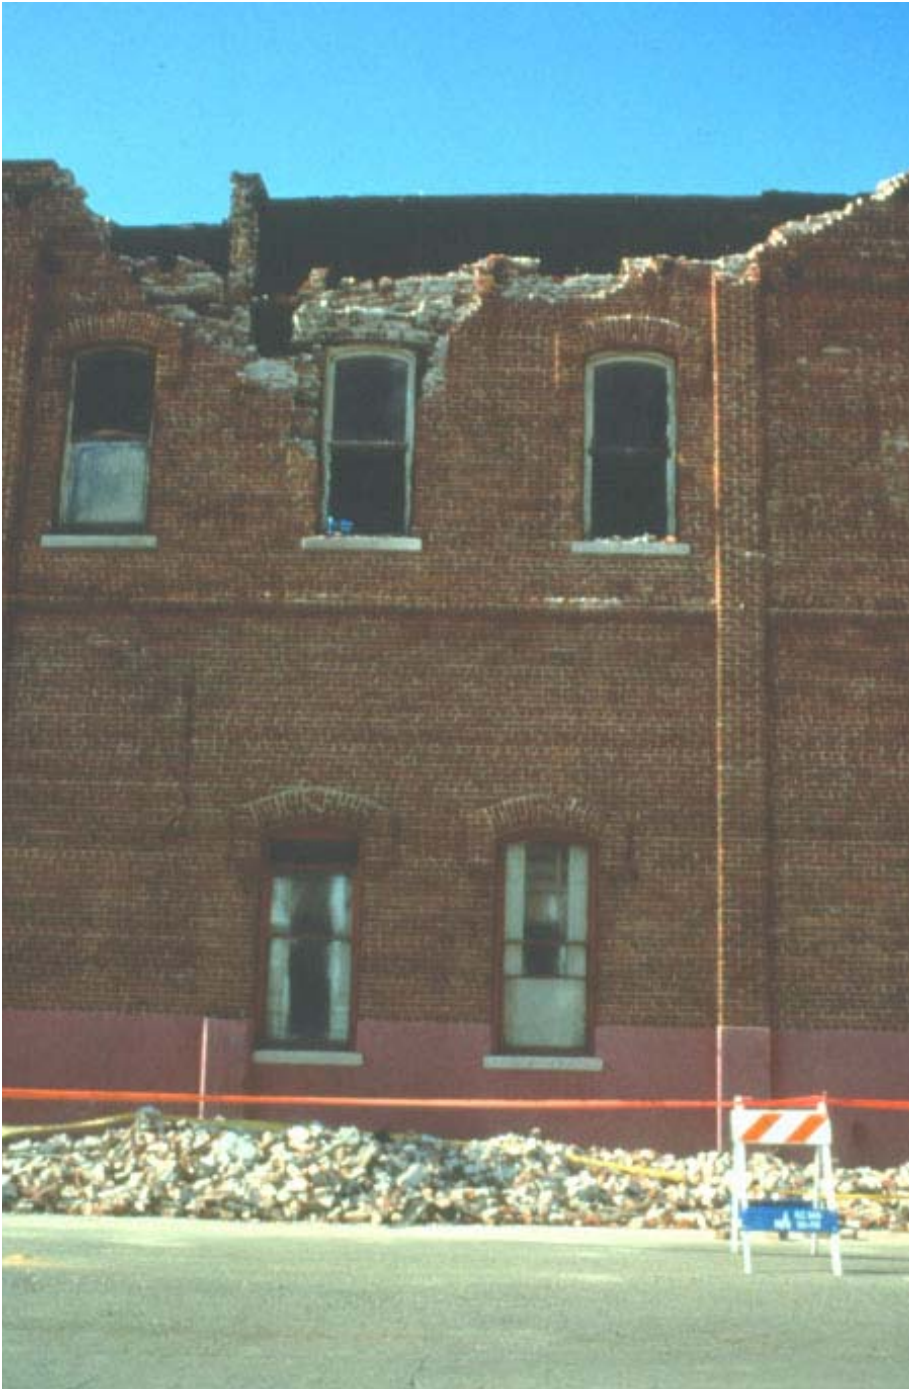
Figure 3-13 Photo showing fallen parapets from an earthquake-damaged unreinforced masonry building. (ATC-20 Training Slide Set photo)

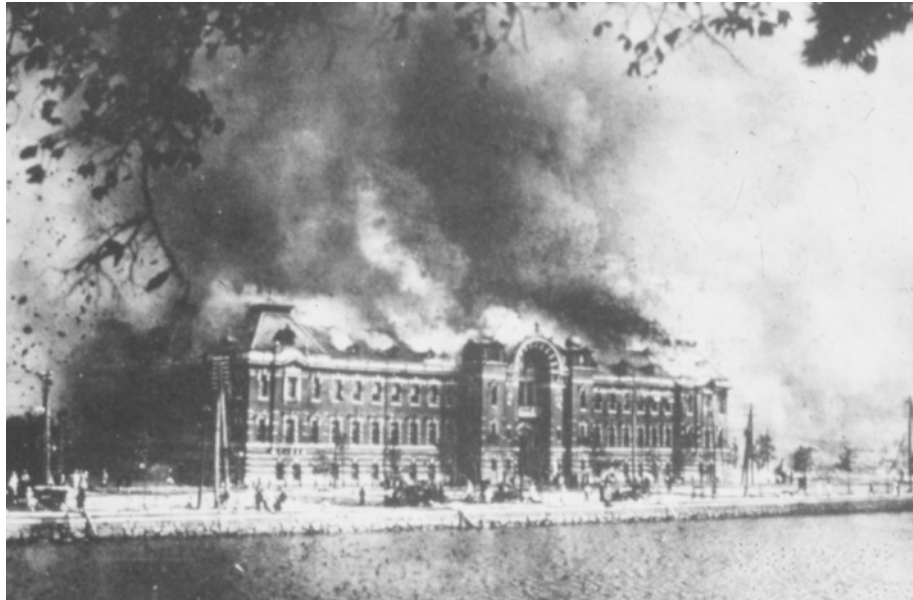
Figure 3-14 Photo showing the burning of the Tokyo Police Station following the magnitude-8.3 Tokyo/Kanto earthquake of 1923.

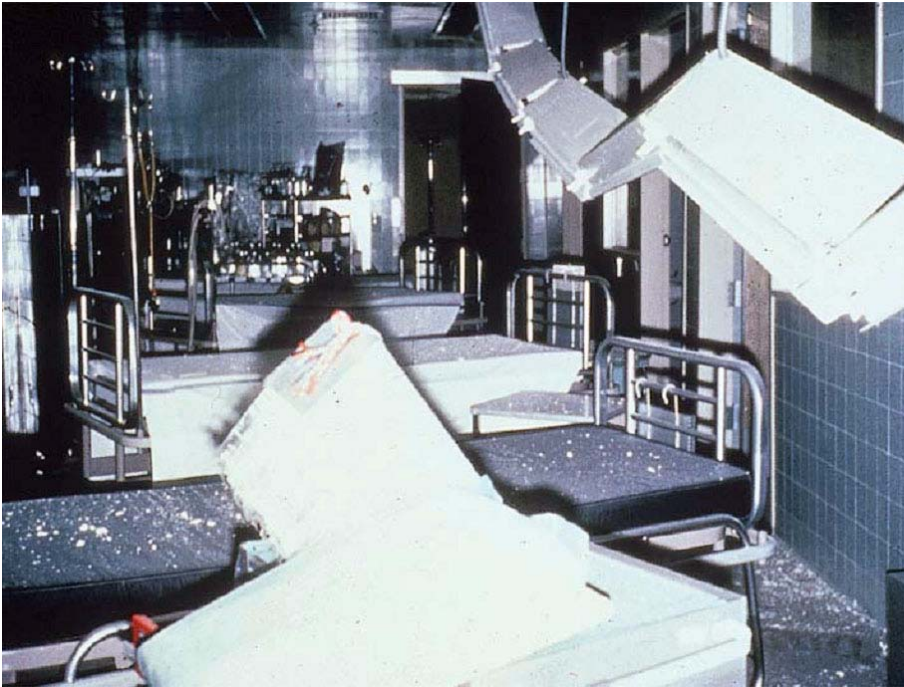
Figure 4-1 Photo of lights set into a fixed ceiling system that shook loose during an earthquake and are hanging from their conduits. (ATC-20 Training Slide Set photo)

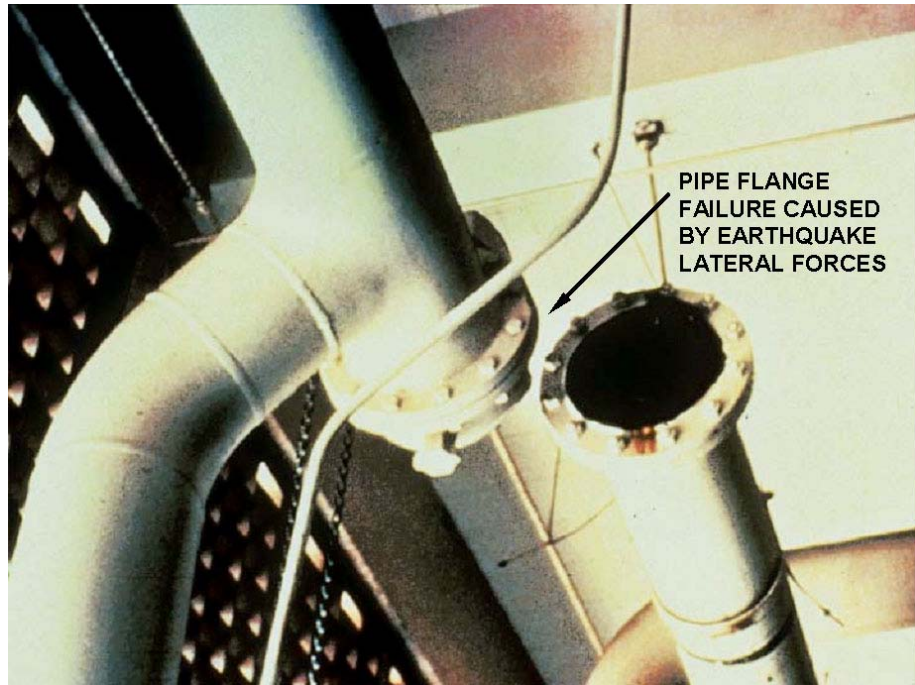
Figure 4-2 Photo of pipe flange failure caused by earthquake lateral forces. (ATC-20 Training Slide Set photo)

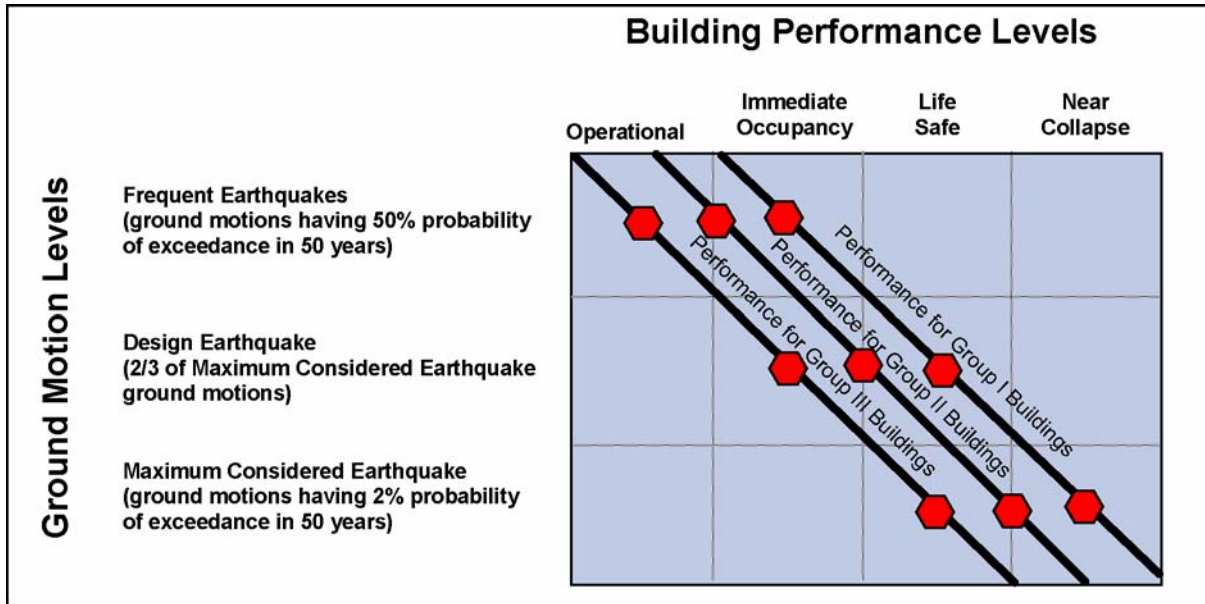
Figure 4-4 Expected building performance. (from BSSC, 2001)

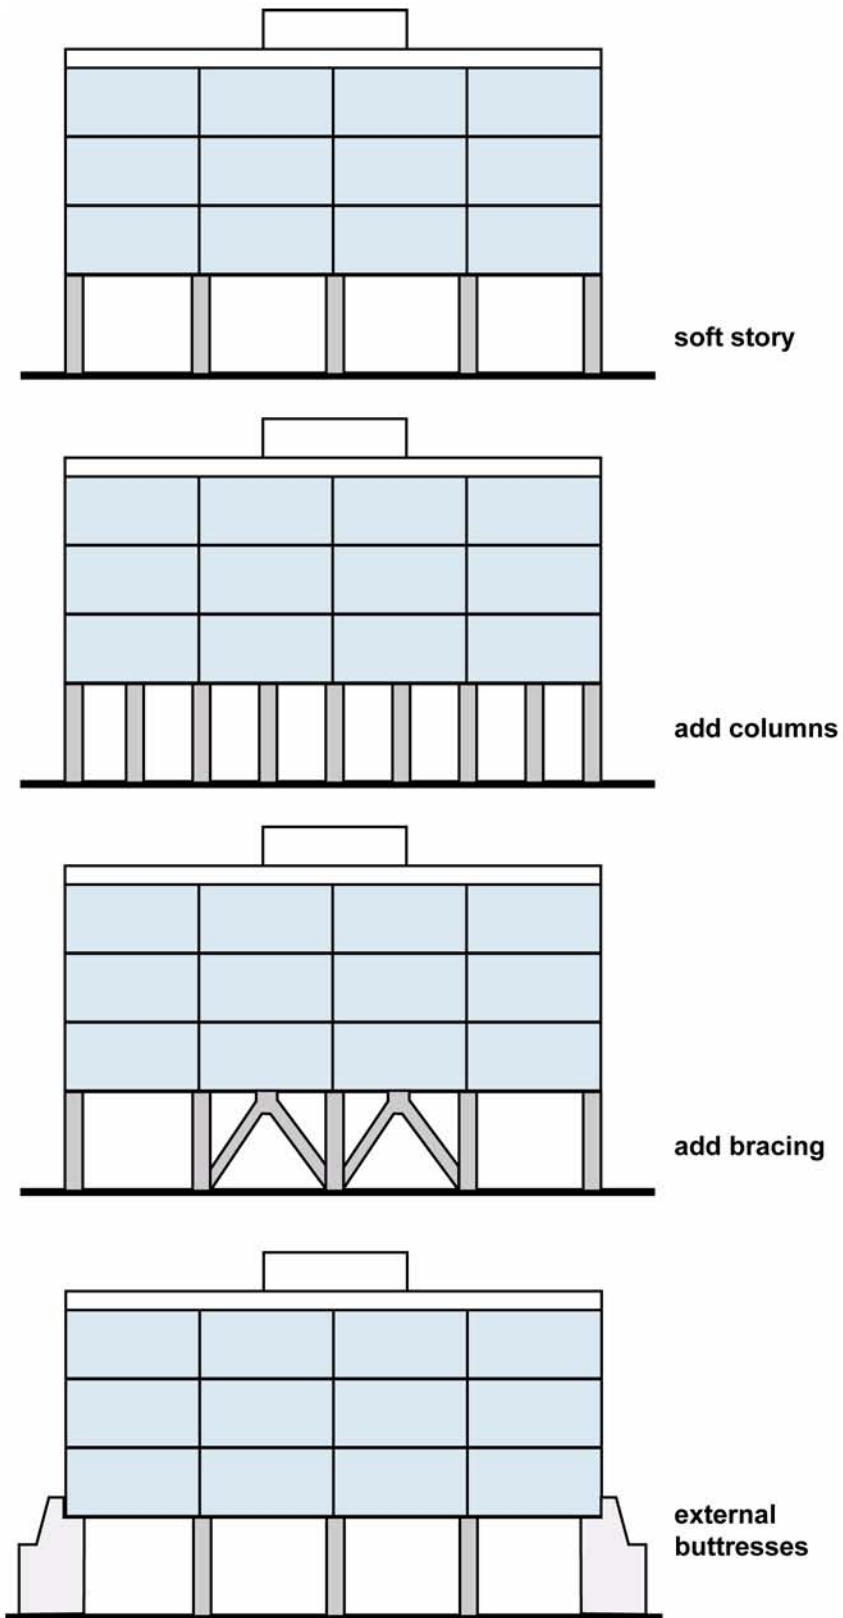
Figure 5-1 Example design solutions for addressing soft story condition.

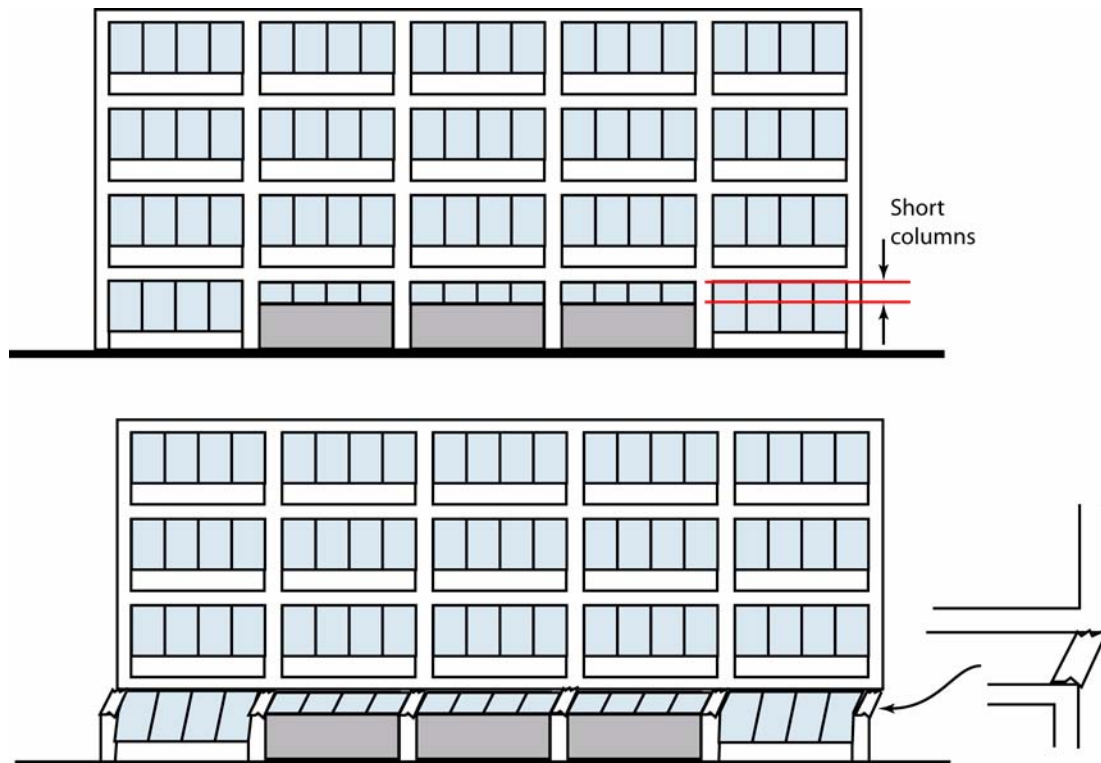
Figure 5-2 Elevation views of building with short columns between first and second floors. Upper sketch show the building in an unshaken state; lower sketch shows damage mechanism under earthquake lateral loading.

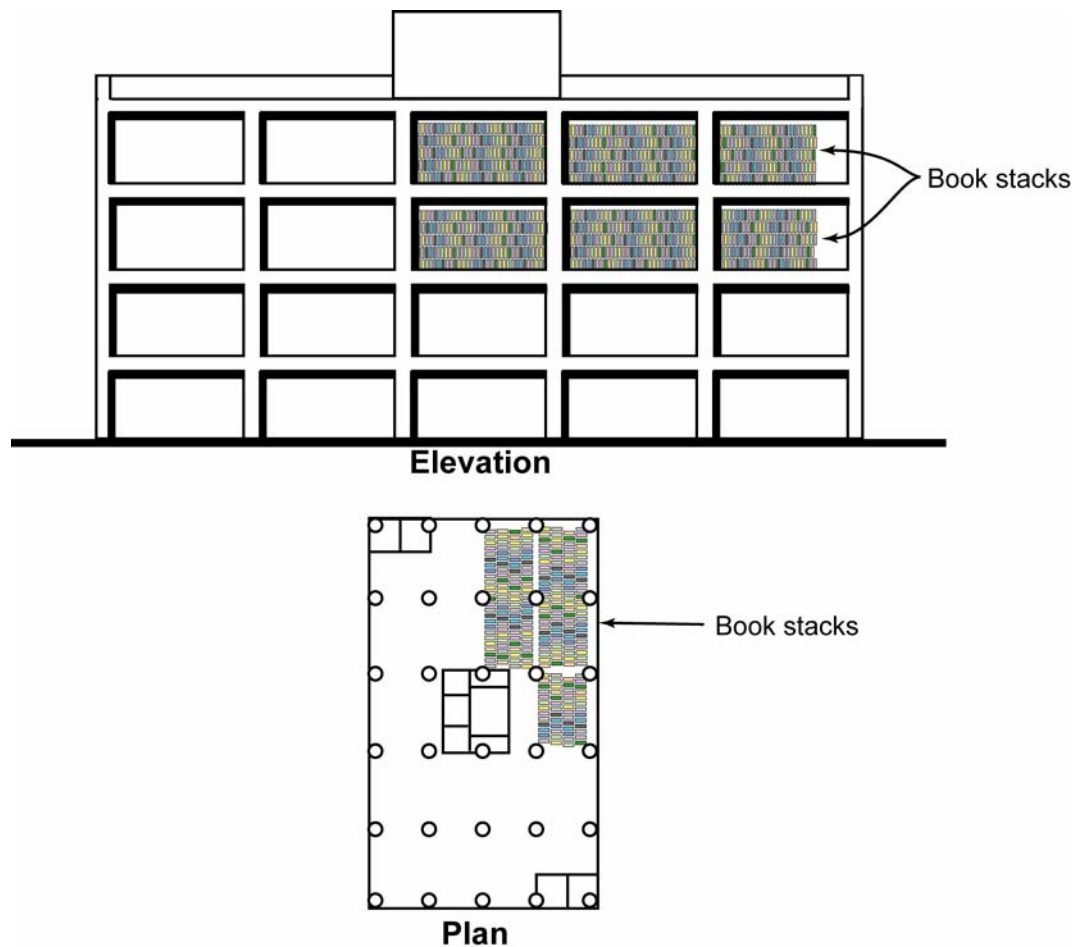
Figure 5-3 Nonsymmetric loading of book stacks in library building. Position and weight of stacks could induce torsional response of building during earthquake shaking.

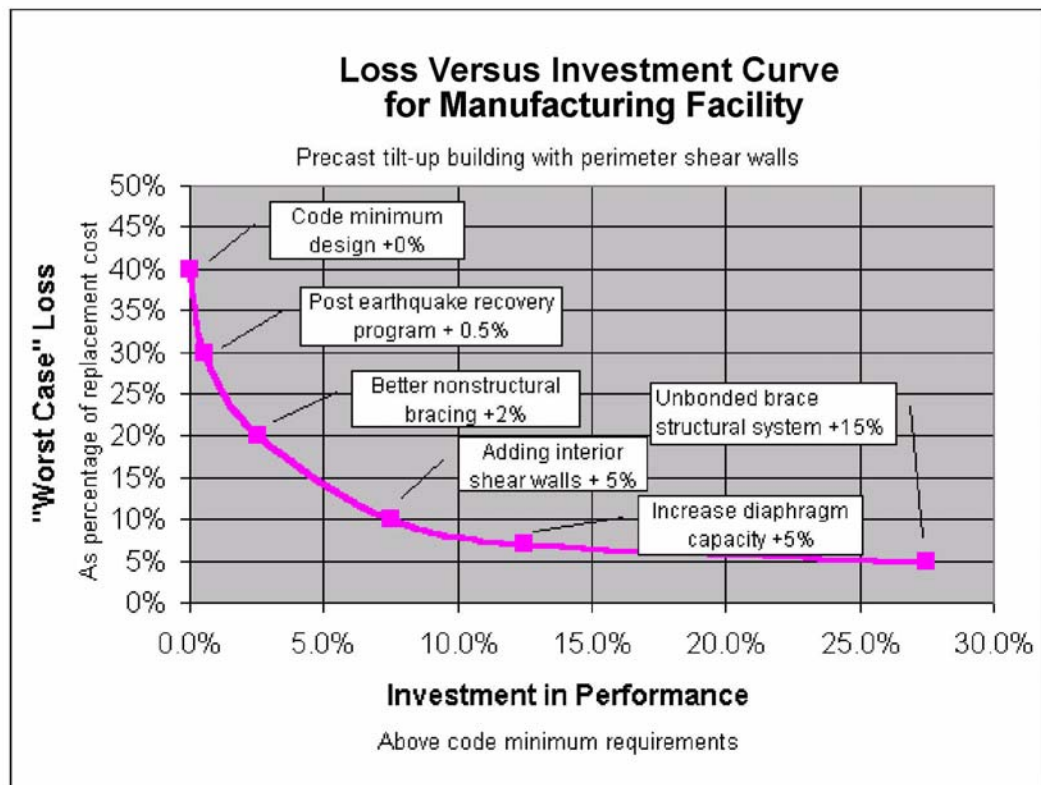
Figure 5-4 Relationship between cost and performance for hypothetical example.

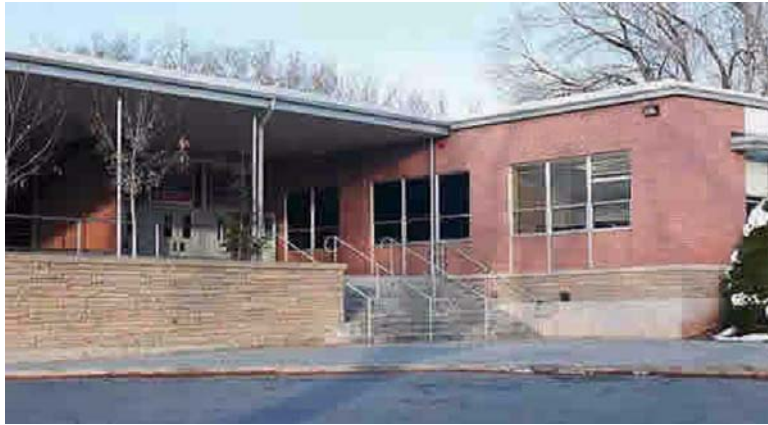
Figure 5-6 Sample existing school building in Salt Lake City K-12 School District.

The Salt Lake City School District consists of 30-40 sites and contains buildings more than 70 years old, as shown in Figure 5-6. The District

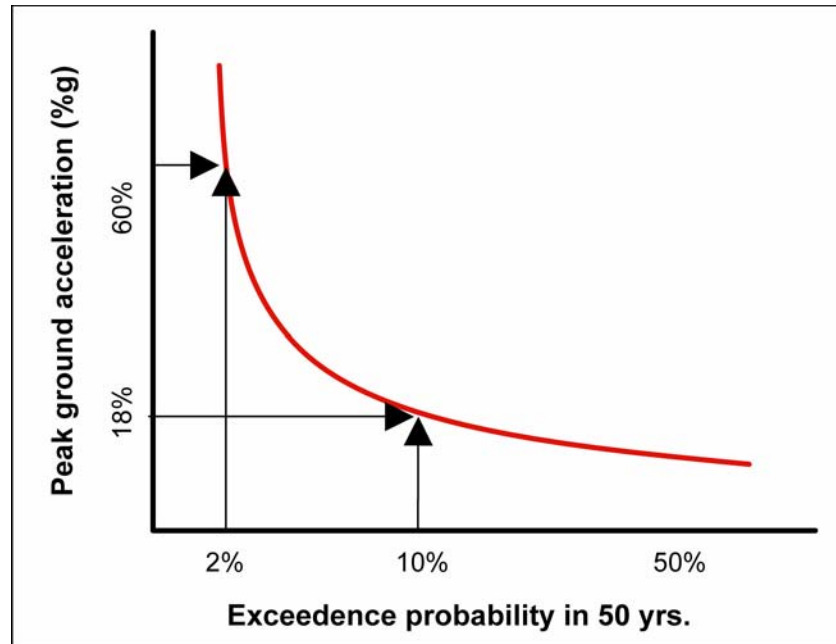
Figure 5-8 Site hazard curve for Salt Lake City K-12 School District seismic risk study.

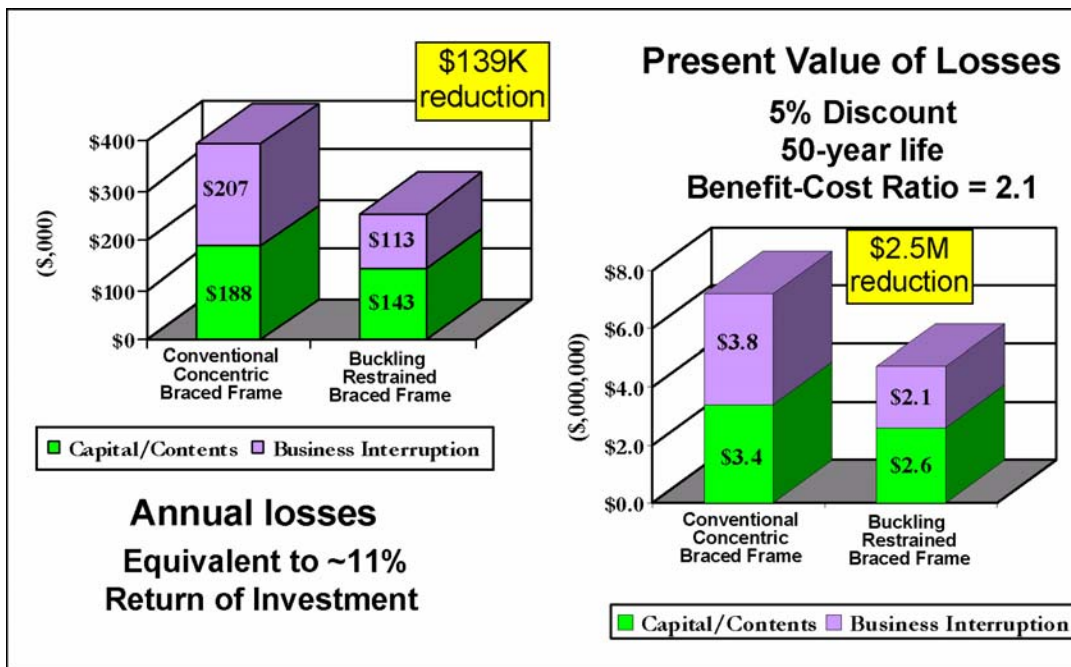
Figure 5-10 Comparison of future losses for two different structural system options for new UC Berkeley laboratory building.

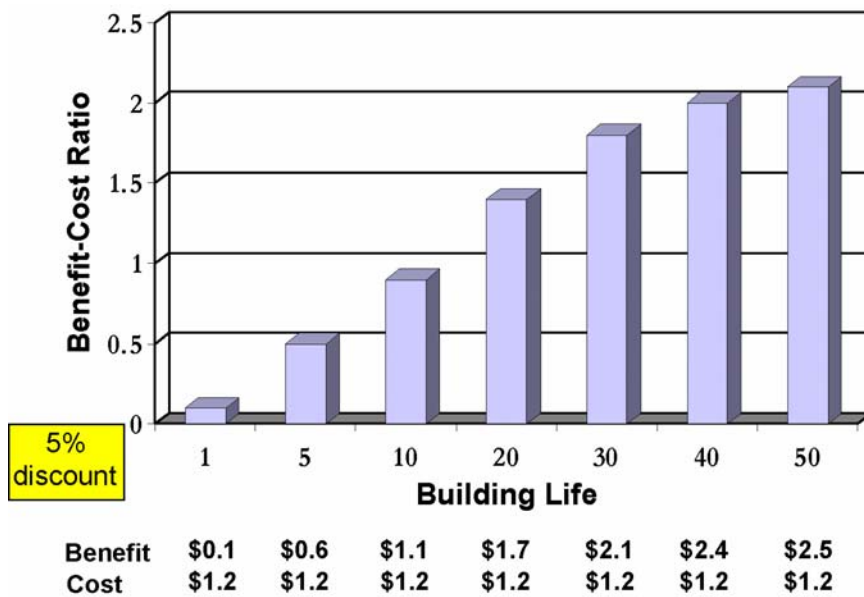
Figure 5-11 Comparison of benefit to cost of using a buckling restrained braced frame, instead of a conventional concentric braced frame, for new UC Berkeley laboratory building. Cost equals cost differential.

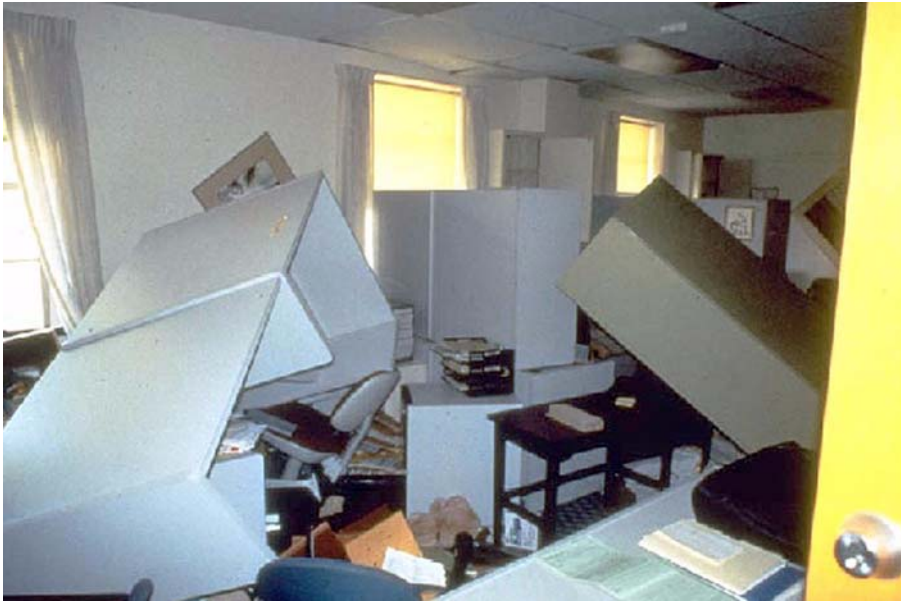
Figure 6-1 Typical earthquake damage to contents and nonstructural components in a modern office building. (photo courtesy of the Earthquake Engineering Research Institute)
