Risk Management Series

Primer for Design Professionals

Communicating with Owners and Managers of New Buildings on Earthquake Risk

January 2004

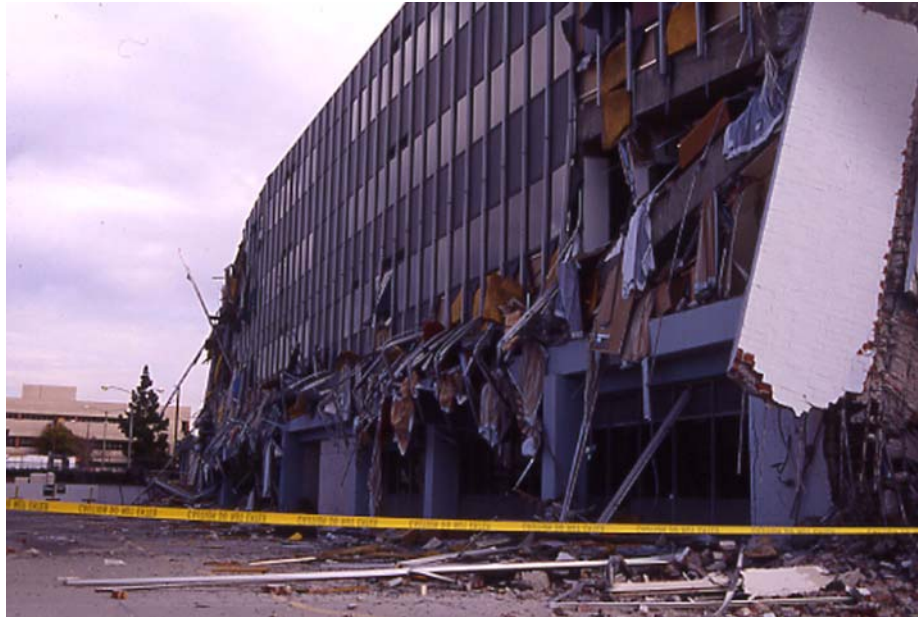
Figure 6-2 Exterior view of medical office building severely damaged by the 1994 Northridge earthquake. (C. Arnold photo)

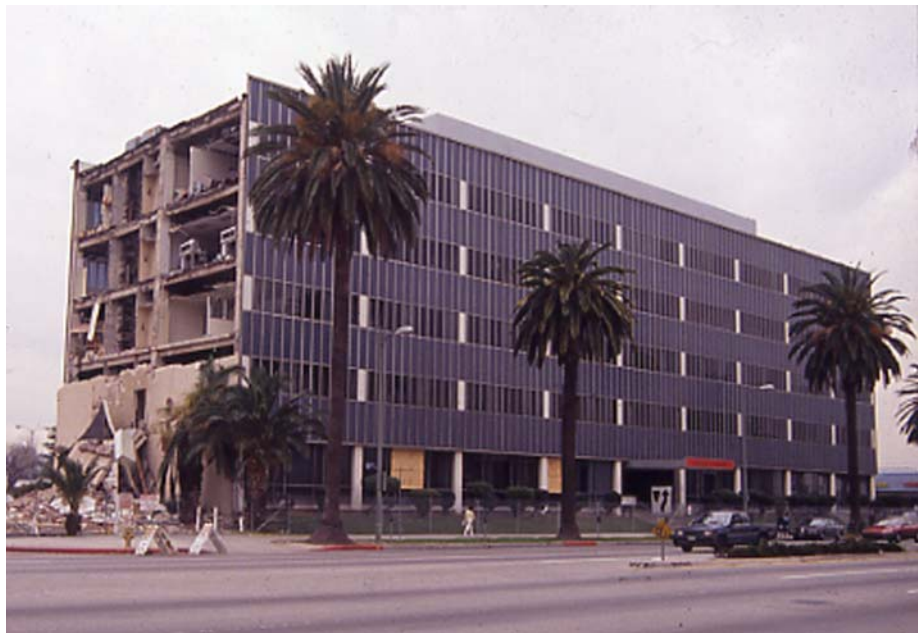
Figure 6-3 Partially collapsed end-wall in 5-story office building caused by severe earthquake ground shaking. (C. Arnold photo)

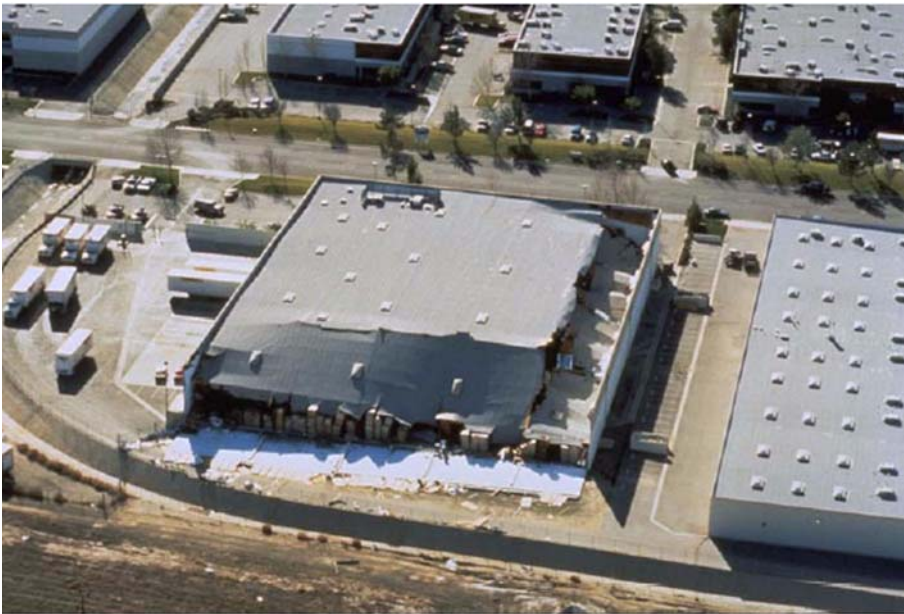
Figure 8-1 Roof and wall collapse of tilt-up building during the 1994 Northridge earthquake. (Photo courtesy of the Earthquake Engineering Research Institute)

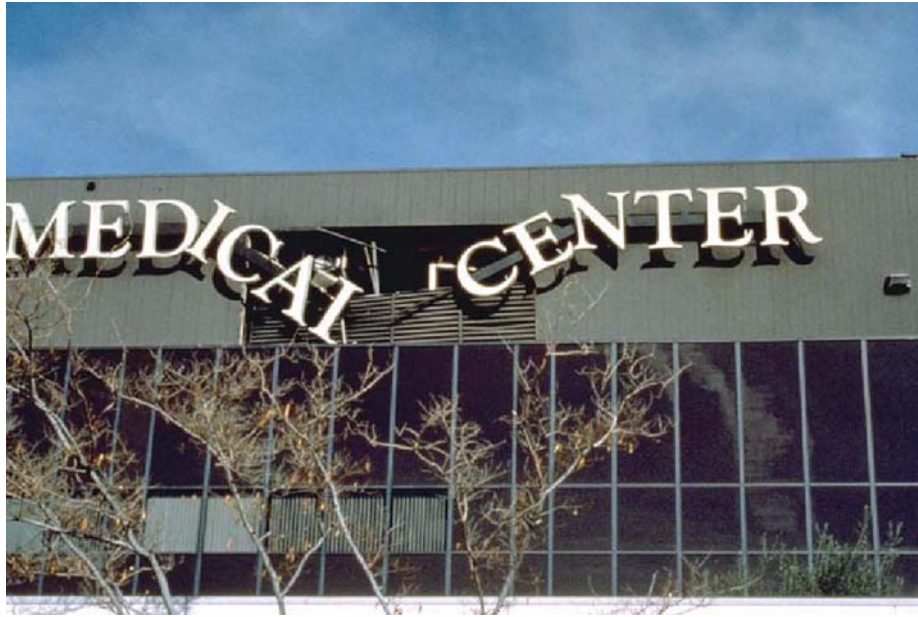
Figure 9-1 Exterior view of Holy Cross Medical Center, which was evacuated after the 1994 Northridge earthquake due to damage to the HVAC system. (photo courtesy of the Earthquake Engineering Research Institute)

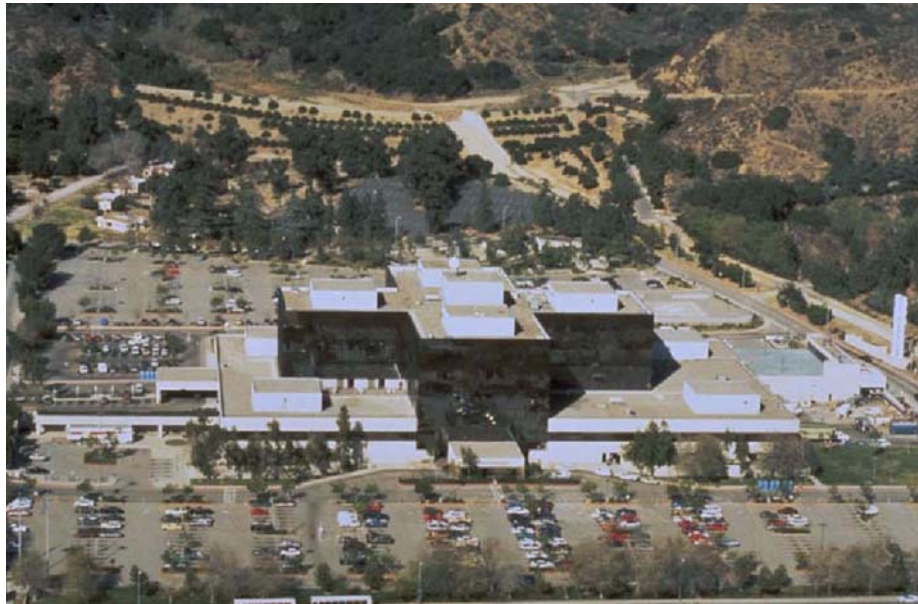
Figure 9-2 Aerial view of Olive View Hospital, which sustained no structural damage during the 1994 Northridge earthquake, but was closed for a short while after the earthquake because of water leakage from broken sprinklers and waterlines. (photo courtesy of the Earthquake Engineering Research Institute)

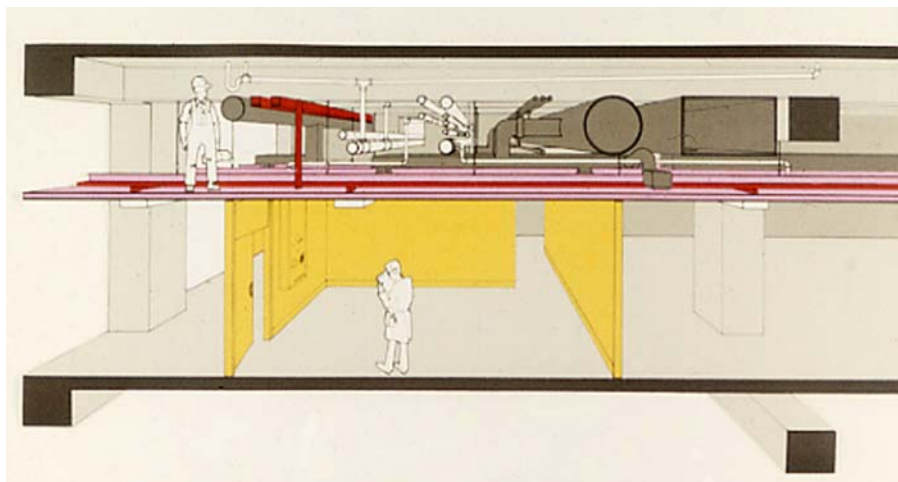
Figure 9-3 Sketch showing typical interstitial space for nonstructural components and systems in new hospitals.

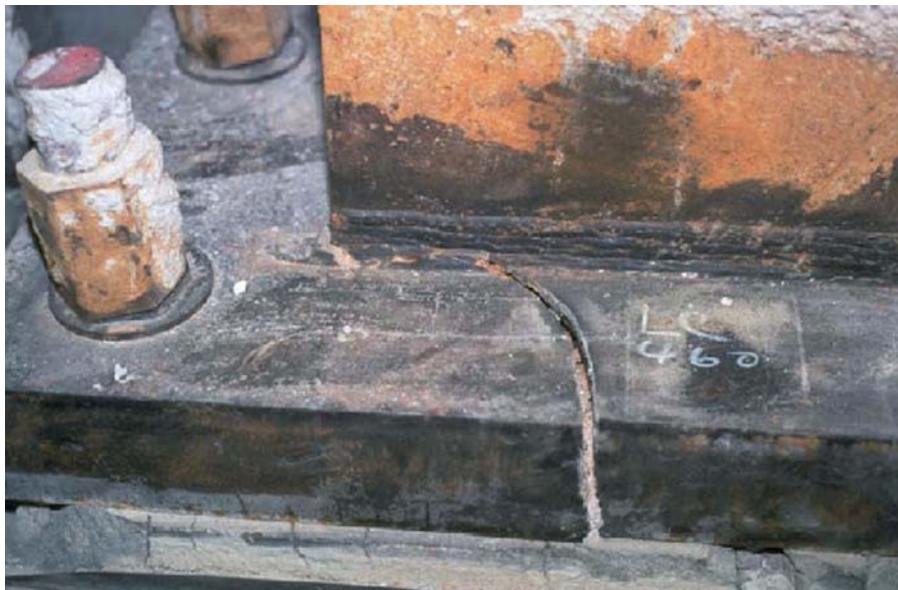
Figure 11-1 Fractured 4-inch-thick steel base plate, university building, Northridge, 1994. (photo courtesy of the Earthquake Engineering Research Institute)
