# Collocation Impacts on the Vulnerability of Lifelines During Earthquakes with Applications to the Cajon Pass, California

Earthquake Hazard Reduction Series 61

Submitted to the Federal Emergency Management Agency  
Washington, D.C.

INTECH Inc.  
11316 Rouen Dr.  
Potomac, MD 20854-3126

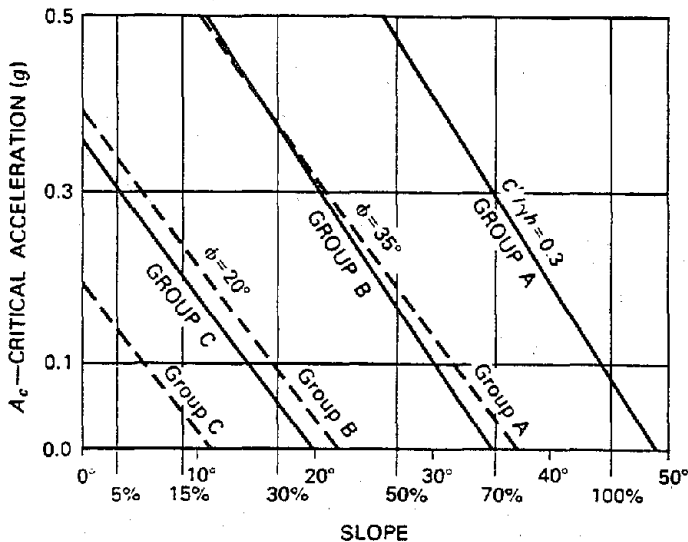
Plots of critical acceleration ( $A_c$ ) versus slope steepness for three sets of lithologies: group A, strongly cemented rocks (crystalline rock and well-cemented sandstone); group B, weakly cemented rocks (sandy soil and poorly cemented sandstone); group C, argillaceous rocks (clayey soil and shale). The cohesion factor,  $c'/\gamma h$ , for group A assumes values of  $c' = 300$  psf,  $\gamma = 100$  pcf, and  $h = 10$  ft. The angle of internal friction ( $\phi$ ) (peak strength, undrained conditions) is  $35^\circ$  for sands, sandstone, and crystalline rocks and  $20^\circ$  for clayey soils and shales. The solid lines depict dry slope materials, and the dashed lines depict saturation from the slide plane to the surface.

Either the Legg formula or the Wilson graph is acceptable for determining the critical acceleration, it's numeric value will be used in the Legg tables discussed below.

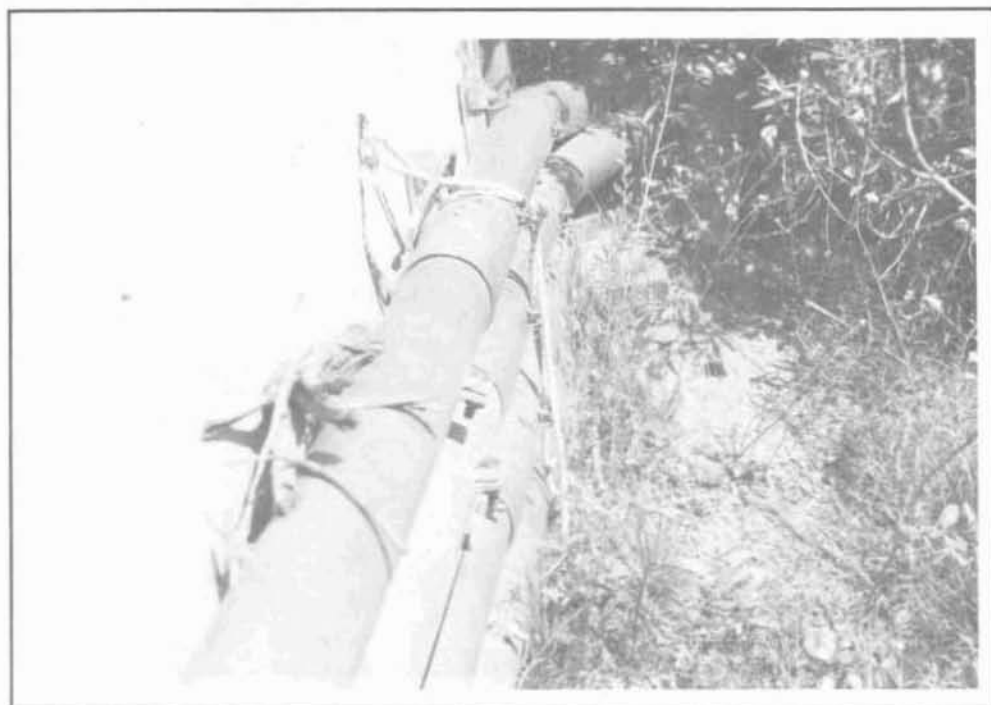
Figure 13 Wall Support Details For The Fiber Optic Conduits Of Figure 12

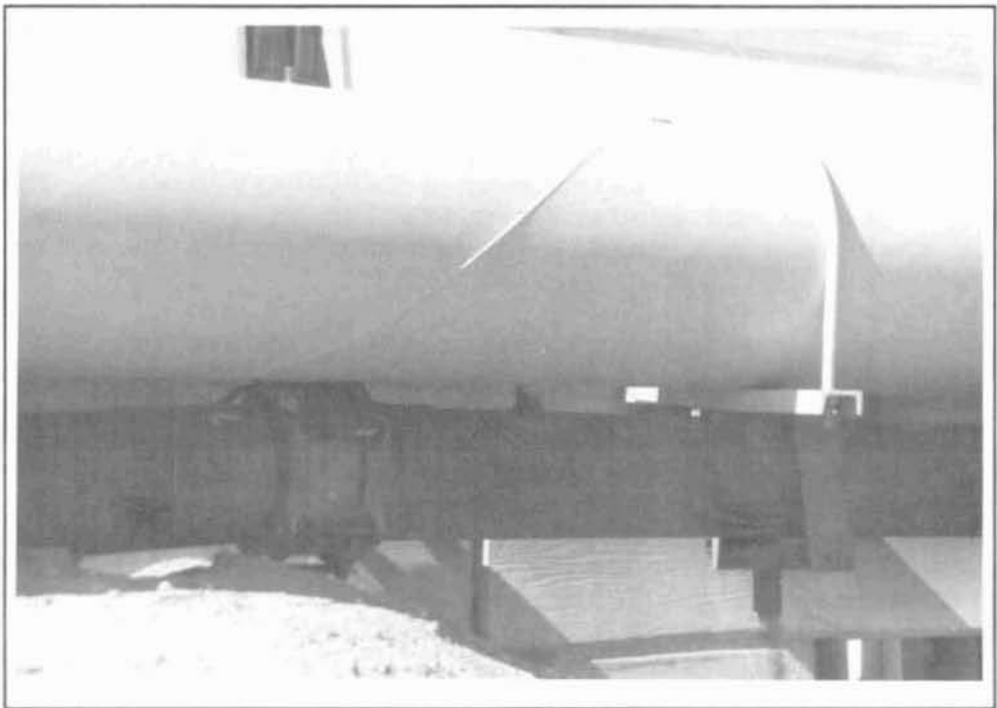
Figure 15 Fiber Optic Conduits Under a Heavy Water Pipe, Both On A Highway Bridge

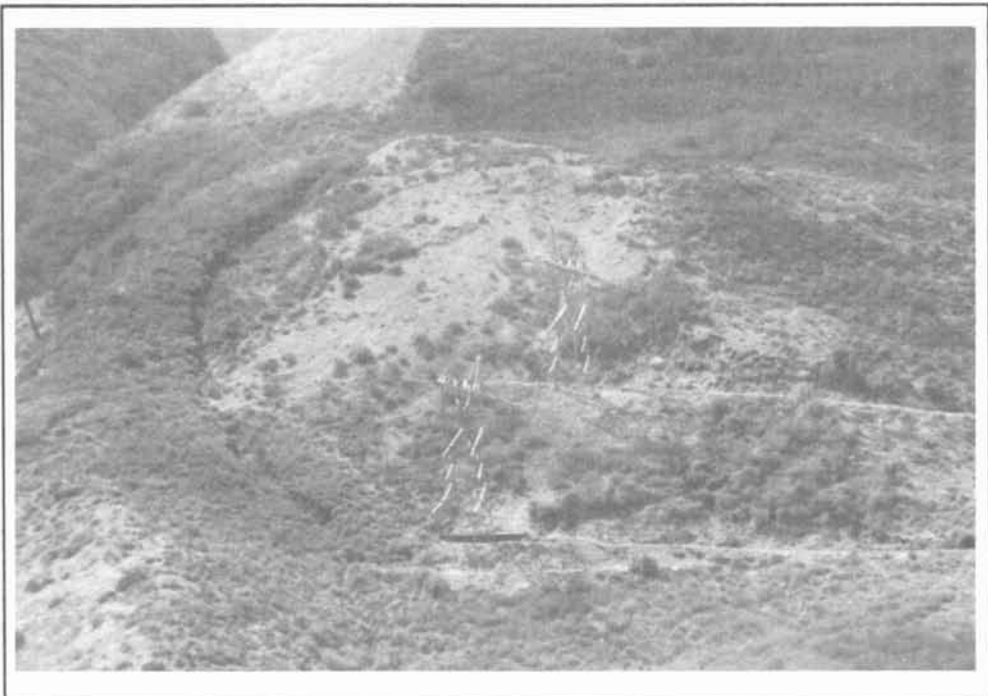
Figure 17 A Landslide Scar With Power Towers In The Slide Area

Transmission lines often traverse more rugged areas, and as such they are susceptible to landslide damage. Figure 17 shows two transmission towers located in an old landslide scar (the original towers were damaged in the landslide). This location is an important collocation site, as a buried natural gas transmission pipeline and the railroad tracts are located just below the slide area. Figure 18 shows the location of two high voltage power transmission tower systems, a buried natural gas transmission pipeline (shown by a surface marker), and the 8- and 14-inch buried petroleum products pipelines (also shown by a surface marker).

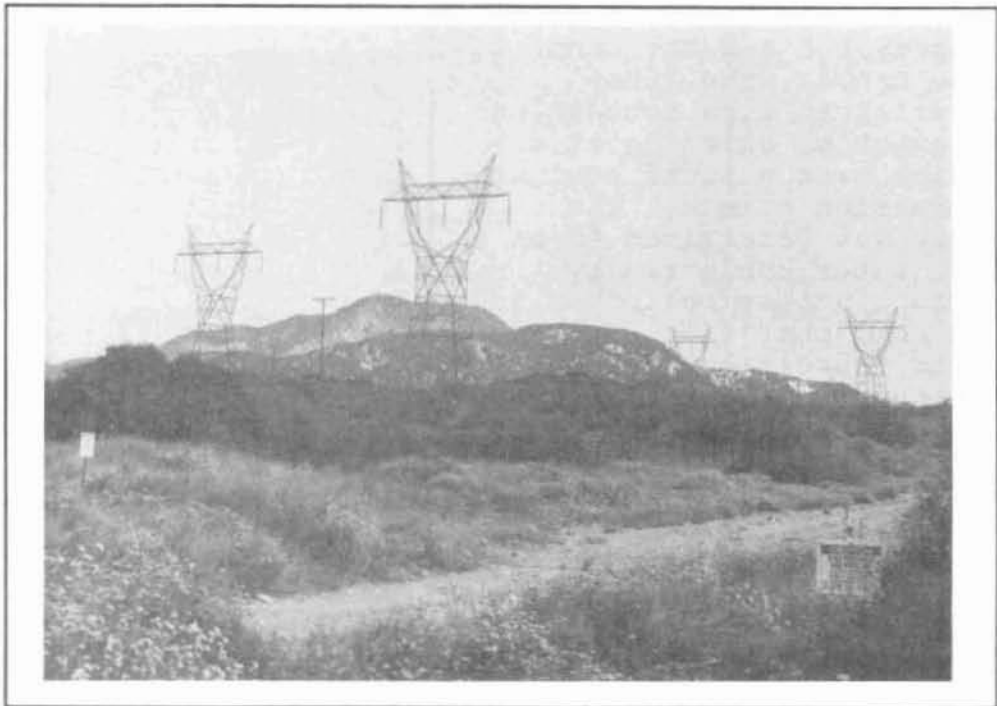
Figure 18 Power Lines, Natural Gas & Petroleum Products Pipelines Intersection Over the San Andreas Fault Rift Zone

the San Andreas fault and rift zone) is the most significant collocation condition for the electric and the fuel lifelines.

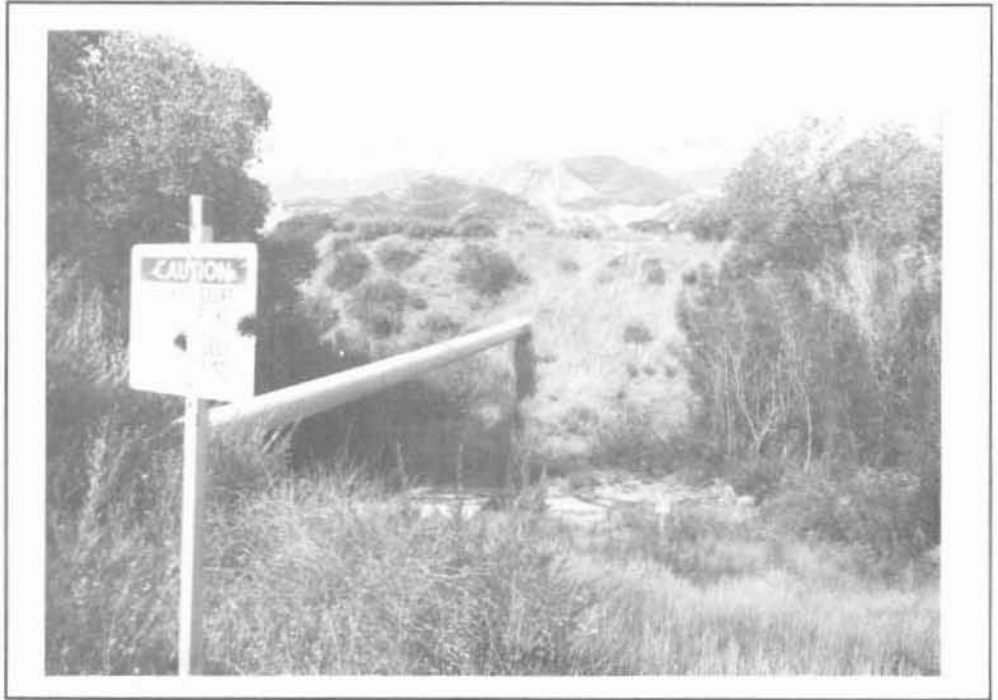
Figure 22 Two Natural Gas Pipelines Near Highway 138, One Buried, One Exposed

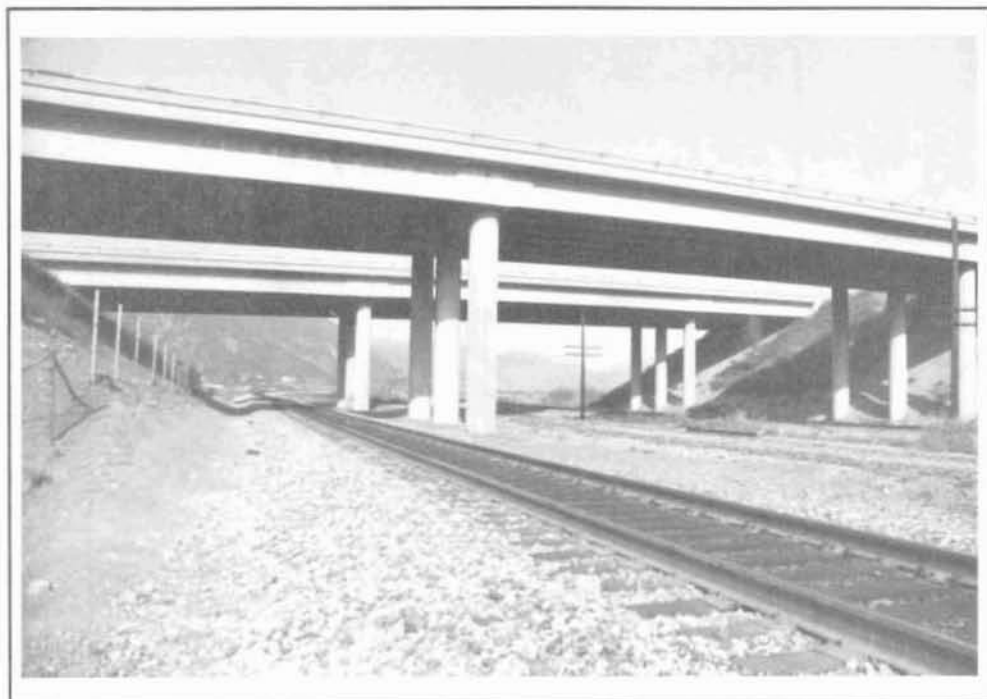
Figure 25 I-15 Bridge Over The Railroads In Cajon Wash

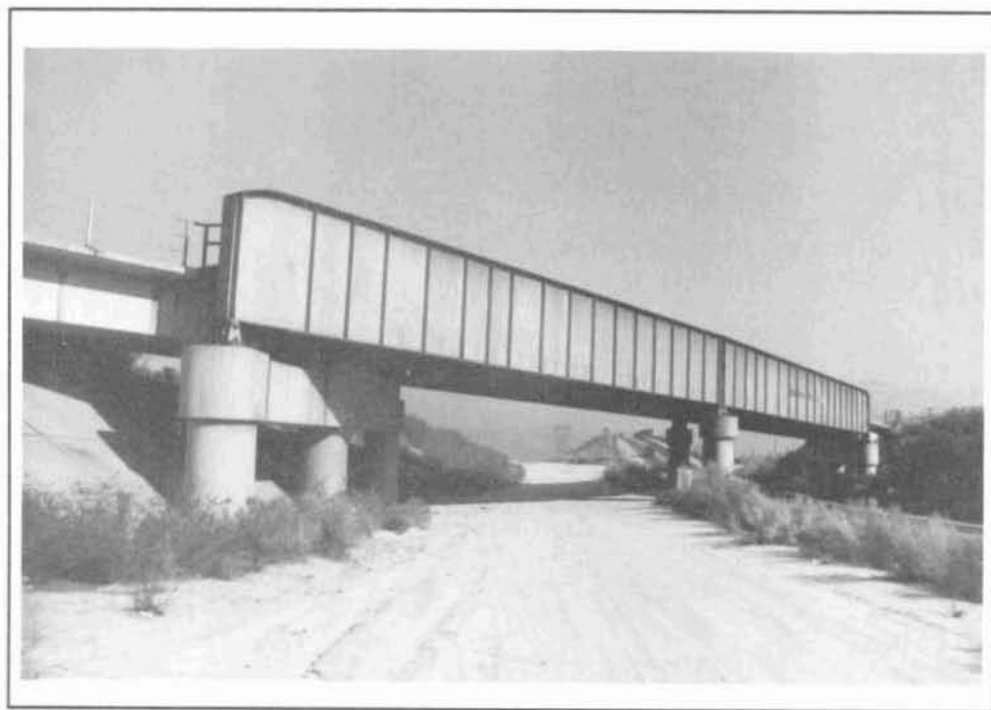
Figure 29 Railroad Bridge Over Highway 138  
(Collapse Expected)

plate, girder bridge on the Southern Pacific railroad over Highway 138 which is sharply skewed, and which has bearings which are vulnerable to loss (Figure 29). It is expected that the multiple span structures will have one or more spans dislodged where they are subjected

to MMI= VIII shaking intensity zones or are on potentially liquefiable soils. The failure of the Bridge shown in Figure 29 was responsible for much of the access time estimate for repair of I-15, since it blocked Highway 138 from being an immediate detour route for equipment needed for the I-15 repairs.
