# Techniques for the Seismic Rehabilitation of Existing Buildings

FEMA 547/2006 Edition

**FEMA 547 – October 2006**

Rutherford & Chekene (R & C) Consulting Engineers (Subconsultant) under contract with National Institute of Standards and Technology (NIST).

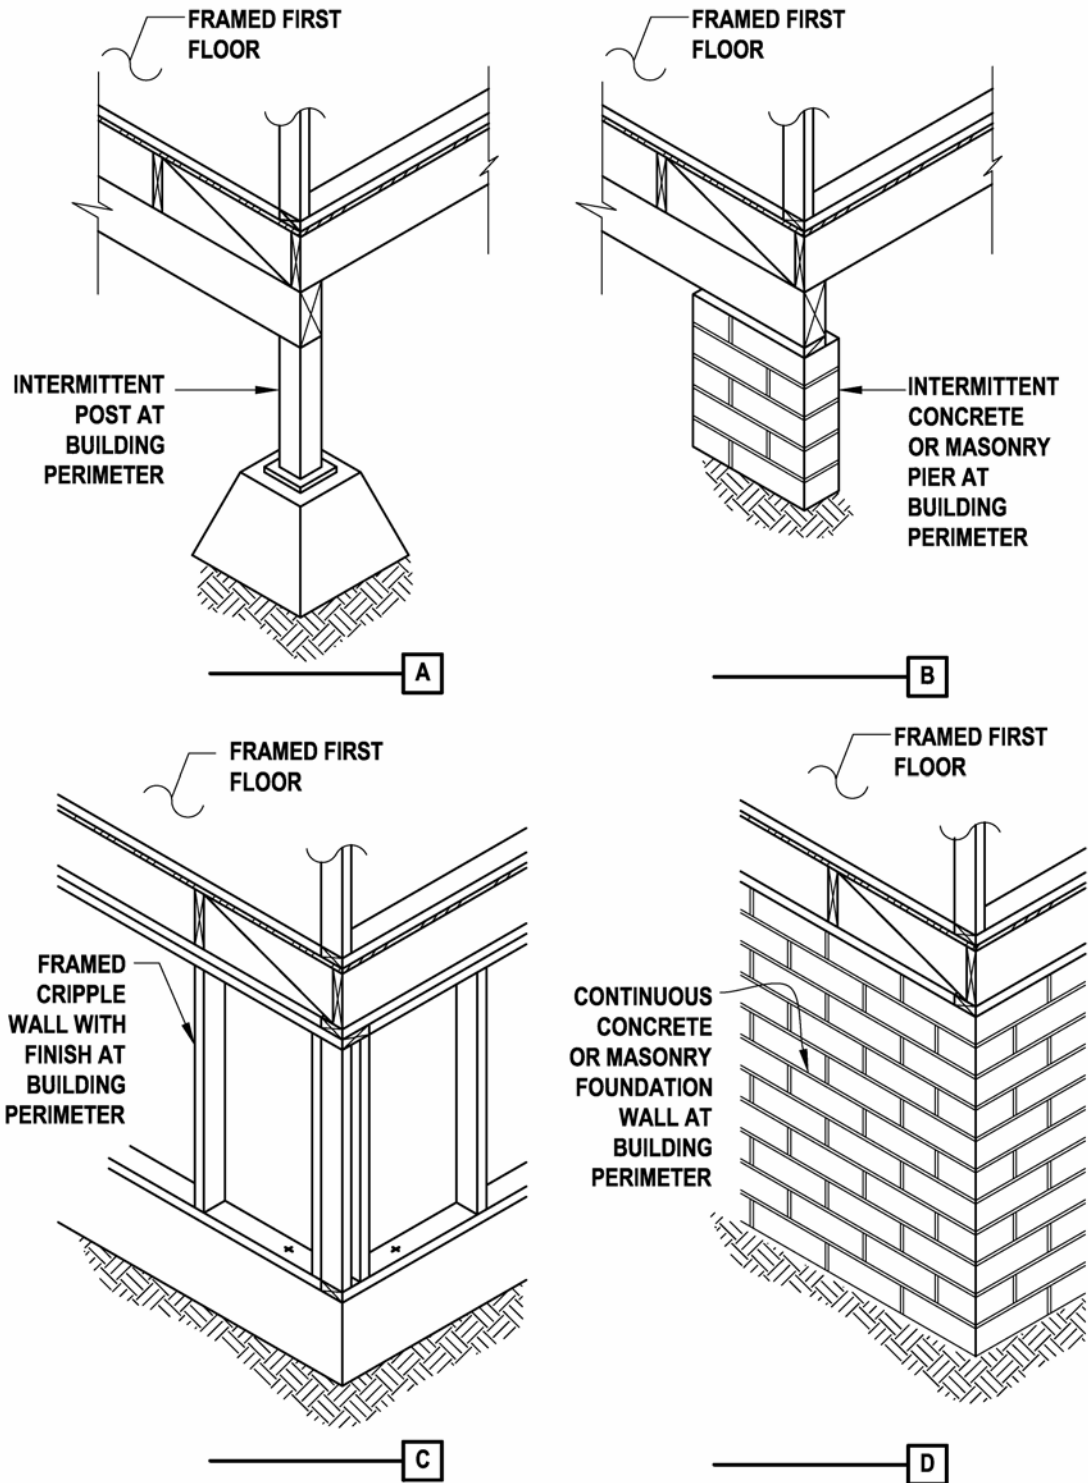
Figure 5.1-2: Systems Between First Framed Floor and Grade – Level Lot Sites

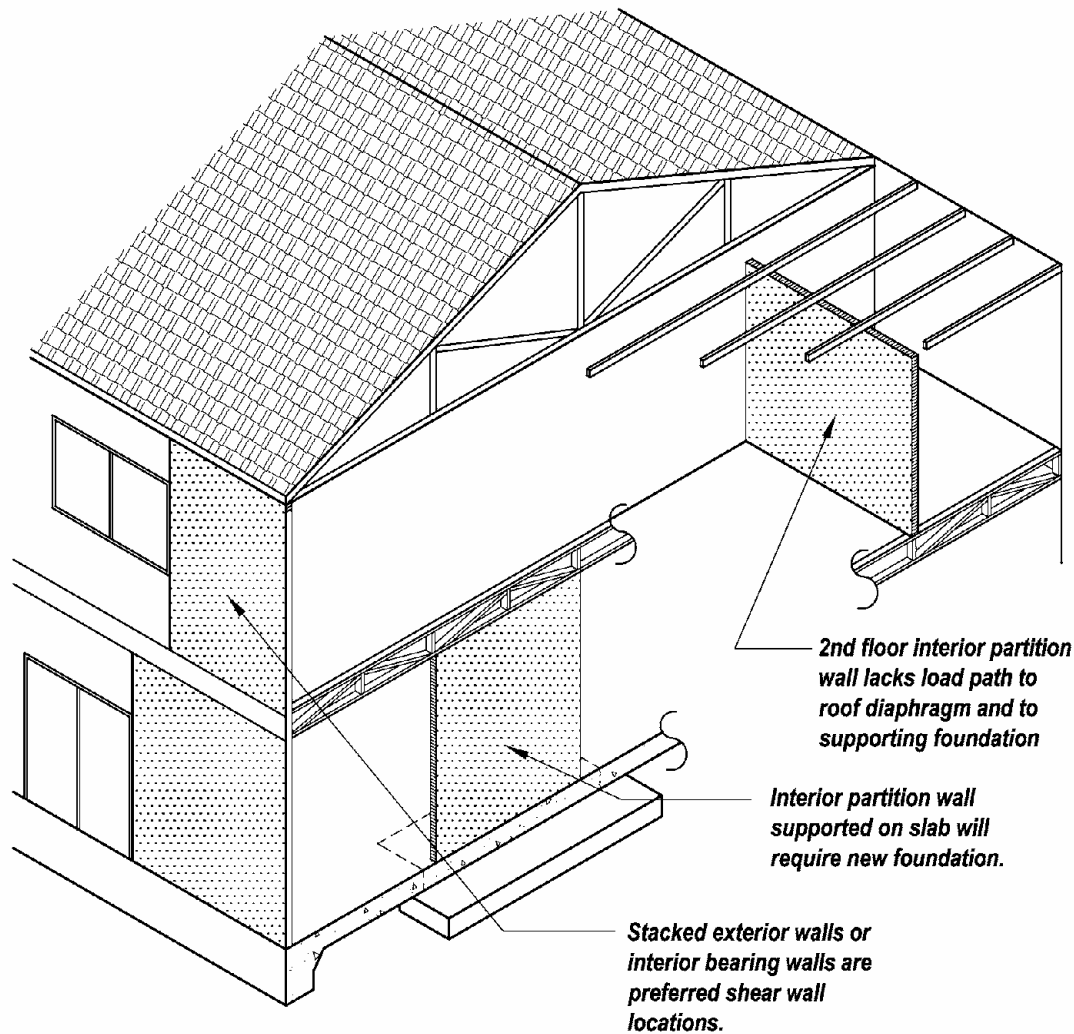
**Figure 5.4.1-2: Preferred and Less Preferred Shear Wall Locations**

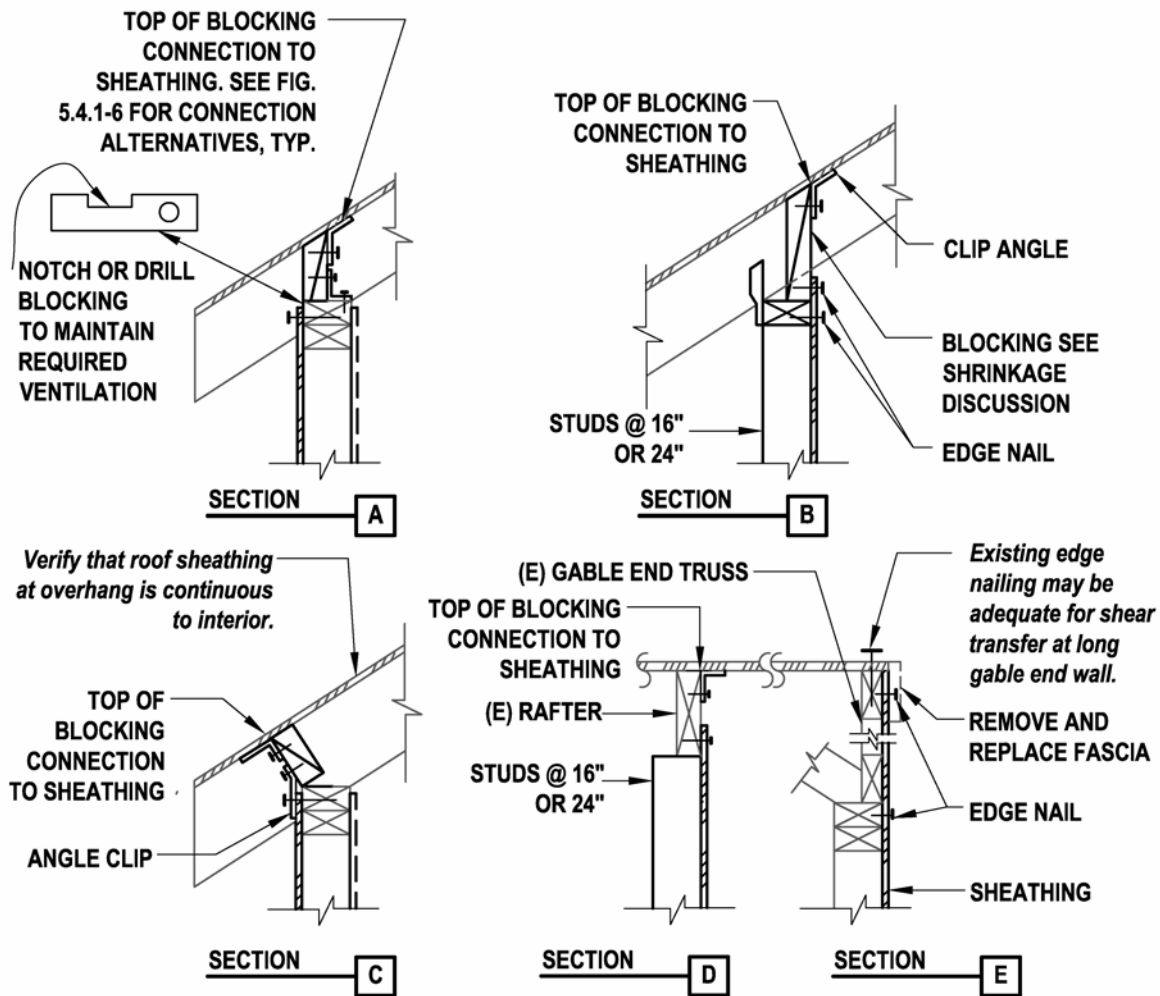
**Figure 5.4.1-5: Load Path from Roof Diaphragm to Top of Shear Wall**

Figure 5.4.1-5 shows a series of top of shear wall details where the shear is being transferred from a roof diaphragm into the top of the wall. Since most diaphragms in residential construction are not blocked, the unit capacity of the new shear wall is likely to be higher than the unit

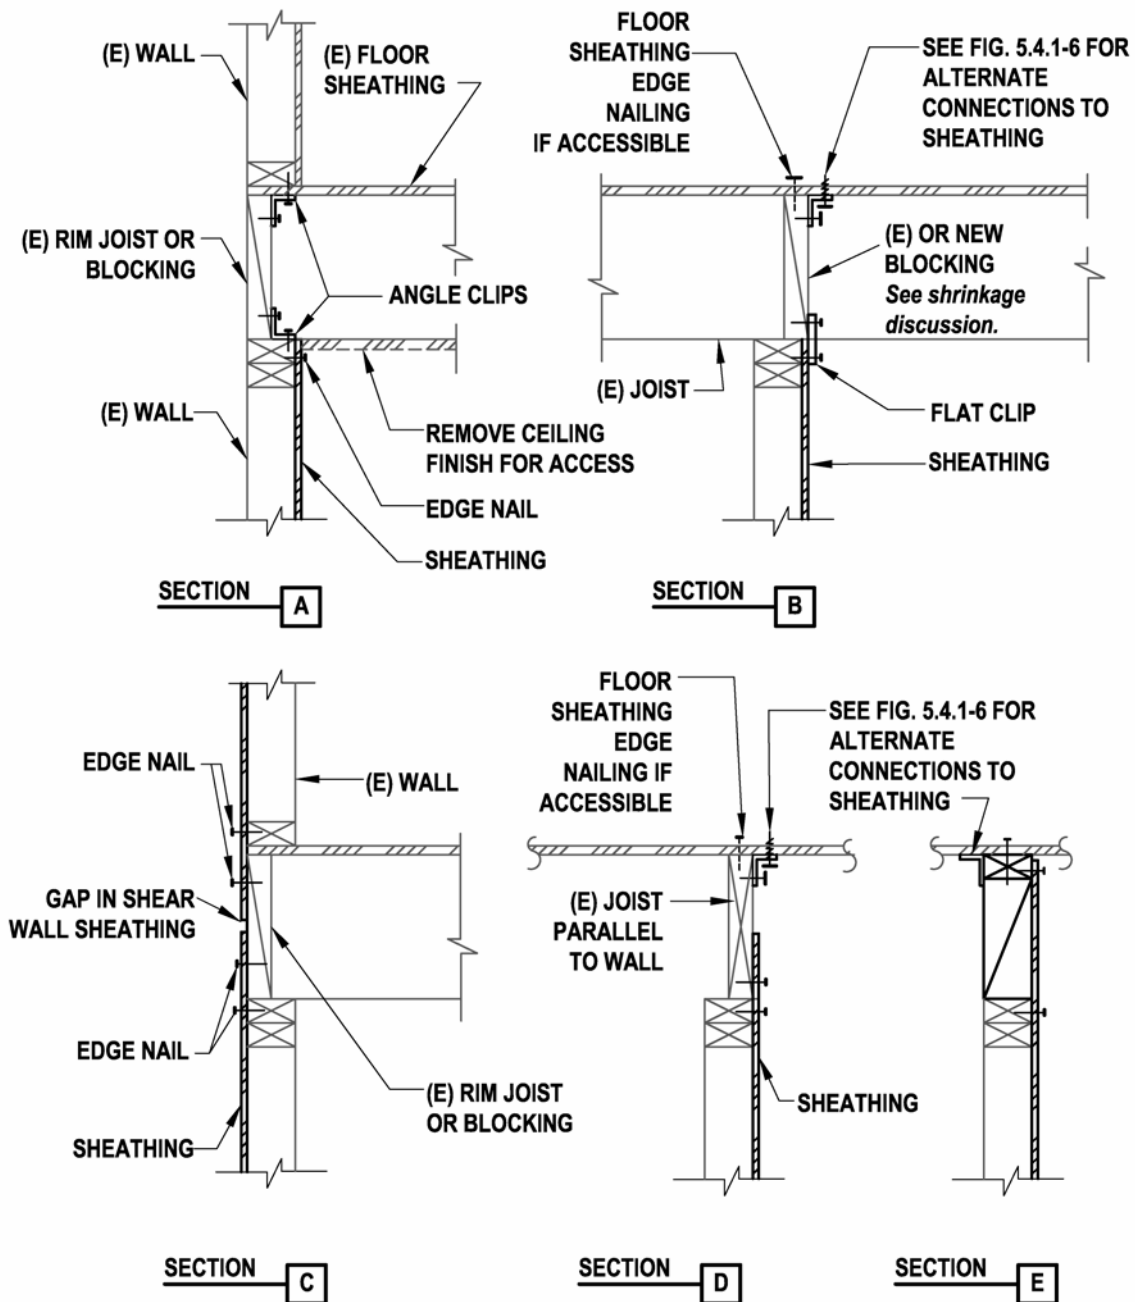
**Figure 5.4.1-7: Load Path From Floor Diaphragm to Lower Story Shear Wall**

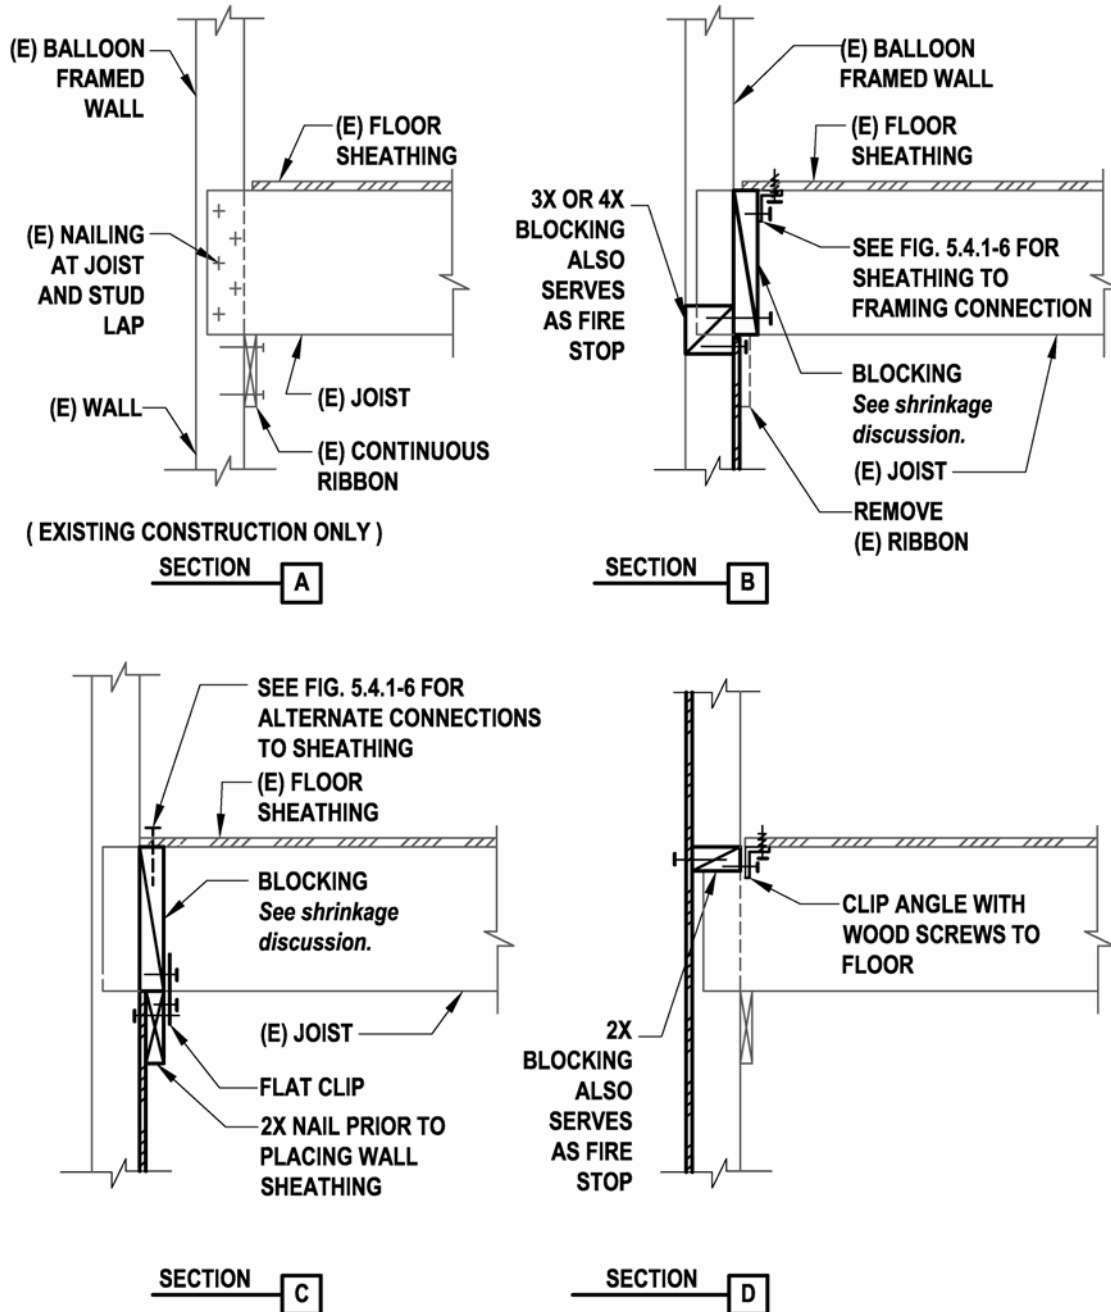
**Figure 5.4.1-8: Load Path From Floor Diaphragm to Lower Story Shear Wall – Balloon Framing**

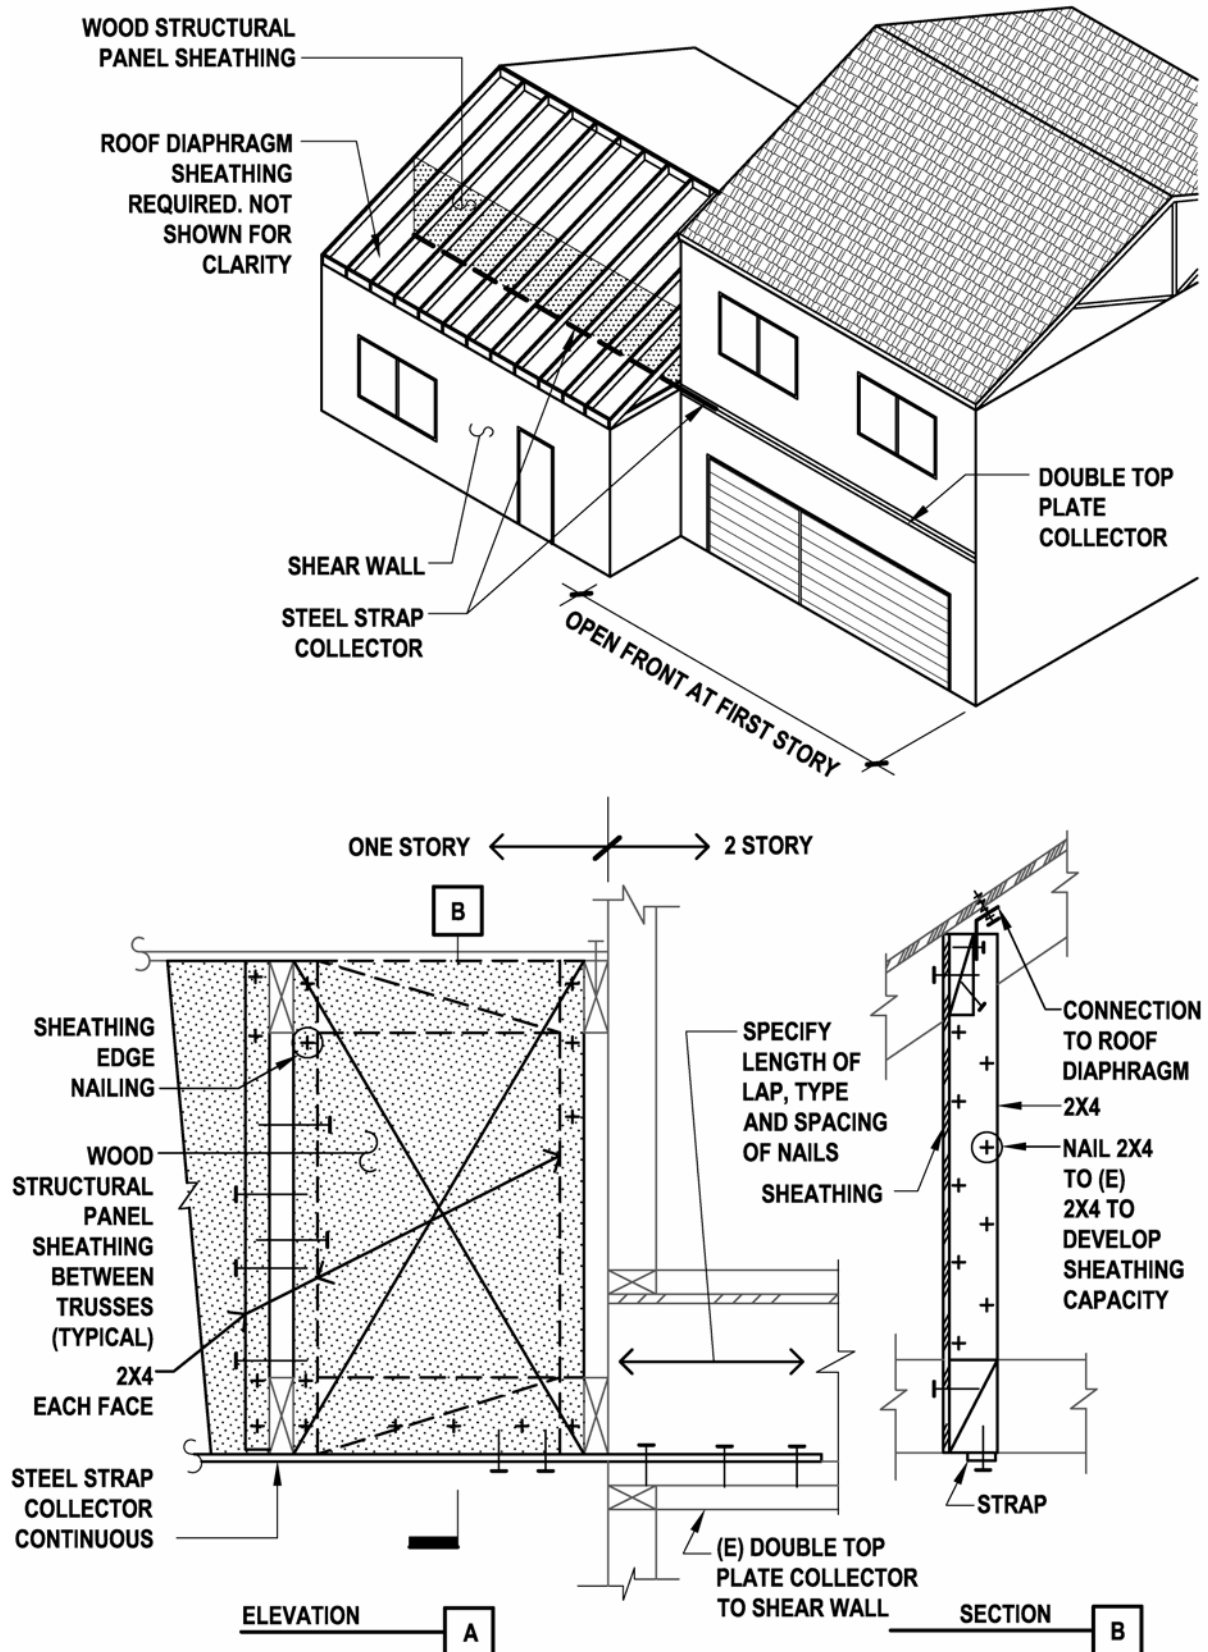
Figure 5.4.2-1: Collector from Garage Open Front to Adjacent Dwelling

Figure 5.4.2-1 shows one of several possible methods of providing a collector. In the illustrated approach, a steel strap ties the top plates from the garage open-front to wood structural panel sheathed infill panels between the roof trusses in the one-story portion of the building. The infill panels transfer the load from the truss bottom chord up to the roof diaphragm, where loads can be carried to the shear walls. In Figure 5.4.2-1, a vertical eccentricity exists between the collector

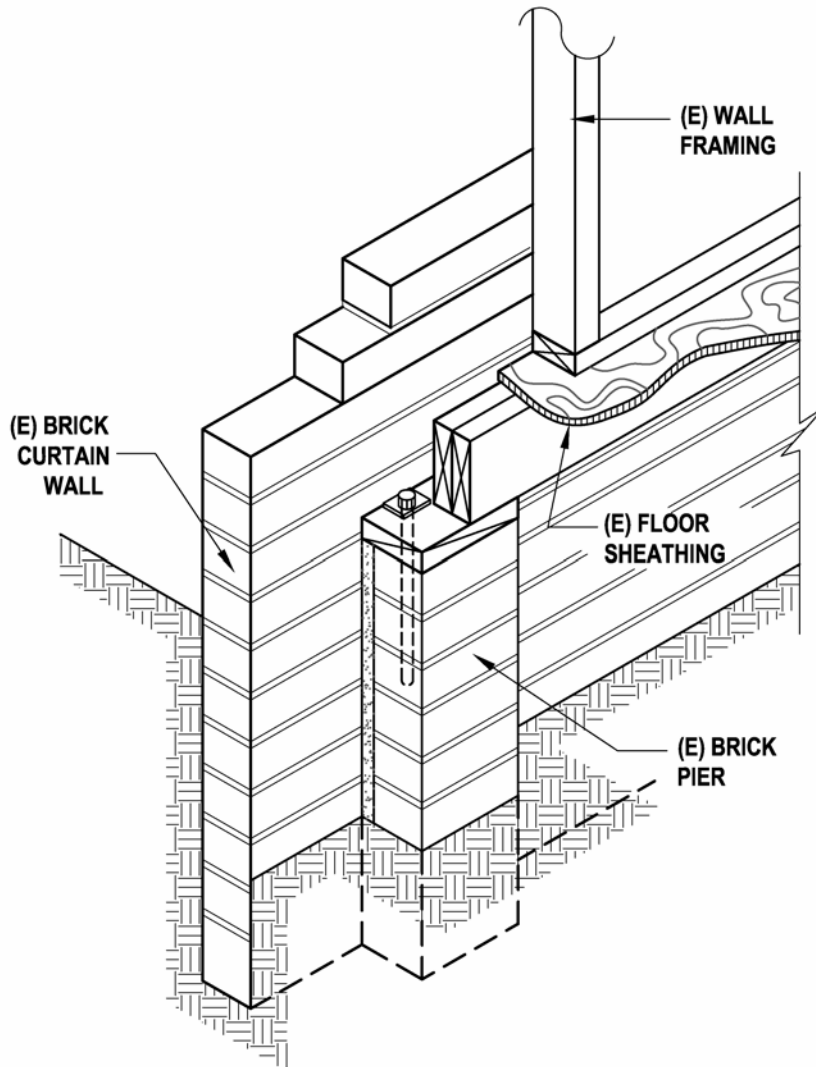
**Figure 5.4.3-4: Pier and Curtain Wall Foundation System with Inadequate Load Path Between Shear Walls and Foundation**

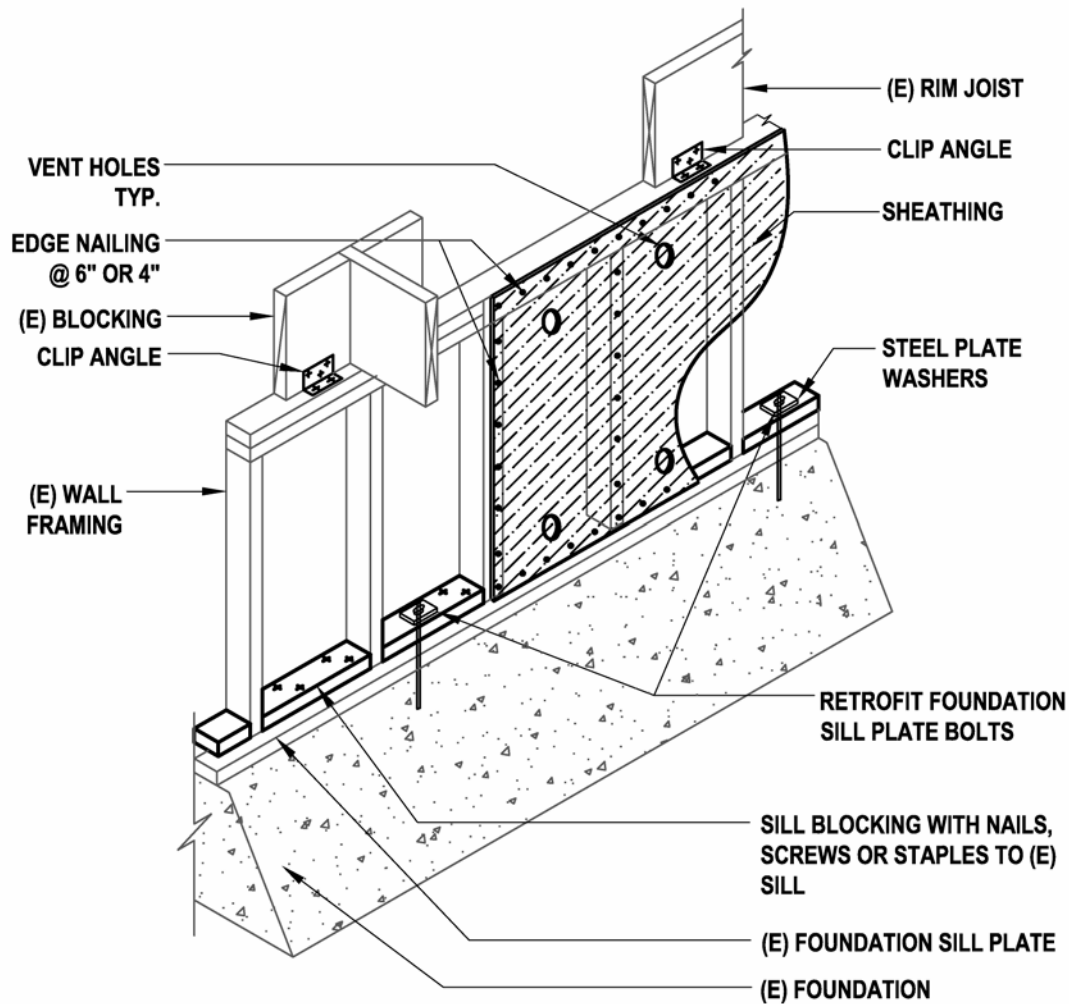
**Figure 5.4.4-1: Cripple Wall Enhancement**

Where cripple walls are 14 inches tall or less, wood structural panel sheathing may no longer provide reliable bracing of the studs, and splitting of the studs becomes a more significant concern. For this configuration, use of solid blocking between studs is recommended in lieu of sheathing.

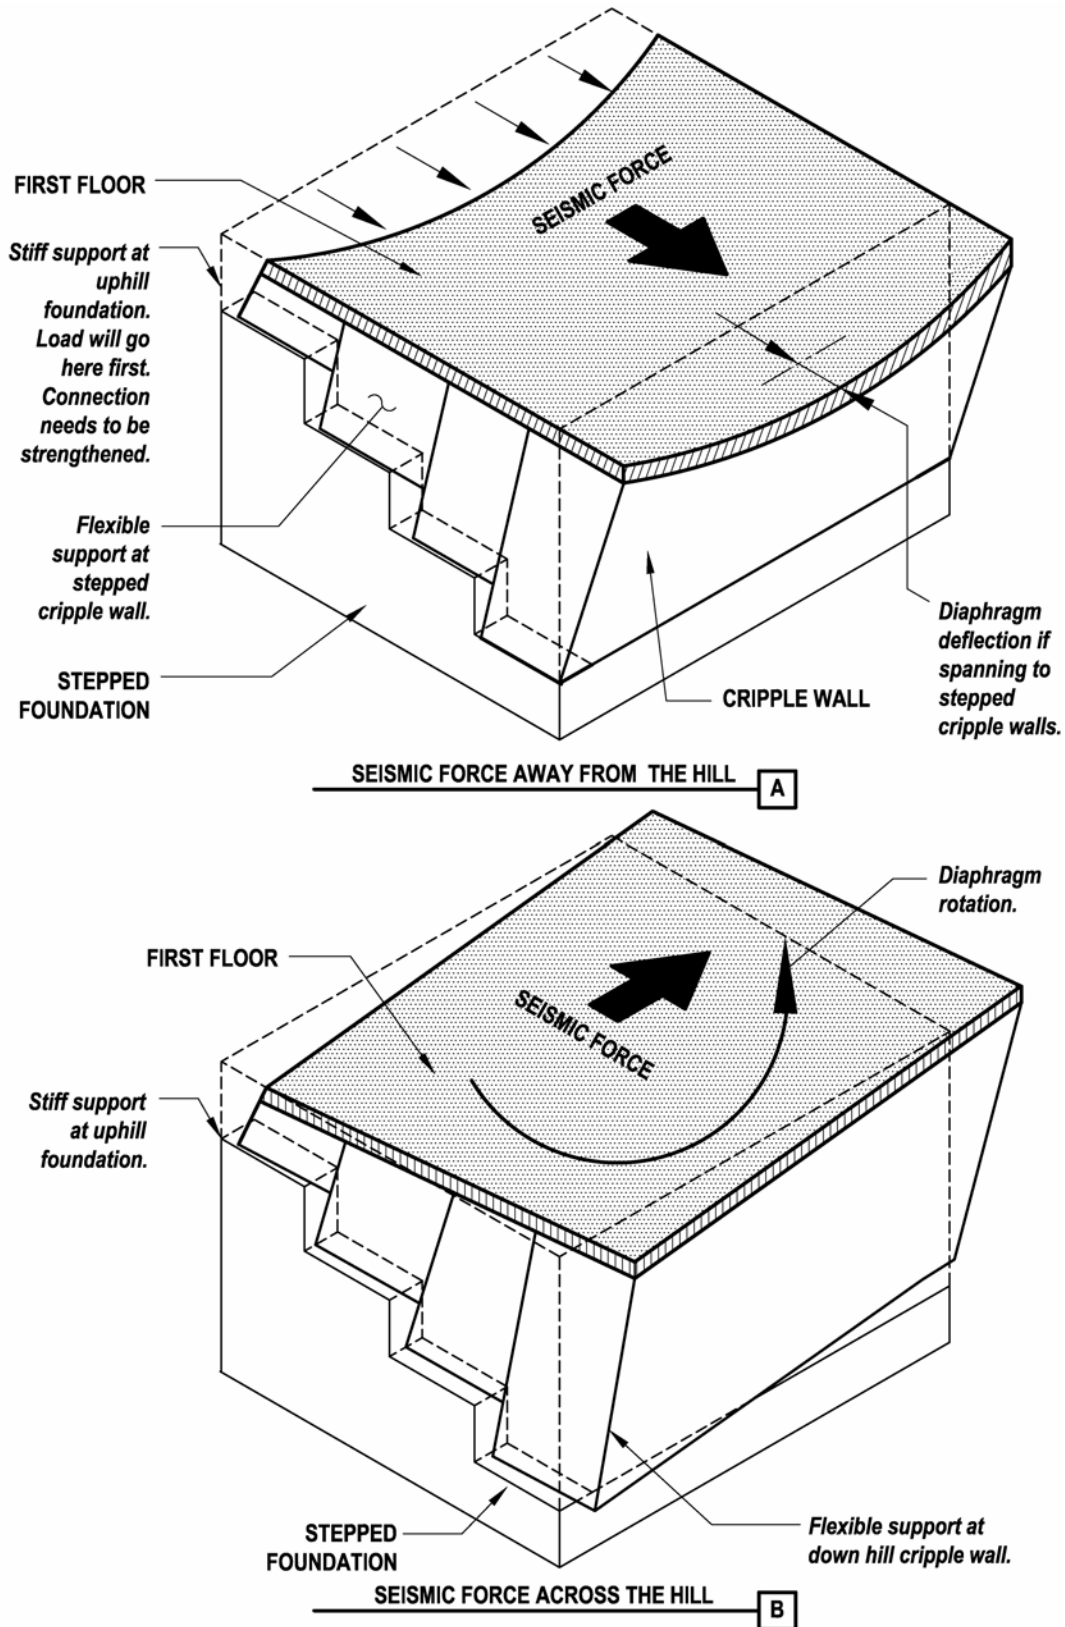
**Figure 5.4.5-1: Hillside Home Response to Seismic Forces**  
*Adapted from Von Winterfeldt, Roselund and Kitsuse (2000)*

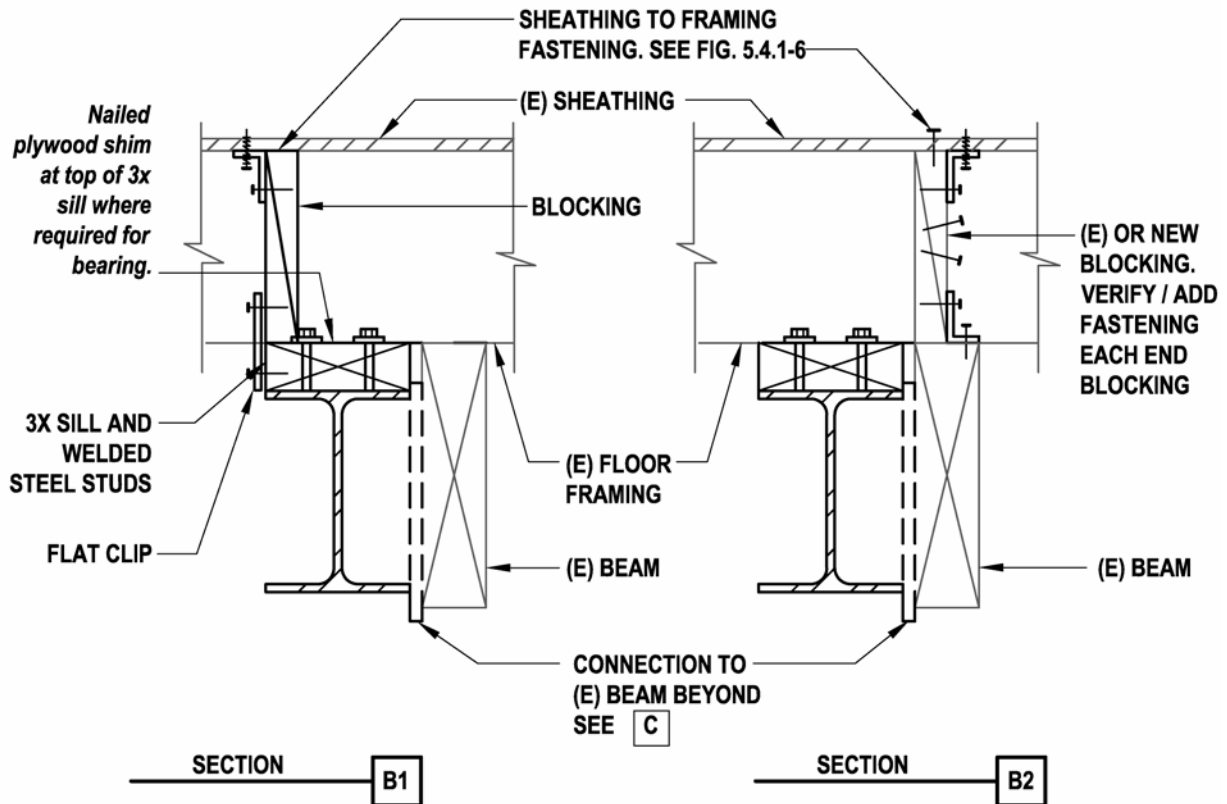
**Figure 6.4.1-1B: Shear Transfer Between Moment Frame Beam and Diaphragm**

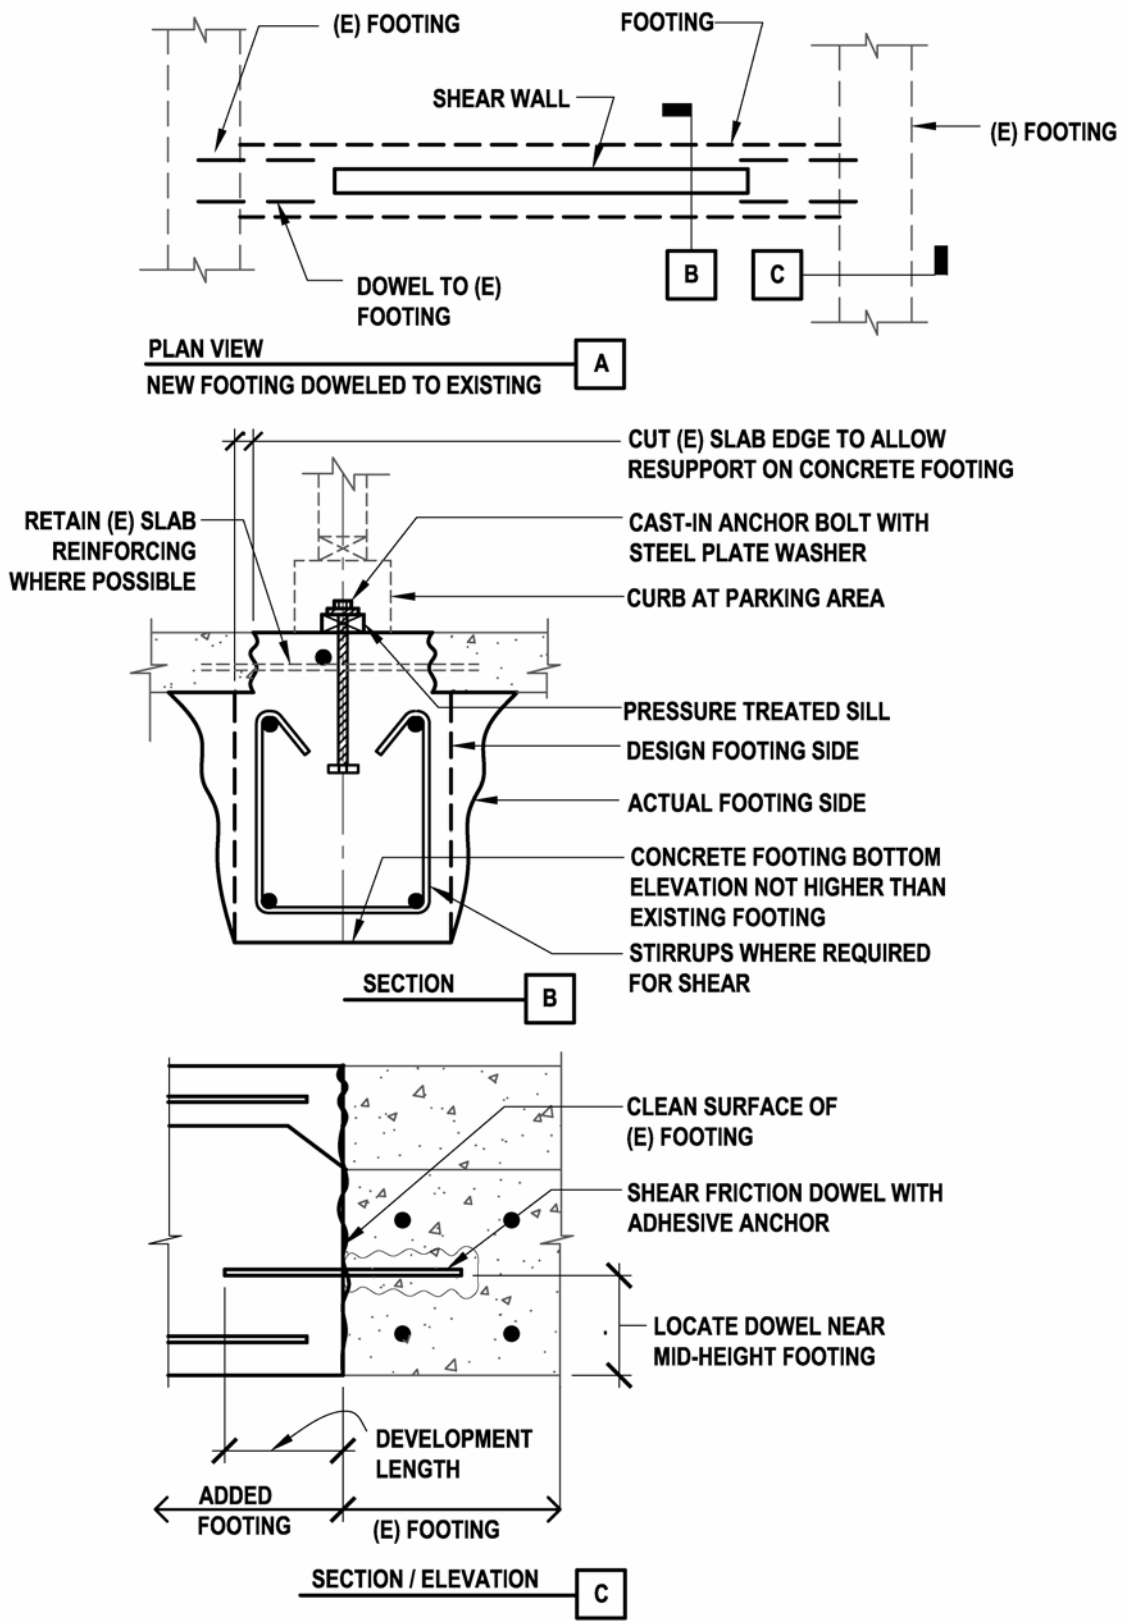
Figure 6.4.2-2: Added Shear Wall Supported by New and Existing Footings

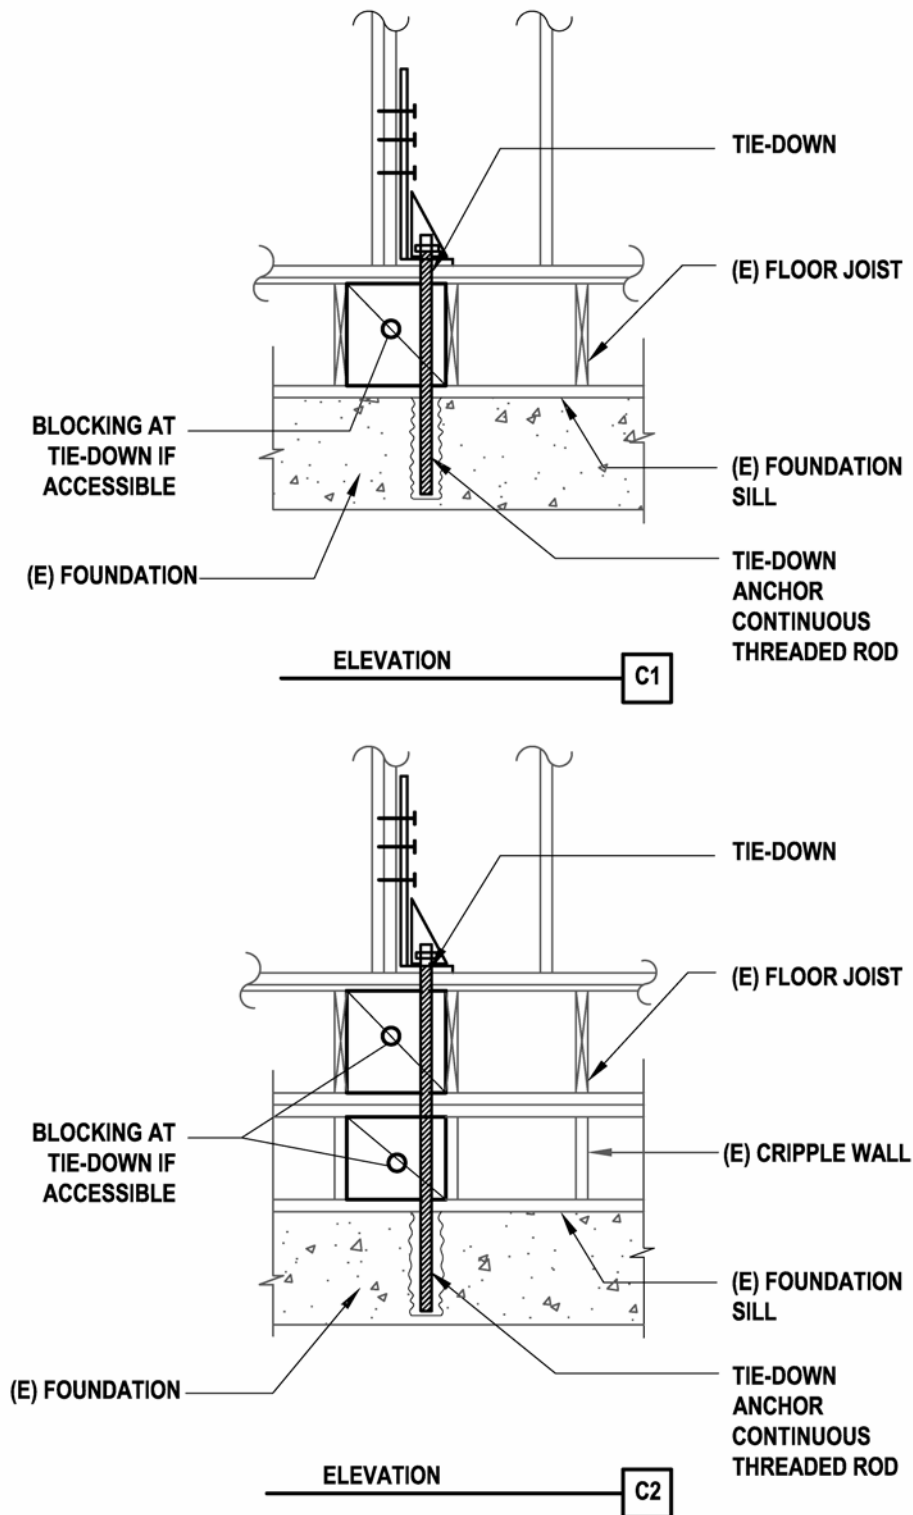
Figure 6.4.4-1C: Tie-down Details at Alternate Base Conditions

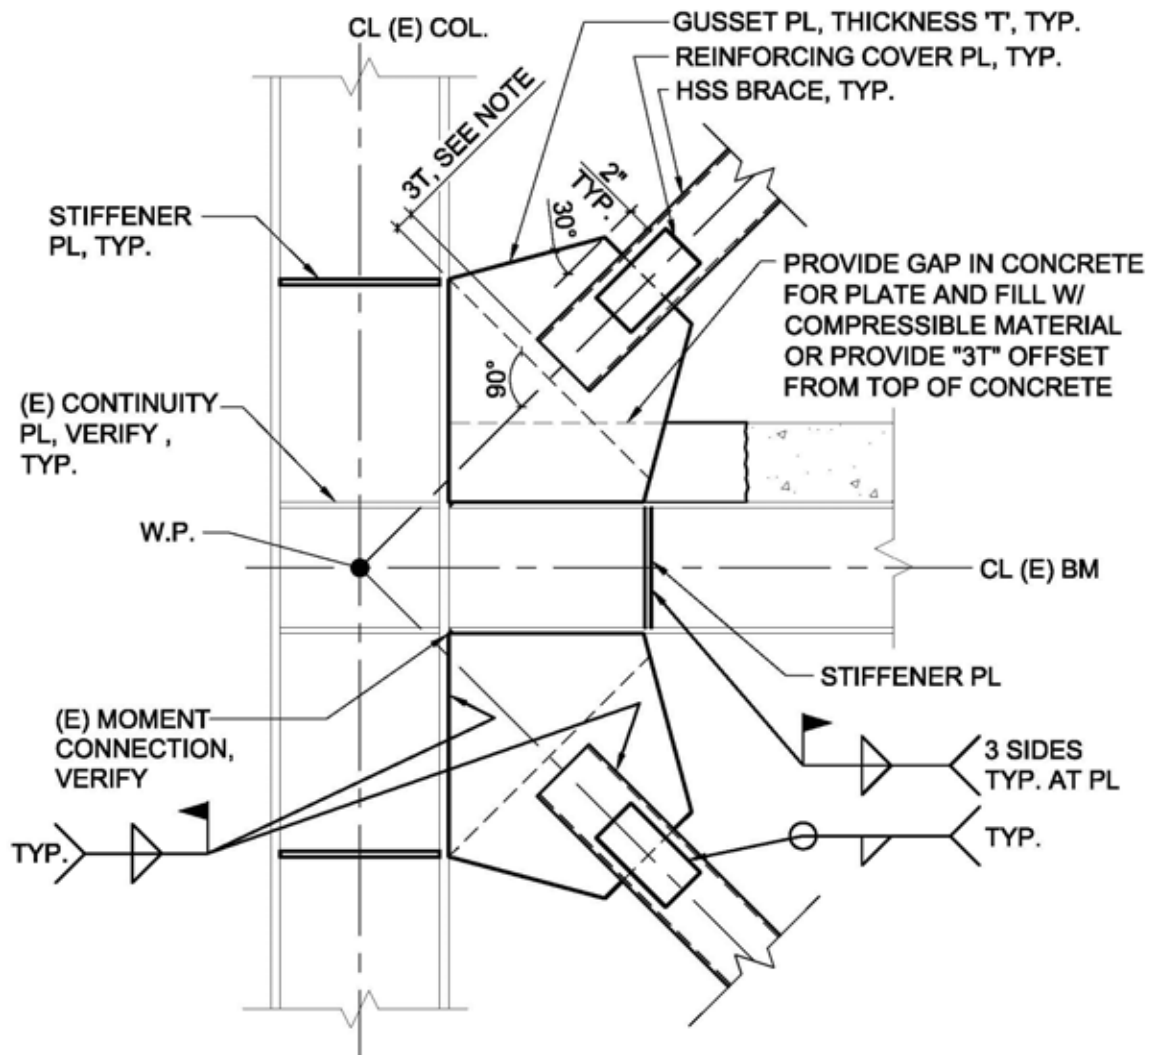
**Note:**  
AISC recommends  $2T$  to allow for restraint-free plastic rotations.  
 $3T$  is shown here to accommodate overcutting of HSS slots.

**Figure 8.4.1-1: HSS Brace at Existing Beam-Column Connection in SCBF**

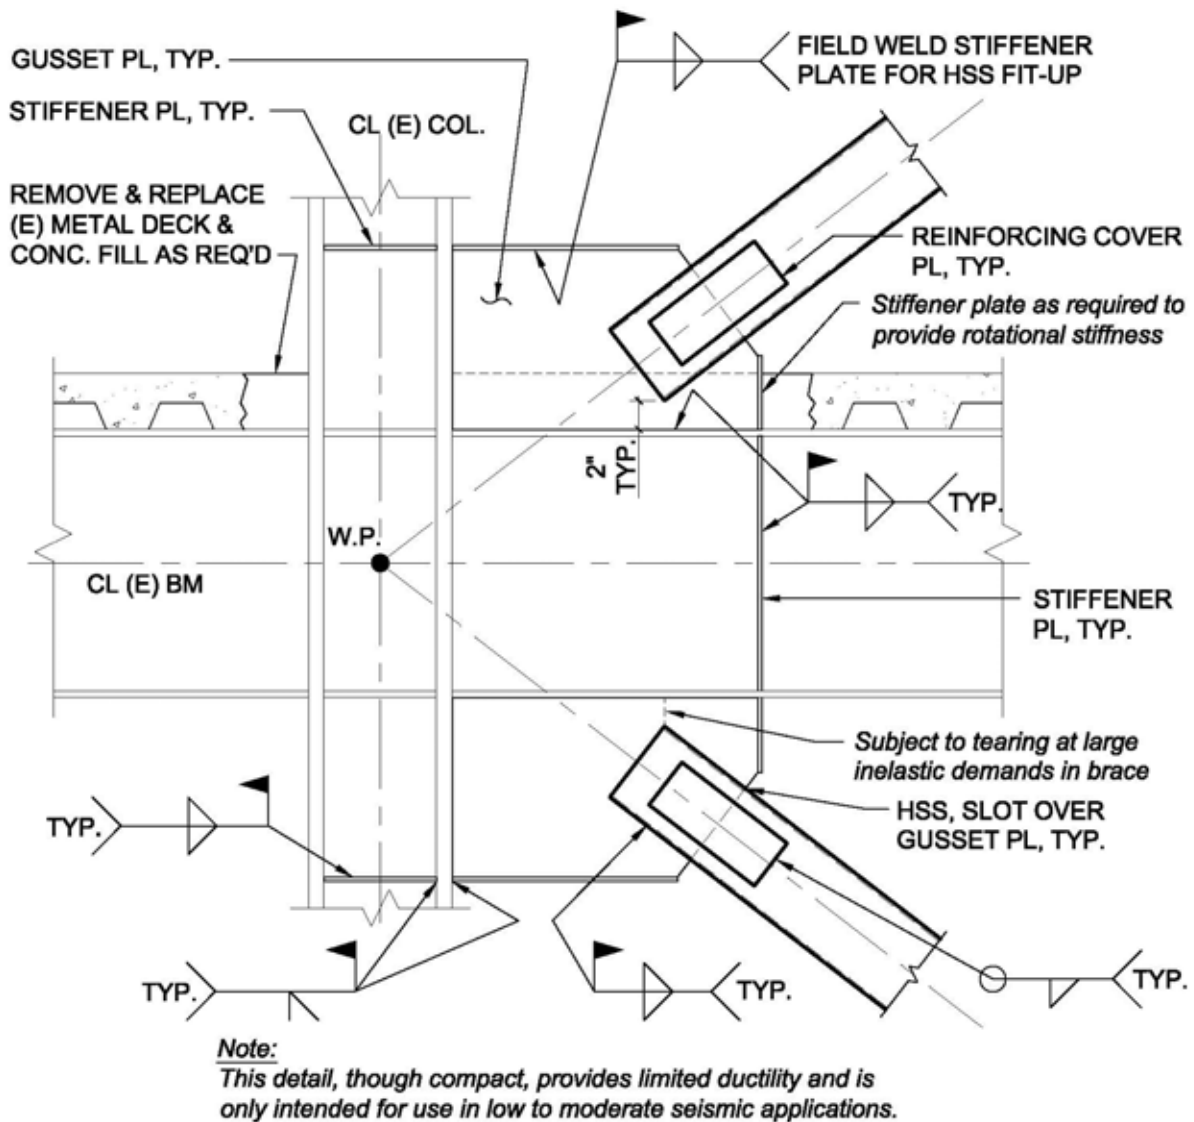
**Figure 8.4.1-2: HSS Brace at Existing Beam-Column Connection in Ordinary CBF**

For low to moderate seismic applications, Figure 8.4.1-2 shows a more compact connection. An example of a W-shape used as a brace and welded directly to the beam and column is shown in Figure 8.4.1-3. The two latter connections do not allow for restraint-free plastic rotations out-of-plane and should be used primarily in situations where in-plane buckling of the braces govern or

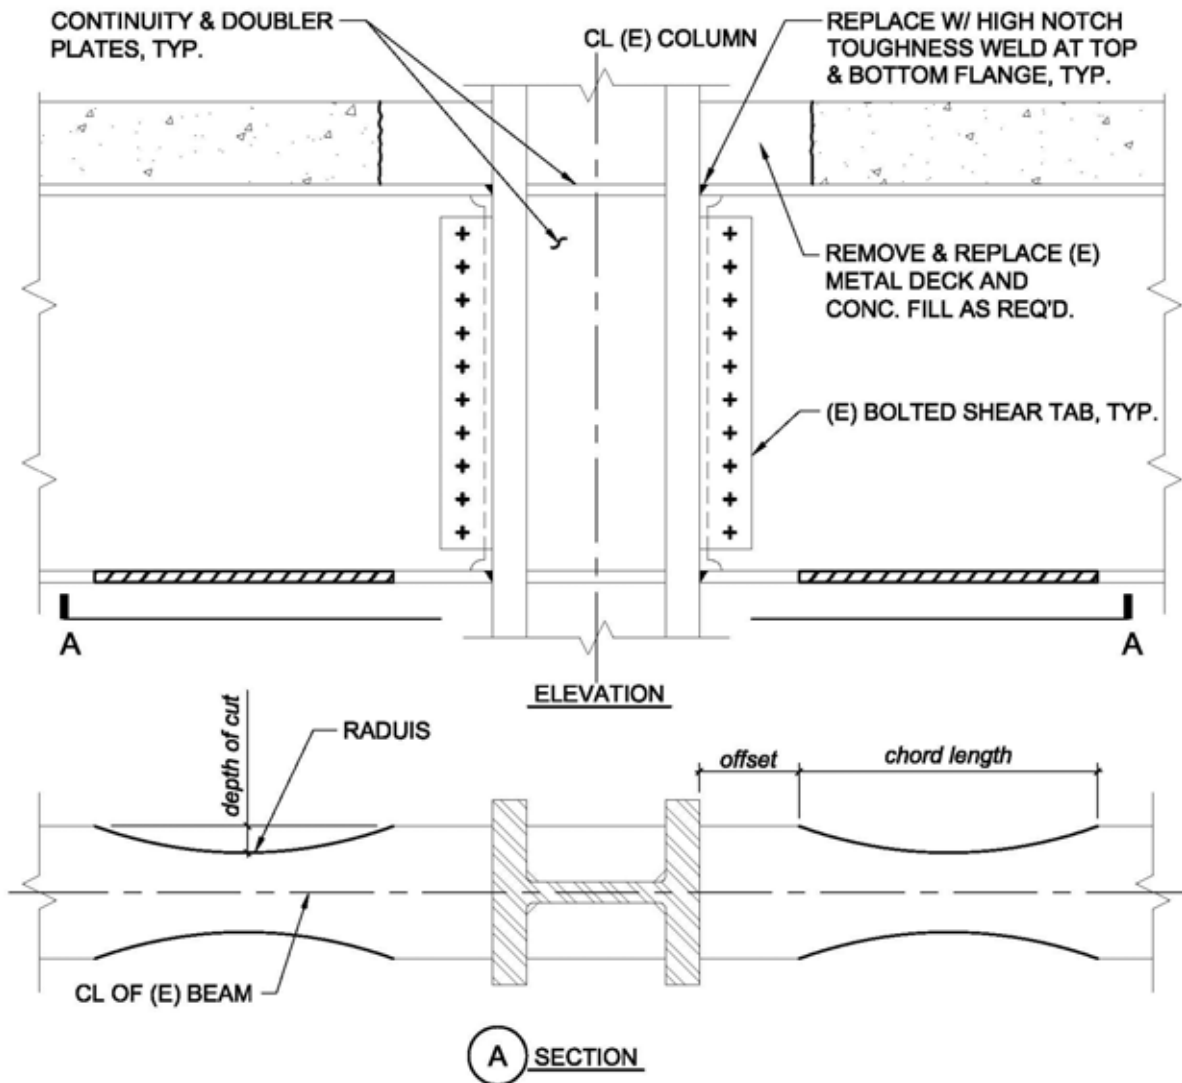
**Figure 8.4.6-1: Reduced Beam Section at Bottom Flange of Existing Beam**  
*(adapted from AISC Design Guide 12)*

length of the cut should also be long enough to control the inelastic strains along the RBS. The radius of the cut is a function of its depth and the chord length. See *AISC Design Guide 12* for specific recommendations and guidelines for selecting these dimensions.

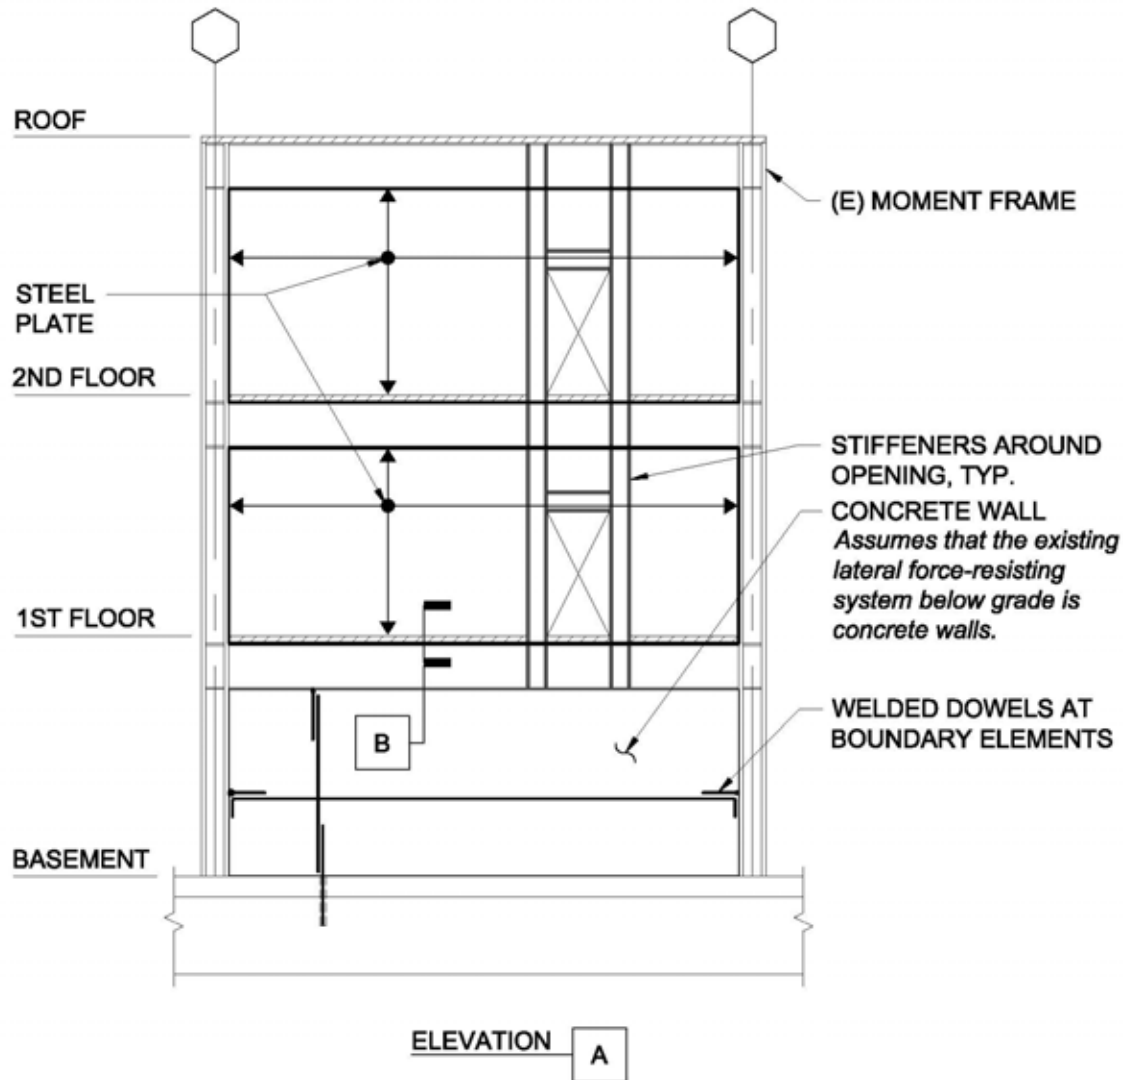
**Figure 8.4.8-1A: Unstiffened Steel Plate Shear Wall**
