# Techniques for the Seismic Rehabilitation of Existing Buildings

FEMA 547/2006 Edition

**FEMA 547 – October 2006**

Rutherford & Chekene (R & C) Consulting Engineers (Subconsultant) under contract with National Institute of Standards and Technology (NIST).

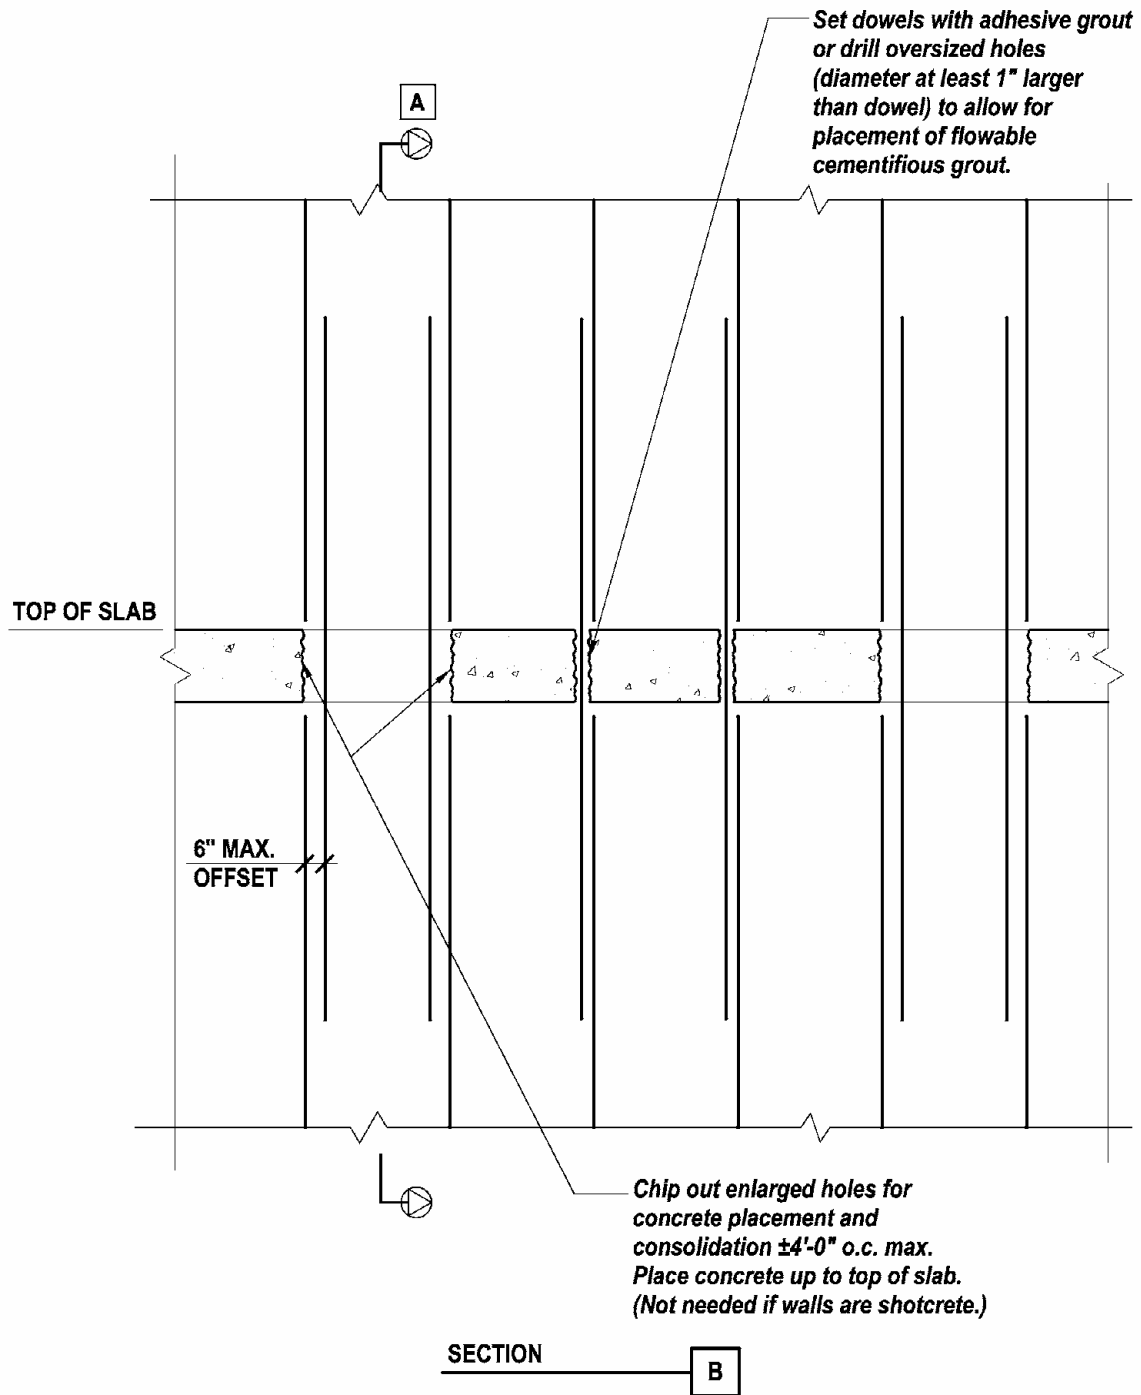
Figure 12.4.2-1B: Concrete Wall Connection to Concrete Slab – Partial Elevation View

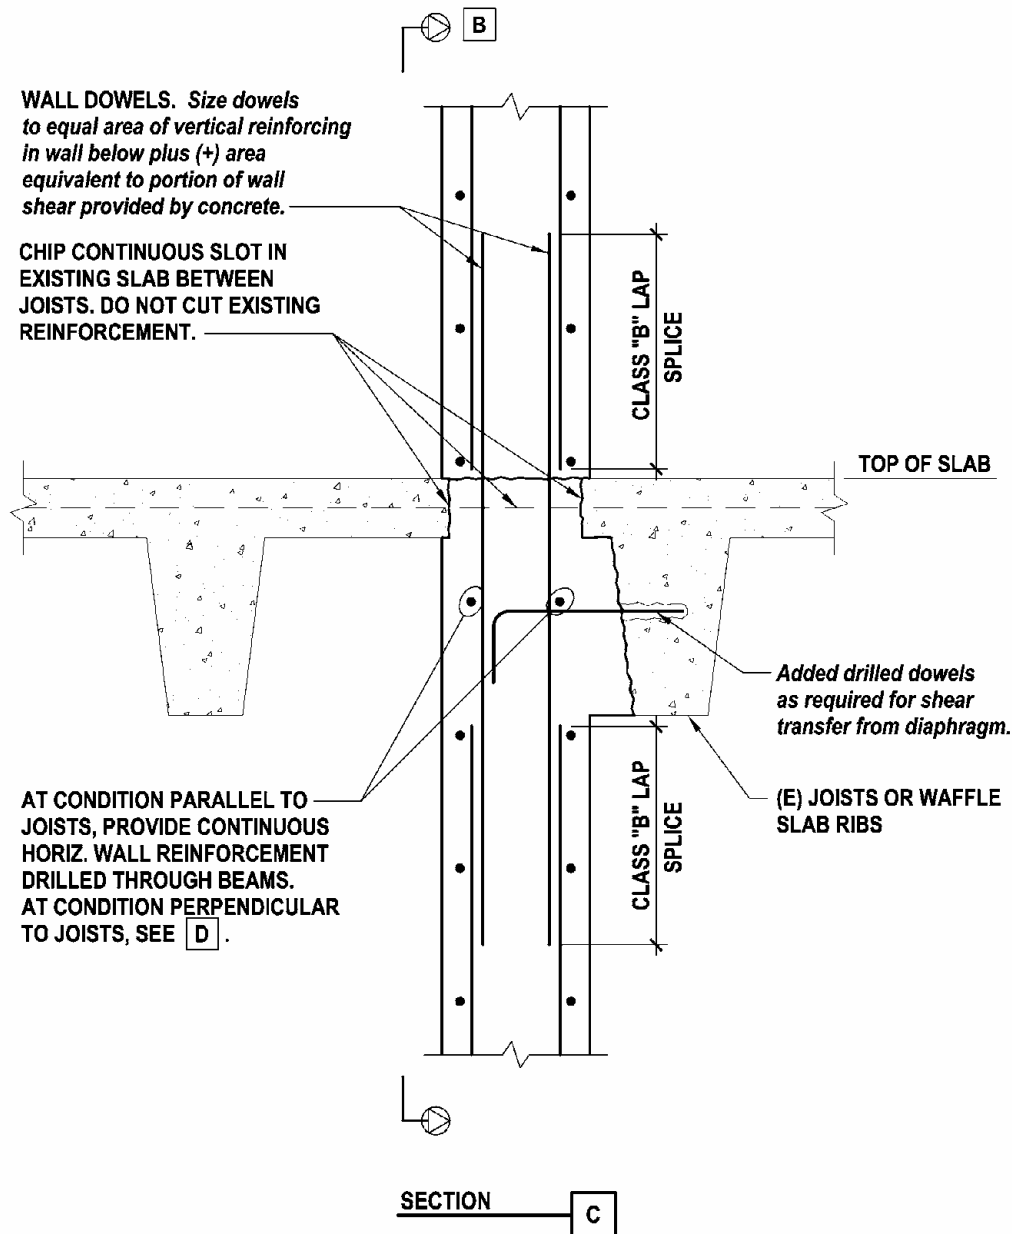
**Figure 12.4.2-1C: Connection of Concrete Wall to Concrete Joists or Waffle Slab**

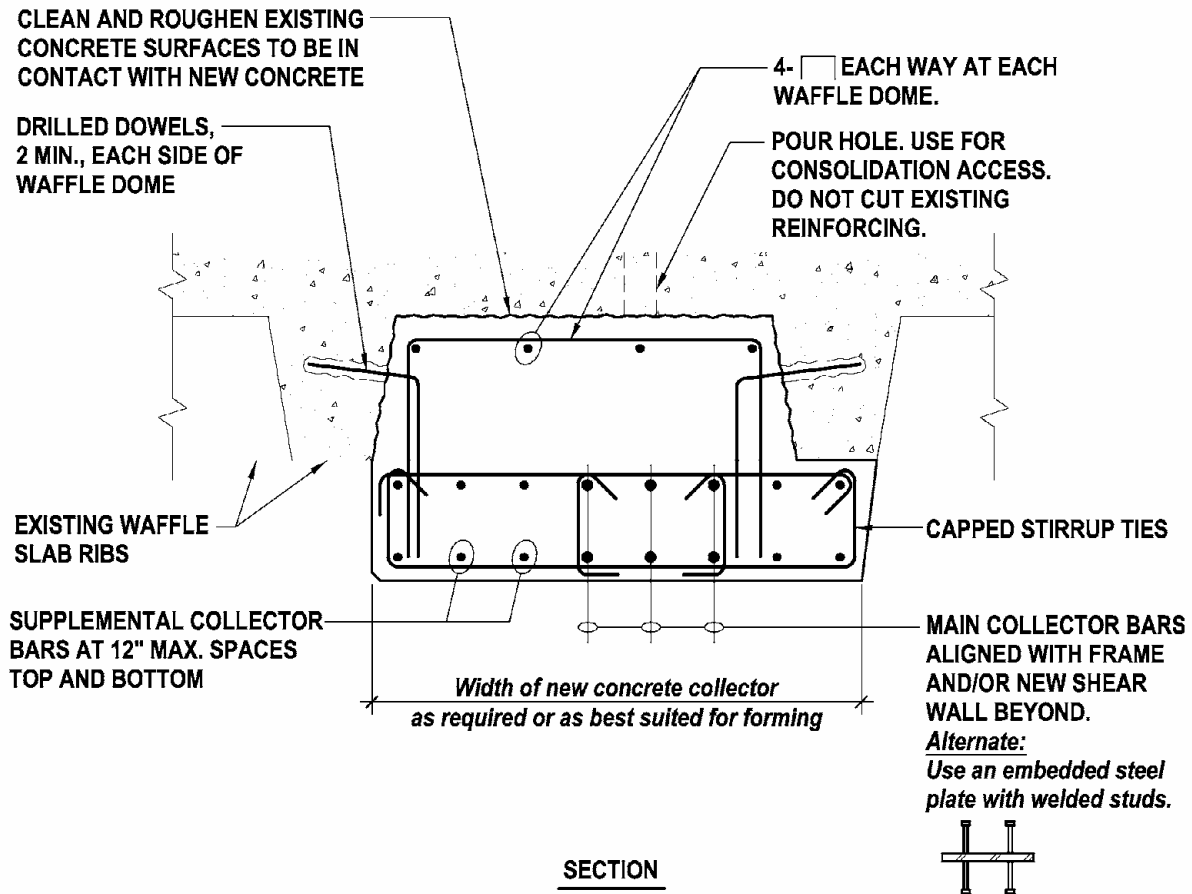
**Figure 12.4.3-2: Concrete Collector at Waffle Slab**

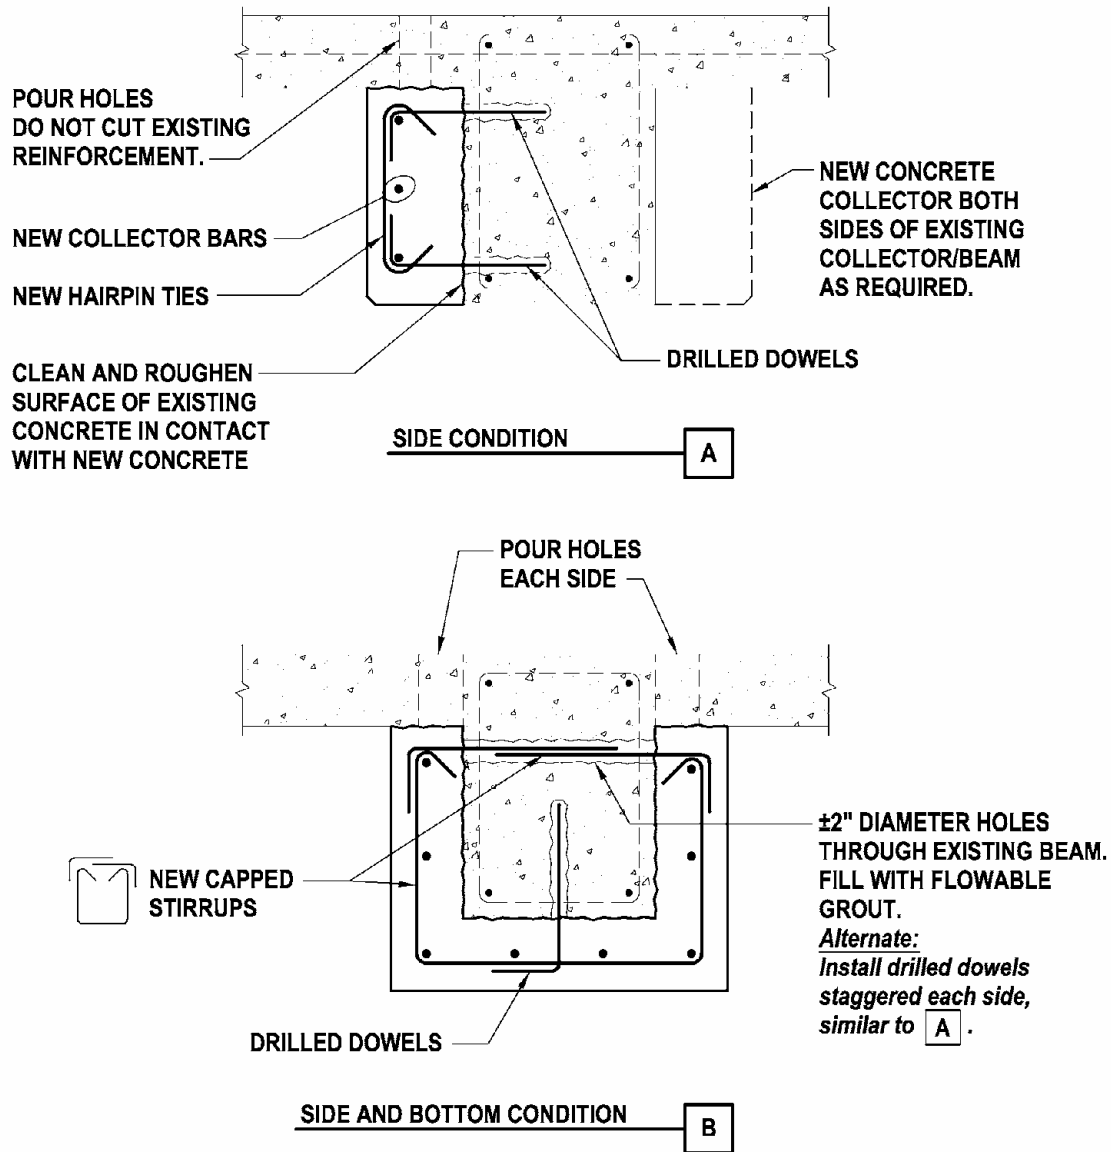
**Figure 12.4.3-3: Concrete Collector at Existing Beam**

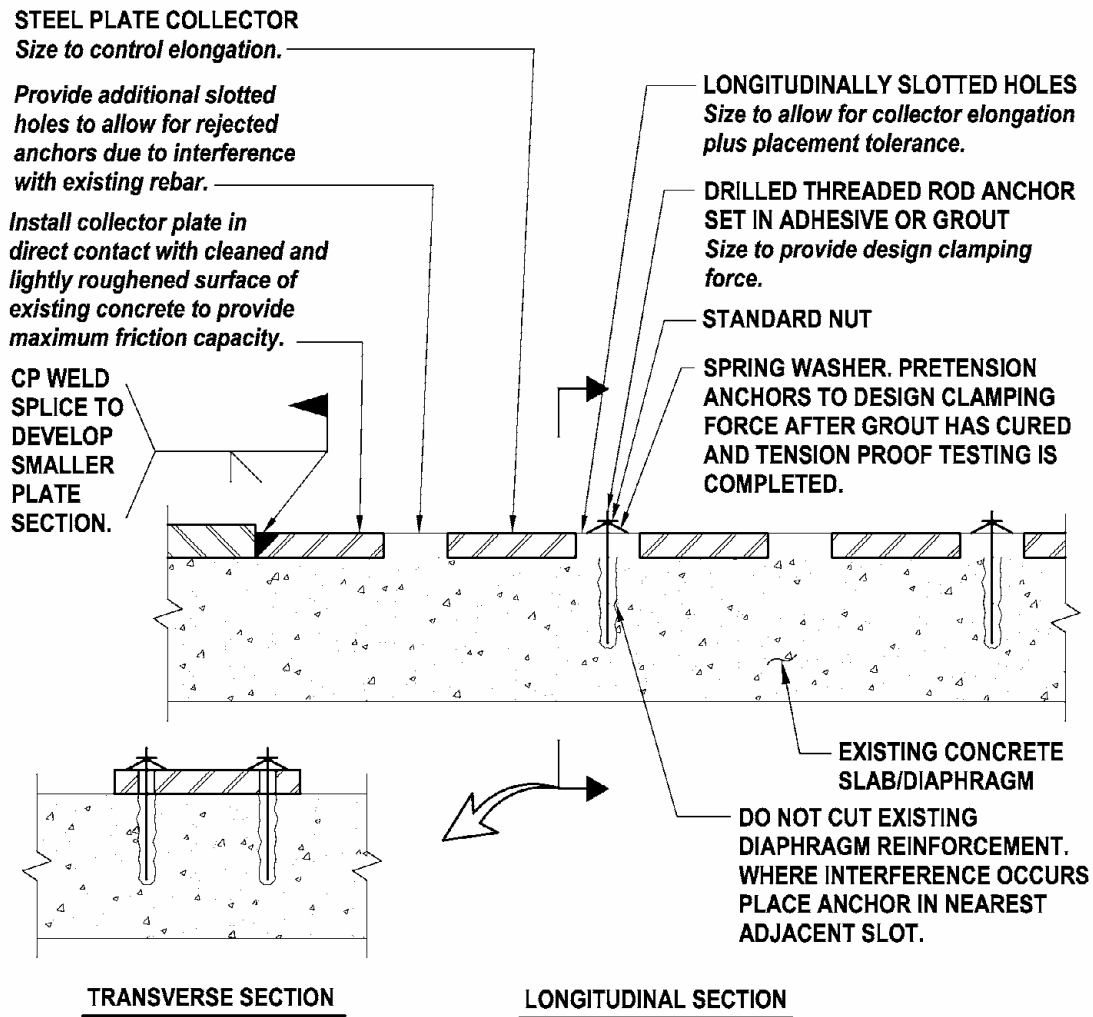
**Figure 12.4.3-4: Steel Plate Collector**

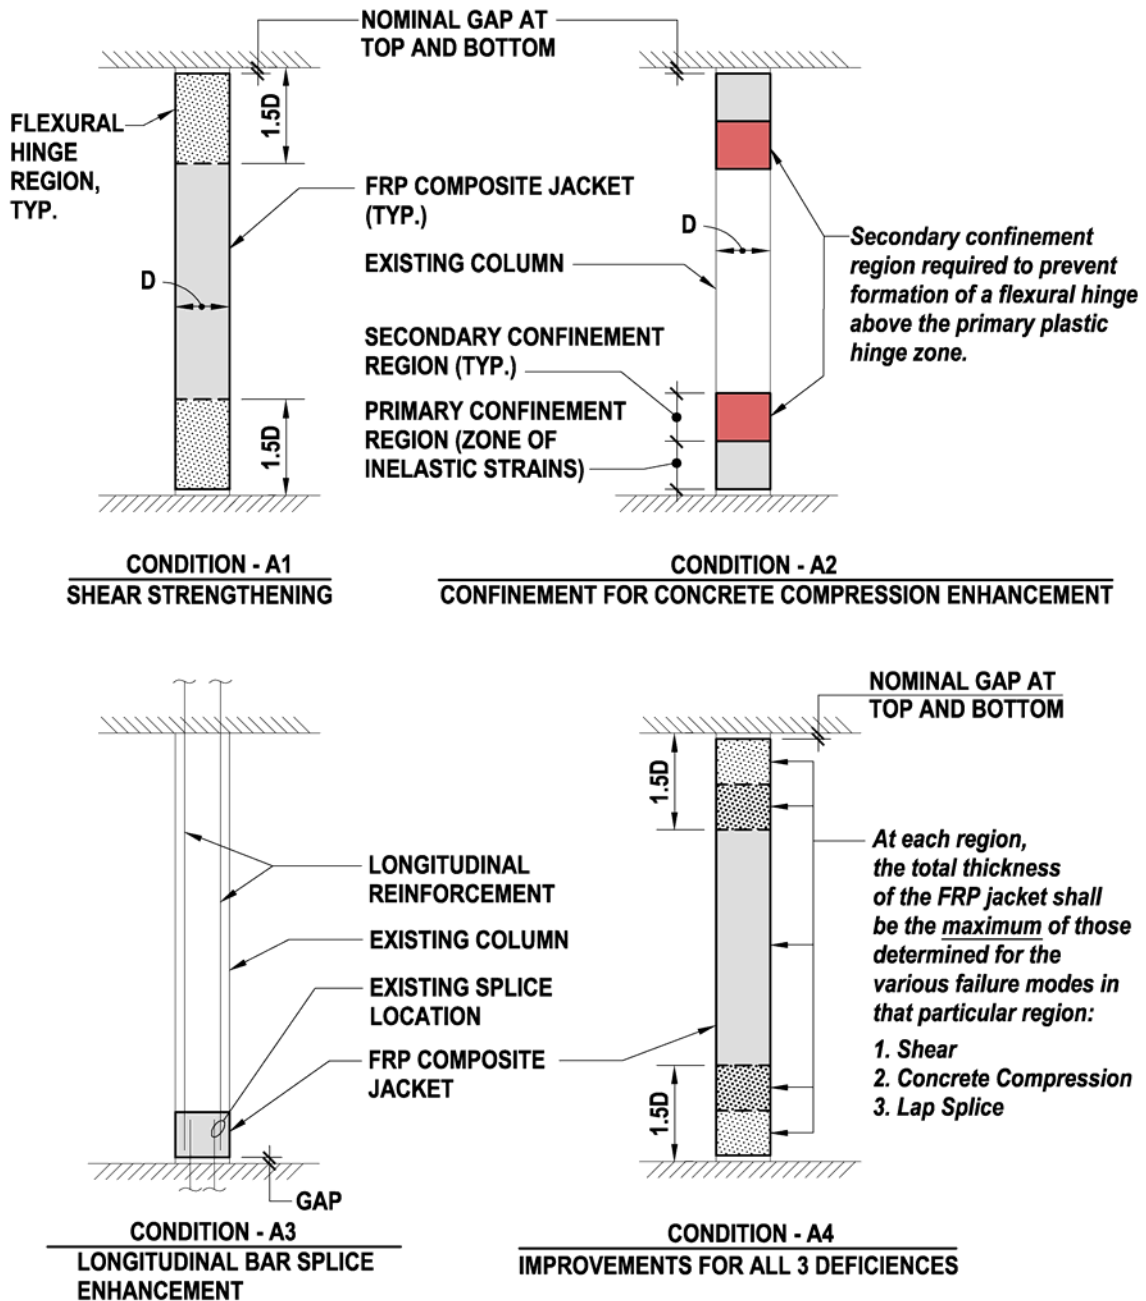
Figure 12.4.4-1A: Seismic Retrofit of Columns Using FRP Composites

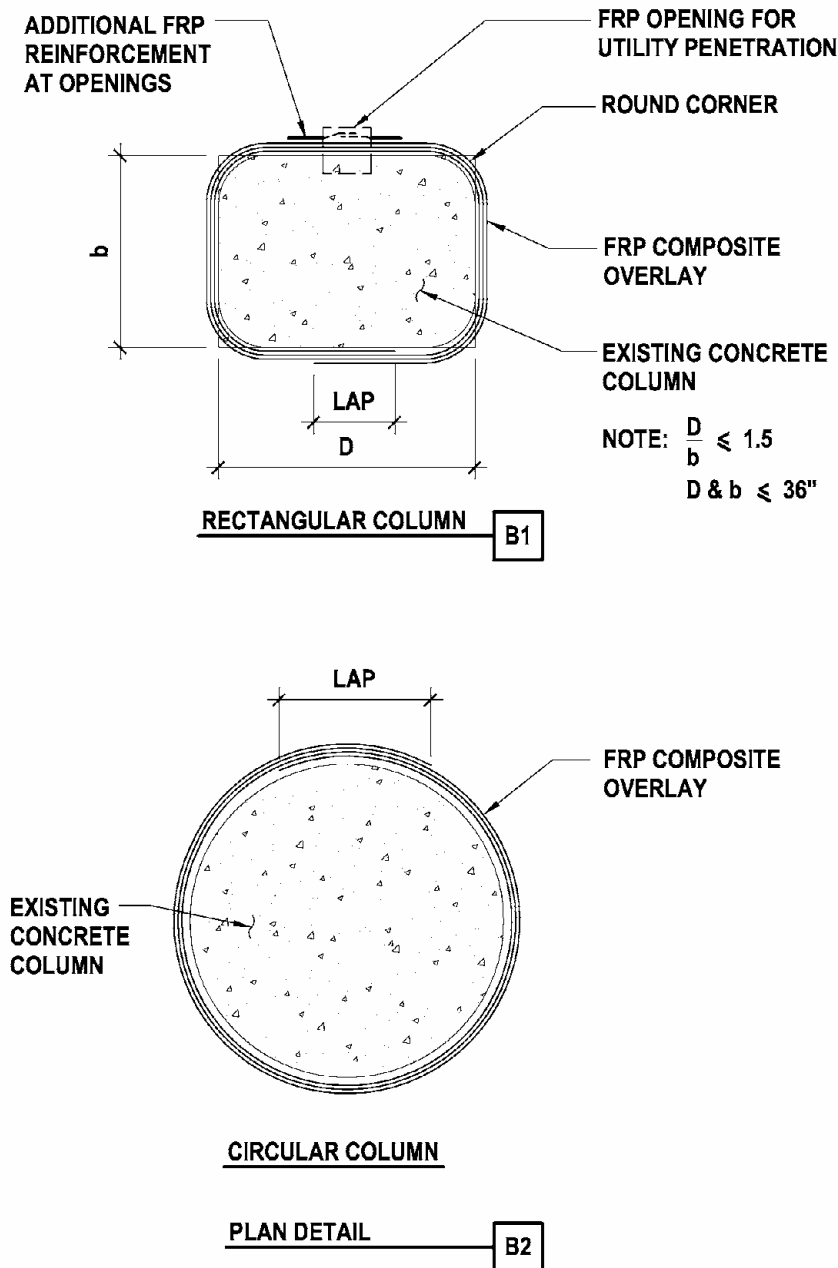
**Figure 12.4.4-1B: Seismic Retrofit of Columns Using FRP Composites**

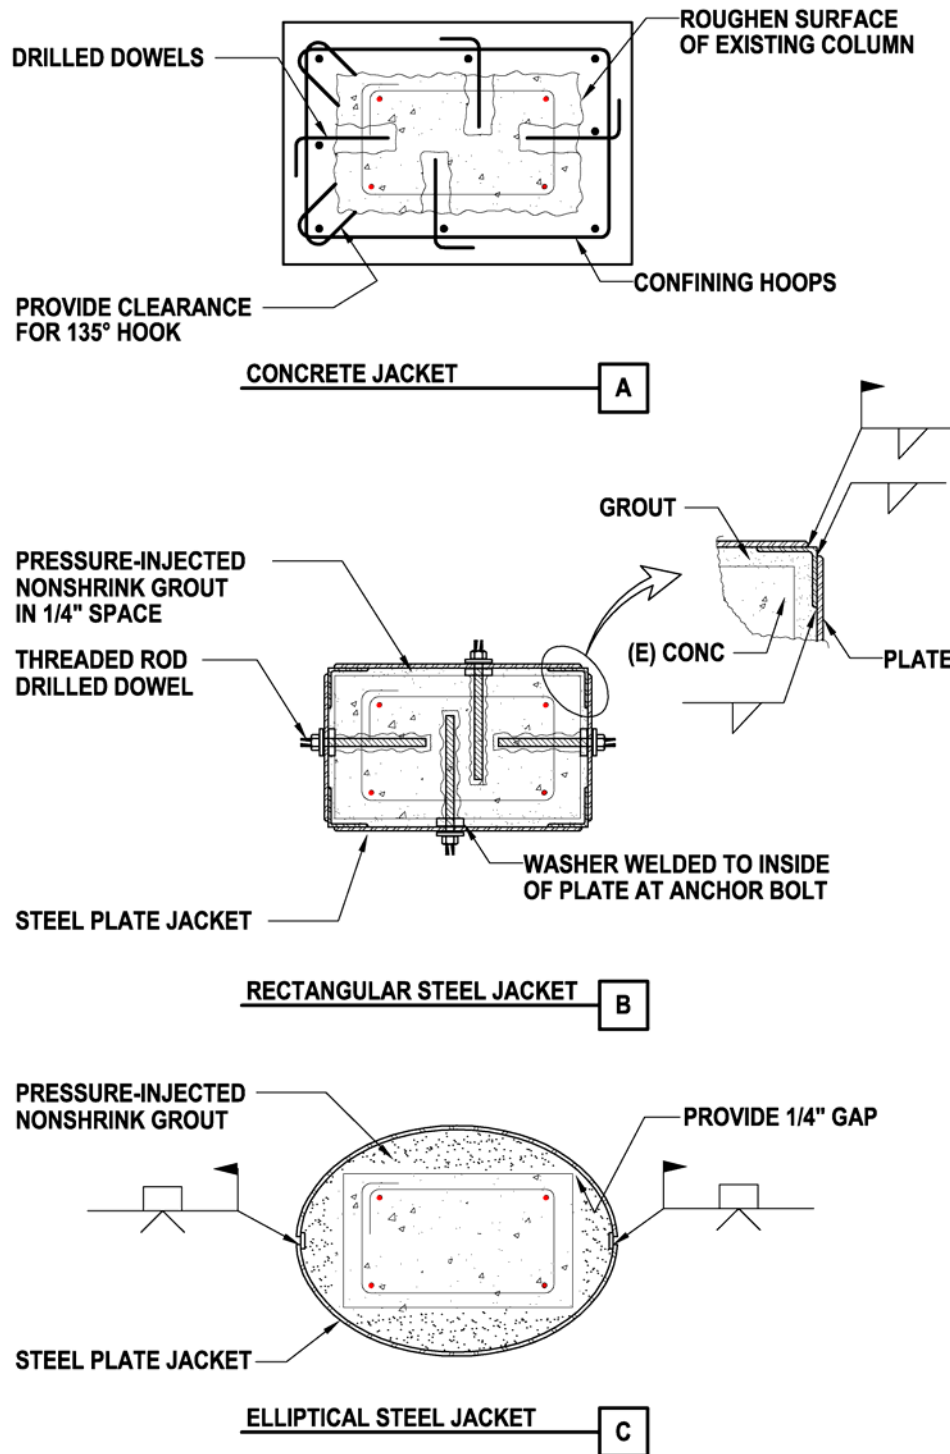
Figure 12.4.5-1: Concrete and Steel Overlays for Concrete Columns

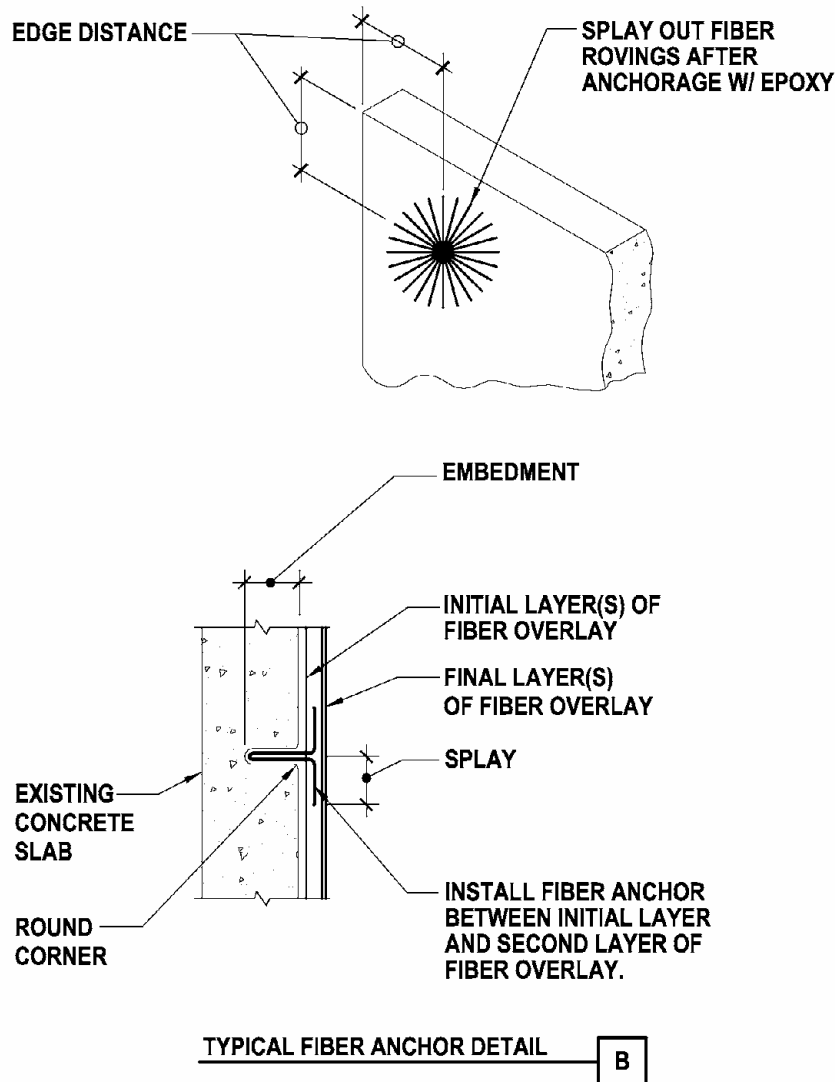
**Figure 13.4.1-1B: Fiber Anchor Details**

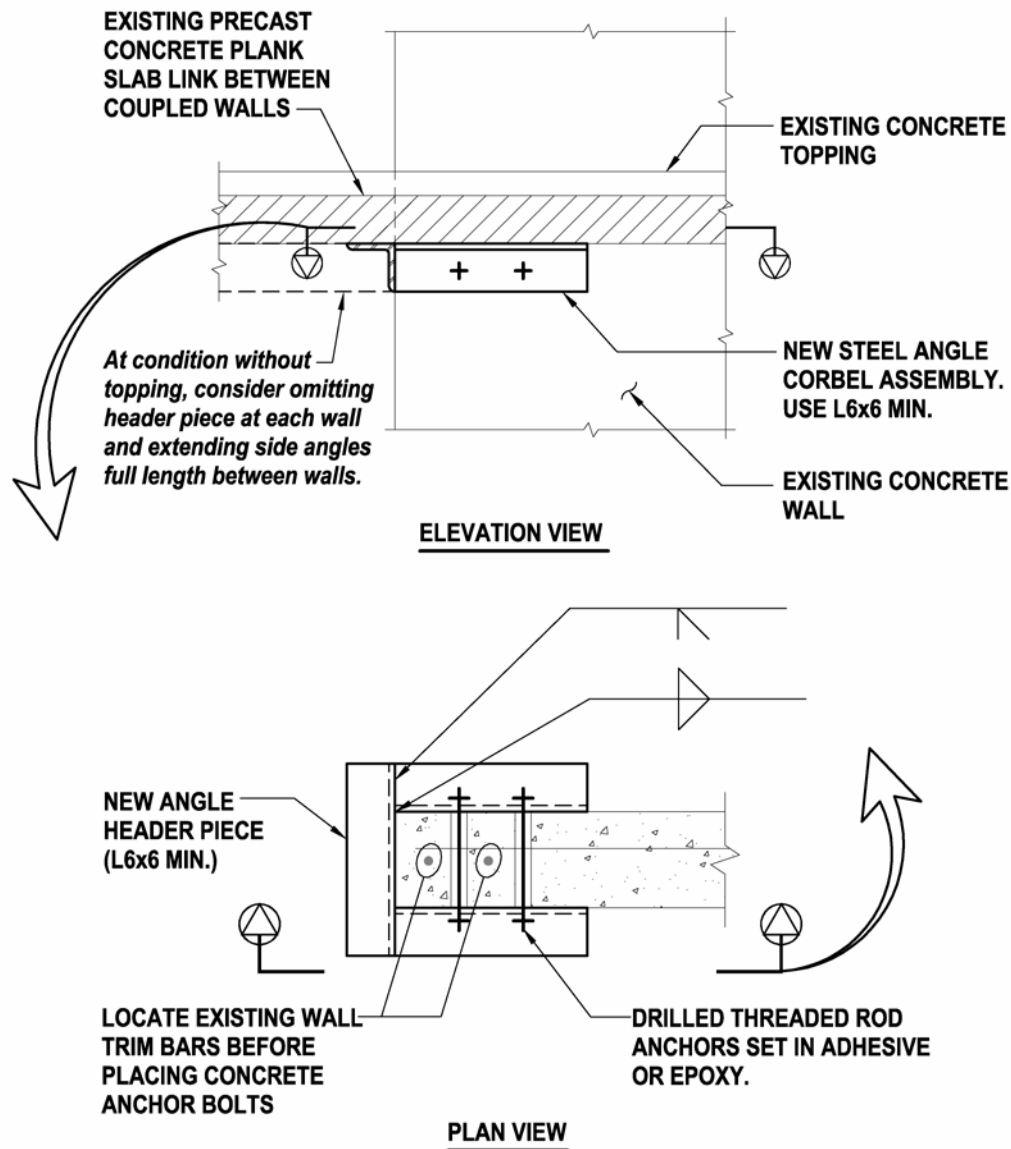
**Figure 13.4.2-1: Typical Corbel at Linking Slab**

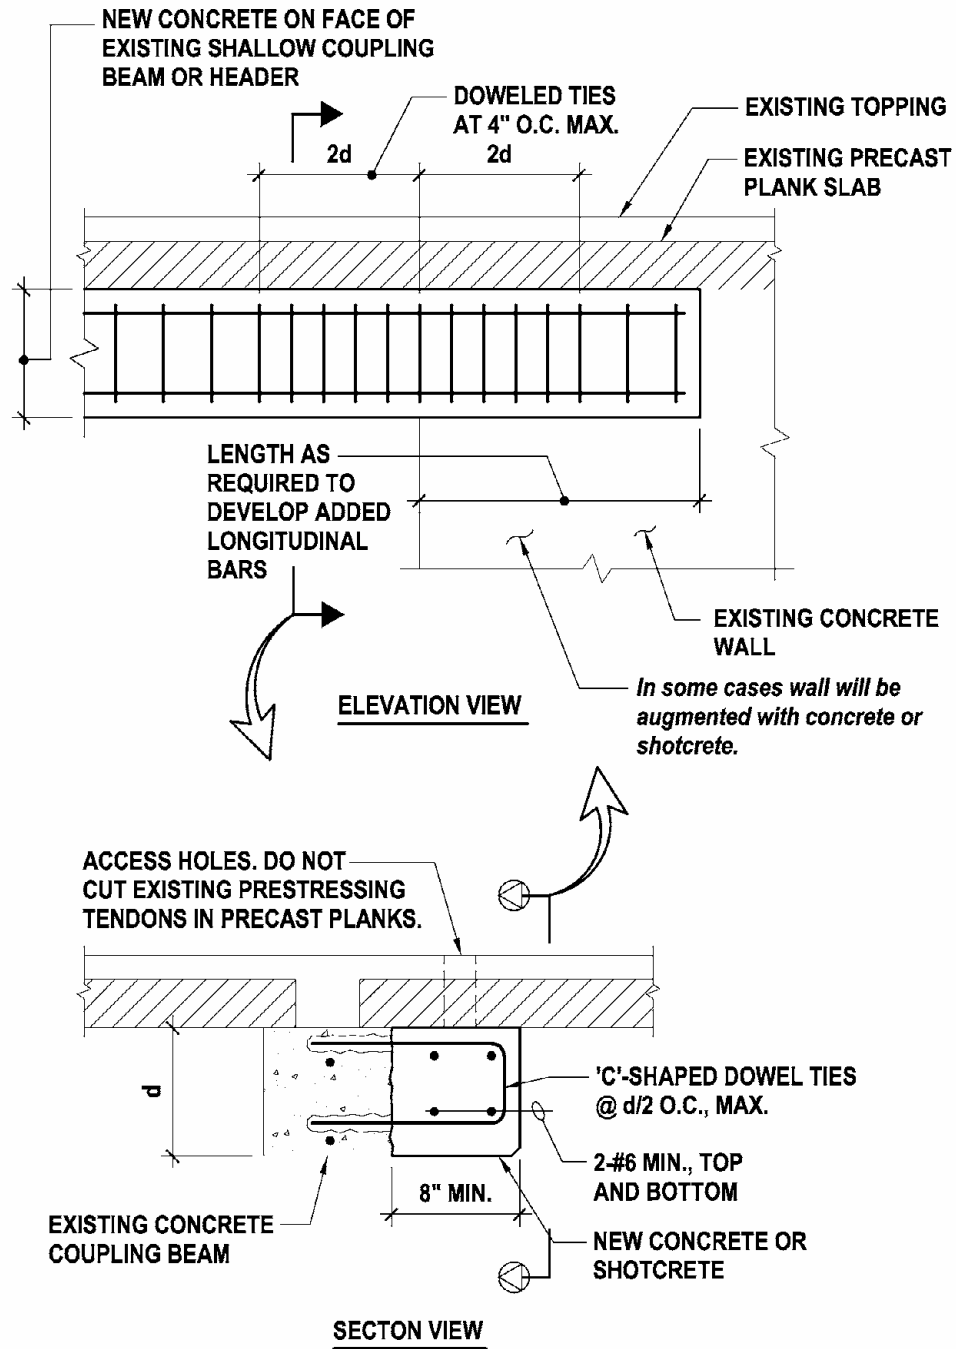
**Figure 13.4.2-2: Typical Strengthening of Shallow Coupling Beam**

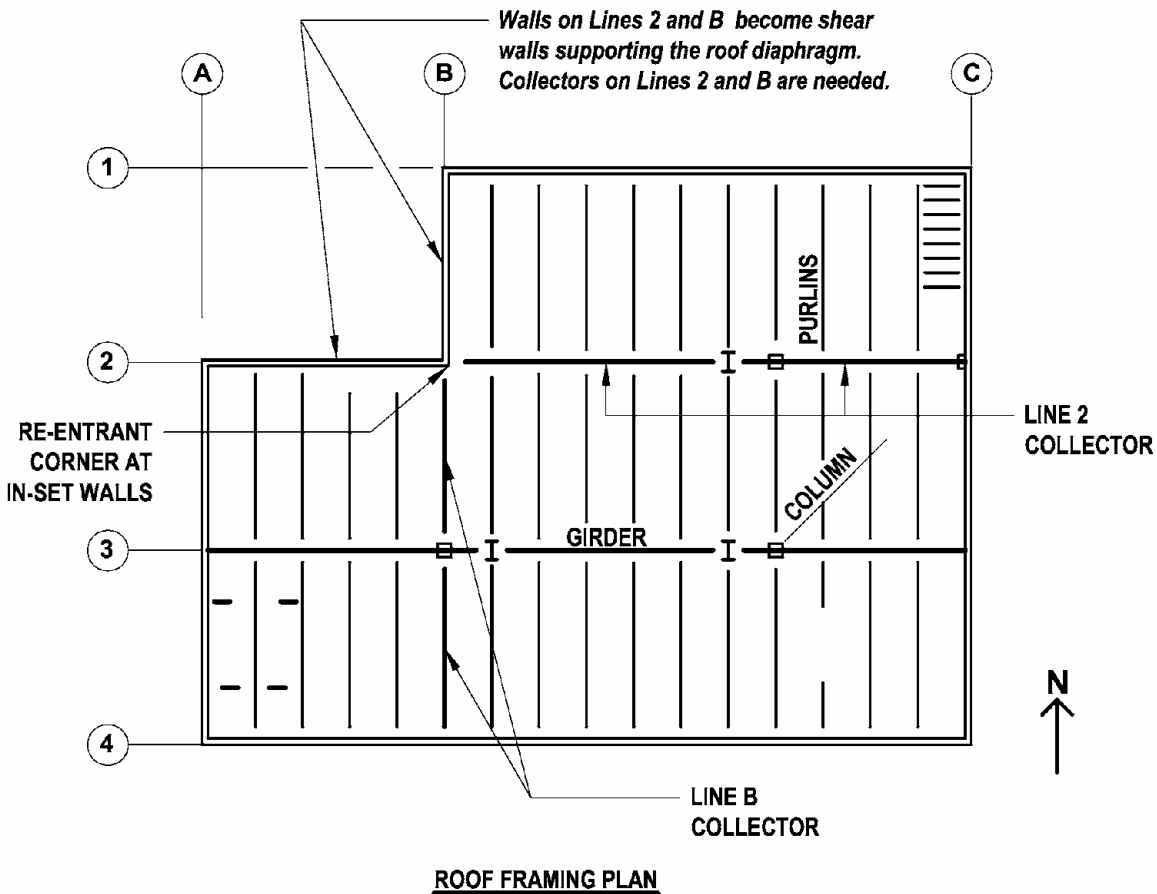
**Figure 16.3-1: Plan of PC1 Building with Re-entrant Corner at In-Set Panels**

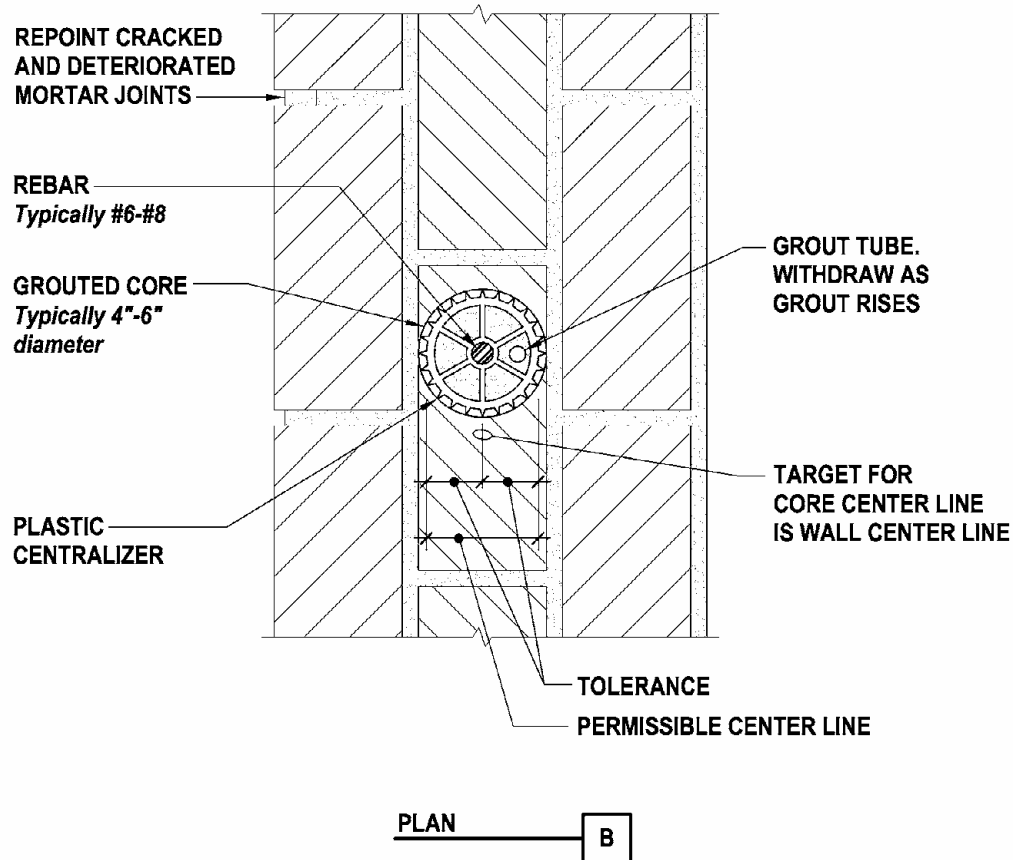
**Figure 21.4.4-1B: Plan Detail of Reinforced Core in Masonry Wall**

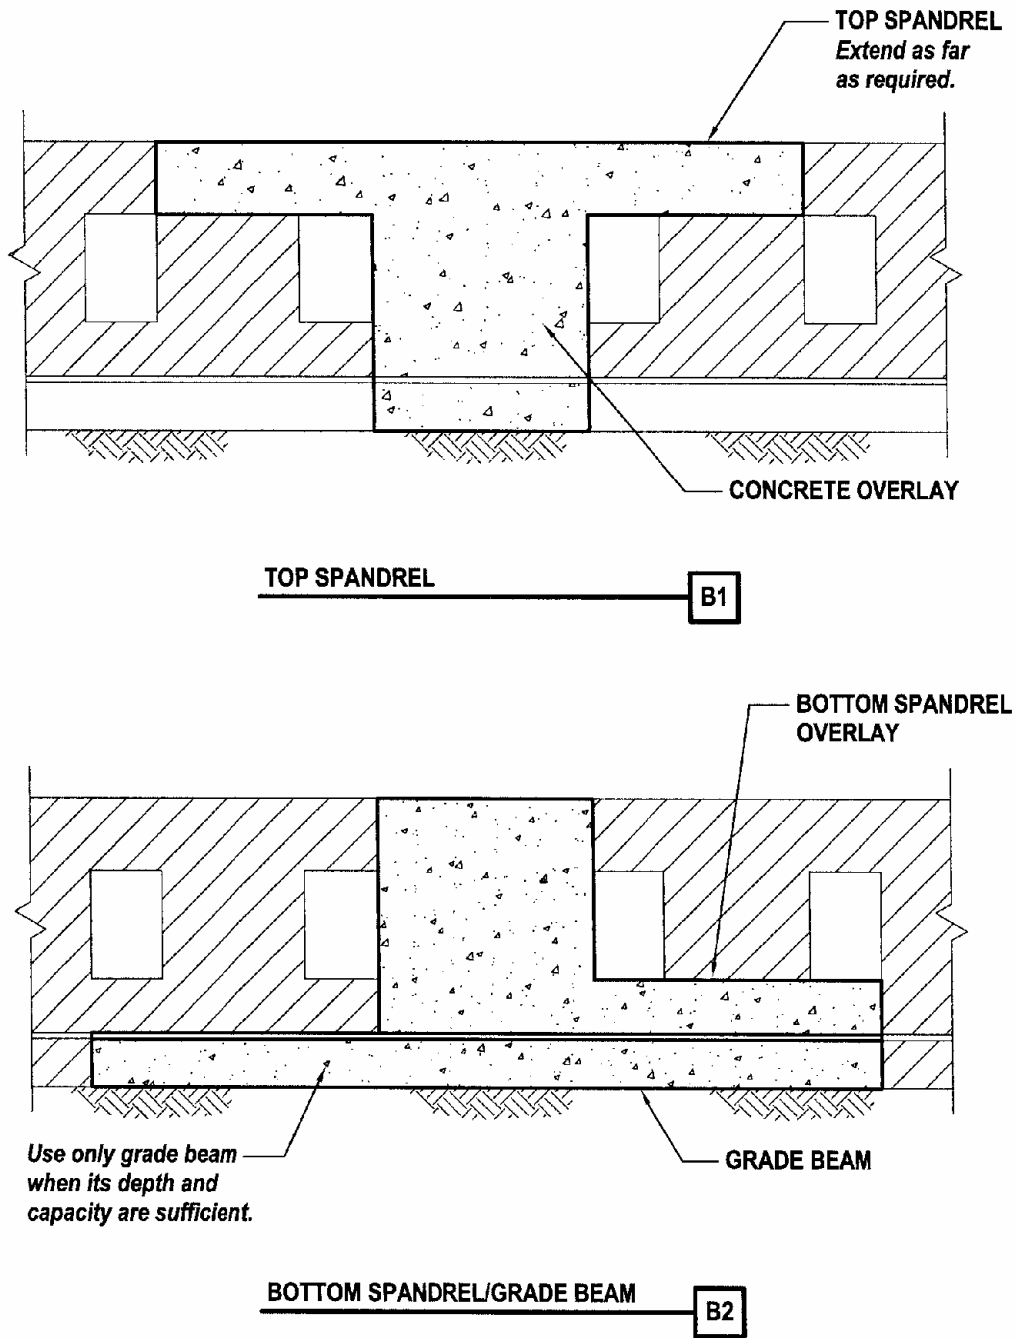
**Figure 21.4.5-2B: Alternatives to Distribute Overturning Loads in Concrete Overlay**

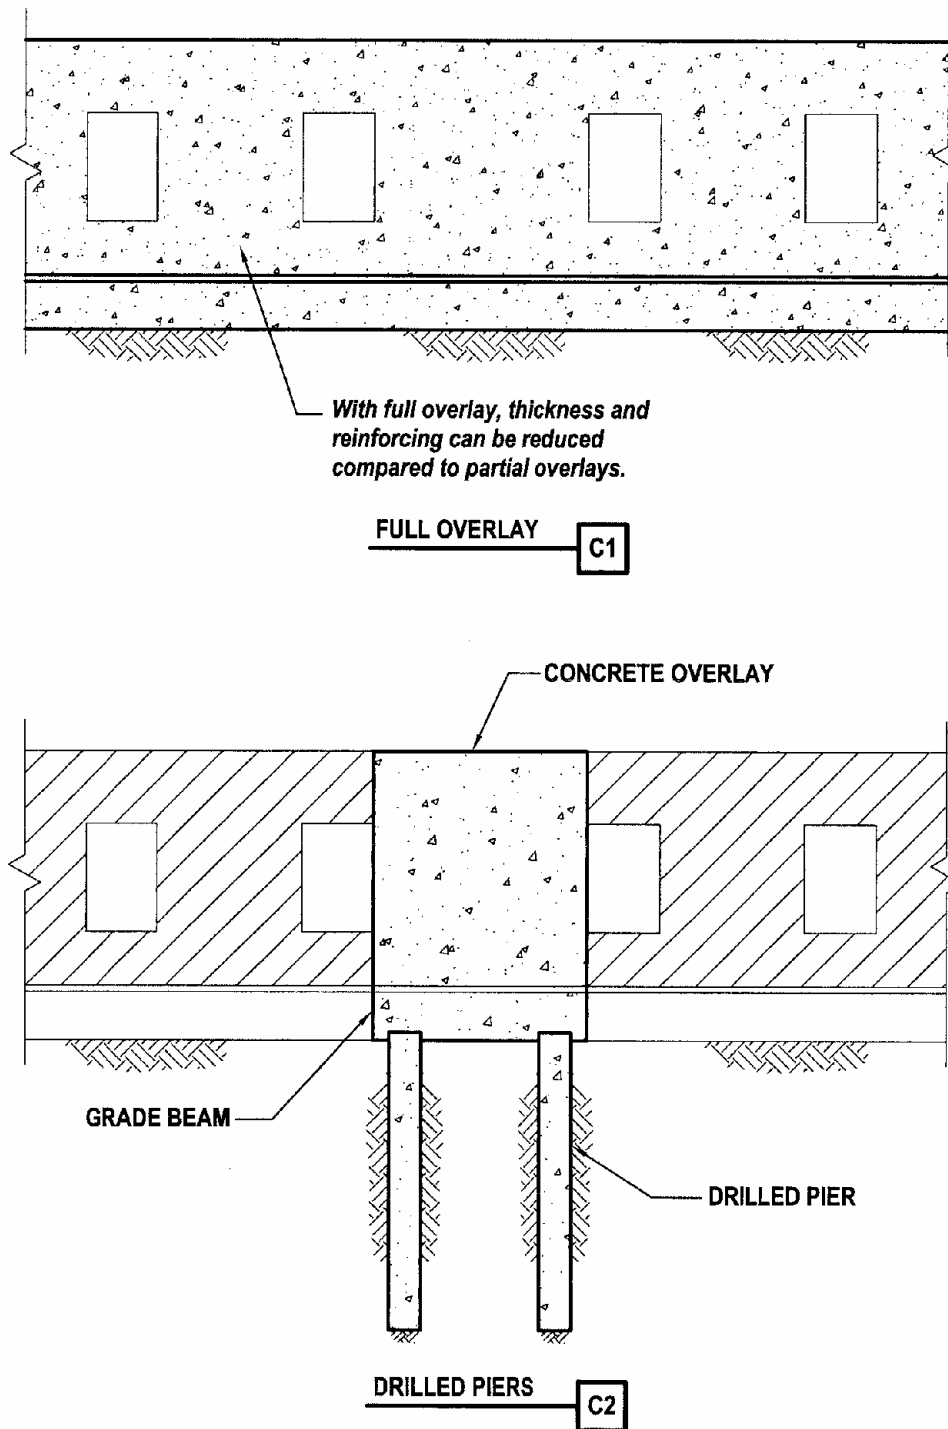
Figure 21.4.5-2C: Alternatives to Distribute Overturning Loads in Concrete Overlay

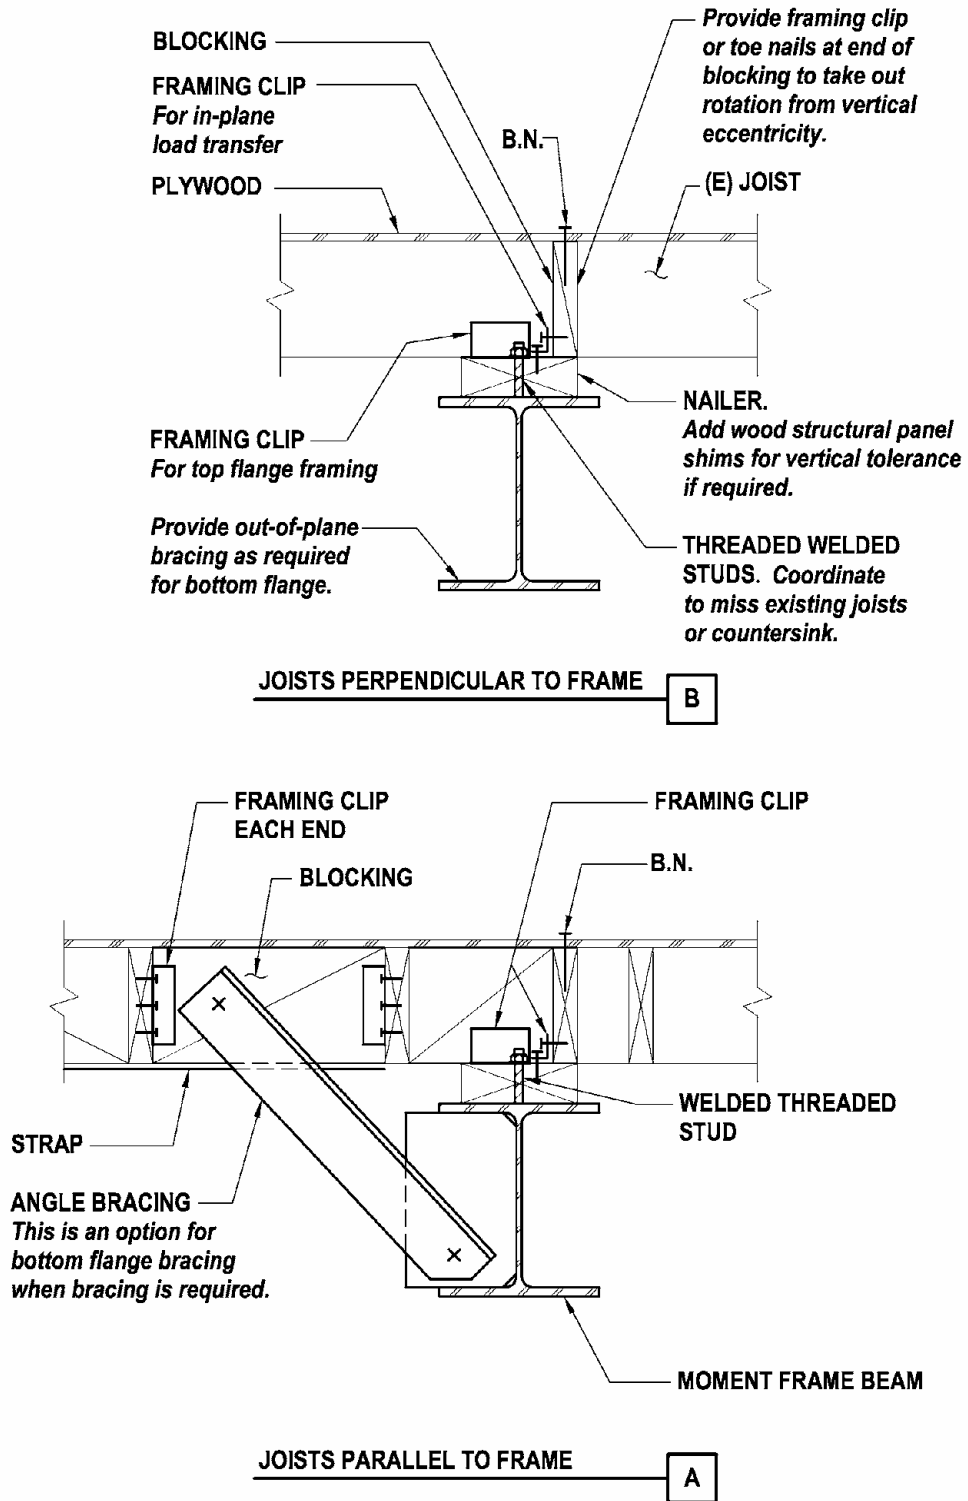
Figure 21.4.9-2: New Interior Steel Moment Frame to an Existing Wood Floor

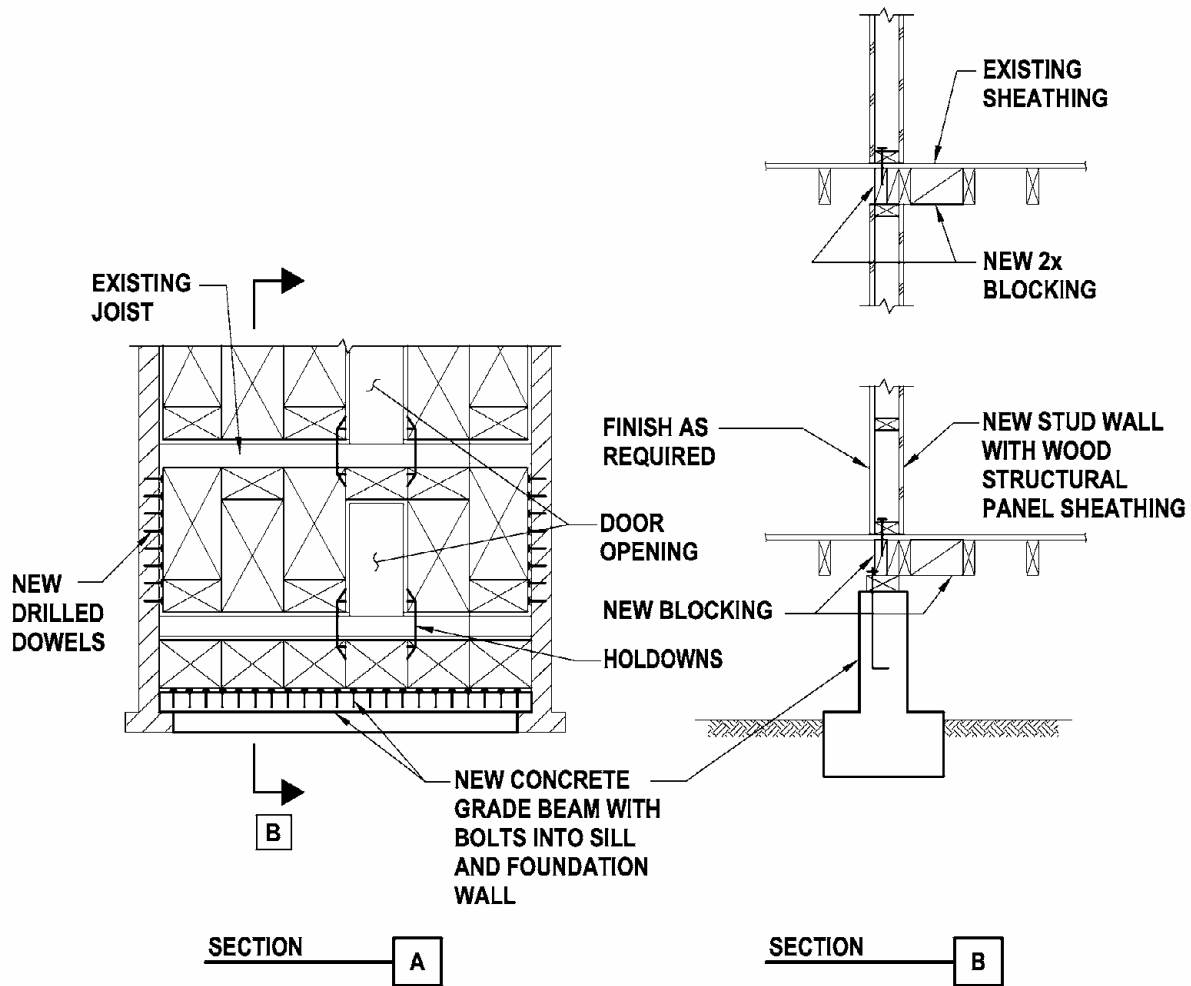
**Figure 21.4.10-2: Add New Crosswalls**

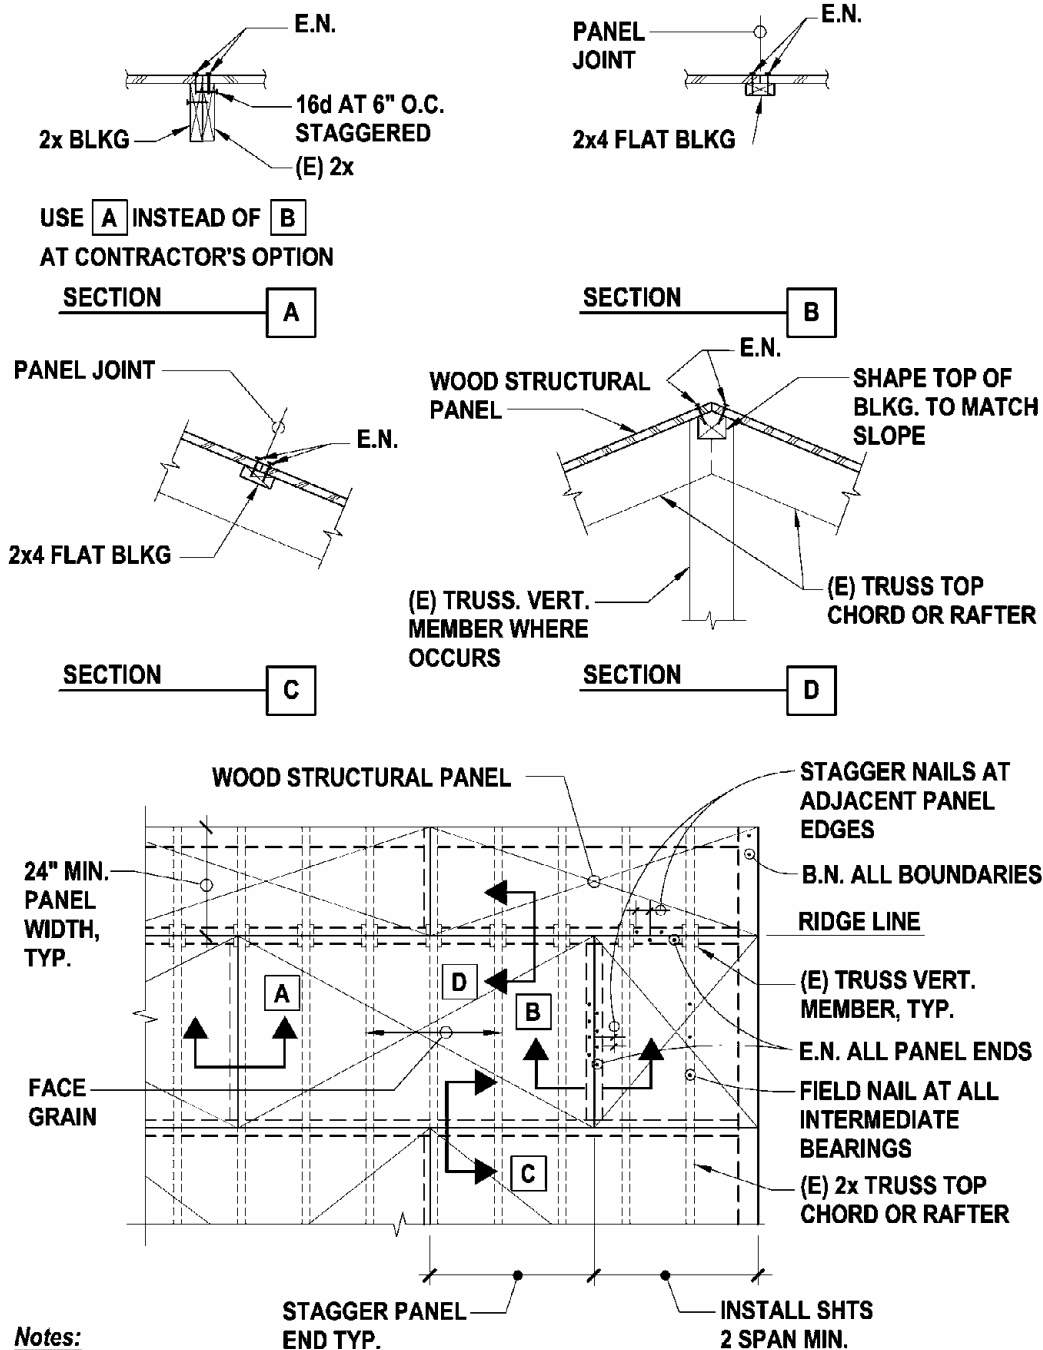
Figure 22.2.1-1: Remove and Replace Existing Wood Sheathing with Wood Structural Panel at a Roof
