# Techniques for the Seismic Rehabilitation of Existing Buildings

FEMA 547/2006 Edition

**FEMA 547 – October 2006**

Rutherford & Chekene (R & C) Consulting Engineers (Subconsultant) under contract with National Institute of Standards and Technology (NIST).

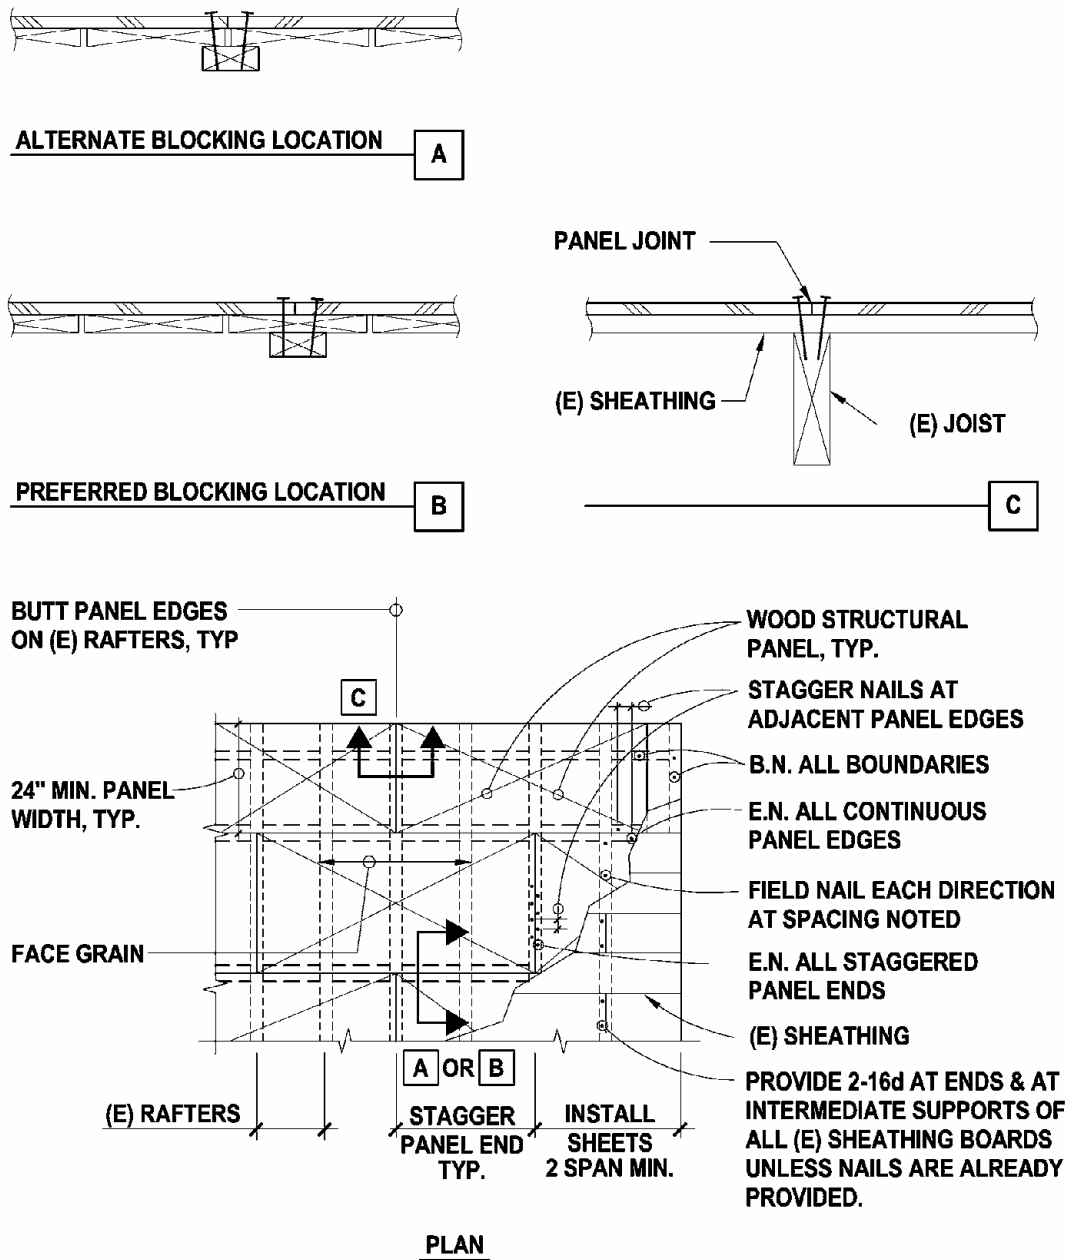
Figure 22.2.1-2: Wood Panel Overlay with Blocking Over Existing Sheathing

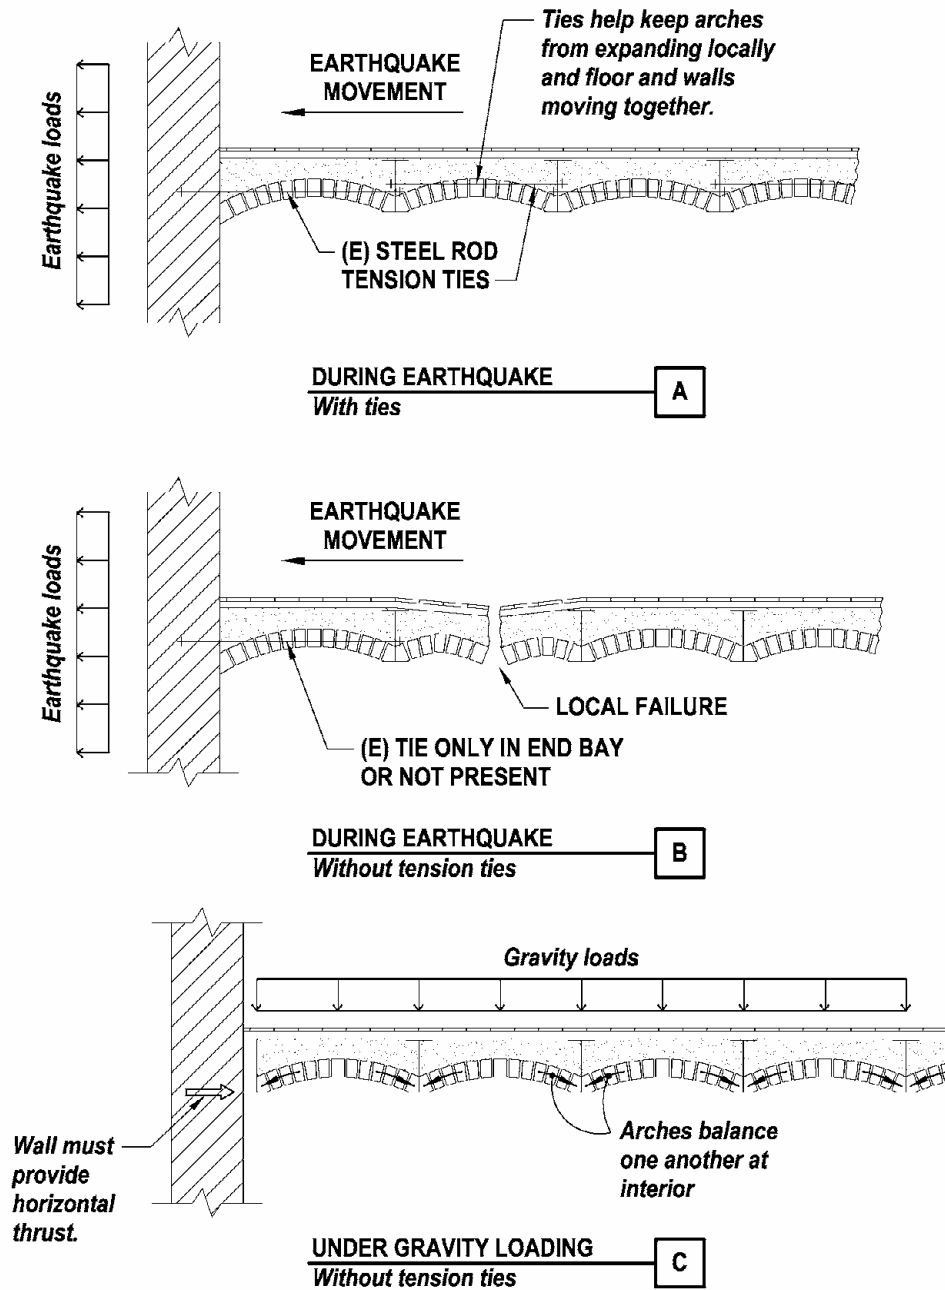
Figure 22.2.8-1: Failure Scenarios for Masonry Flat Arch Floors

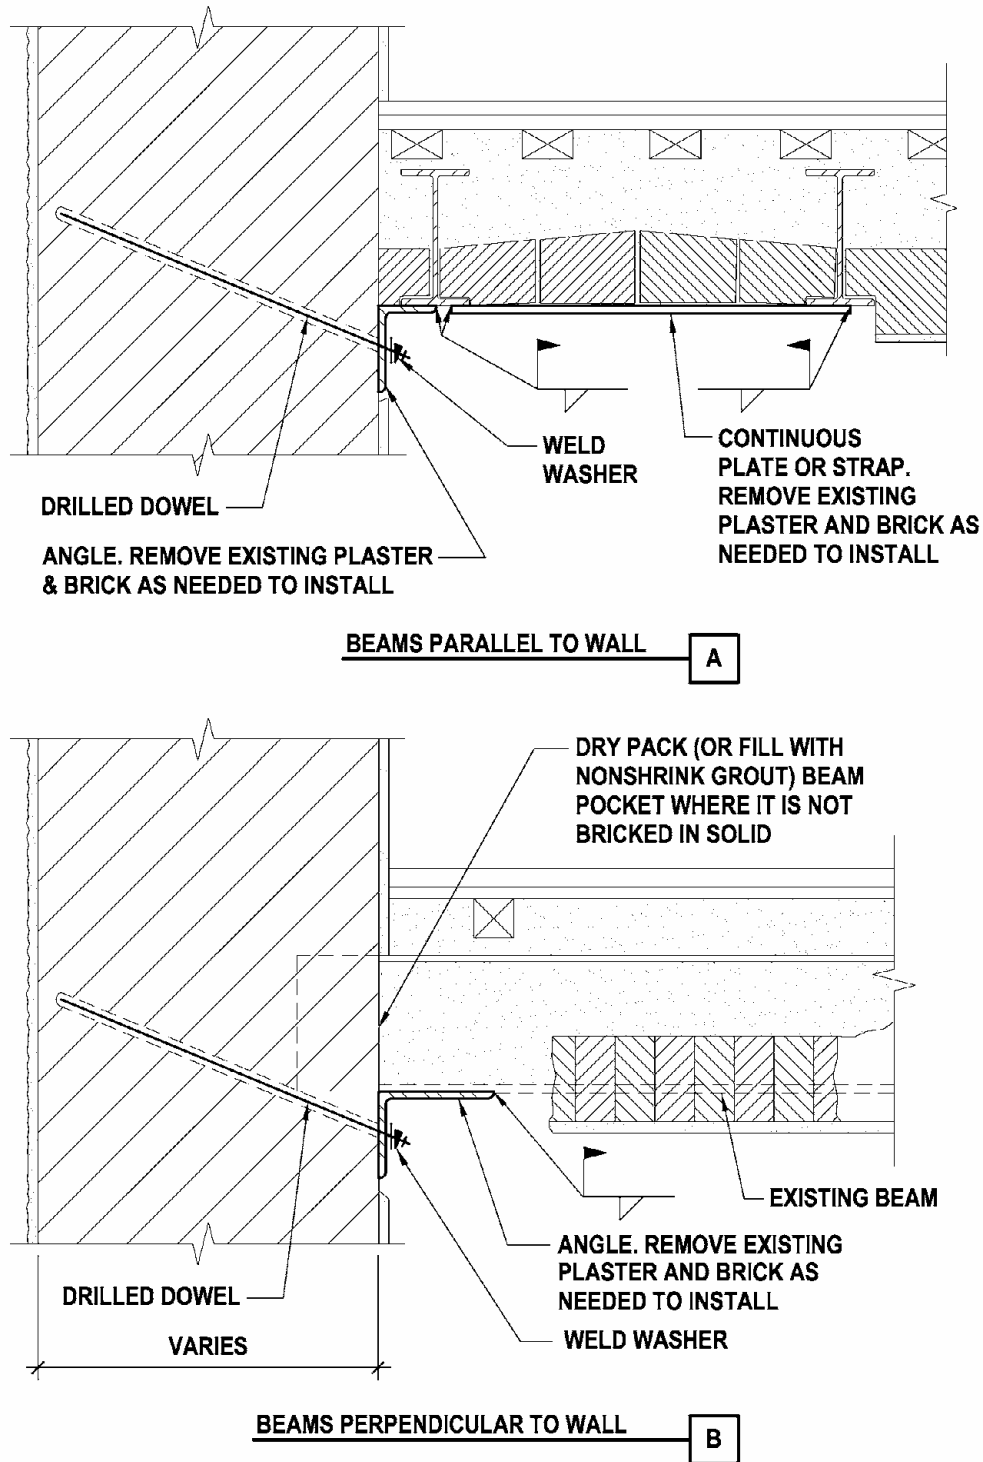
**Figure 22.2.8-2: Add Wall-to-Diaphragm Ties and Chord for Masonry Flat Arch Floor - Access from Below the Floor**

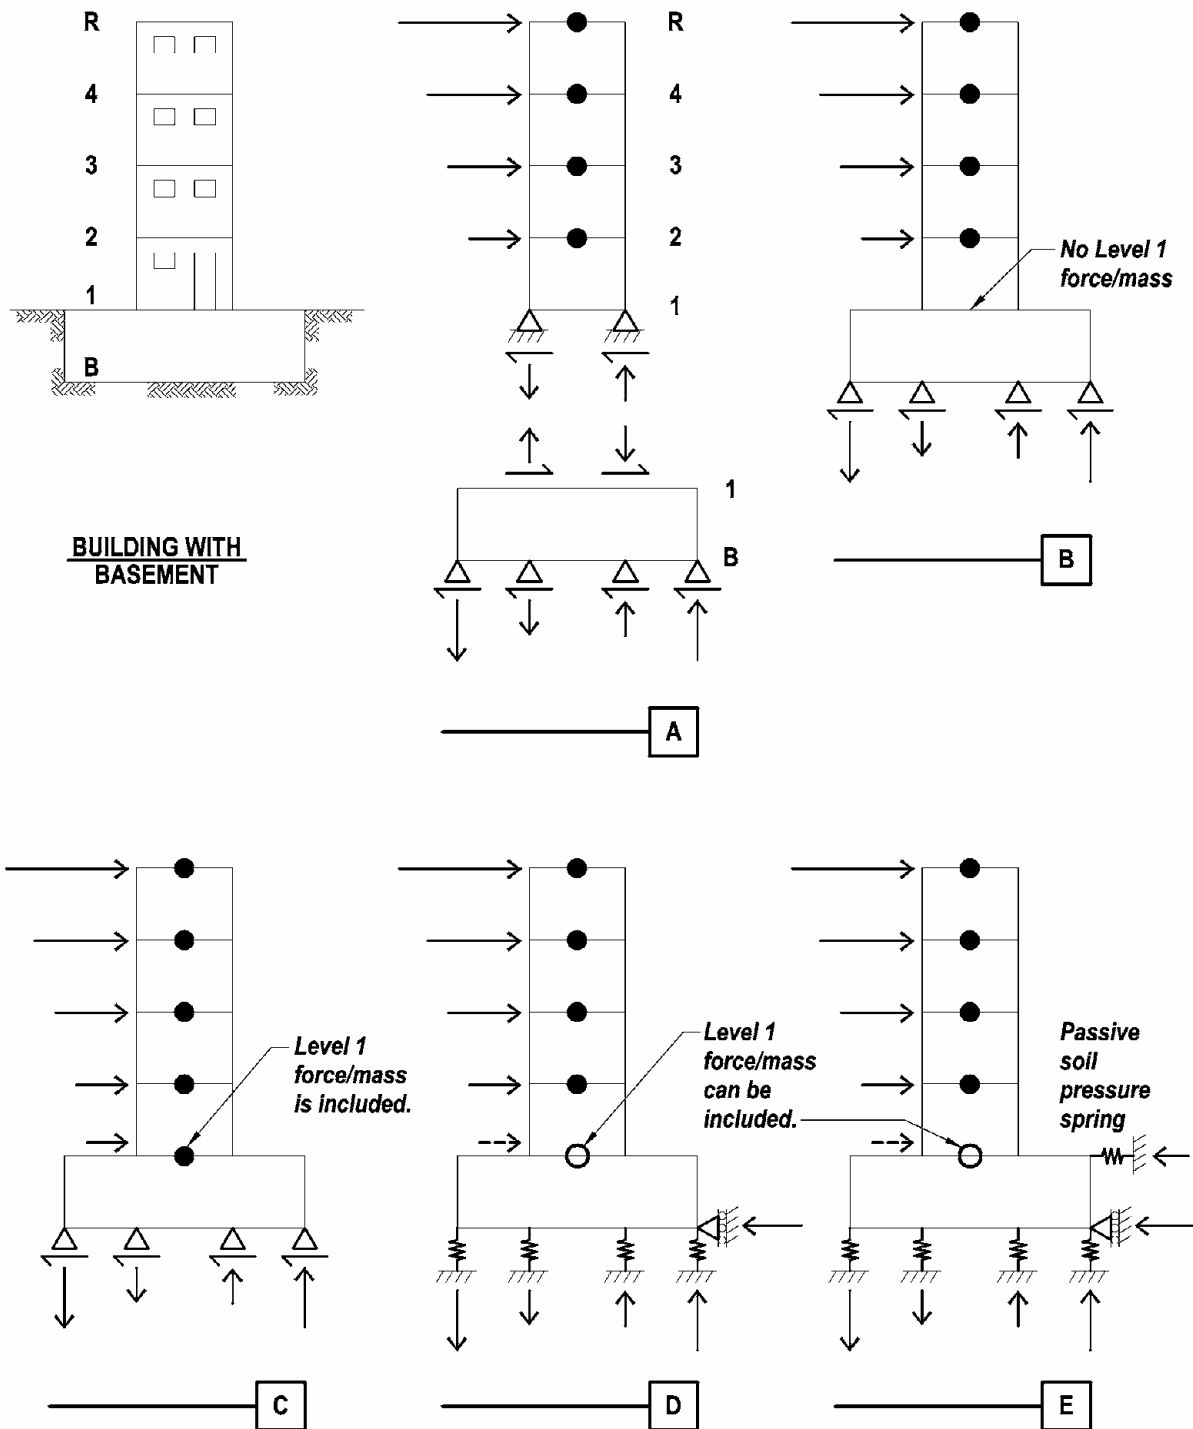
Figure 23.4-1: Modeling Approaches for Buildings with Basements

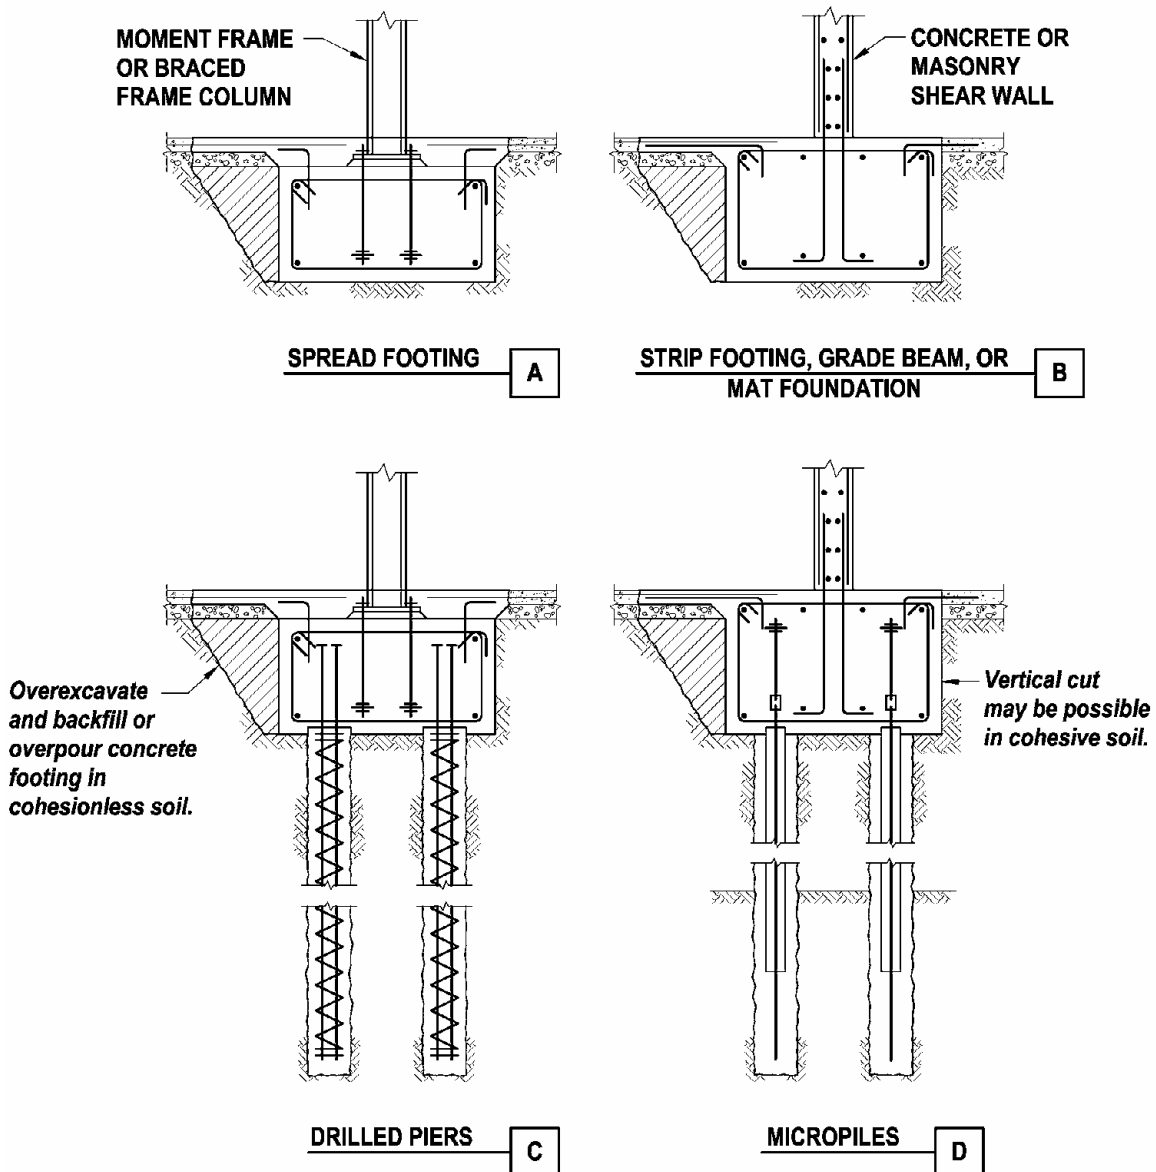
Figure 23.6.1-1: Types of New Foundations Commonly Used in Seismic Rehabilitation

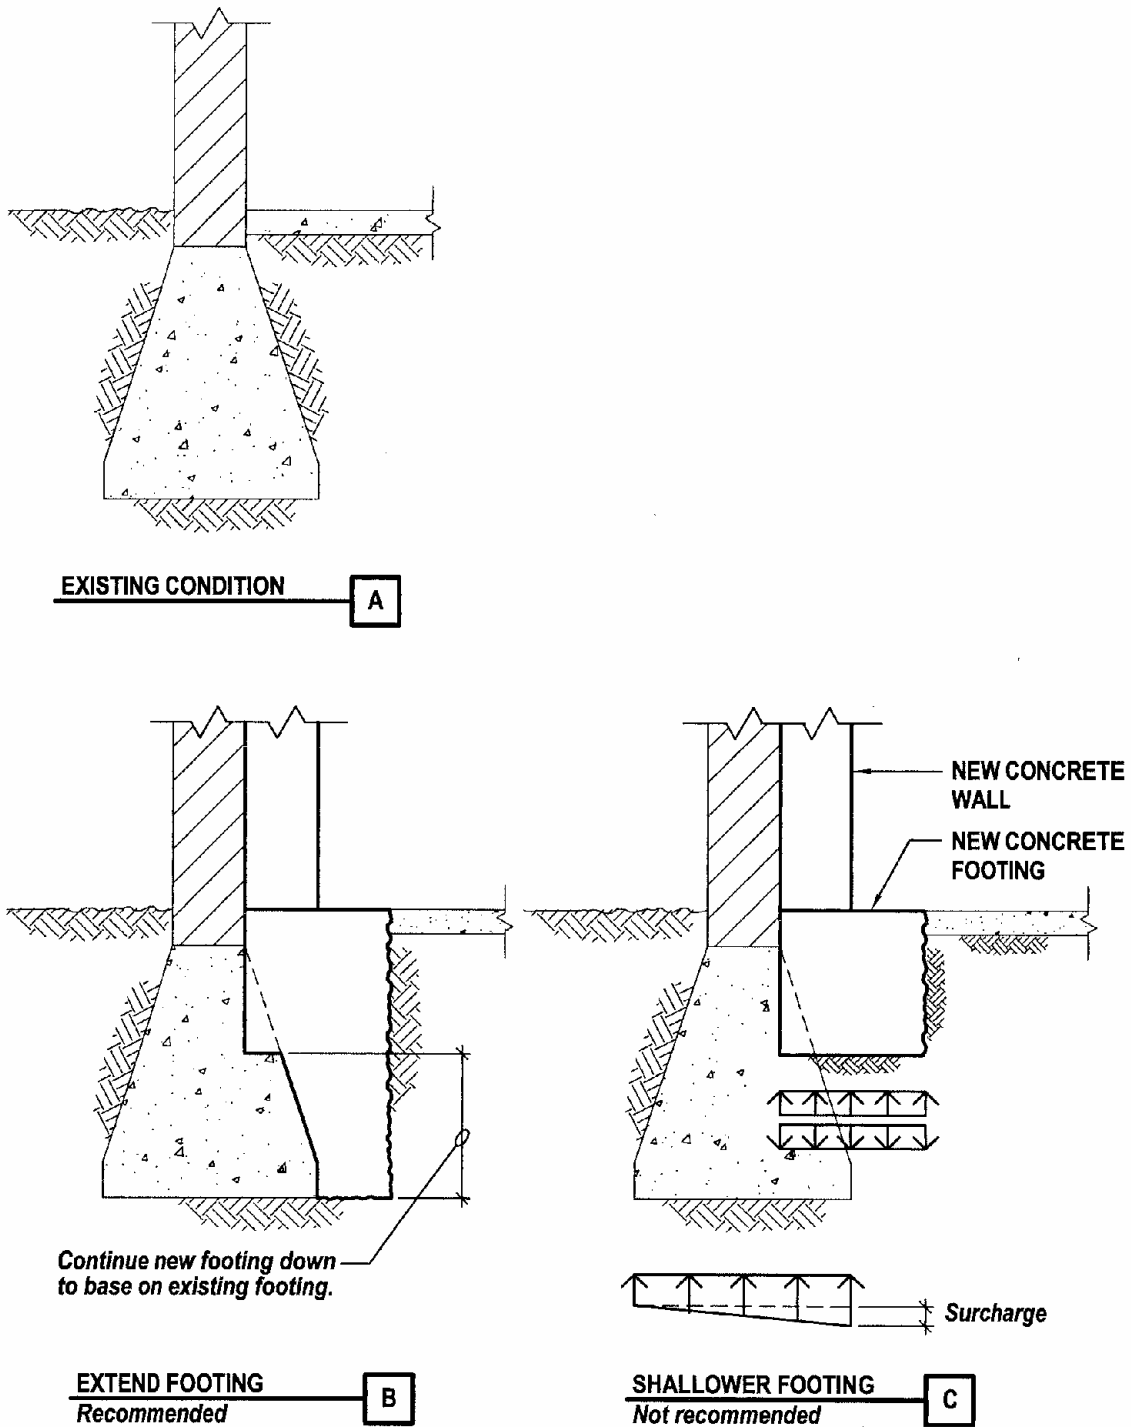
**Figure 23.6.2-3: New Shallow Footing Does Not Need to be as Deep as Existing Shallow Footing**

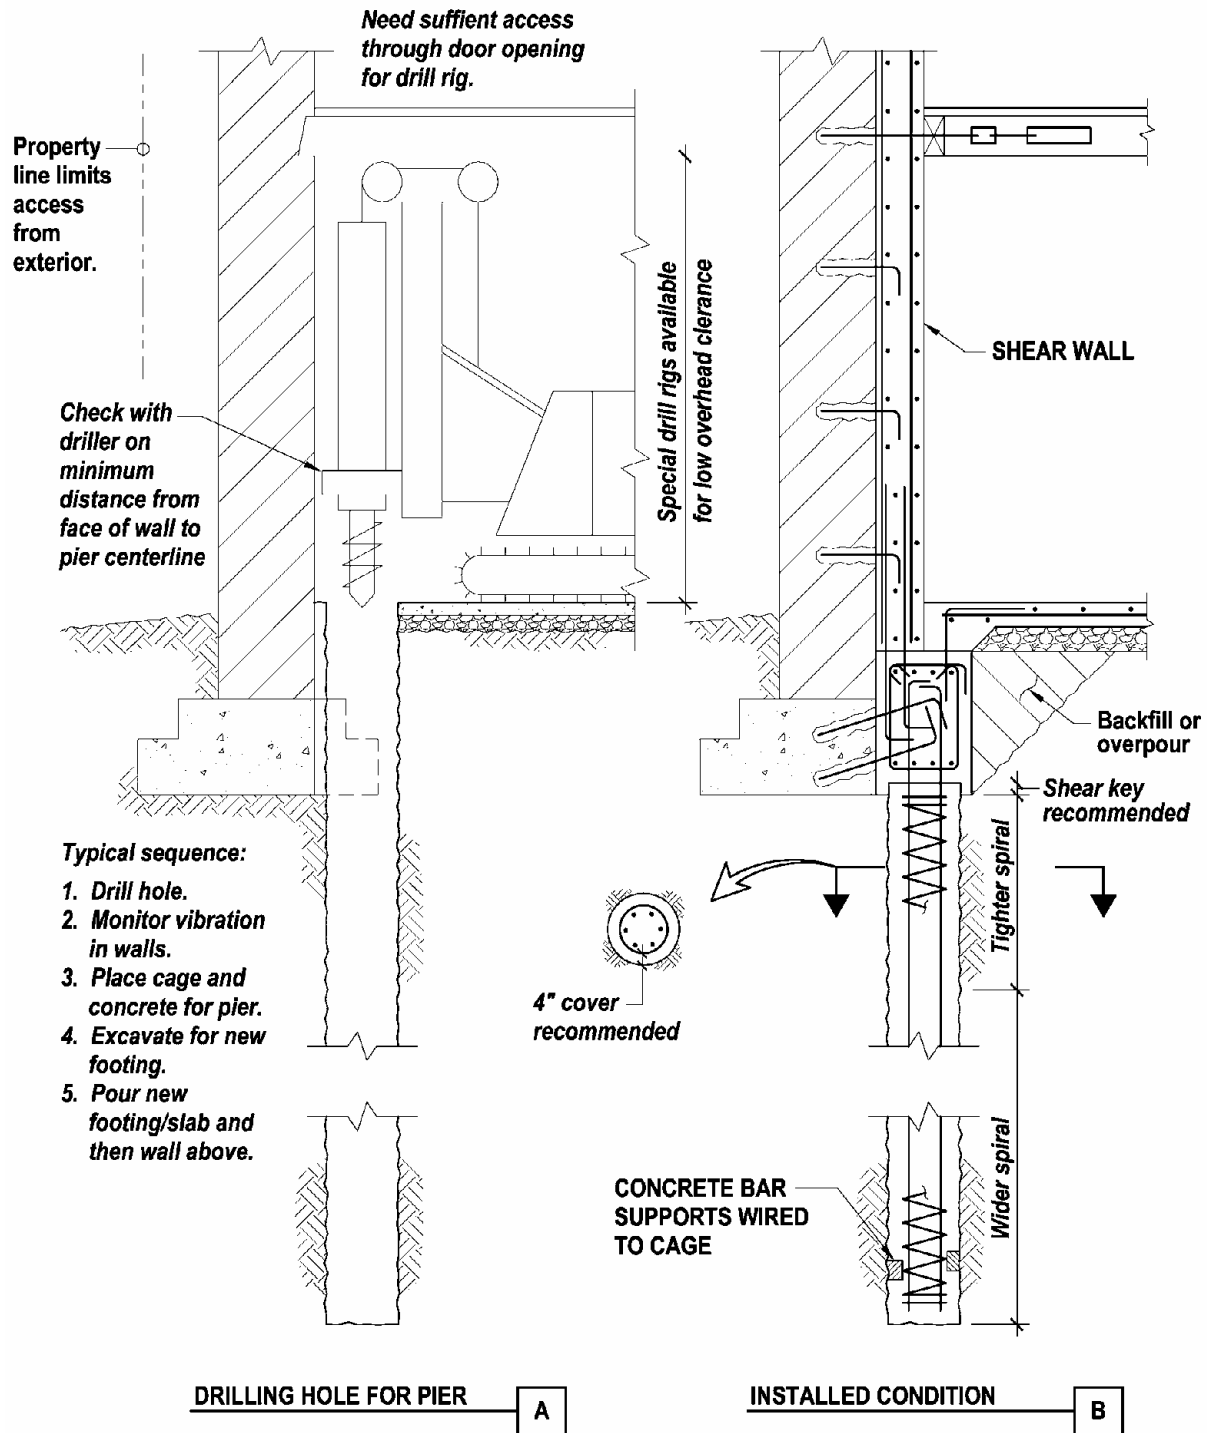
Figure 23.6.4-1: New Drilled Pier Next to Existing Strip Foundation

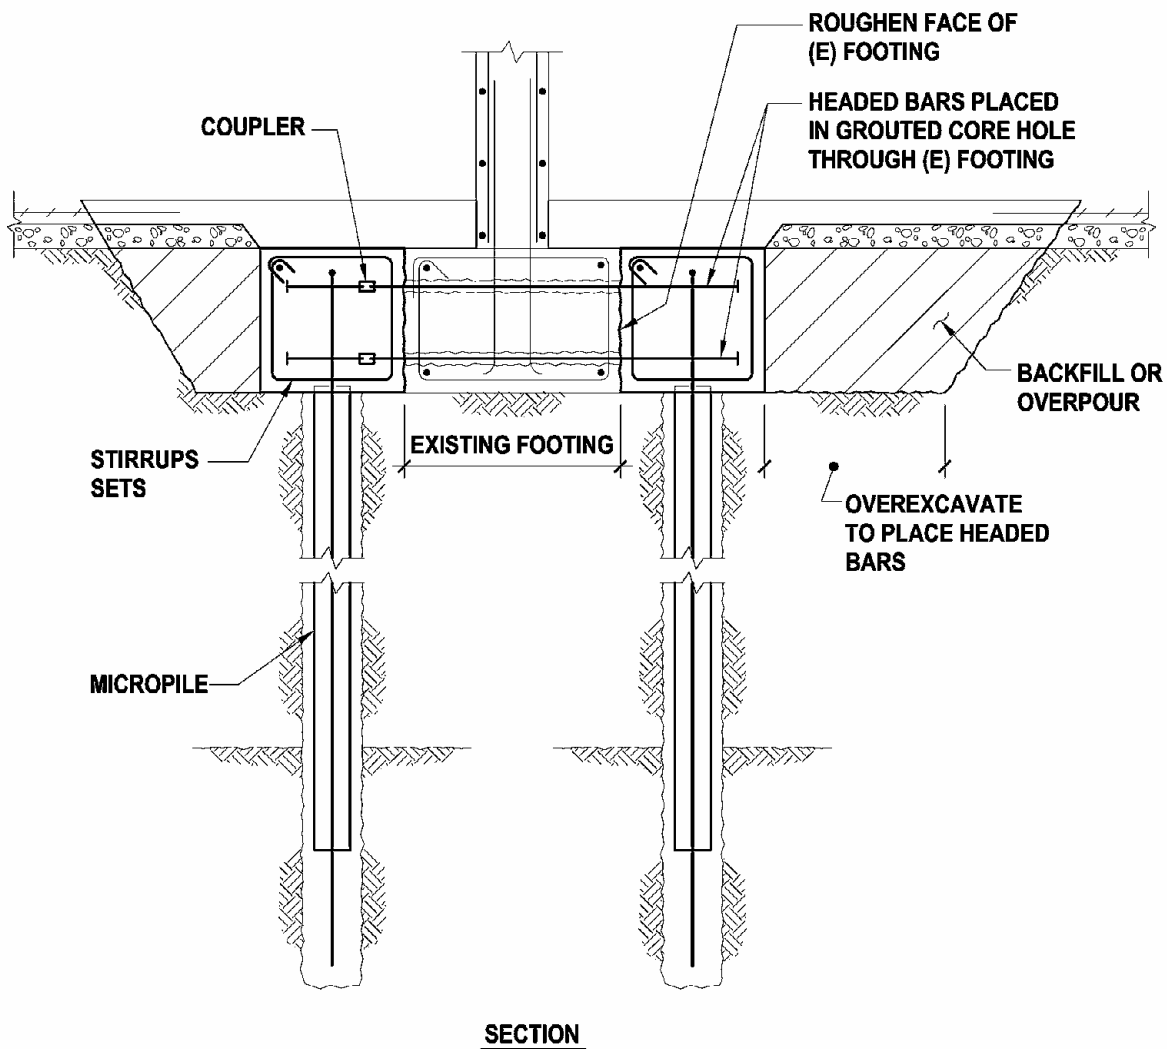
**Figure 23.7.2.-1: Micropile Enhancement to Existing Strip Footing**

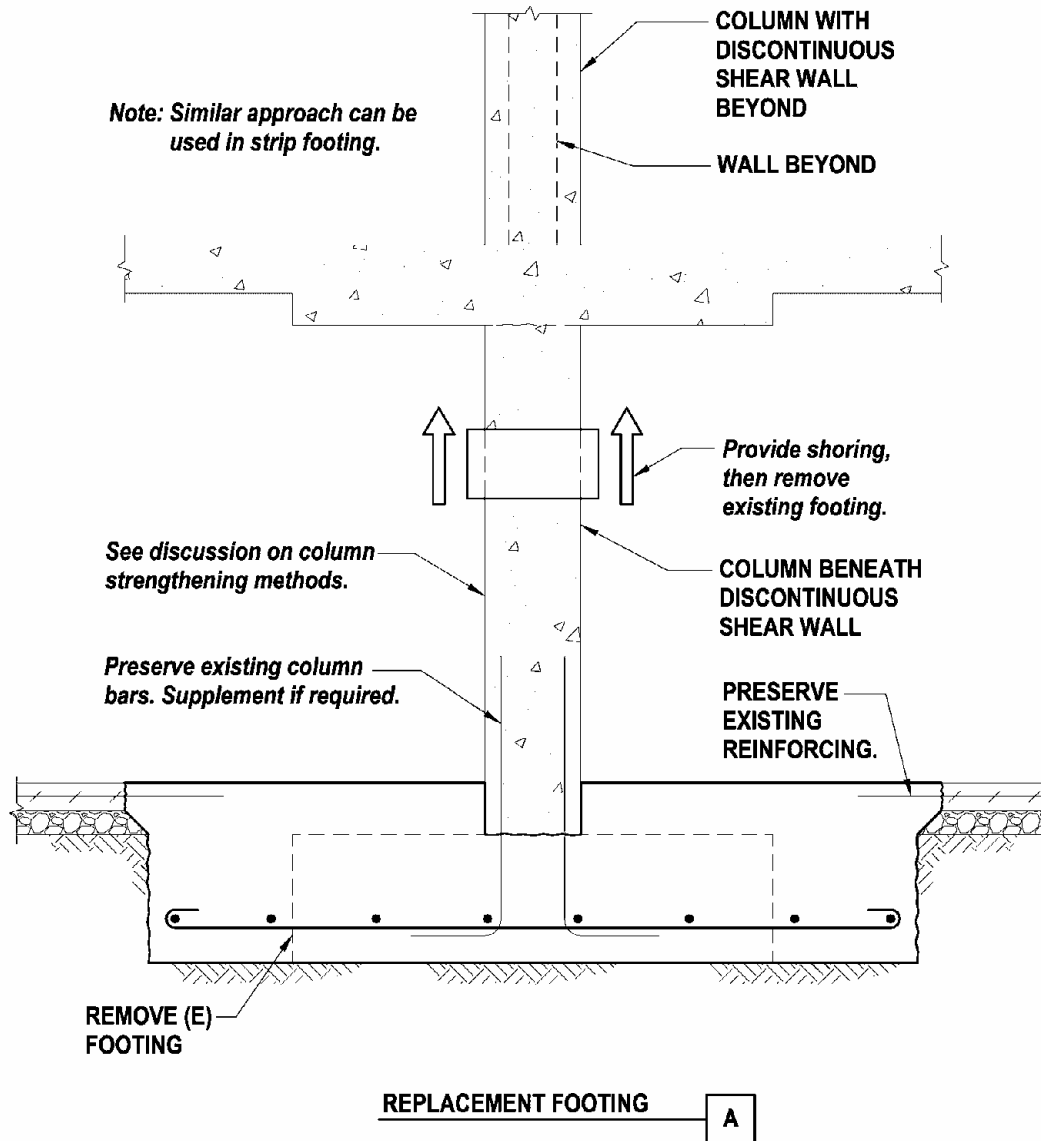
**Figure 23.7.3-2: Replace Existing Spread Footing**

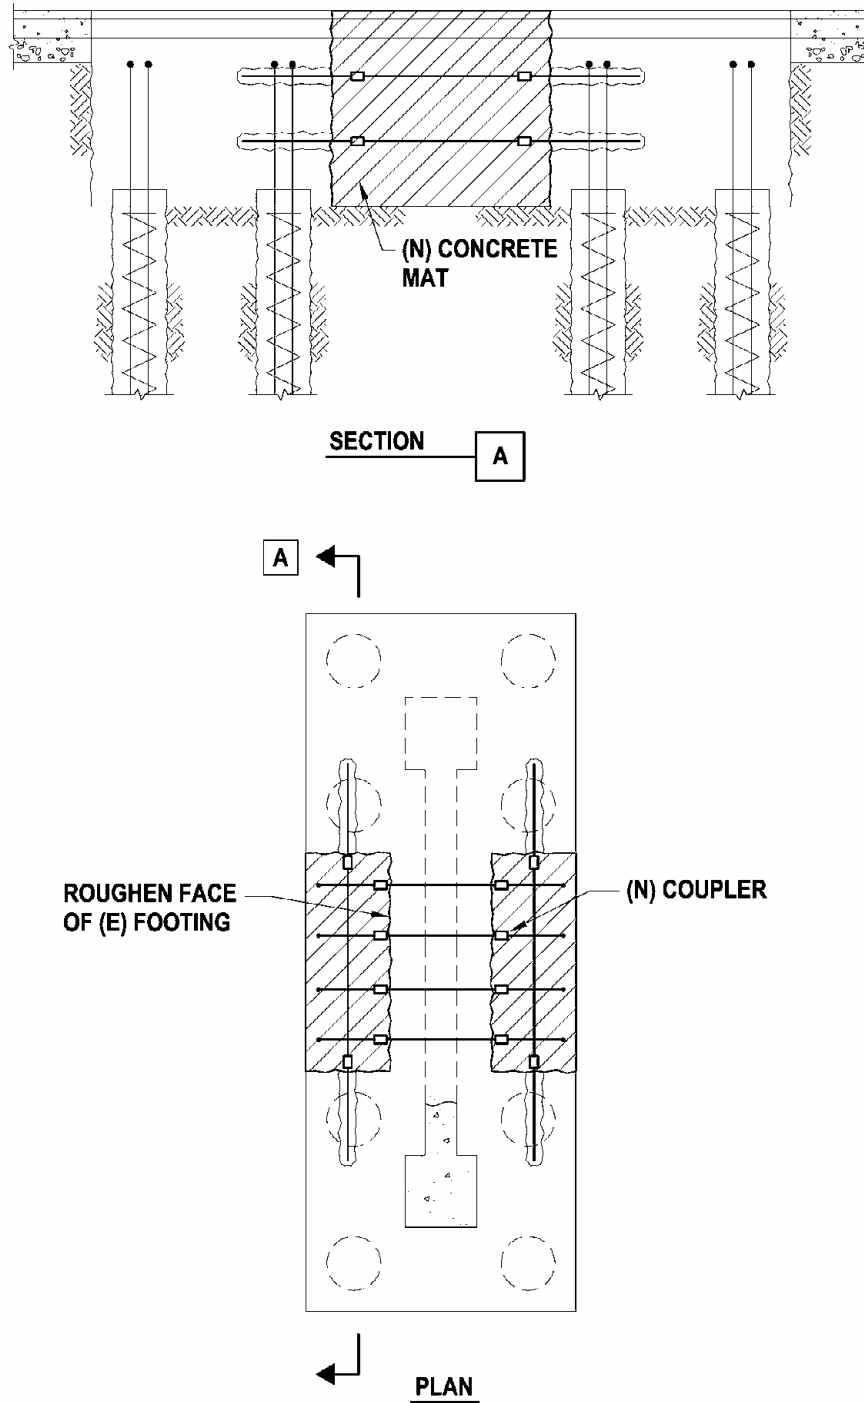
Figure 23.8.2-1: New Mat Foundation Between Existing Drilled Piers

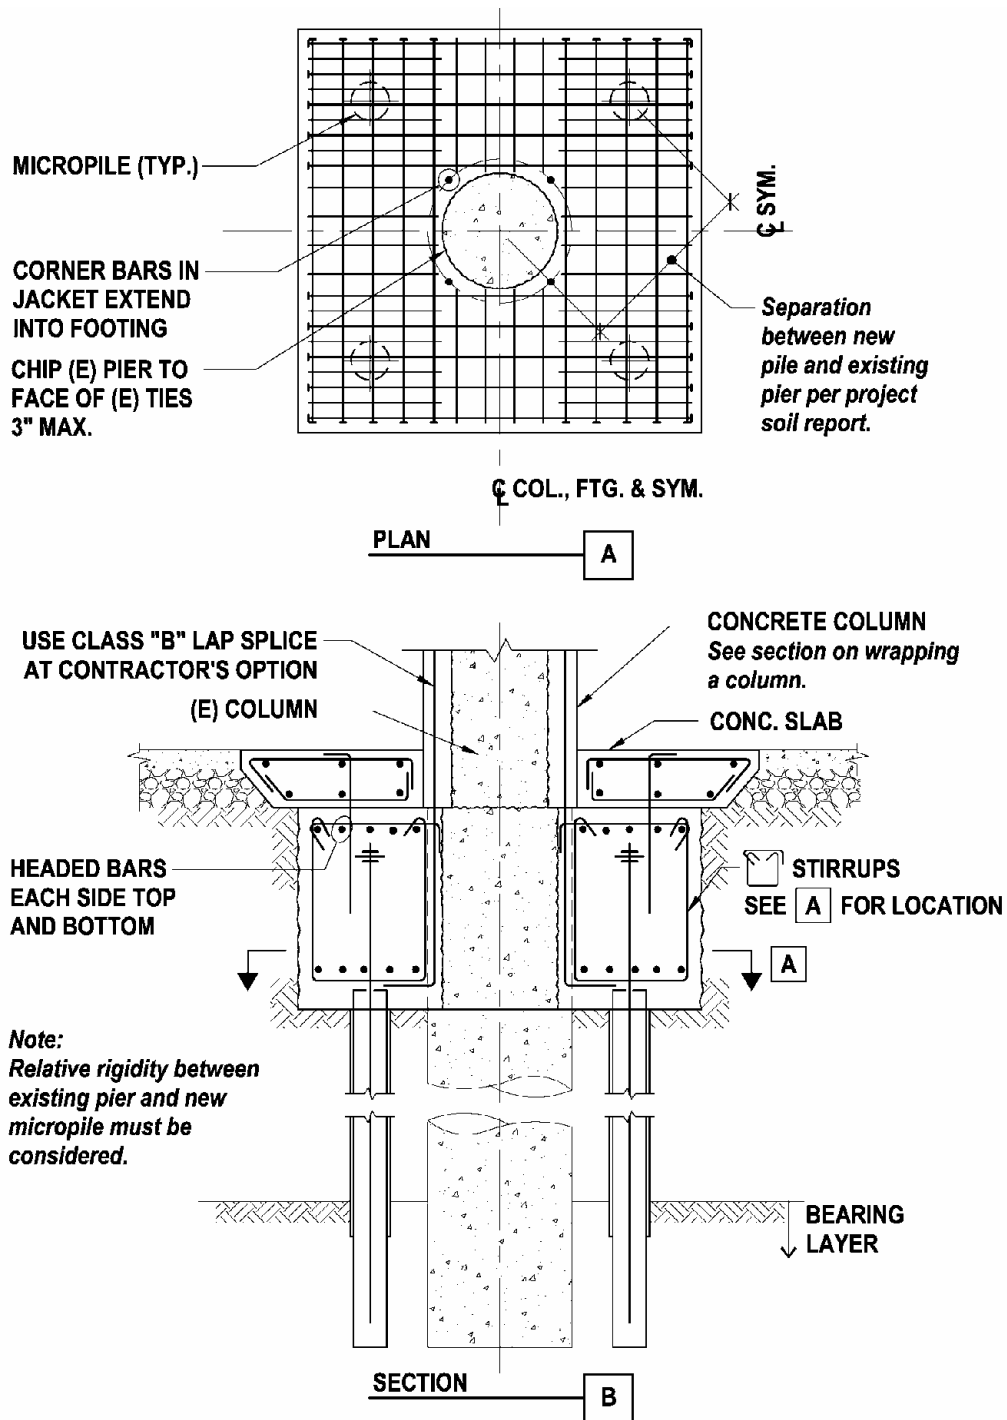
Figure 23.8.4.-1: Micropile Enhancement of an Existing Drilled Pier Footing

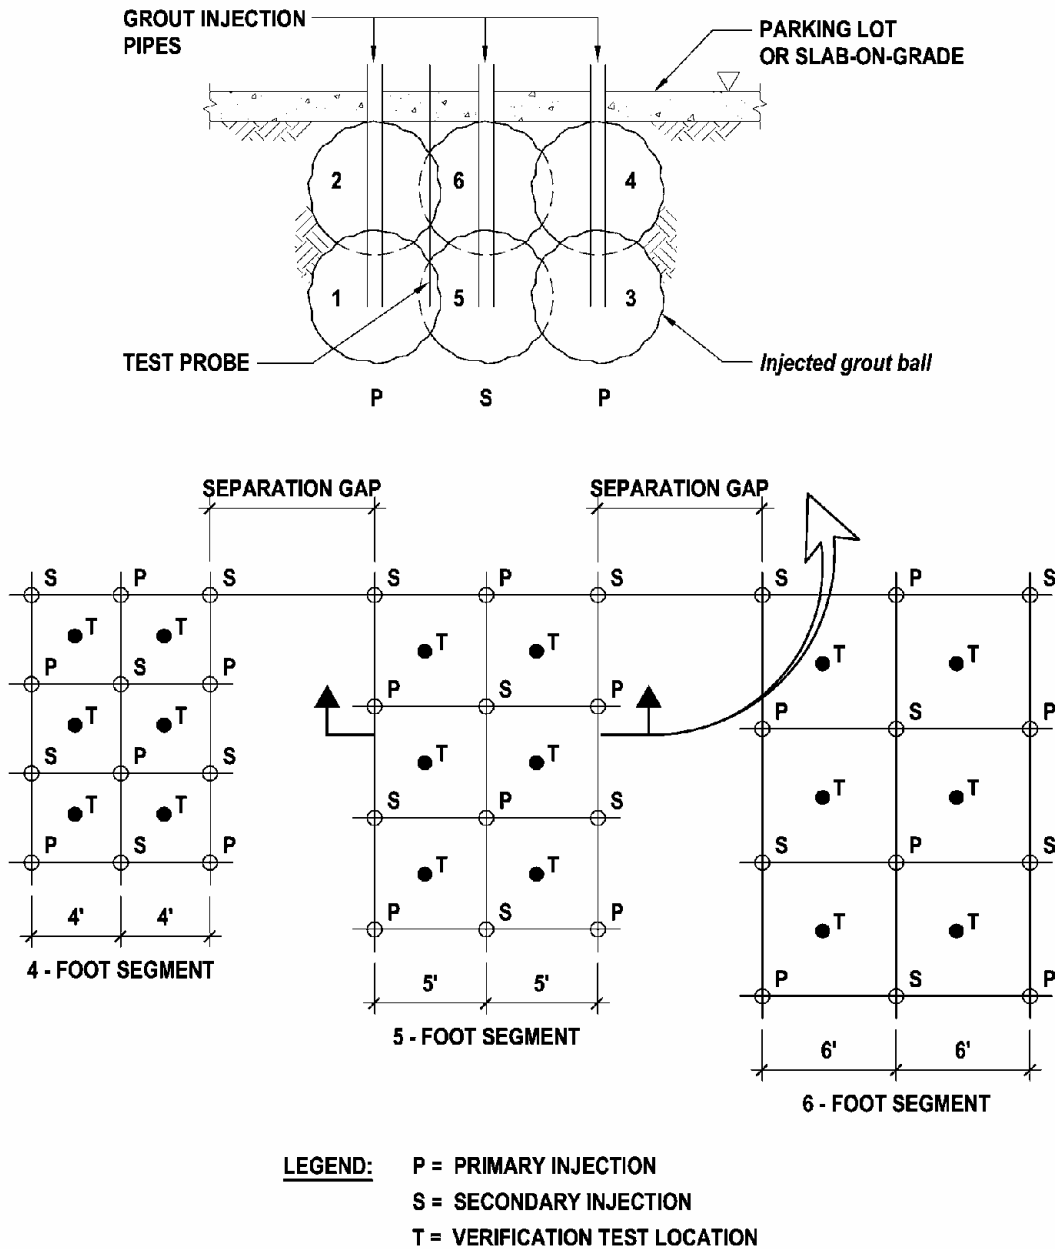
**Figure 23.9.2-1: Compaction Grouting Under Existing Shallow Foundations – Pilot Test Program**

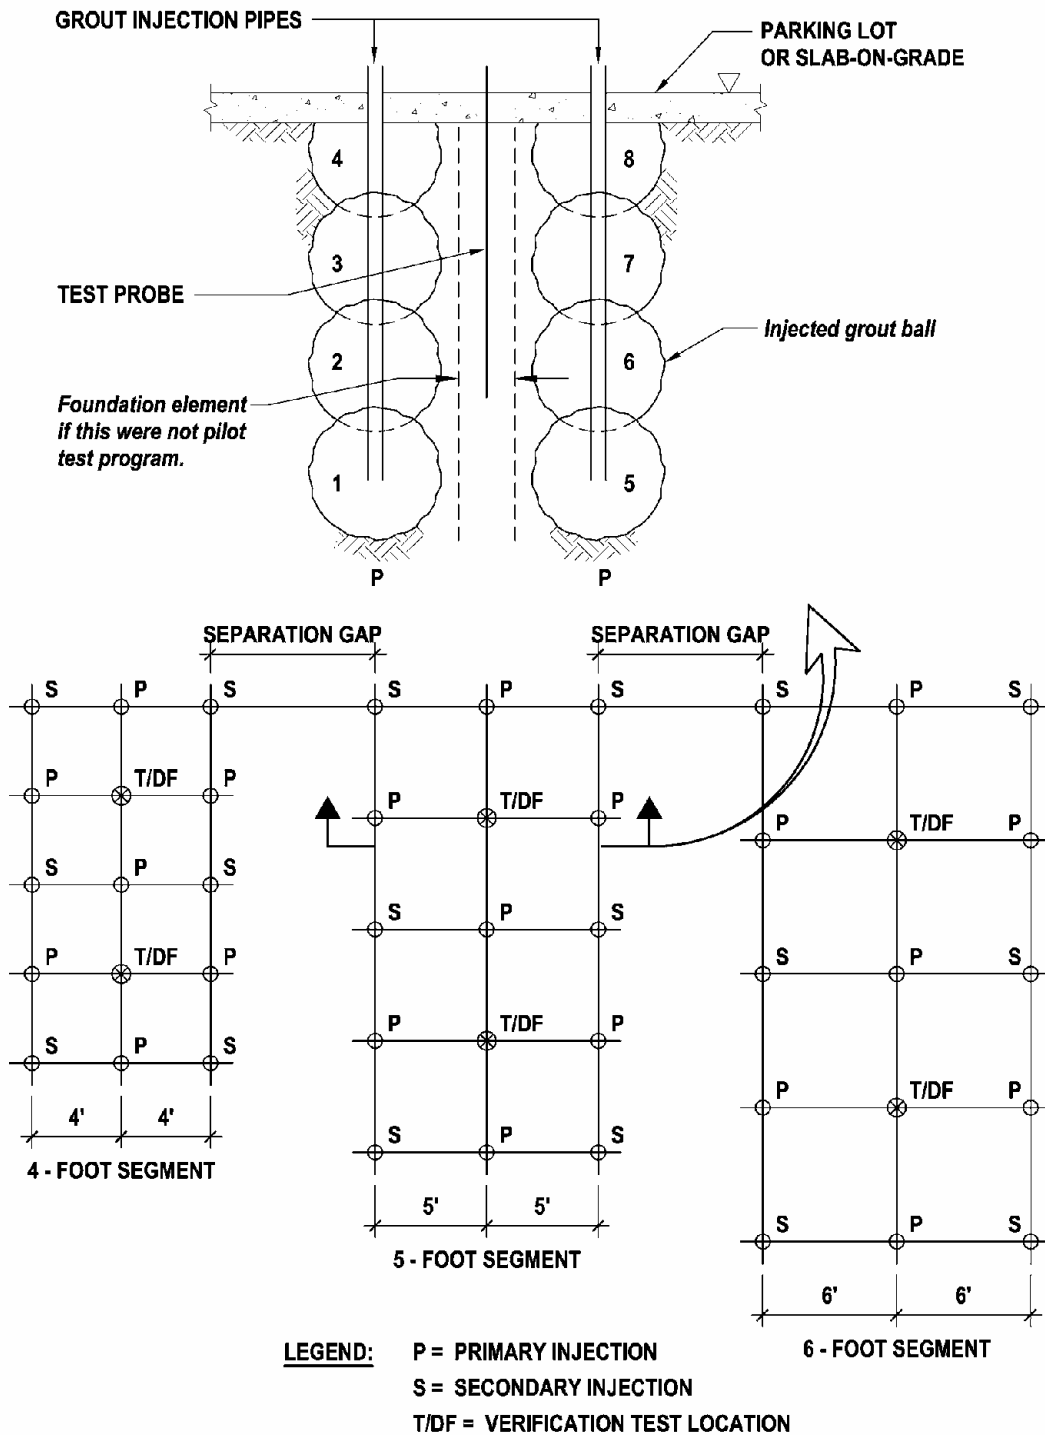
**Figure 23.9.2-2: Compaction Grouting Under Existing Deep Foundations – Pilot Test Program**

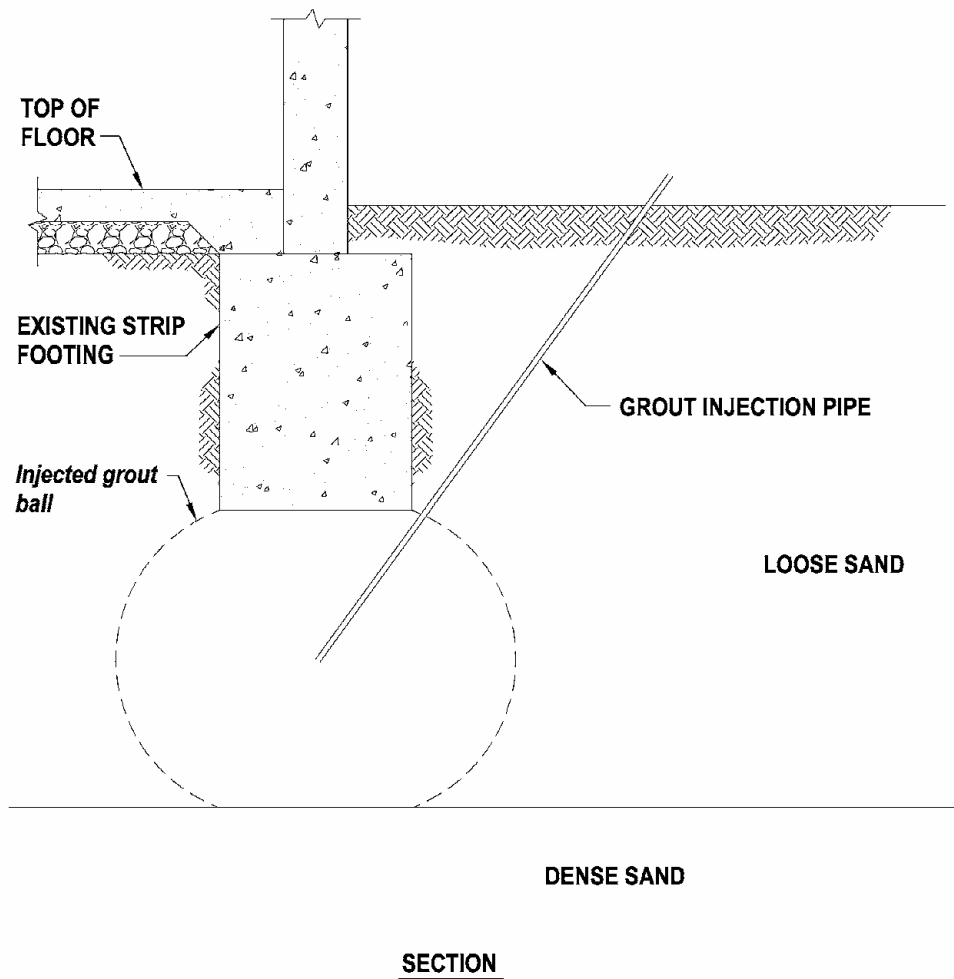
**Figure 23.9.3-1: Permeation Grouting of Loose Sand Under Existing Shallow Foundation**

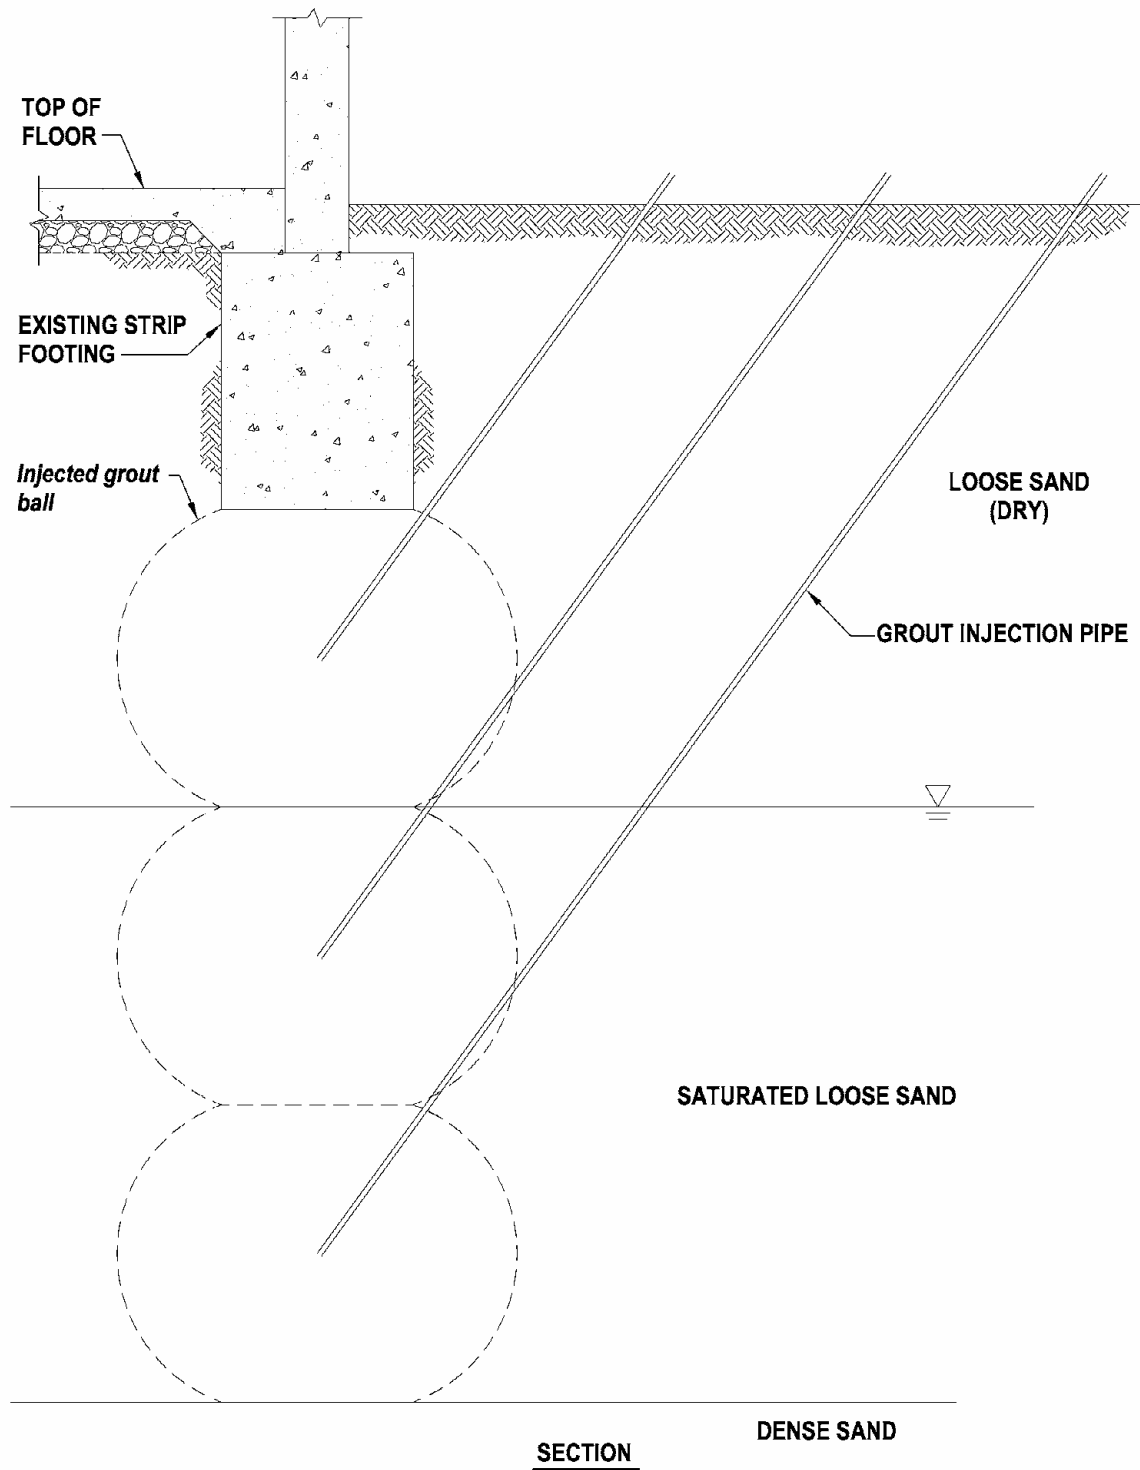
**Figure 23.9.3-2: Permeation Grouting of Liquefiable Layer Under Existing Shallow Foundation**

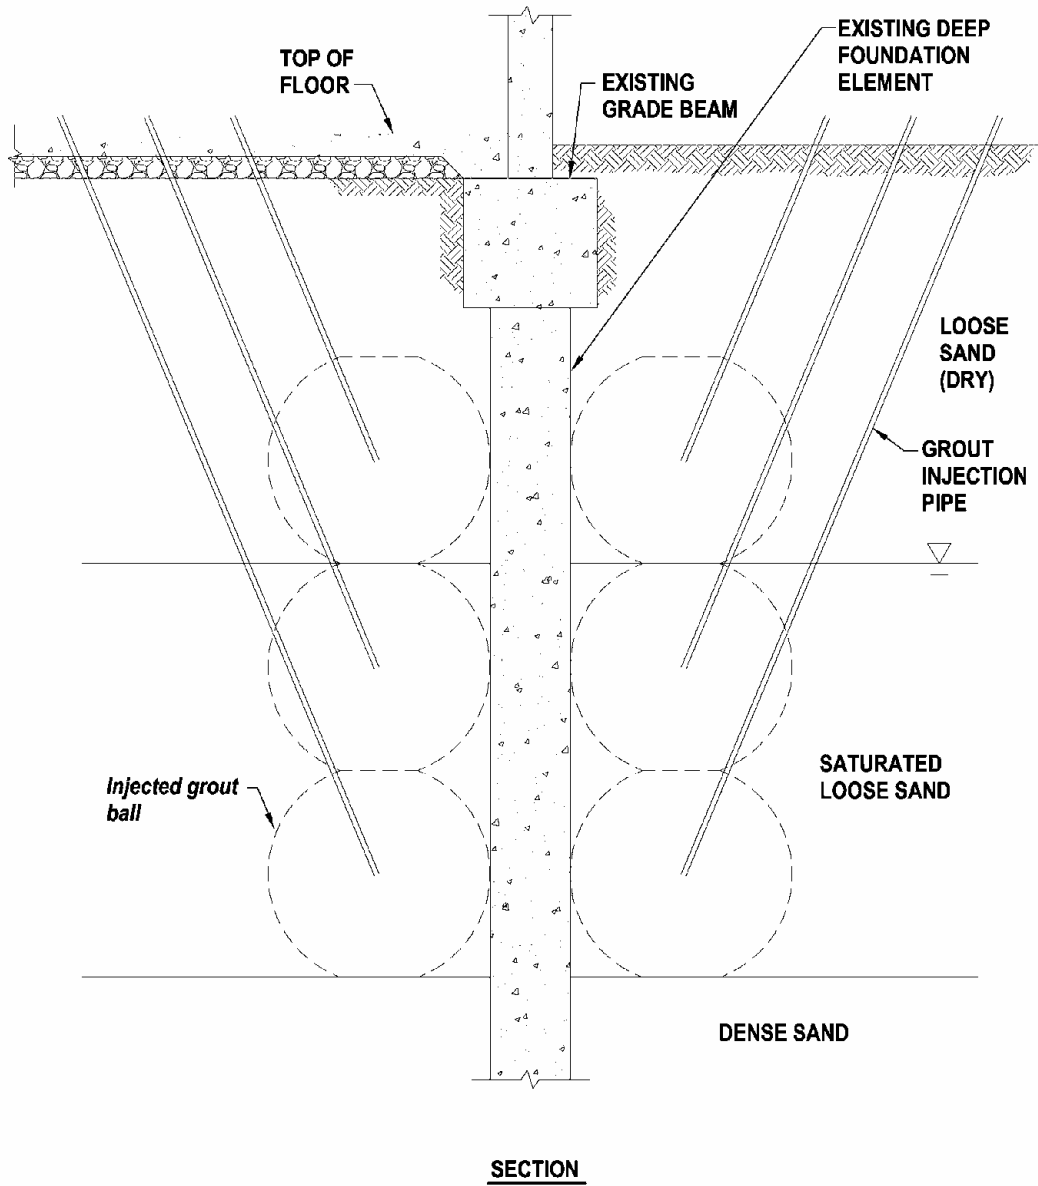
**Figure 23.9.3-3: Permeation Grouting of Liquefiable Layer Around Existing Deep Foundation**
