# Techniques for the Seismic Rehabilitation of Existing Buildings

FEMA 547/2006 Edition

**FEMA 547 – October 2006**

Rutherford & Chekene (R & C) Consulting Engineers (Subconsultant) under contract with National Institute of Standards and Technology (NIST).

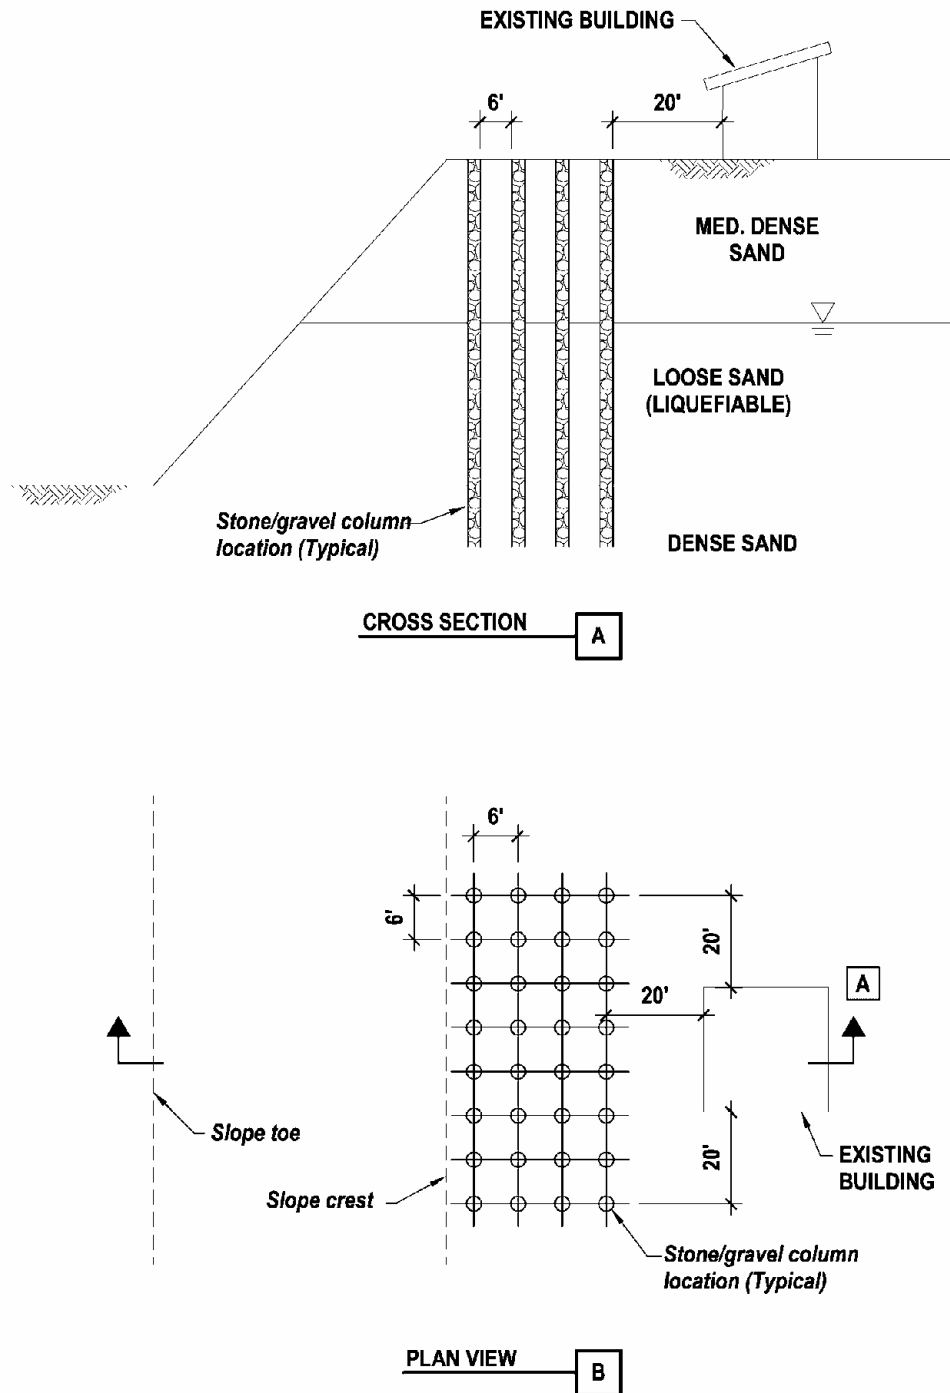
Figure 23.10.3-2: Mitigation Measure for Lateral Spreading – Stone/Gravel Column

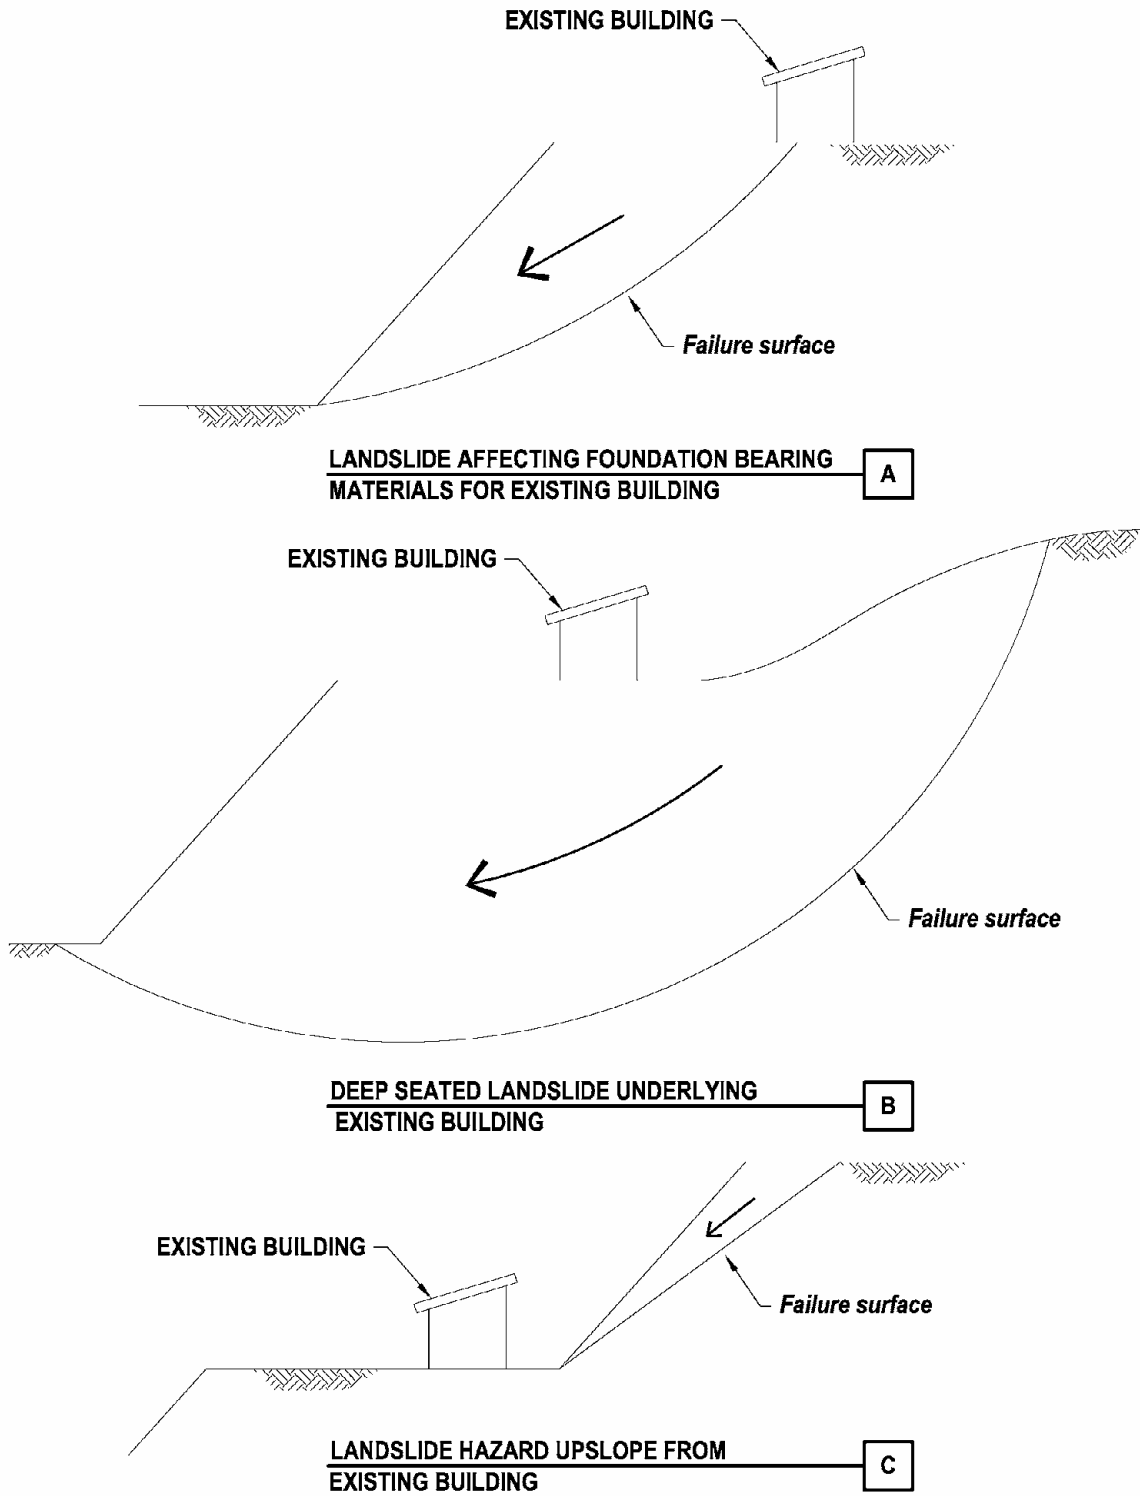
Figure 23.10.4-1: Landslide Hazards

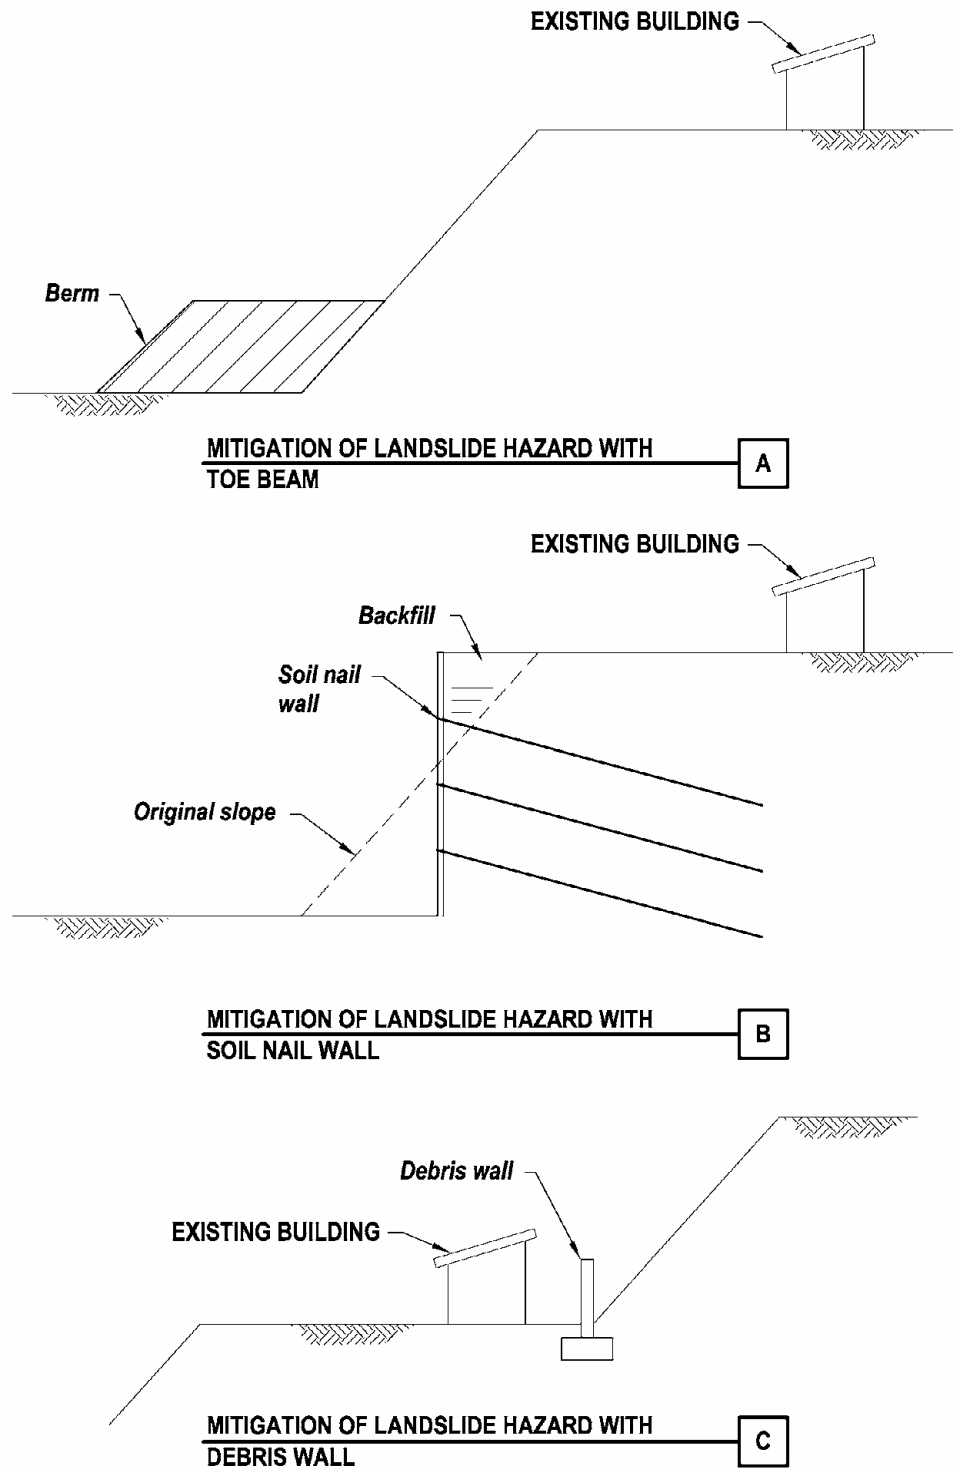
Figure 23.10.4-2: Mitigation of Landslide Hazards

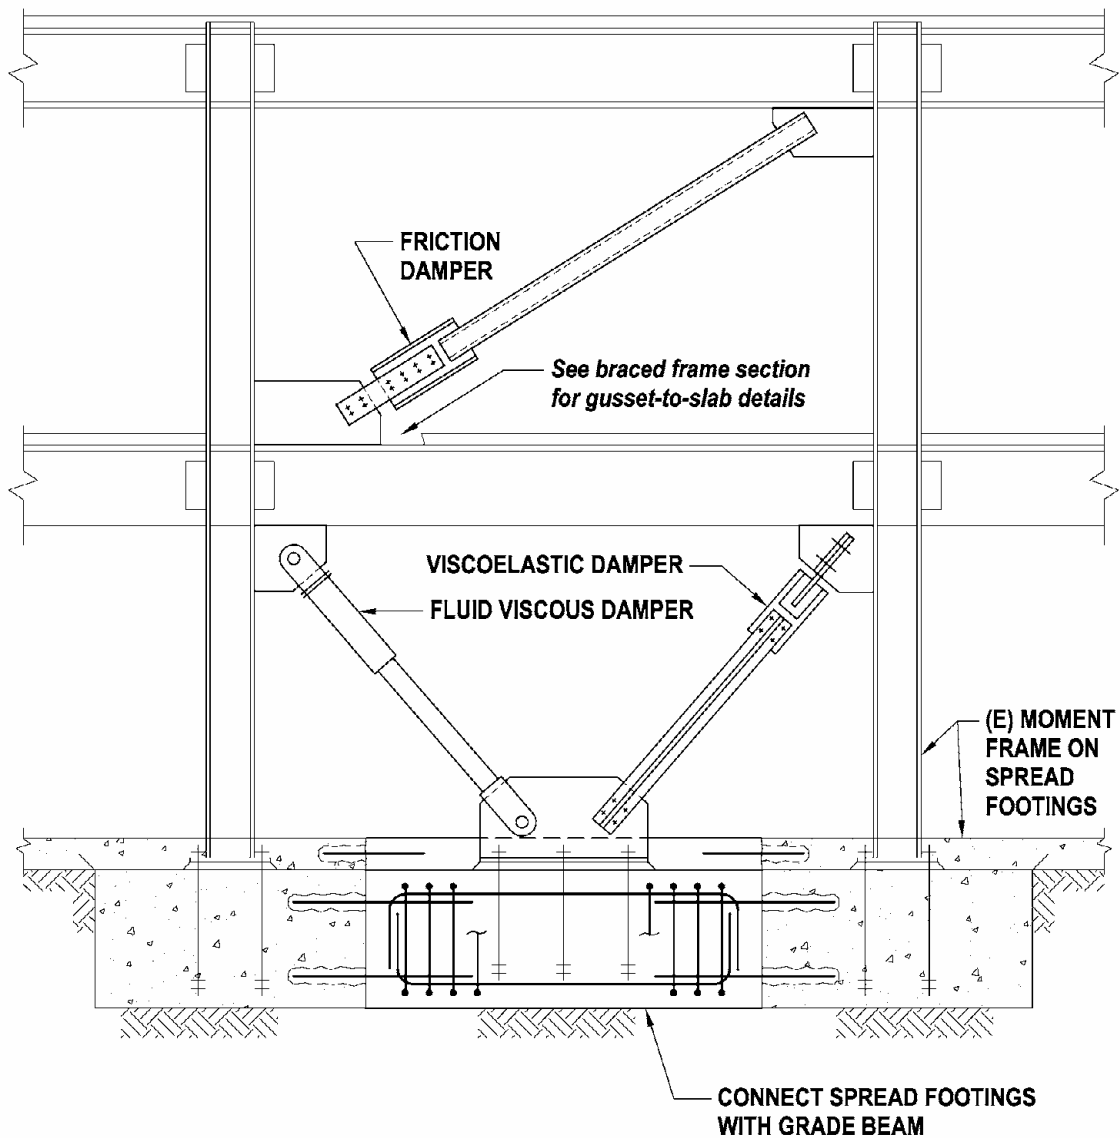
**Figure 24.4-1: Damper Alternatives for Rehabilitating an Existing Moment Frame**

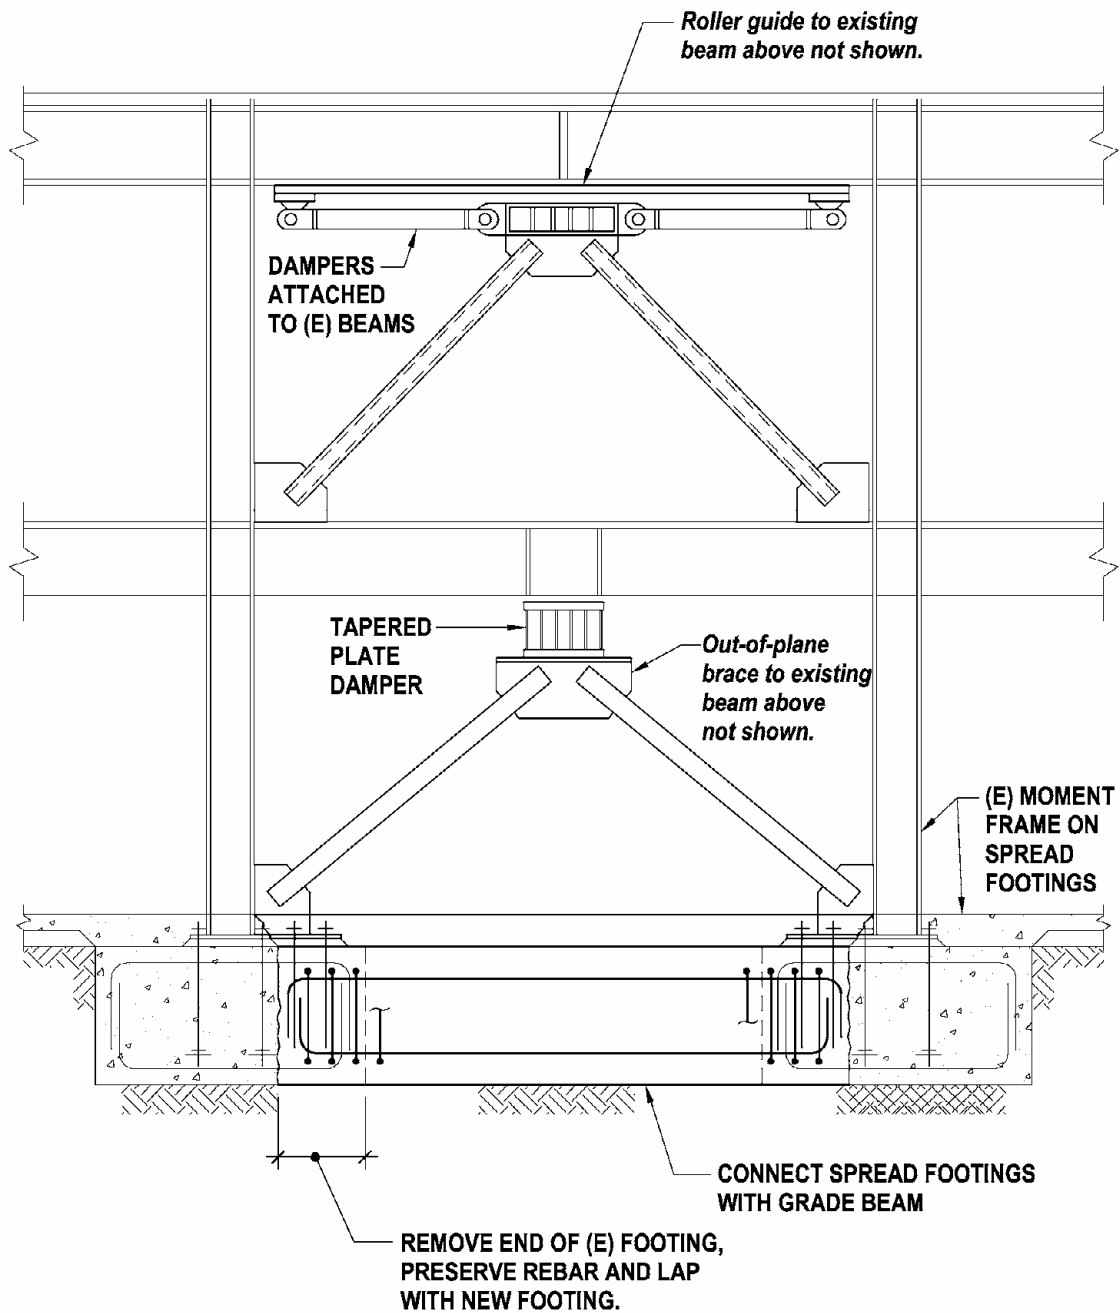
**Figure 24.4-2: Additional Damper Alternatives for Rehabilitating an Existing Moment Frame**
