# Repair of Earthquake Damaged Concrete and Masonry Wall Buildings

# **FEMA 308**

## **REPAIR OF EARTHQUAKE DAMAGED CONCRETE AND MASONRY WALL BUILDINGS**

**The Applied Technology Council**

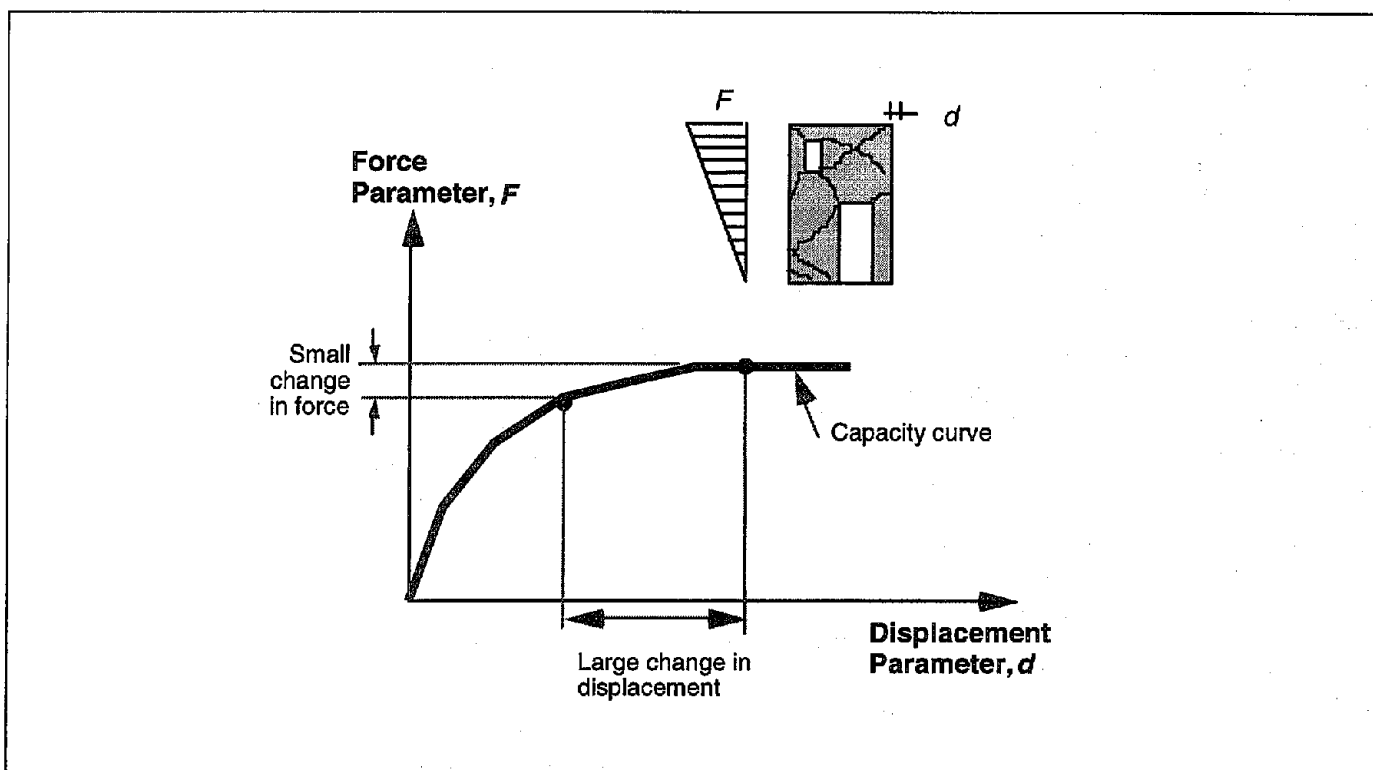
Figure 2-1 Sensitivity of displacement to changes in force

The key to realistic evaluation of the effects of earthquake damage on performance is a methodology that focuses on displacements rather than forces.

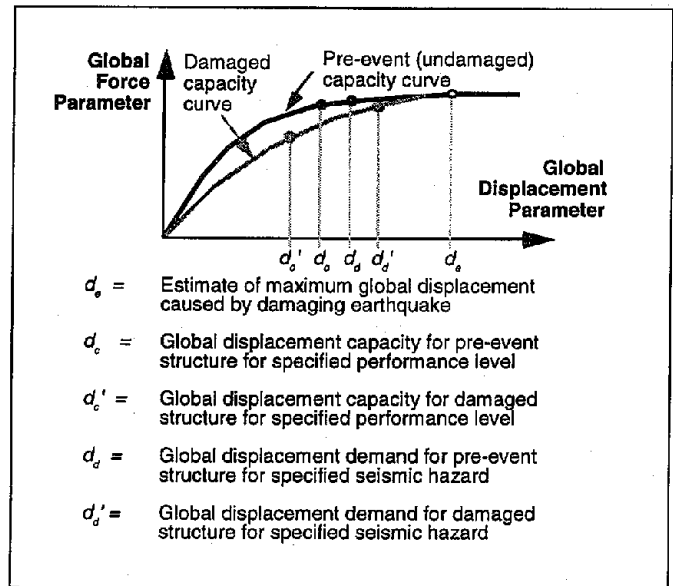
Figure 3-1 Capacity curves from nonlinear static procedures.

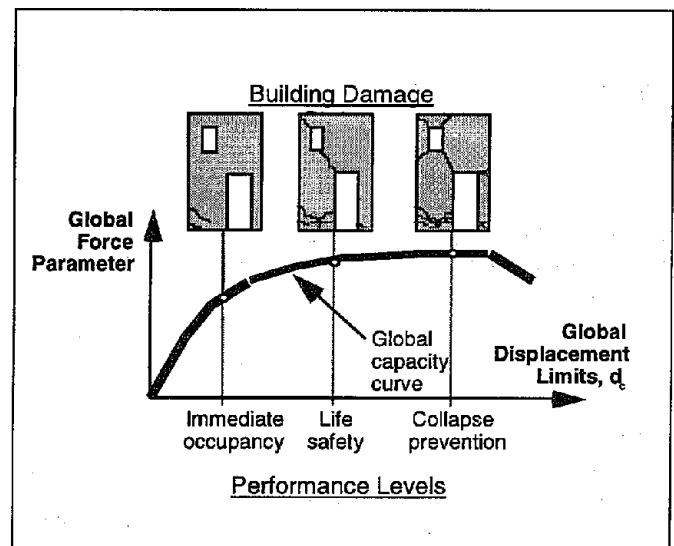
Figure 3-2 Global displacement capacities,  $d_c$ , for various performance levels

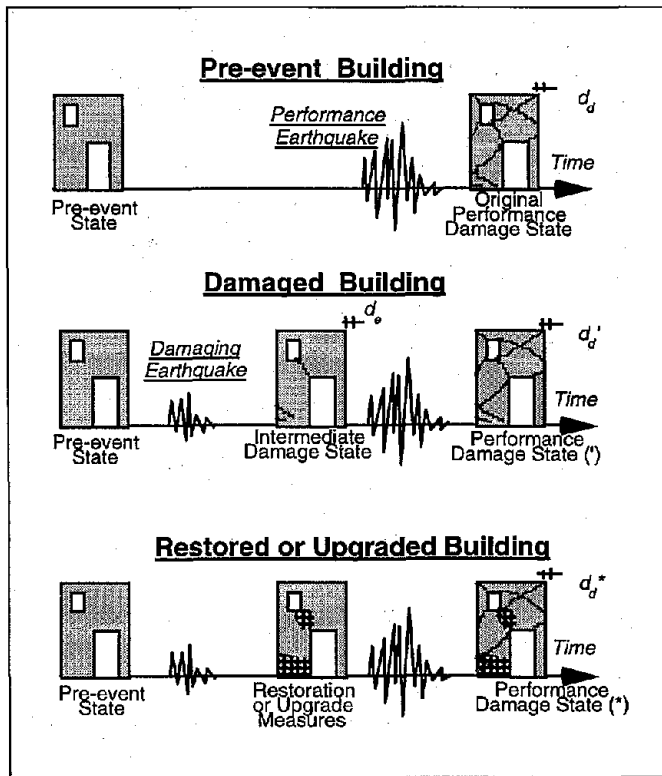
**Figure 3-3** Global displacement demand for undamaged, damaged, and restored/upgraded conditions

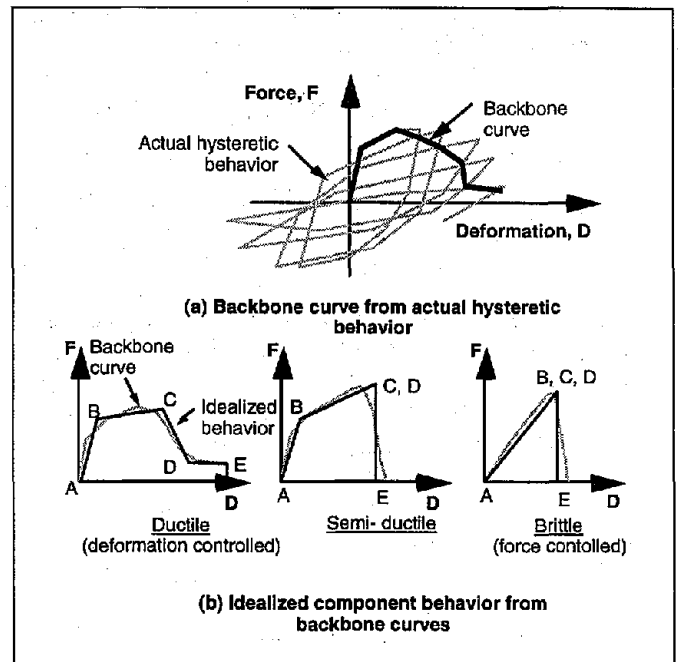
**Figure 3-4** Structural component force-deformation characteristics

conditions (Figure 3-4). For a given global displacement of a structure subjected to a given lateral load pattern, there is an associated deformation for each of the structural components of the building. Since inelastic deformation indicates component damage, then the maximum global displacement,  $d_d$ , to occur during an earthquake represents a structural damage state for the building in terms of inelastic deformations for each of its components. The capacity of a given structure for a given performance level is represented by the maximum global displacement,  $d_c$ , at which the damage is on the verge of exceeding the limit for the specific performance level. For example, the collapse-prevention capacity of a building might be the roof displacement at which the associated damage would result in one or more of the column components being in danger of imminent collapse.

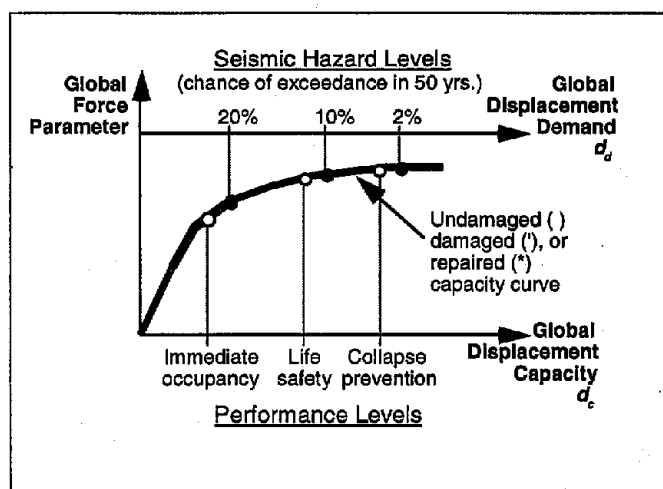
Figure 3-5 Global displacement demands and capacities

displacement demands for various levels of seismic hazard as shown in Figure 3-5. These may be generated using nonlinear static procedures according to the recommendations in FEMA 306, in conjunction with the appropriate capacity curve. In Figure 3-5 these are plotted on the upper horizontal axis noting their chance of exceedance in 50 years. Component acceptability criteria in conjunction with capacity curves also can be

used to define global displacement limits for various performance levels (e.g., immediate occupancy, life safety, collapse prevention). These are shown in Figure 3-5 along the lower horizontal axis. The combined plot provides a complete picture of the risks associated with the particular repair alternative.

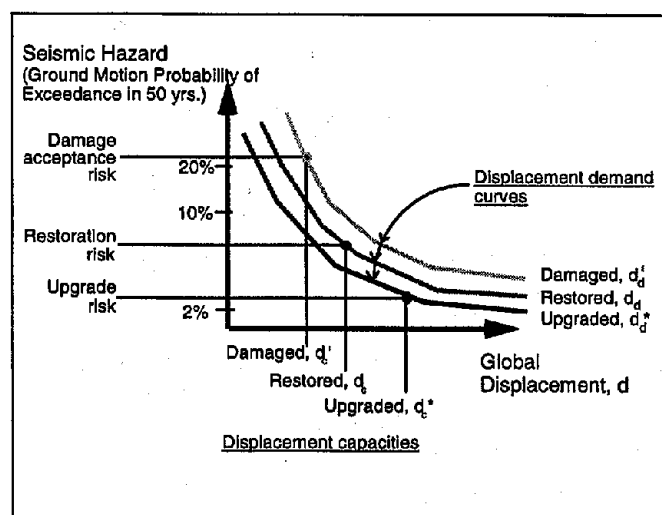
Figure 3-6 Risk associated with damage acceptance, restoration, and upgrade for a specific performance objective

Global displacement demand for various repair alternatives can also be plotted versus a risk parameter as shown in Figure 3-6. The intersection of a global displacement capacity value, for a selected performance level, with the corresponding displacement demand curve allows an estimate of the risk that the performance level would be exceeded for a given repair alternative. Doing this for several repair alternatives, as

shown in Figure 3-6, provides a comparison of the risks associated with each alternative for the selected performance level. For example, suppose that the performance level of interest is life safety. Figure 3-6 illustrates that the chance that the global displacement demand would exceed the life safety capacity of the damaged structure is slightly higher than 20% in fifty years. Restoration of the structure to its pre-event condition would reduce the life safety risk to less than 10%. The upgrade could reduce risk to just above 2% or approximately ten times less than the damaged structure in this illustration.

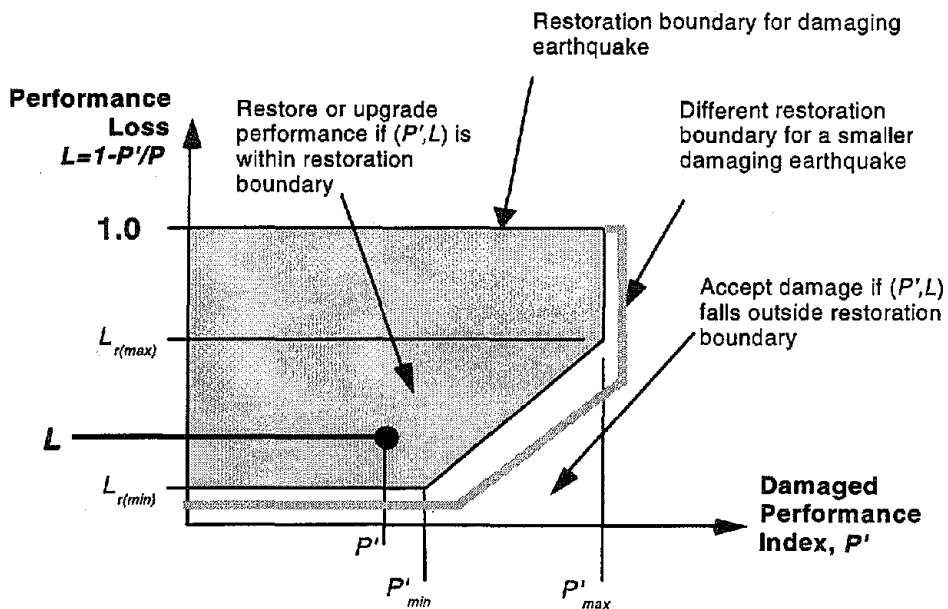
a) Relationship between acceptance of damage versus repair or upgrade

Figure 3-7 Thresholds and performance limits for restoration and upgrade of earthquake-damaged buildings

performance index must be greater than  $P'_{max}$  ( $P' > P'_{max}$ ) if damage is to be acceptable regardless of the loss. If the damaged performance index ( $P', L$ ) is within the restoration boundary, then either restoration or upgrading is required.

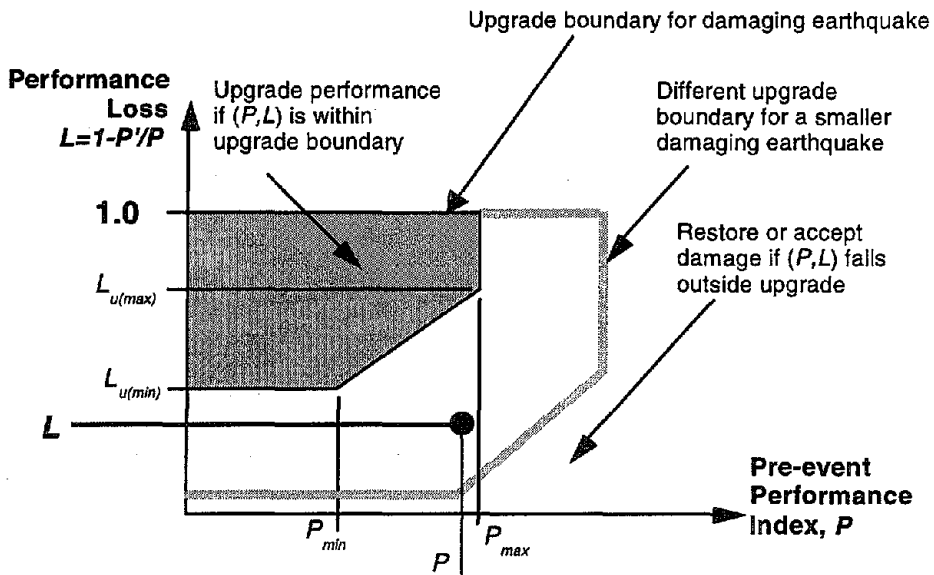
b) Relationship between acceptance of damage or restoration versus upgrade

The parameters affecting the decision between upgrade or restoration are illustrated in Figure 3-7b. The decision between upgrade or restoration is controlled by the loss ( $L$ ) and the pre-event performance index ( $P$ ). The upgrade boundary is delineated similarly to the restoration boundary using the parameters in Table 3-2.
