NBSIR 87-3540

**WIND AND  
SEISMIC  
EFFECTS**

Proceedings  
of the  
Eighteenth  
Joint  
Meeting

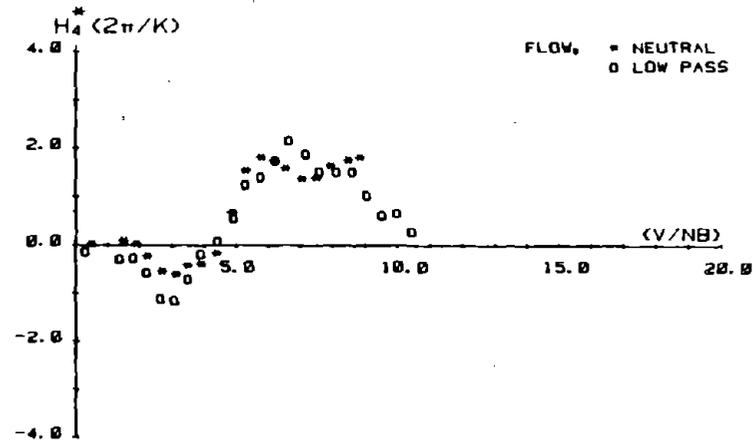
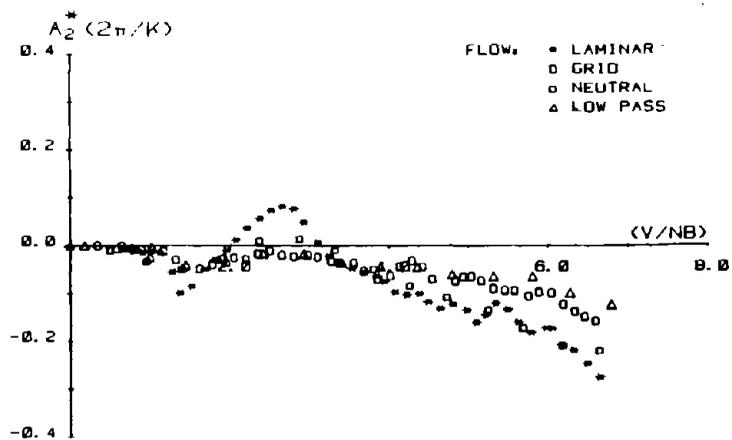
Fig. 6. Unmodified Deer Isle bridge: flutter derivatives, extracted from initial condition experiments.

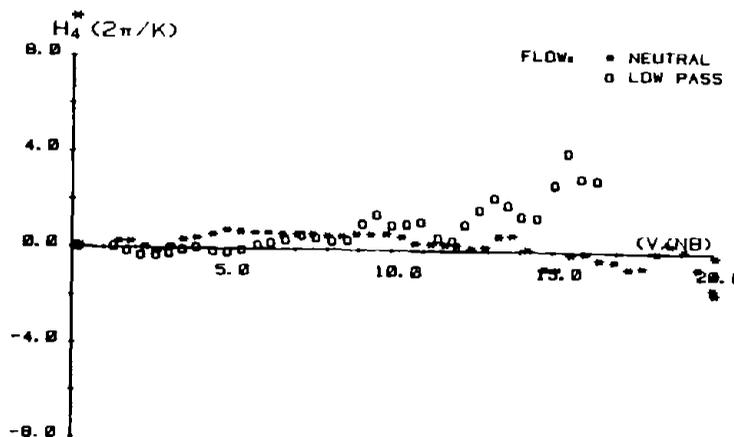
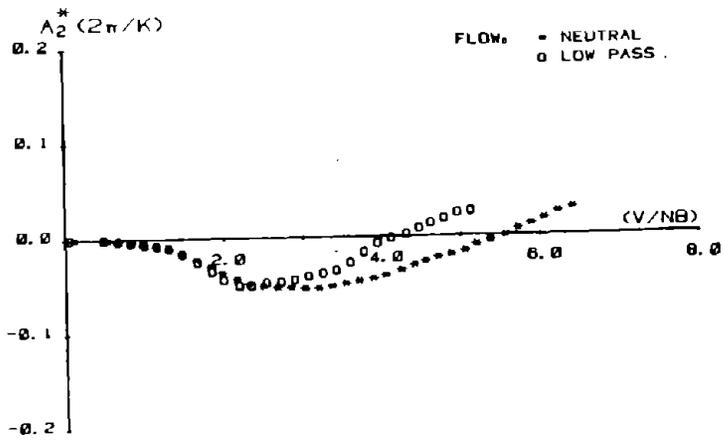
Fig. 7. Fairing-modified version of the Deer Isle bridge: flutter derivatives, extracted from initial condition experiments.

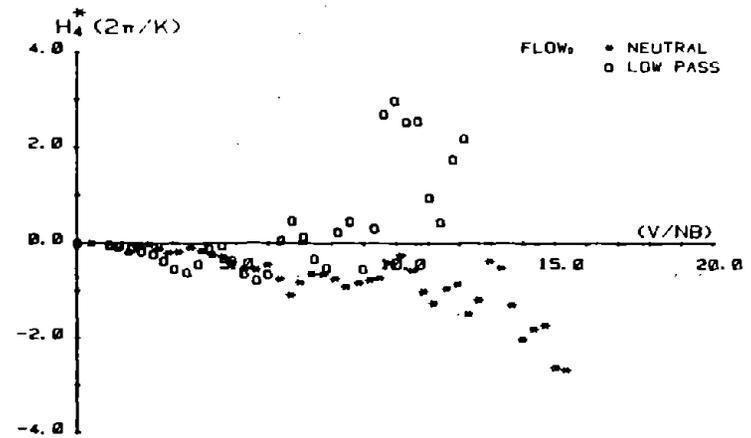
Fig. 8. Golden Gate deck section: flutter derivatives extracted from initial condition experiments.

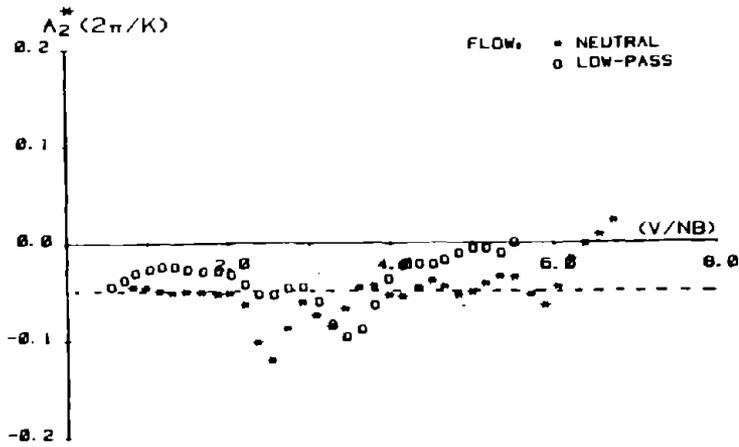
Fig. 9 Golden Gate Bridge deck section flutter derivative, extracted by the stationary time history method, (-----) indicates ad hoc shift in the vertical axis.

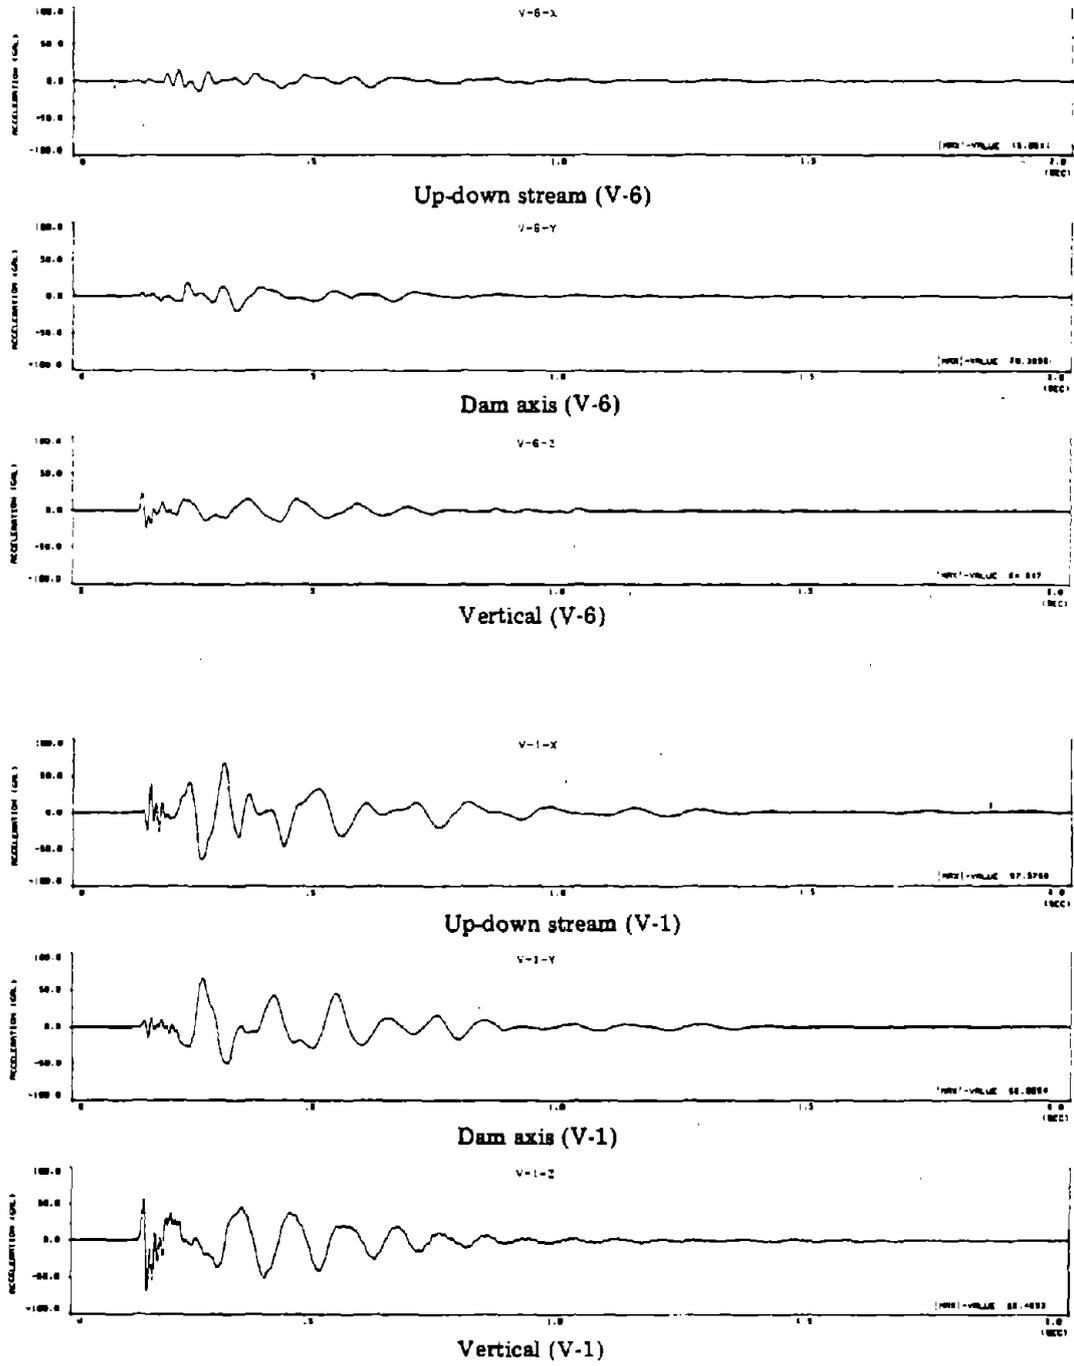
Figure-3(a) Time histories of accelerations at the foundation (V-6) and dam crest (V-1) during the empty reservoir

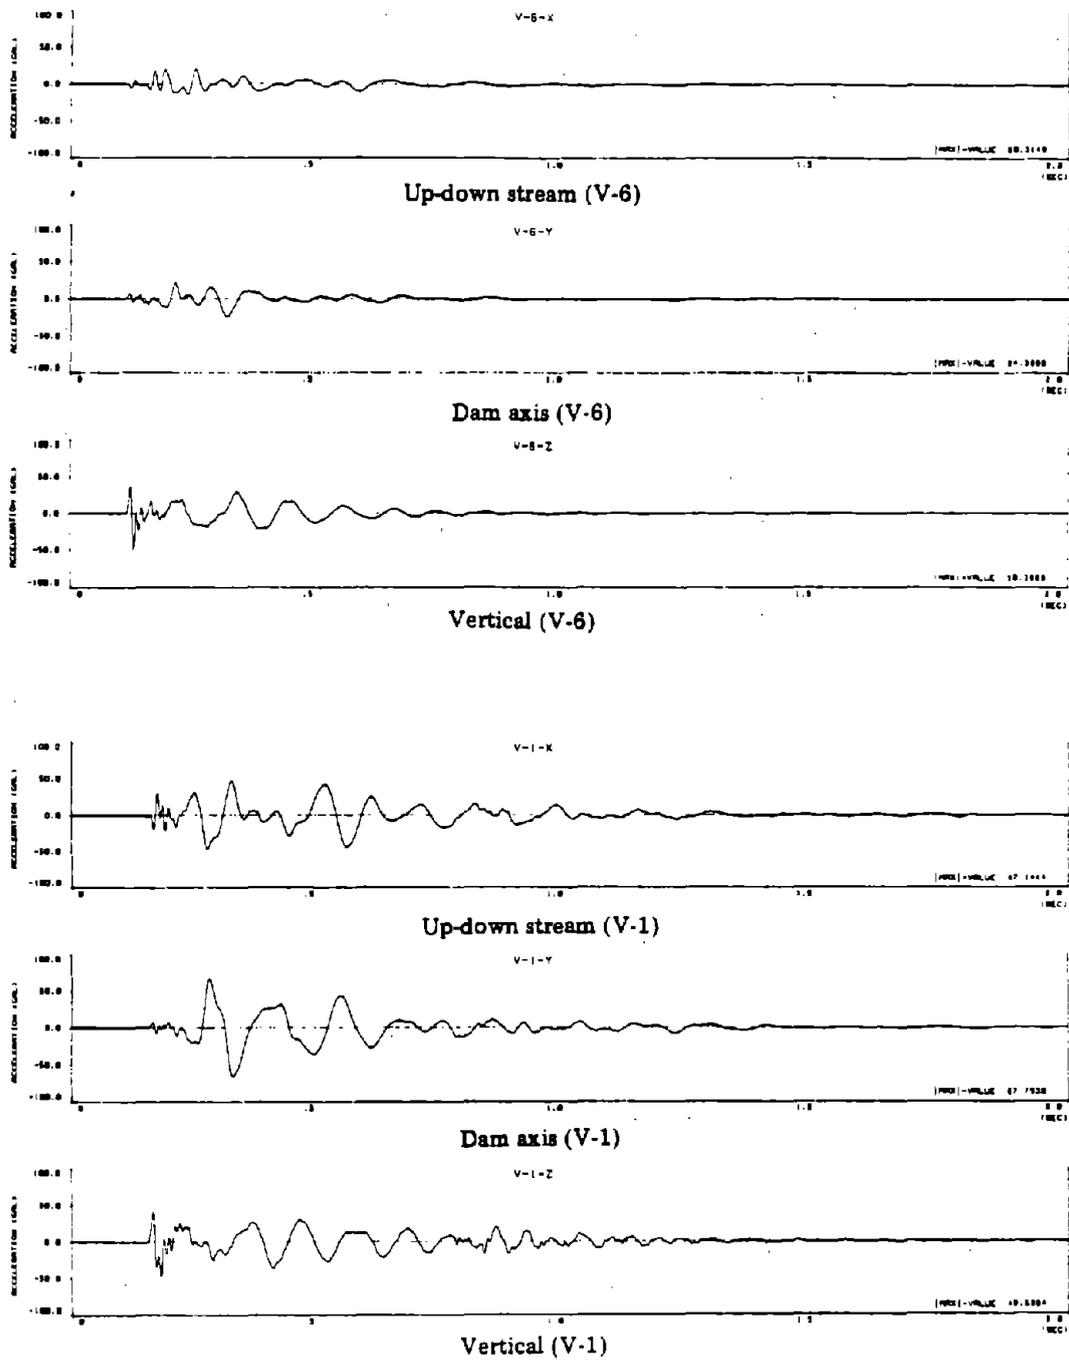
Figure-3(b) Time histories of accelerations at the foundation (V-6) and dam crest (V-1) during the full reservoir

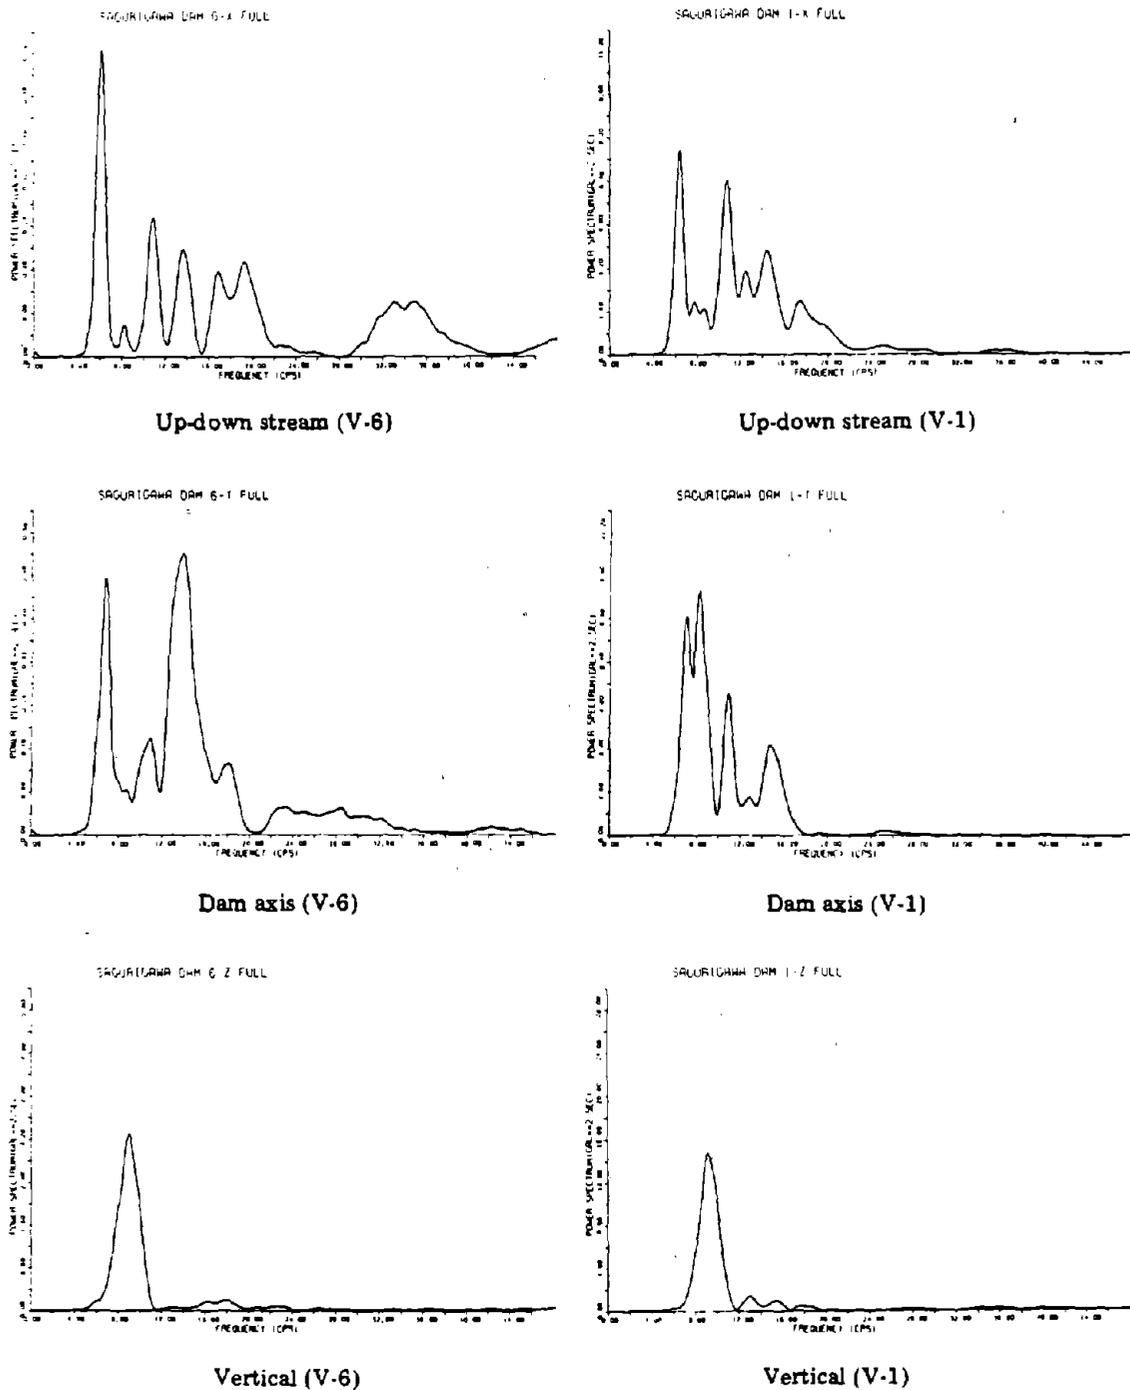
Figure-4 Power spectra of accelerations at the foundation (V-6) and dam crest (V-1) during the full reservoir

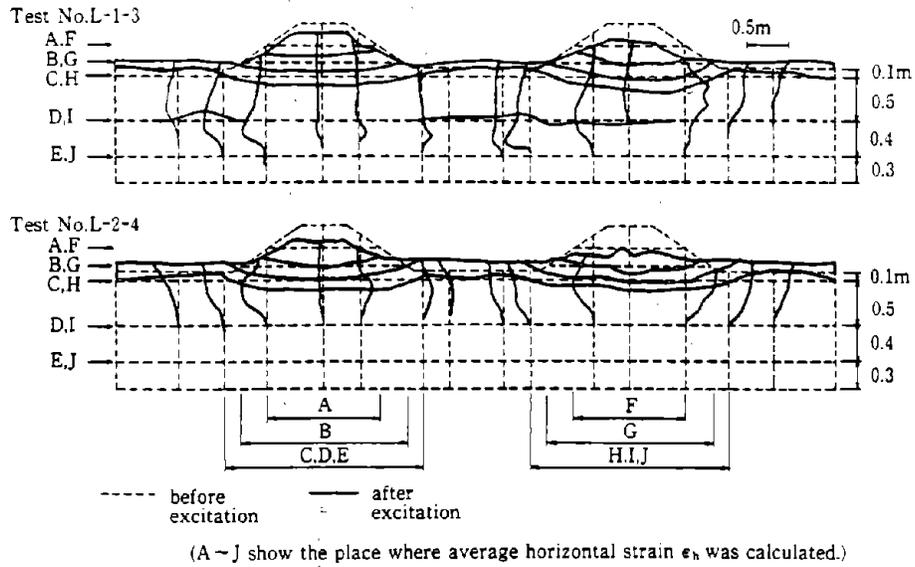
Fig. 3 Failure pattern of models

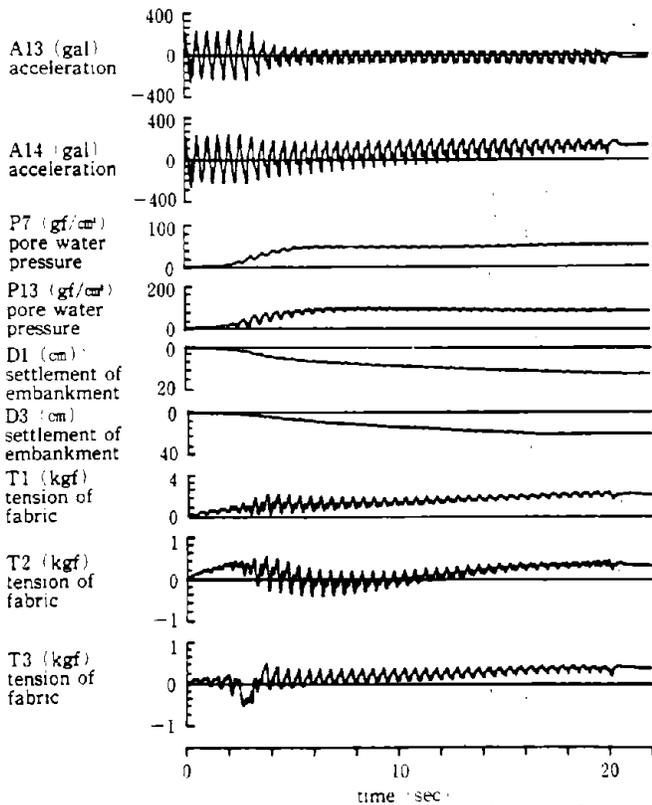
Fig. 4 Records of measurements (Test No. L-1-3)

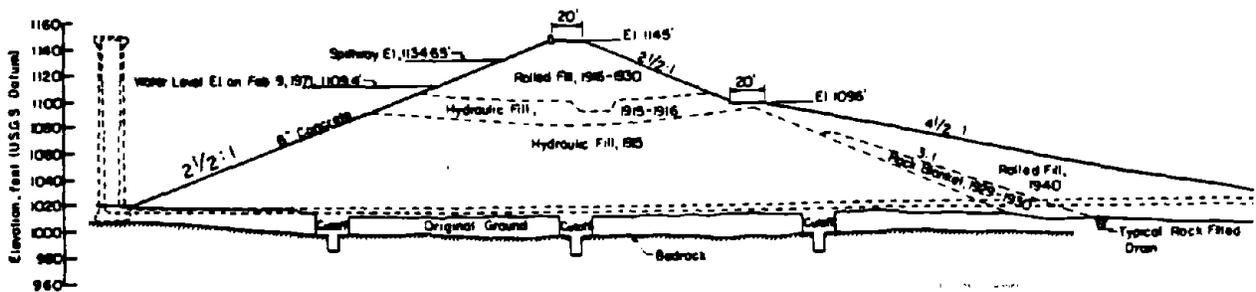
Figure 1. Cross-section through Lower Van Norman Dam (Los Angeles Department of Water and Power)

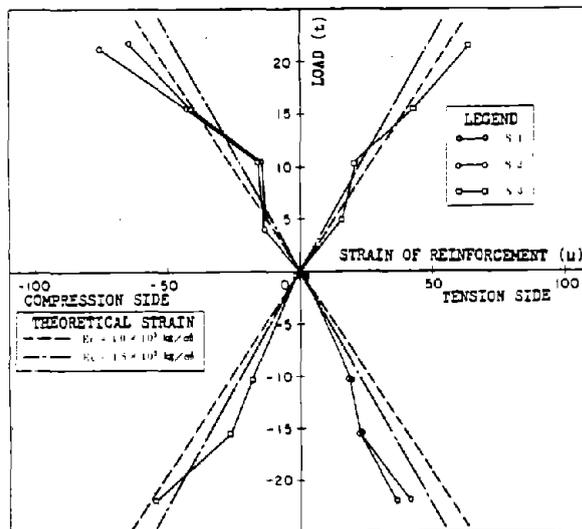
Fig.14 Load vs. Strain of Reinforcing Bar for Dynamic Loading Test with Frequency of 0.5Hz (Test 2, refer to Fig.11 for measuring points of strain)

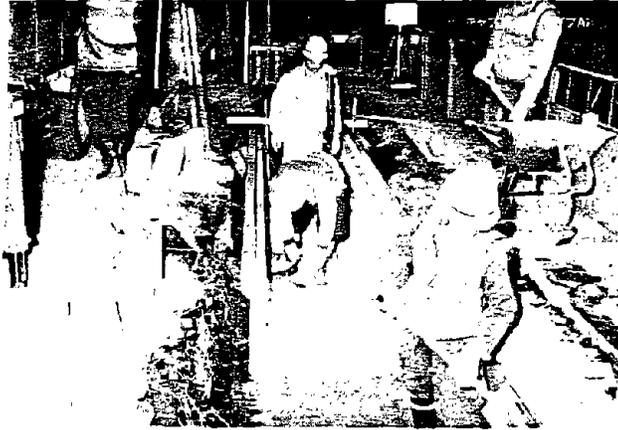
Photo 1 Installation of CAB (U-Shaped Duct)

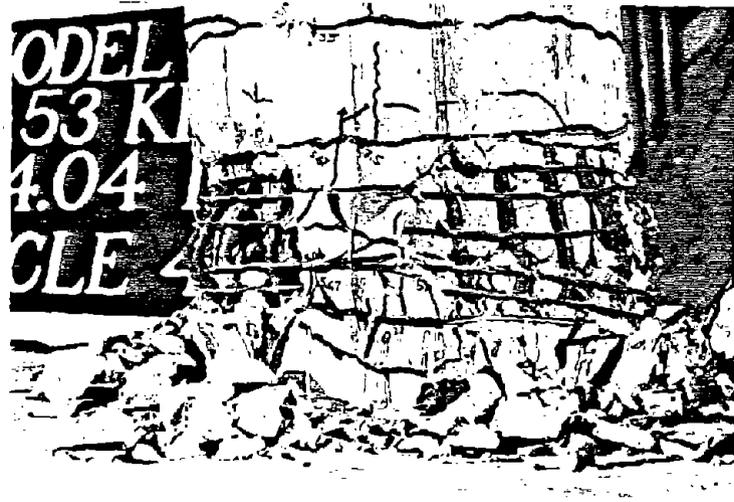
Crushed Concrete and Fractured Vertical Reinforcement

Figure 6. One-sixth Scale Model

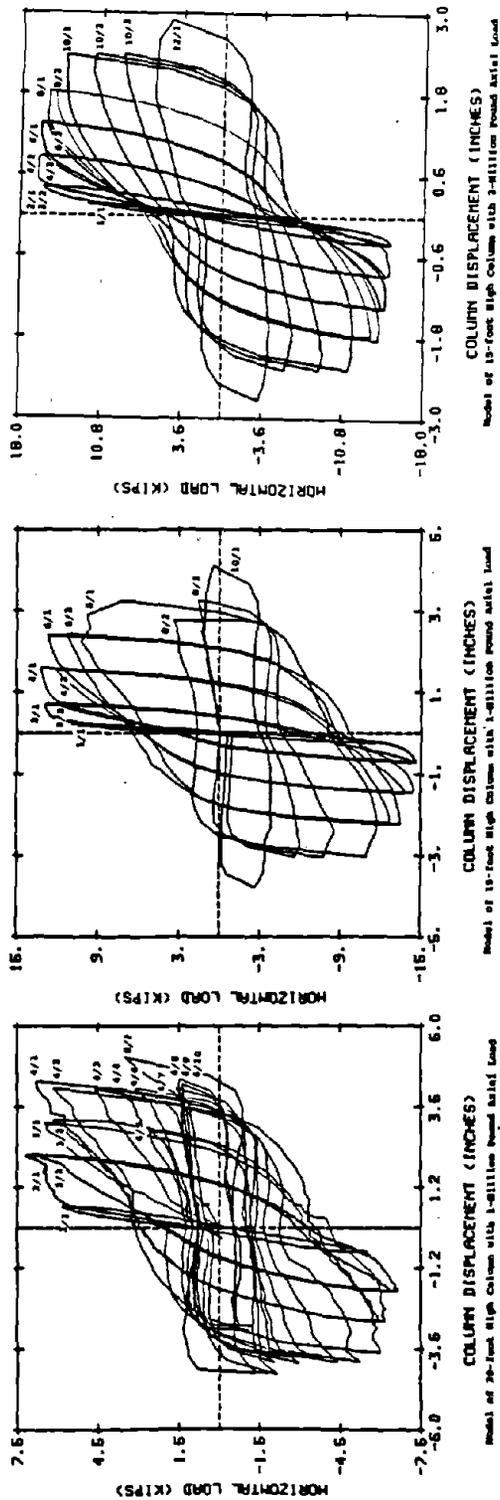
NOTATION:  
 MULTIPLE OF YIELD DISPLACEMENT/CYCLE NUMBER

Figure 7. Load-Displace Cycles for 1/6-scale Models

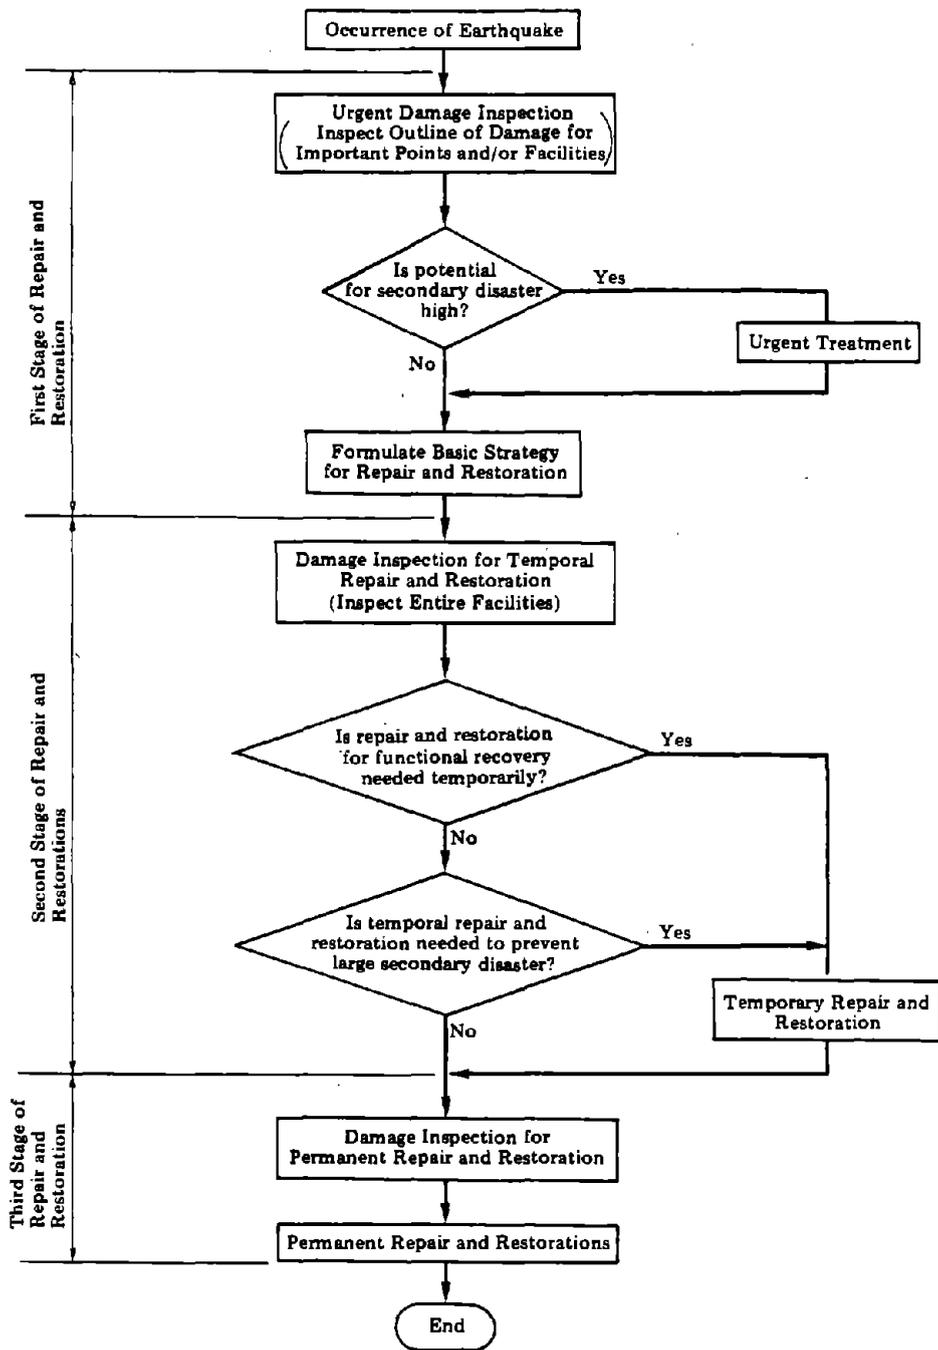
Fig. 2-1 Flow of Repair and Restoration of Seismically Damaged Facilities

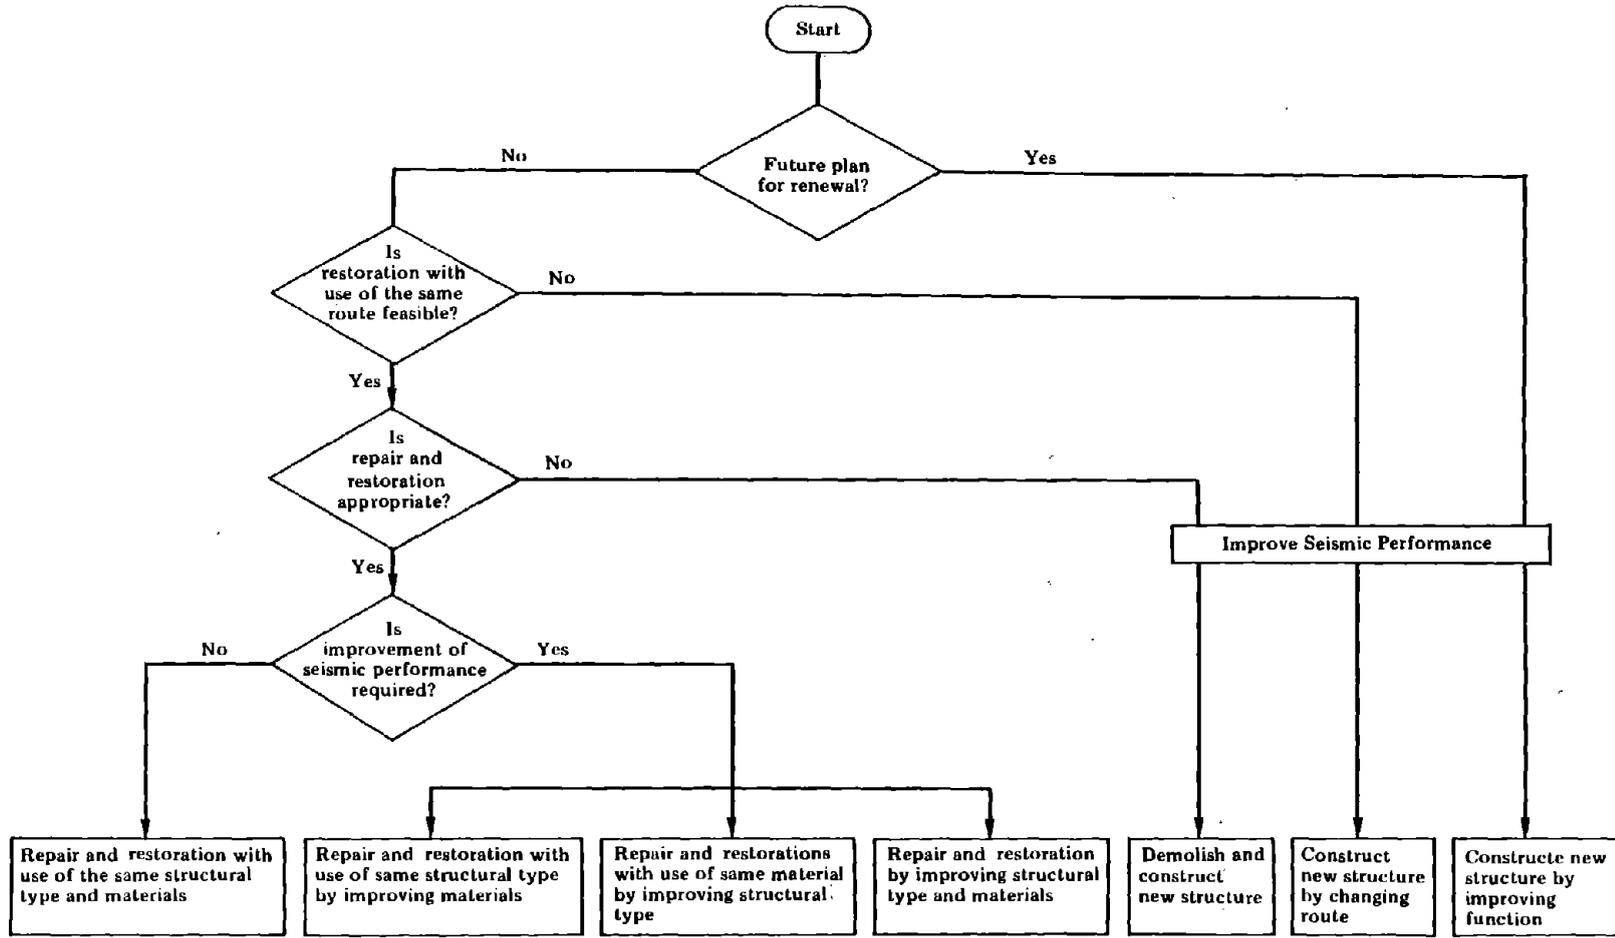
Fig. 2-2 Classification of Permanent Repair and Restoration

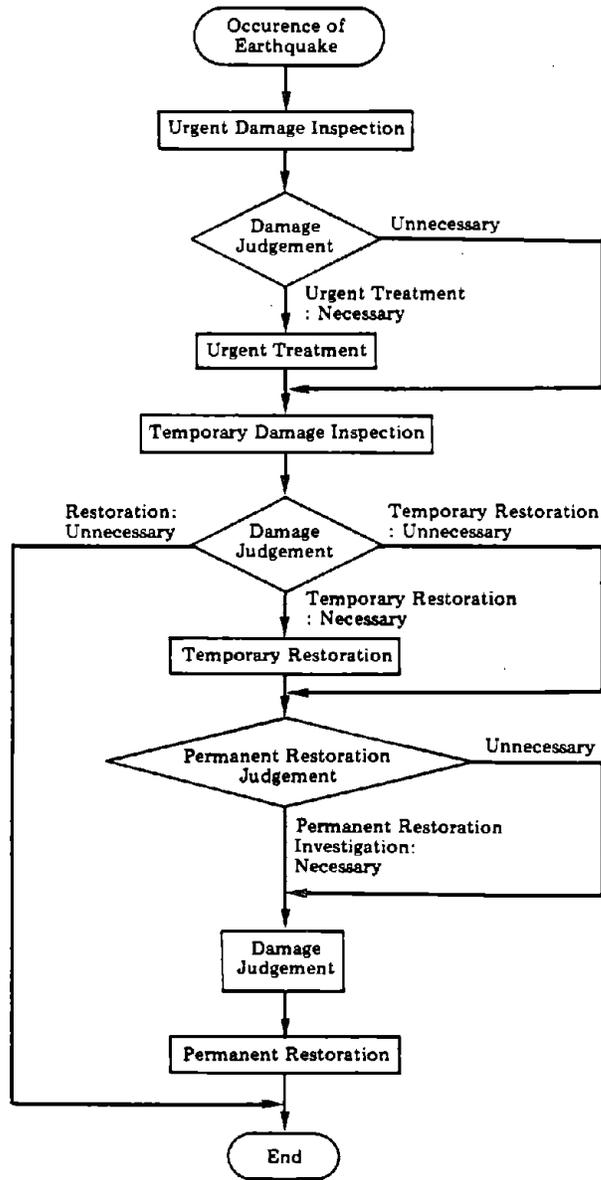
Fig. 3.1 Working Flow from Earthquake Occurrence to Inspection and Restoration

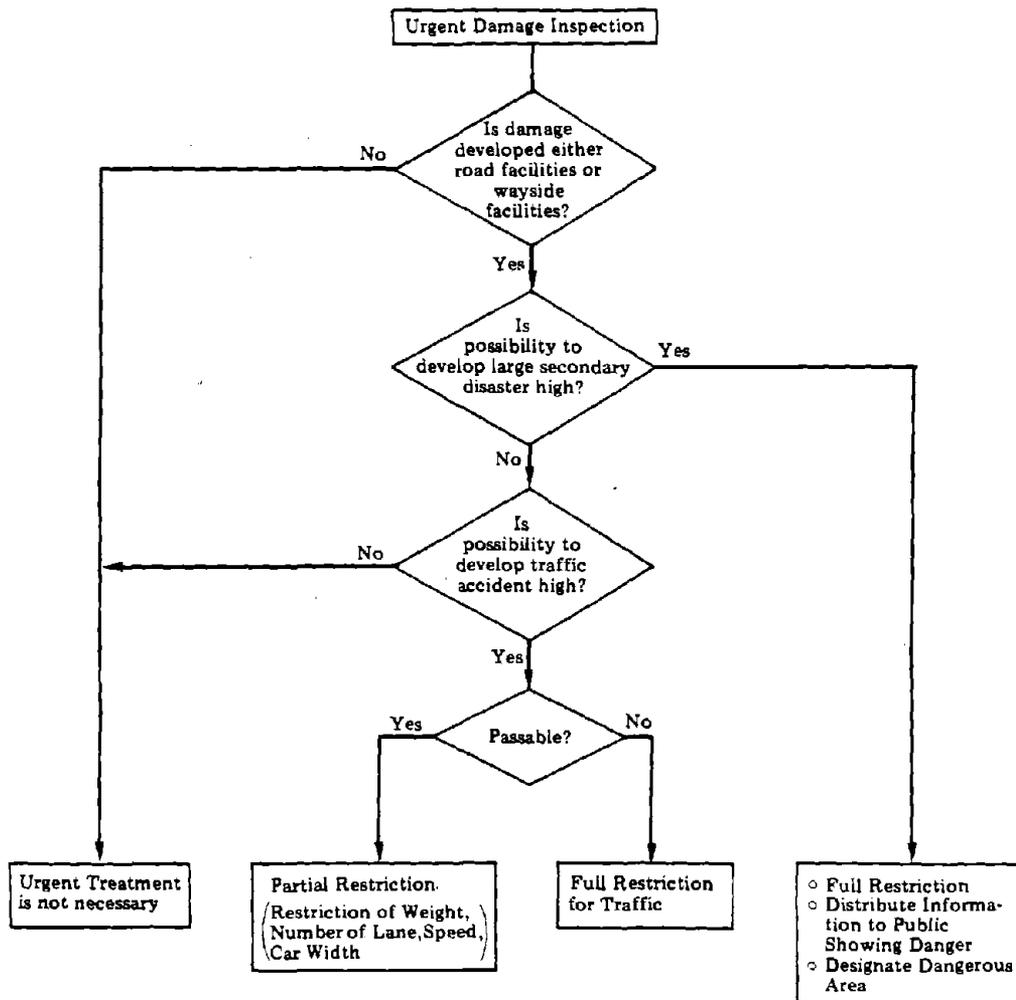
Fig. 4-1 Flow of Urgent Damage Inspection and Urgent Treatment

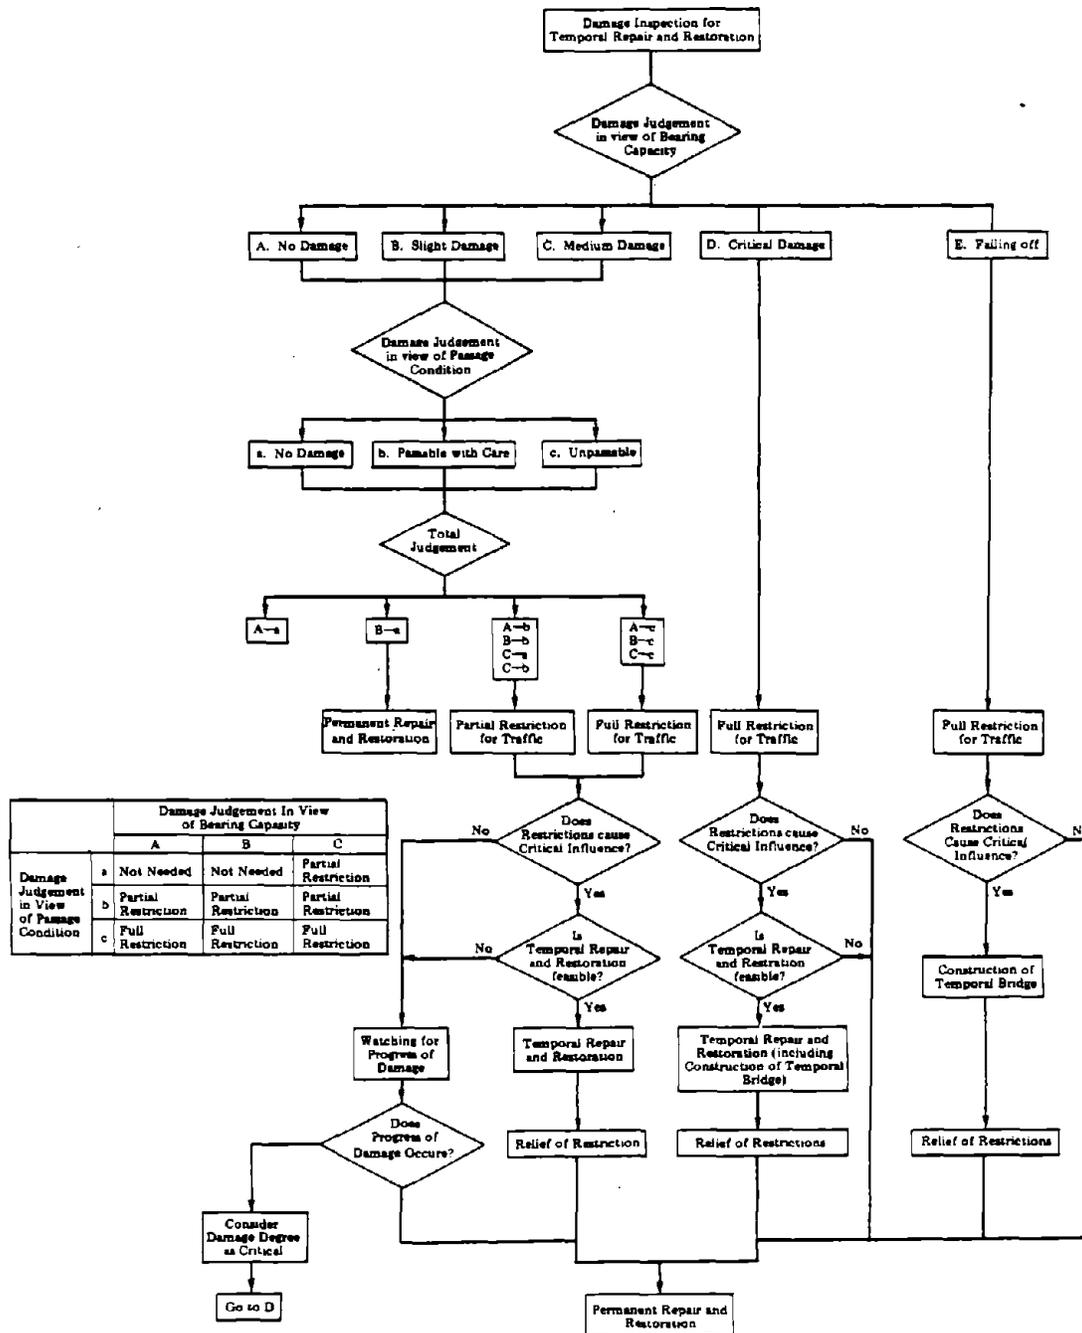
Fig. 4-3 Flow of Damage Judgement for Temporal Repair and Restoration of Bridge

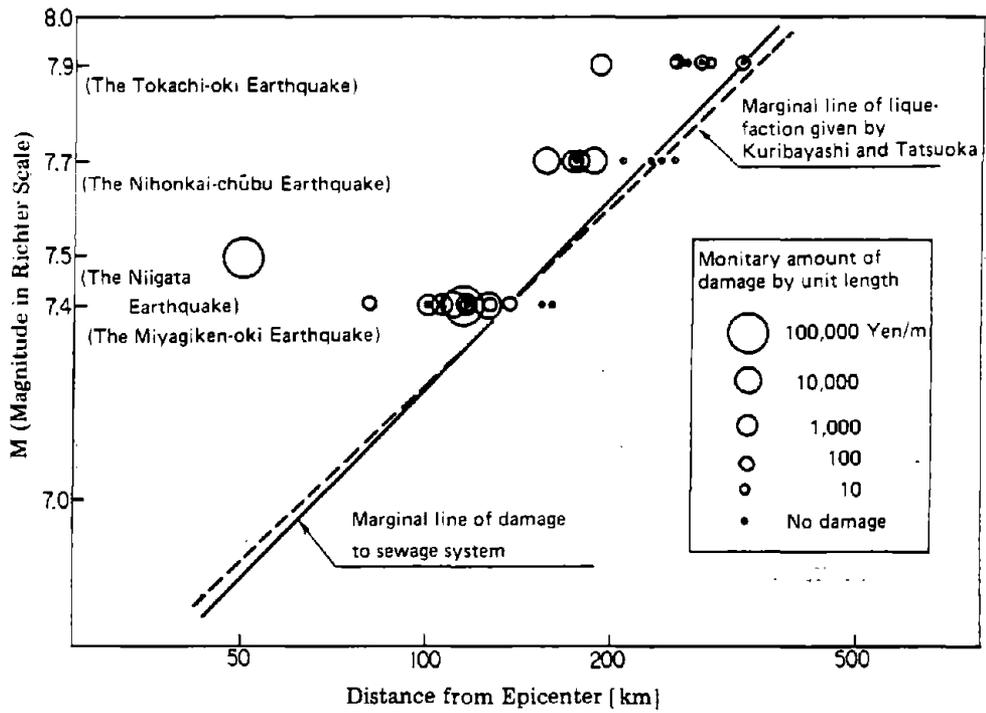
Fig. 5.1 Ground Motion to Cause Damage of Sewage System

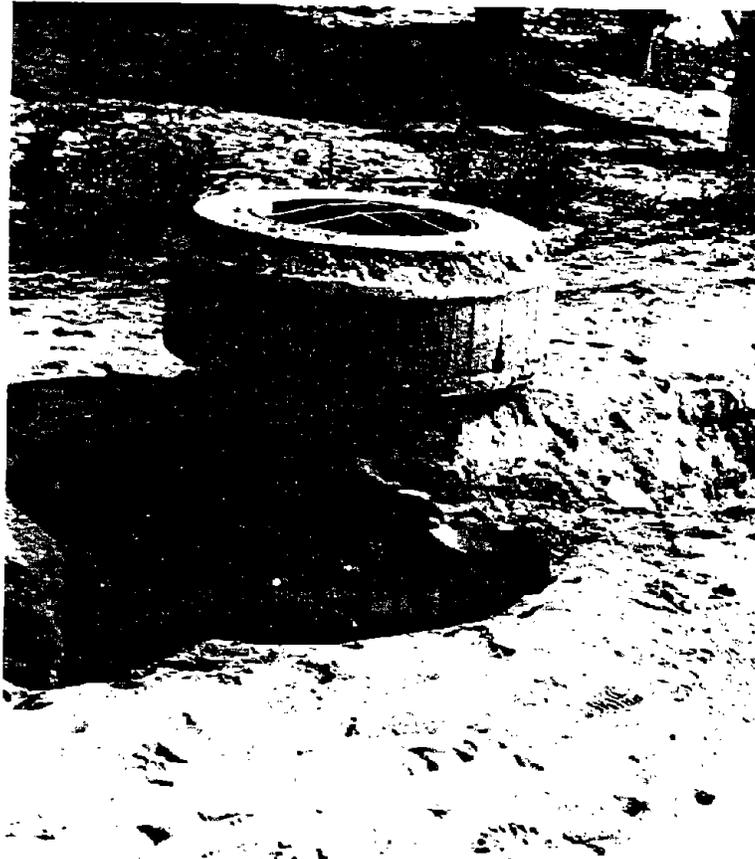
(a) Uplift movement of manhole

Fig. 5.2 Damage of Sewage Facility due to the Ground Liquefaction

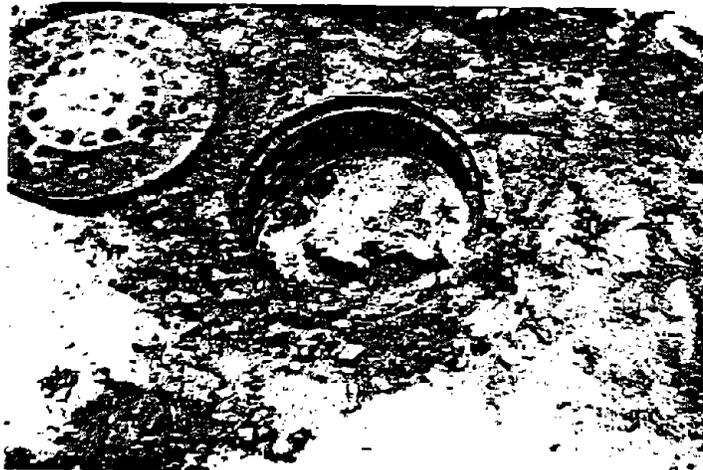
(b) Sand sedimentation in a manhole

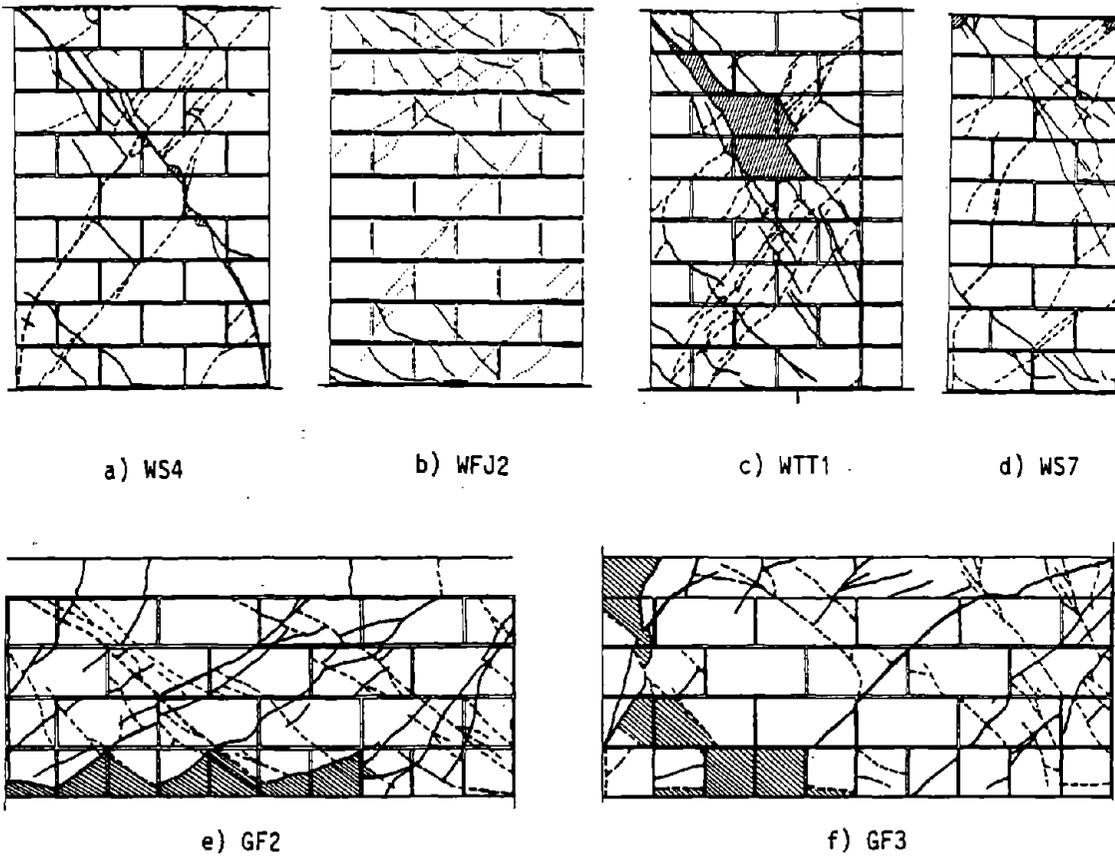
Fig. 4 Crack Pattern

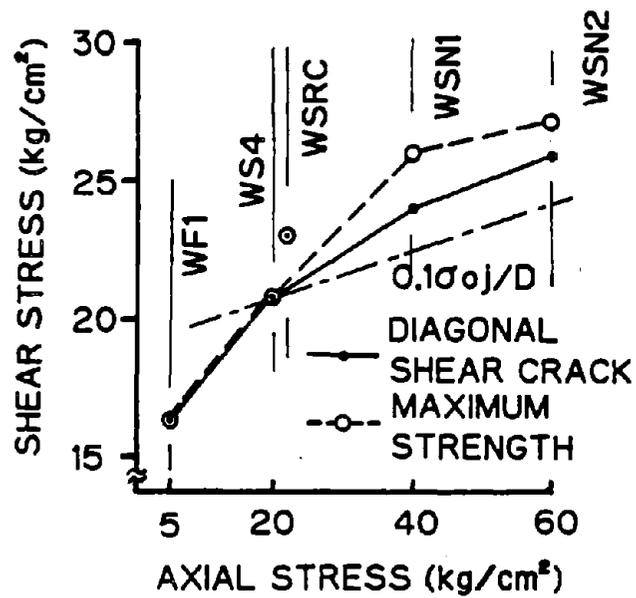
Fig. 5 Effect of Axial Stress

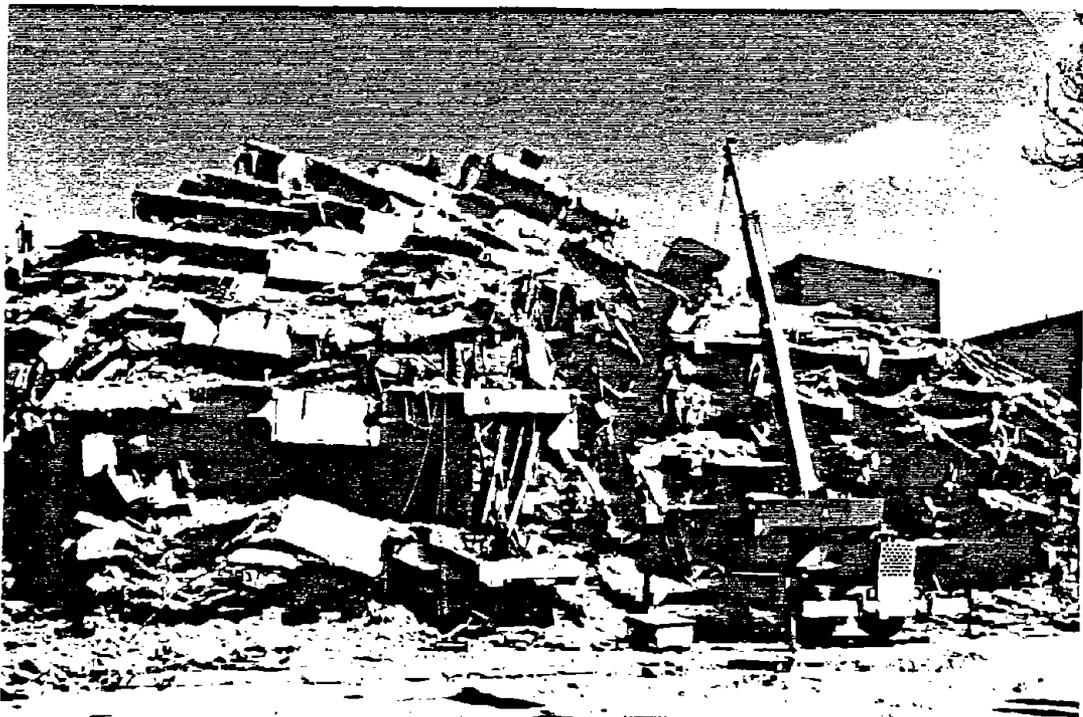
Juarez Hospital

Figure 11. Examples of hospital damage.

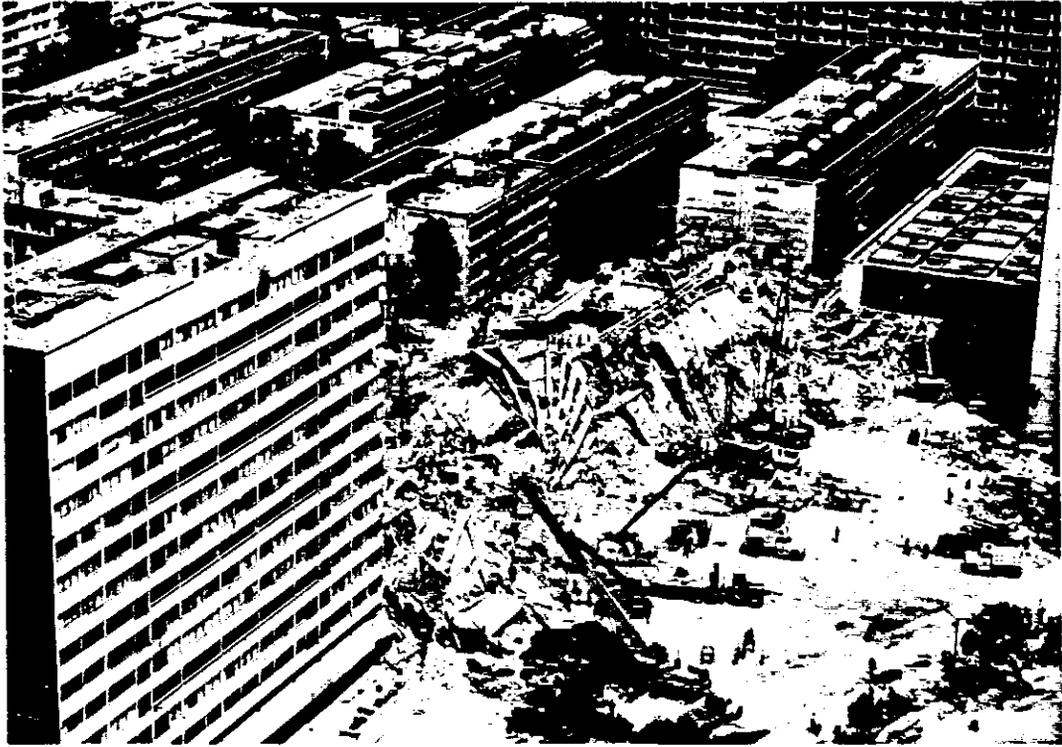
Nuevo Leon

Figure 12. Examples of housing damage.

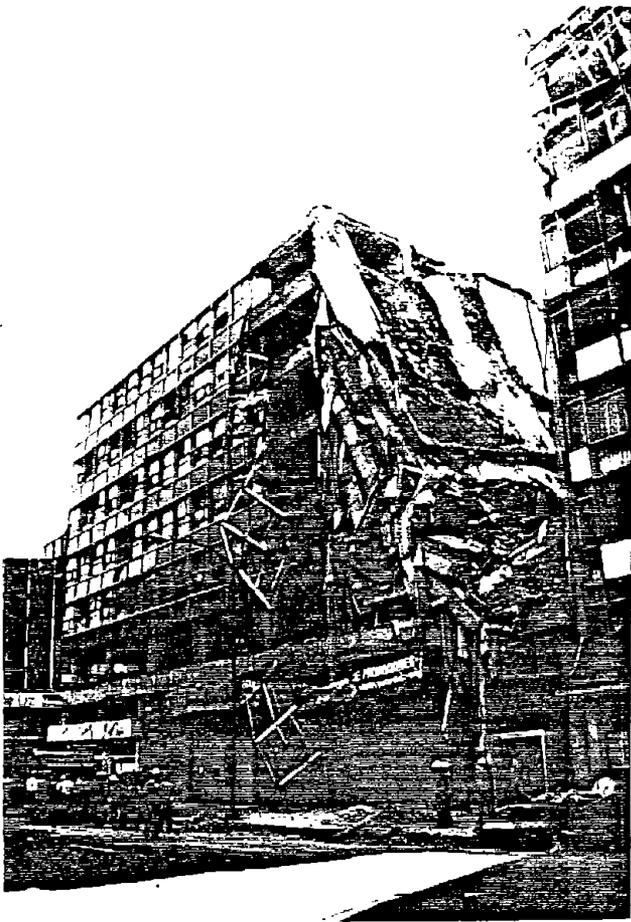
Pounding of equal height buildings

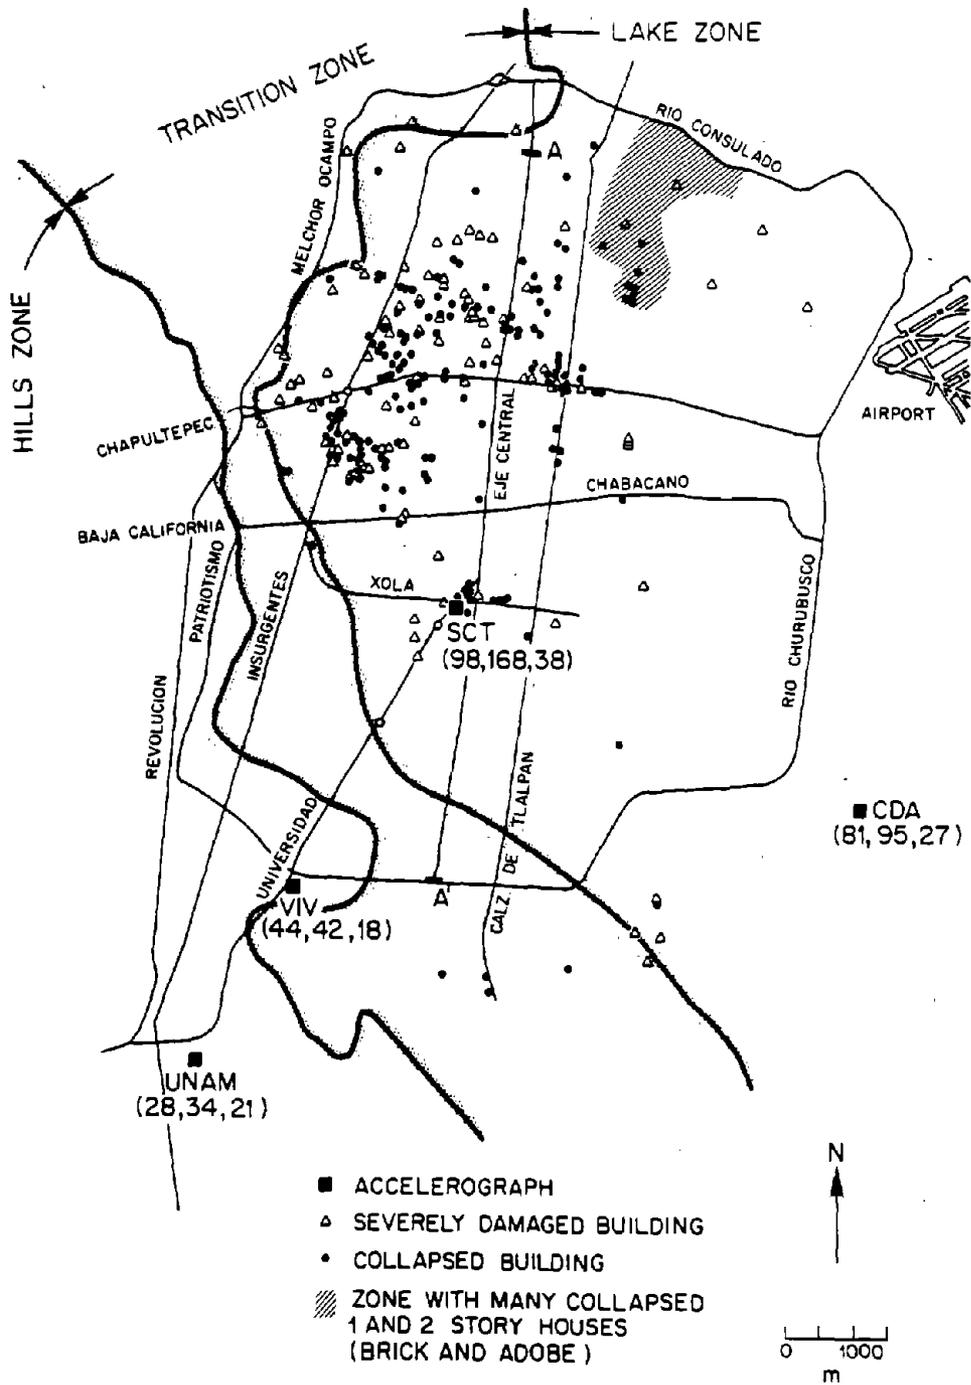
Figure 3. Mexico City map showing free-field accelerograph stations, generalized soil classification, and sites of worst building damage from Instituto de Ingenieria (1985) preliminary report. Peak accelerations ( $\text{cm}/\text{sec}^2$ ) for the north, east, and vertical components, respectively, are given in parentheses by each station.
