NBSIR 87-3540

**WIND AND  
SEISMIC  
EFFECTS**

Proceedings  
of the  
Eighteenth  
Joint  
Meeting

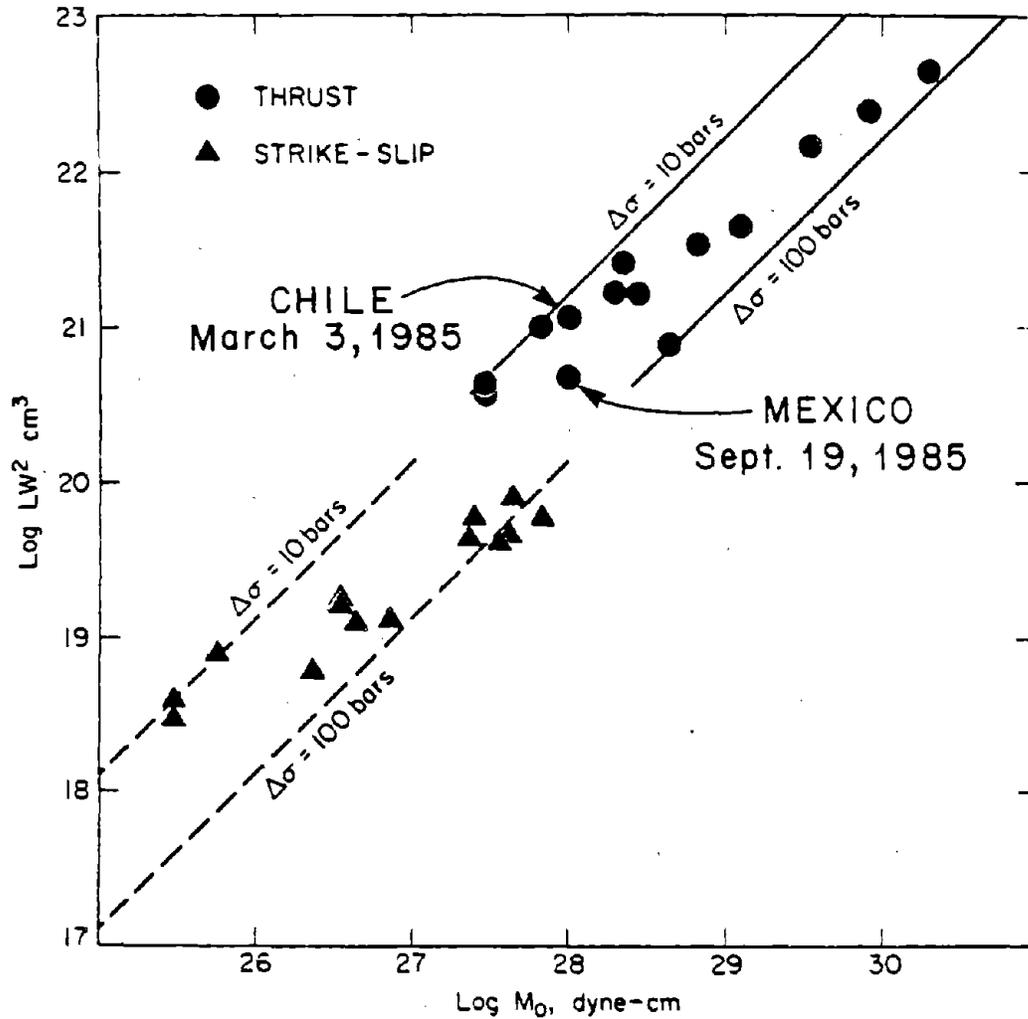
Figure 4. Plot of  $\log LW^2$  versus  $\log M_0$  for the large interplate earthquakes from the data set of Sykes and Quittmeyer (1981). The lines of slope 1 are constant stress drop lines, assuming  $C=0.6$  for the thrust events, and 0.3 for the strike-slip events (after Scholz, 1982).

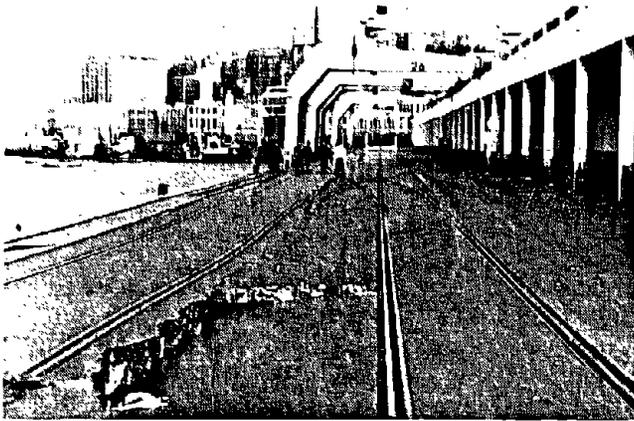
Photo 1 Damage to Apron and Crane Railing  
of Berth 8 at Valparaiso Port

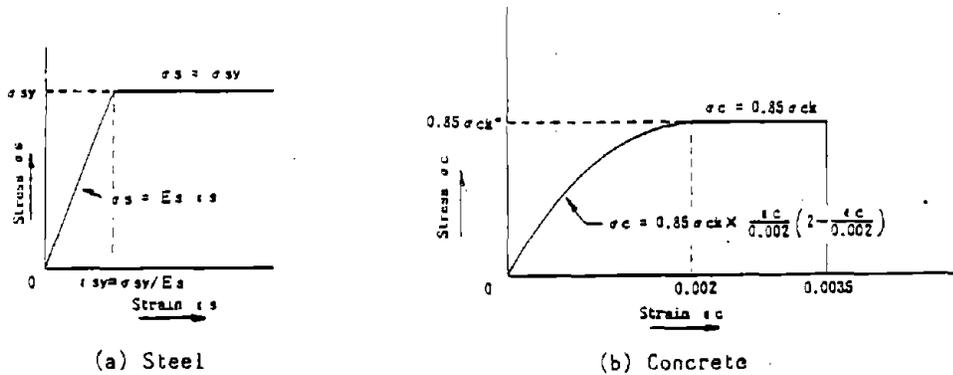
Fig.5 Stress-Strain Curve

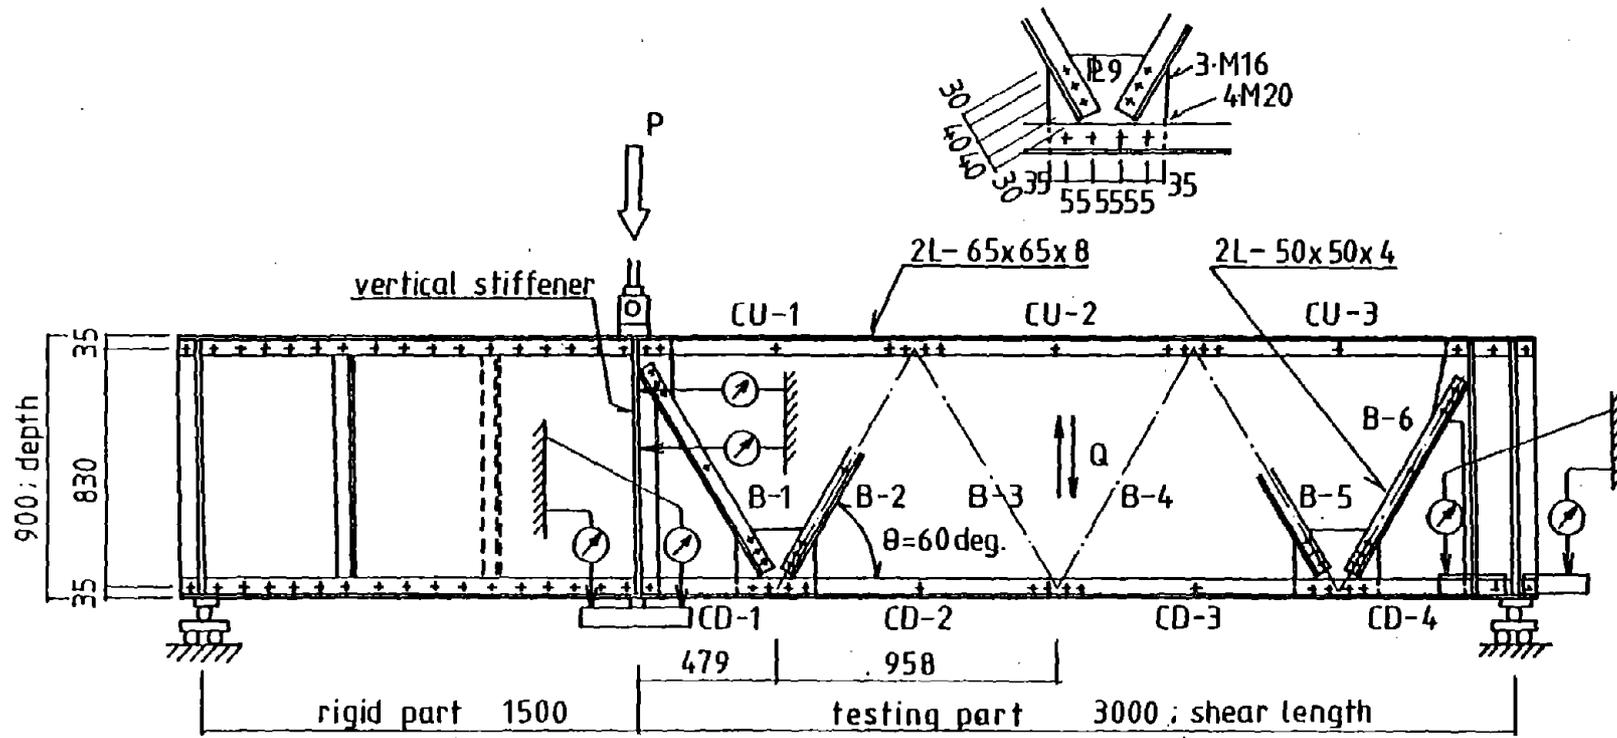
FIG. 1 TEST SPECIMEN, TEST SET-UP AND DEFORMATION MEASUREMENTS (SERIES 1)

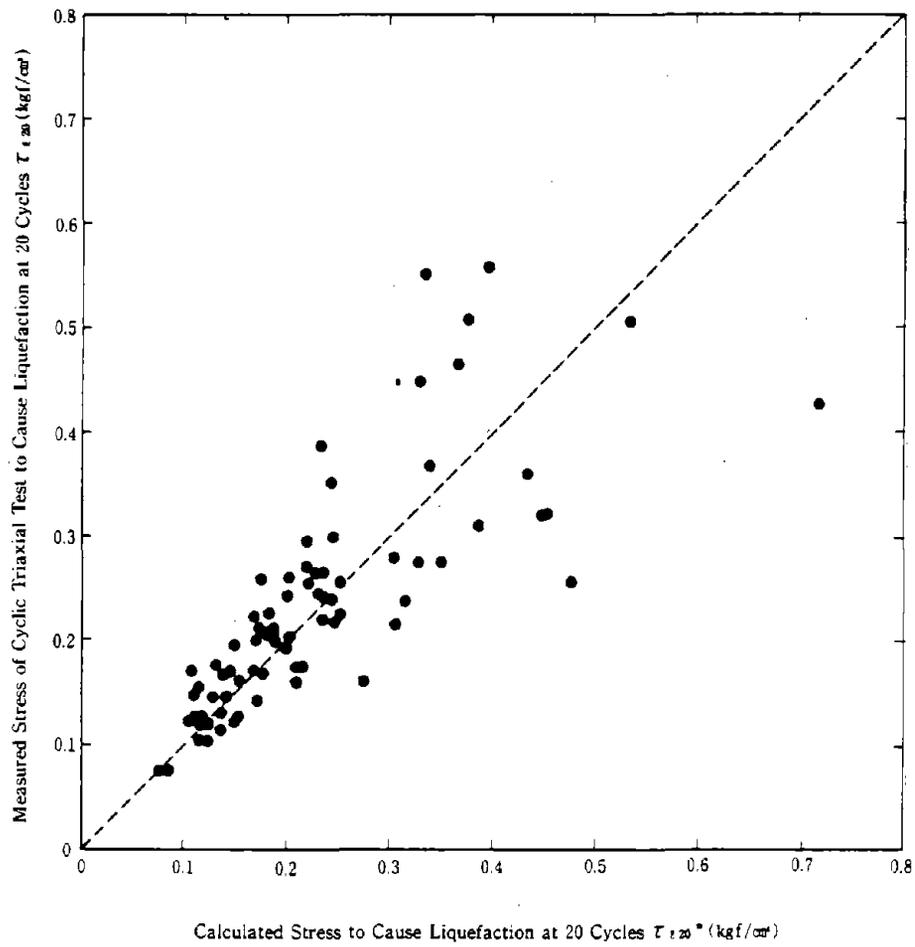
Fig. 5 Comparison of Measured and Calculated Stress to Cause Liquefaction

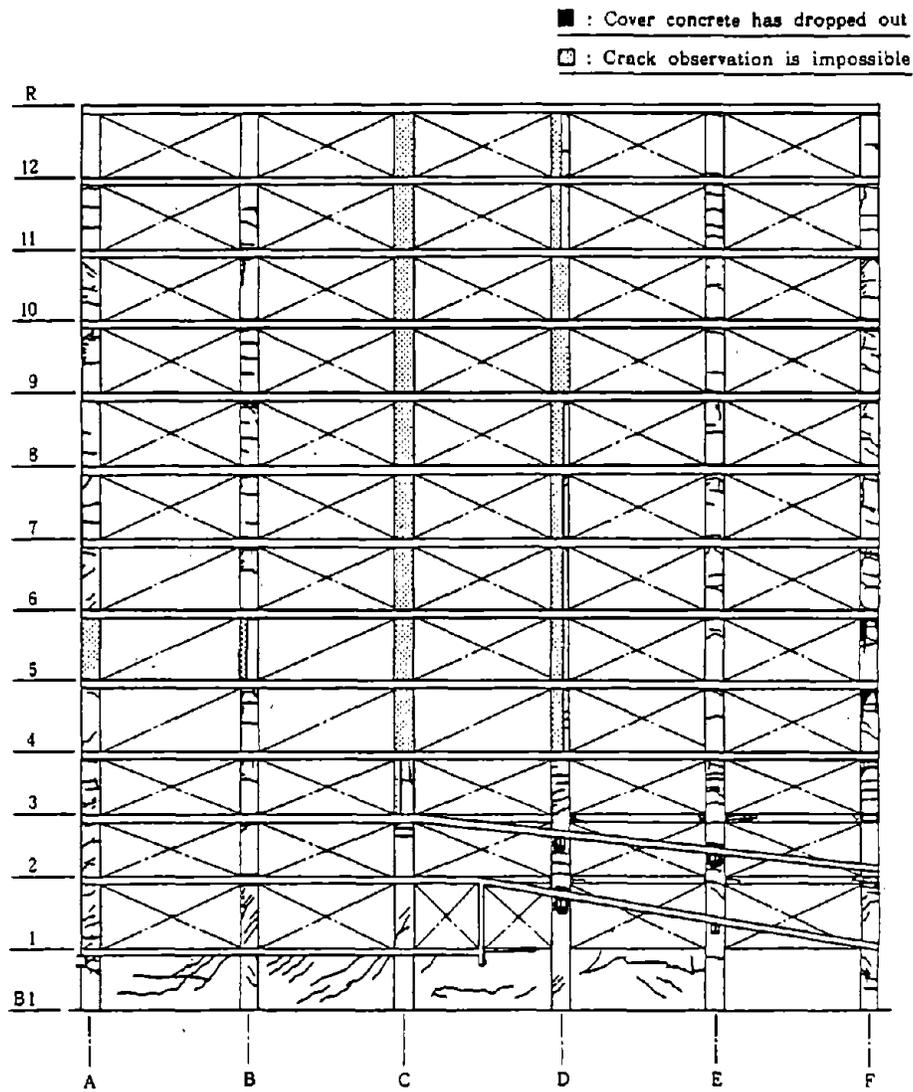
Fig. 2 Crack Pattern of 1 Frame (West Side)

■ : Cover concrete has dropped out  
 □ : Crack observation is impossible

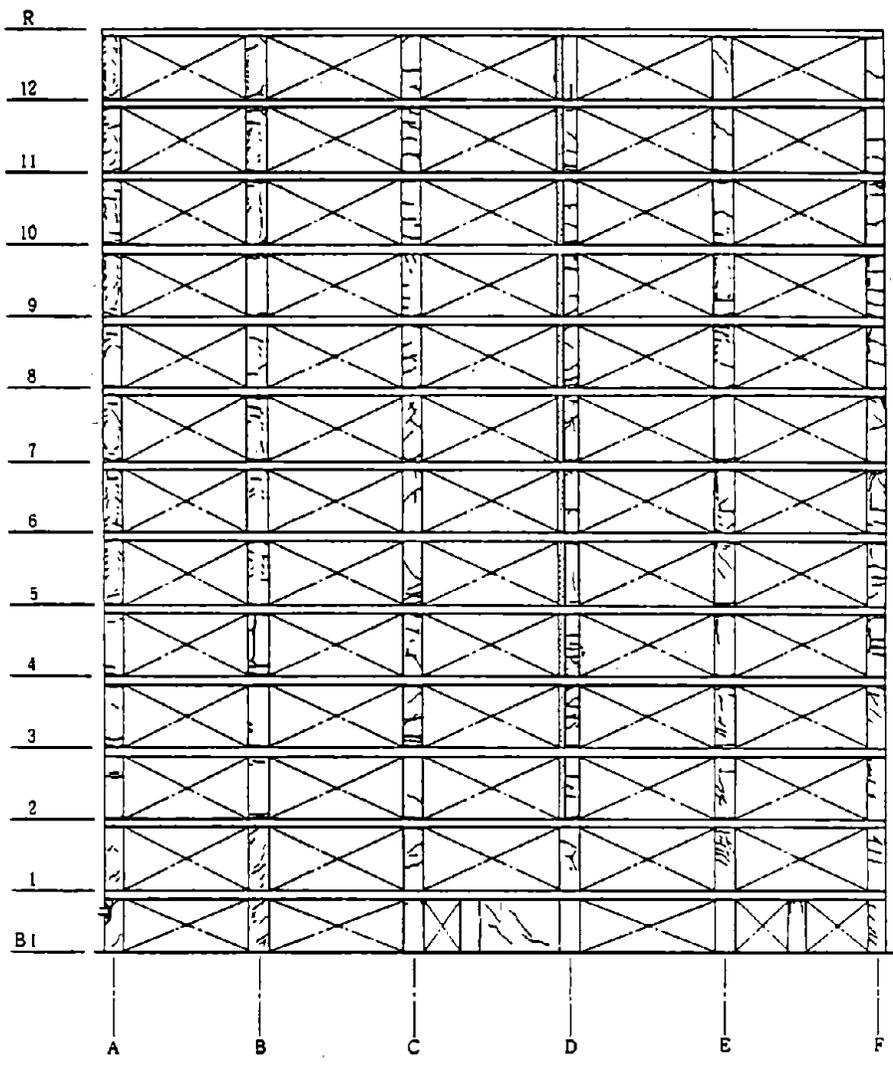
Fig. 3 Crack Pattern of 3 Frame (West Side)

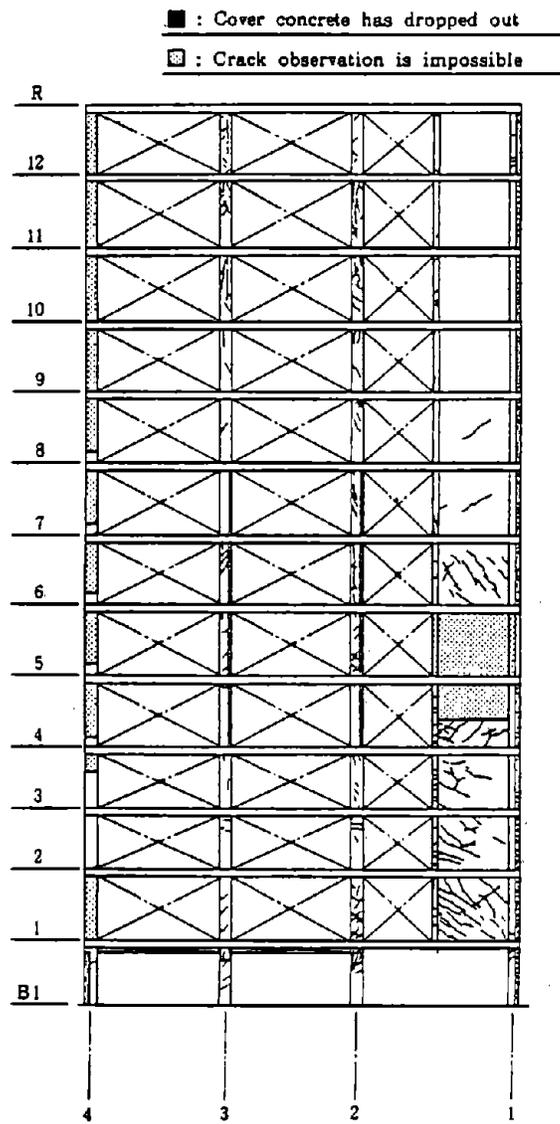
Fig. 4 Crack Pattern of A Frame (South Side)

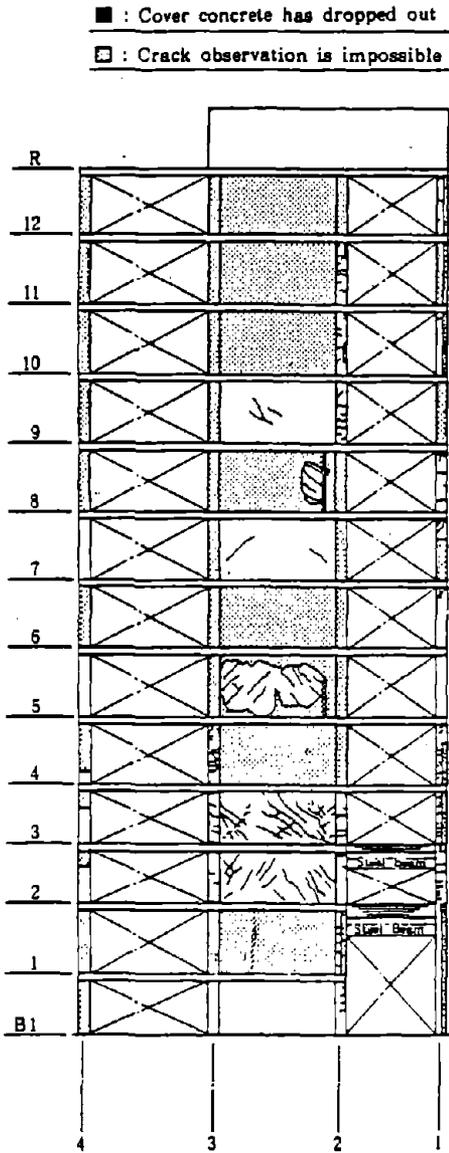
Fig. 5 Crack Pattern of D Frame (South Side)

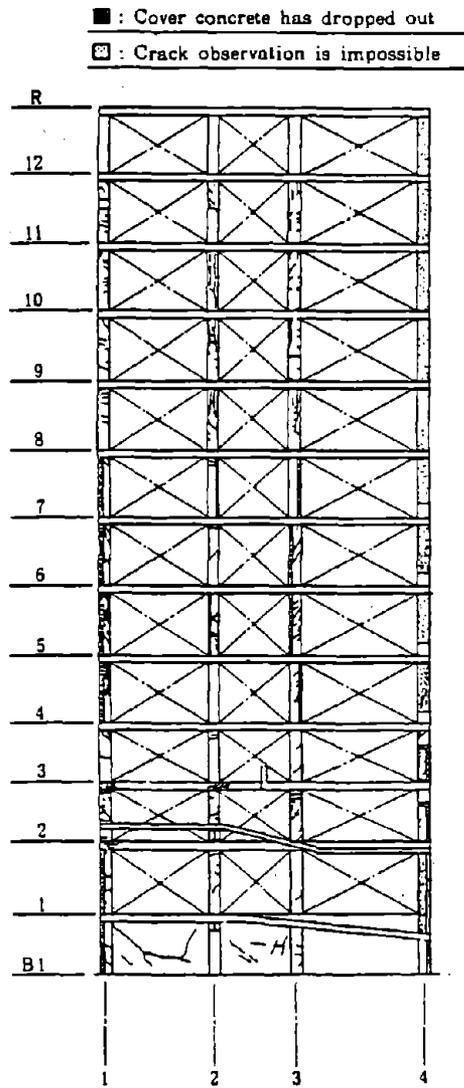
Fig. 6 Crack Pattern of F Frame (North Side)

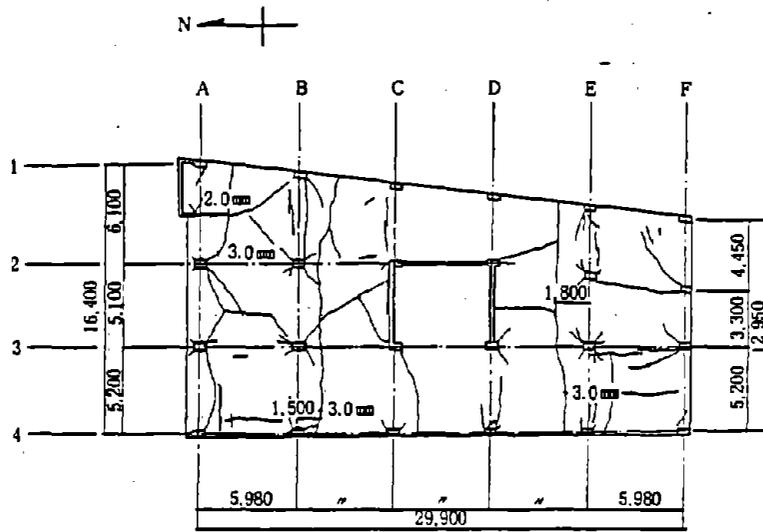
Fig. 7 Crack Pattern of 10th Floor System (Upper)

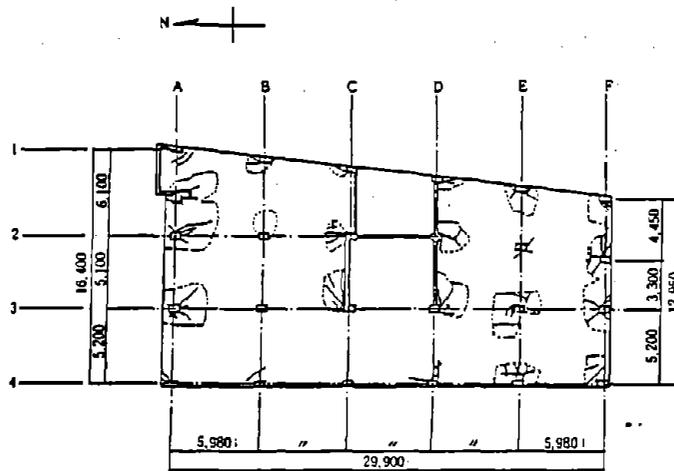
Fig. 8 Crack Pattern of 10th Floor System (Bottom)

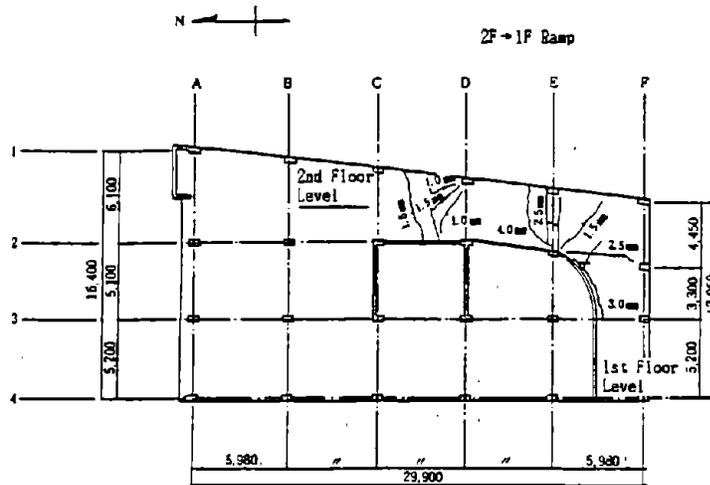
Fig.11 Crack Pattern of Ramp

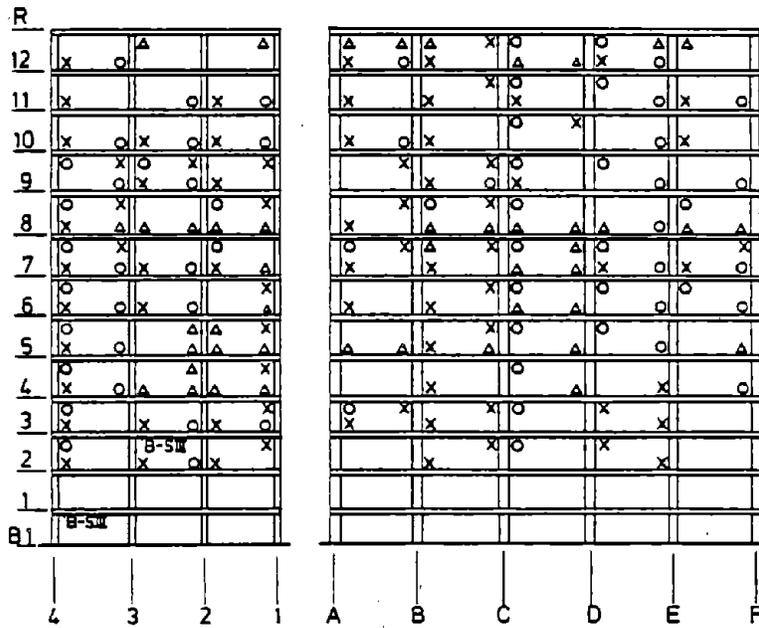
Fig.14 Failure Mechanism
