Wind and Seismic Effects

Proceedings of the 23rd Joint Meeting

NIST SP 820

PROCEEDINGS OF
THE 23RD JOINT
MEETING OF
THE U.S.-JAPAN
COOPERATIVE PROGRAM
IN NATURAL RESOURCES
PANEL ON WIND AND
SEISMIC EFFECTS

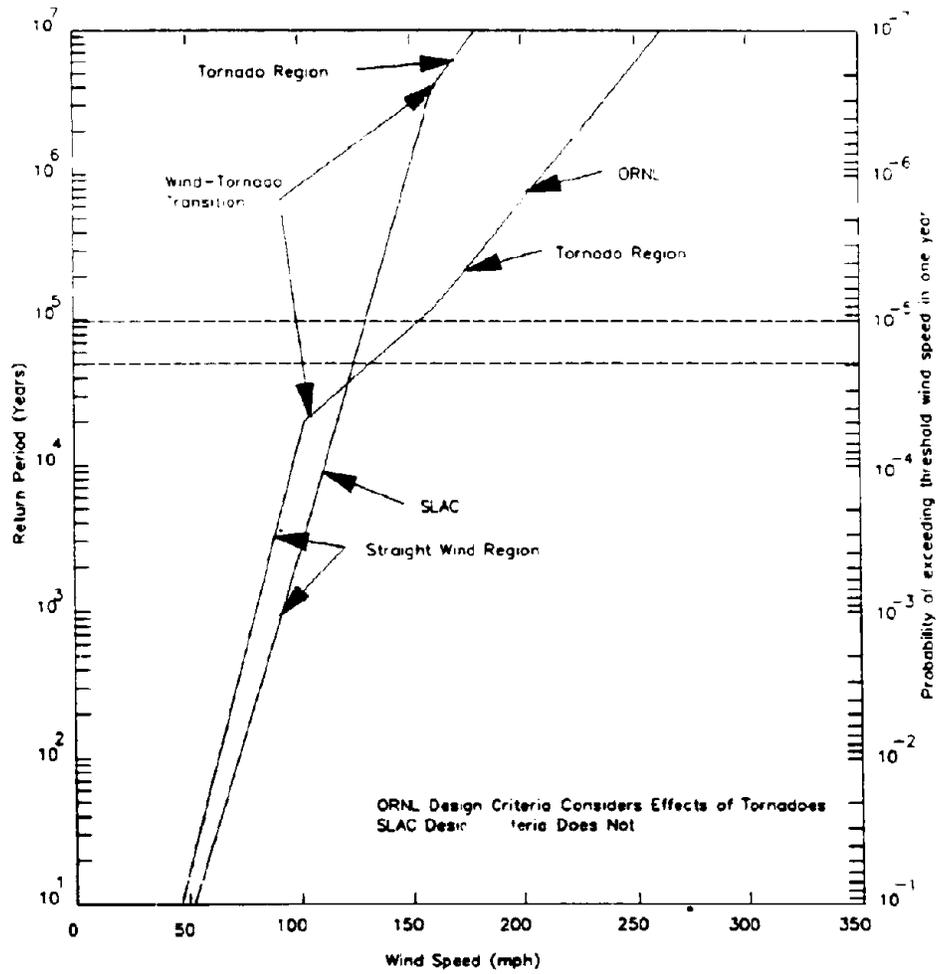
Figure 1. Straight Wind and Tornado Regions of Wind Hazard Curves

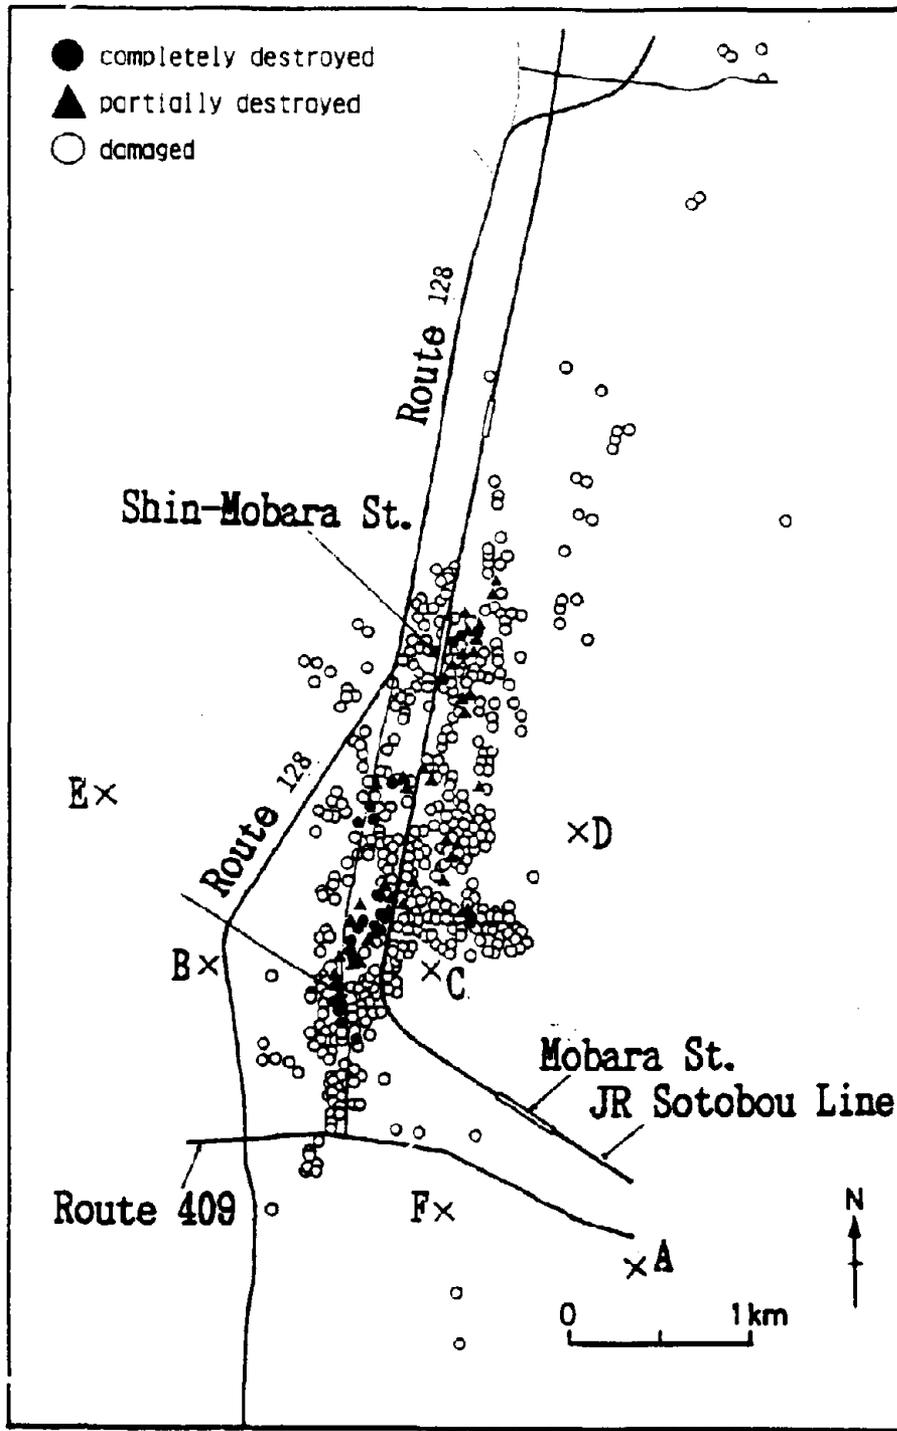
Fig. 3: Damage distribution in the Mobarra City.

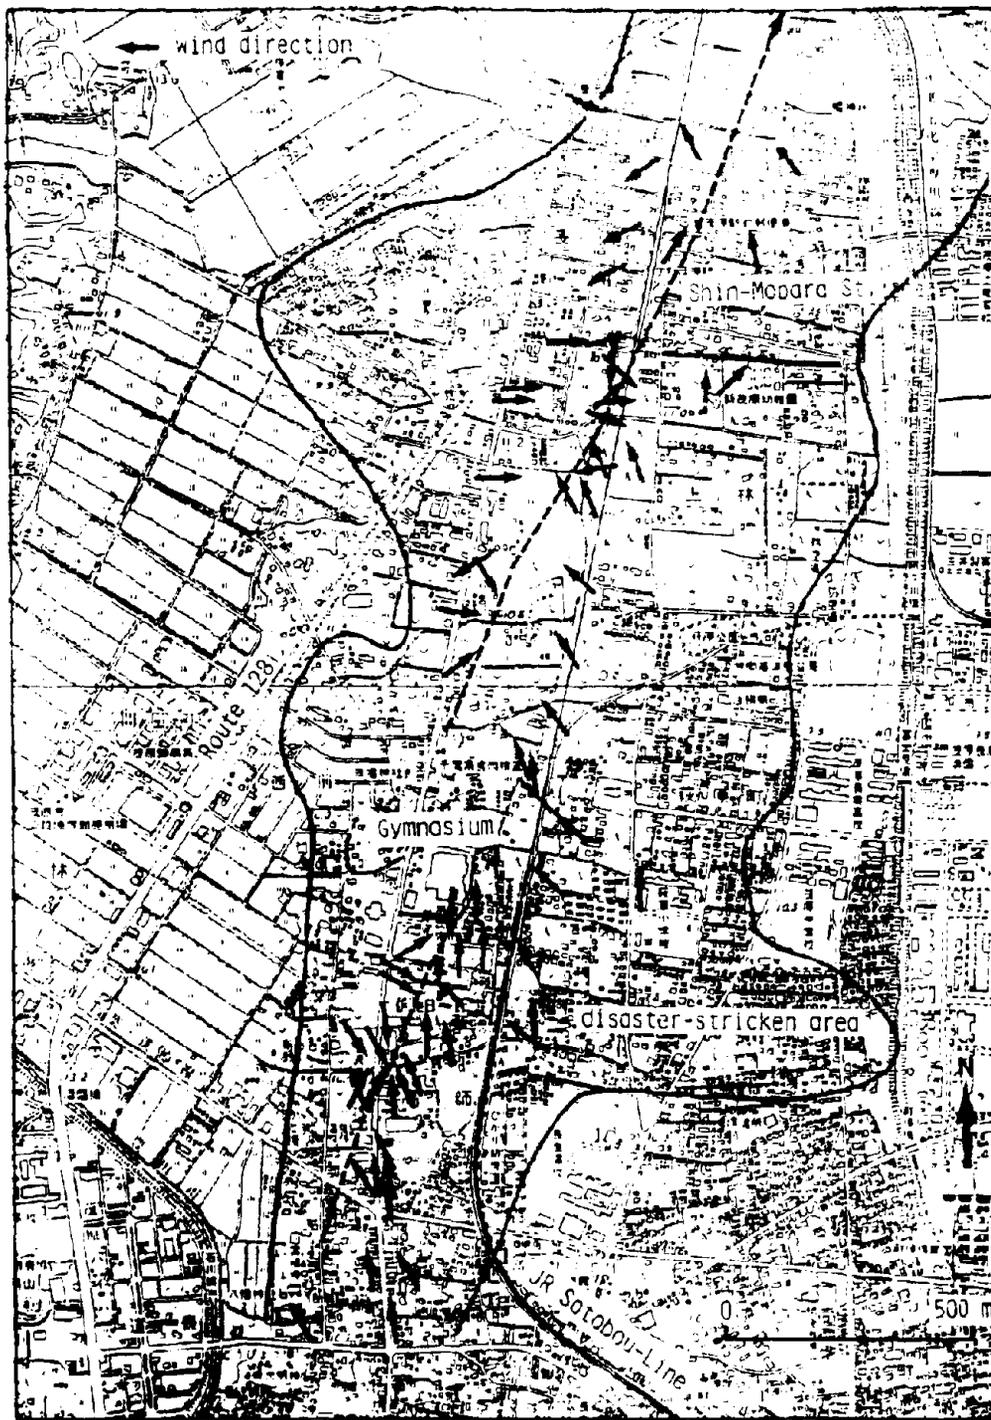
Fig. 5: Distribution of estimated wind directions and the tornado path.

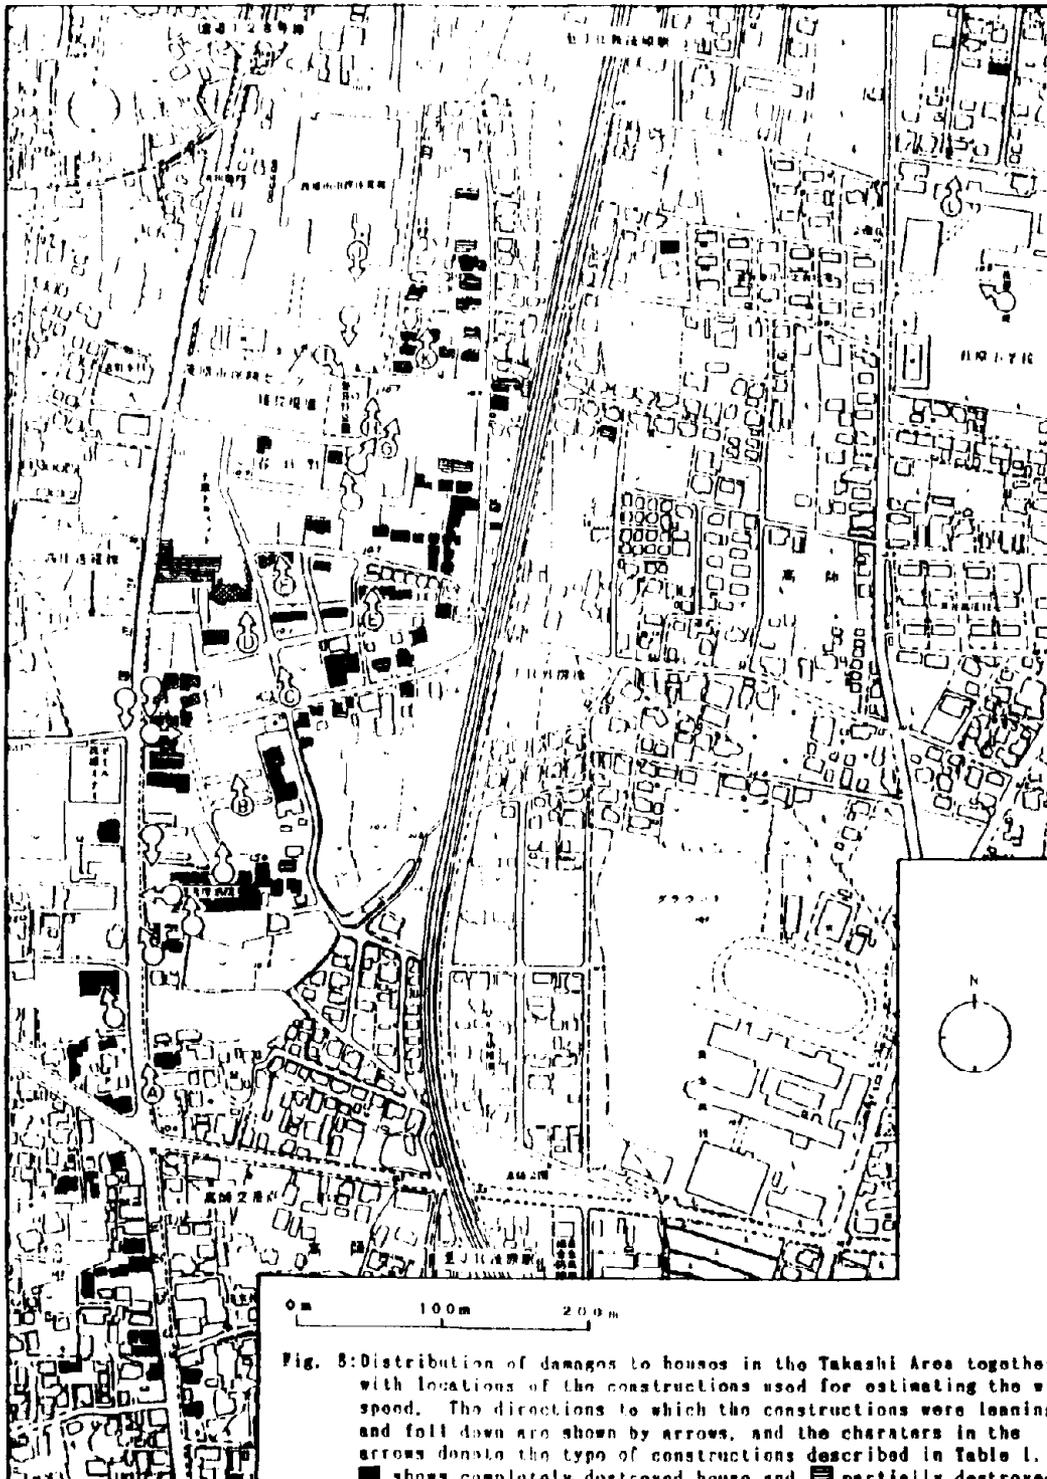
Fig. 8: Distribution of damages to houses in the Takashi Area together with locations of the constructions used for estimating the wind speed. The directions to which the constructions were leaning and fell down are shown by arrows, and the characters in the arrows denote the type of constructions described in Table I.
 ■ shows completely destroyed house and ▨ partially destroyed house.

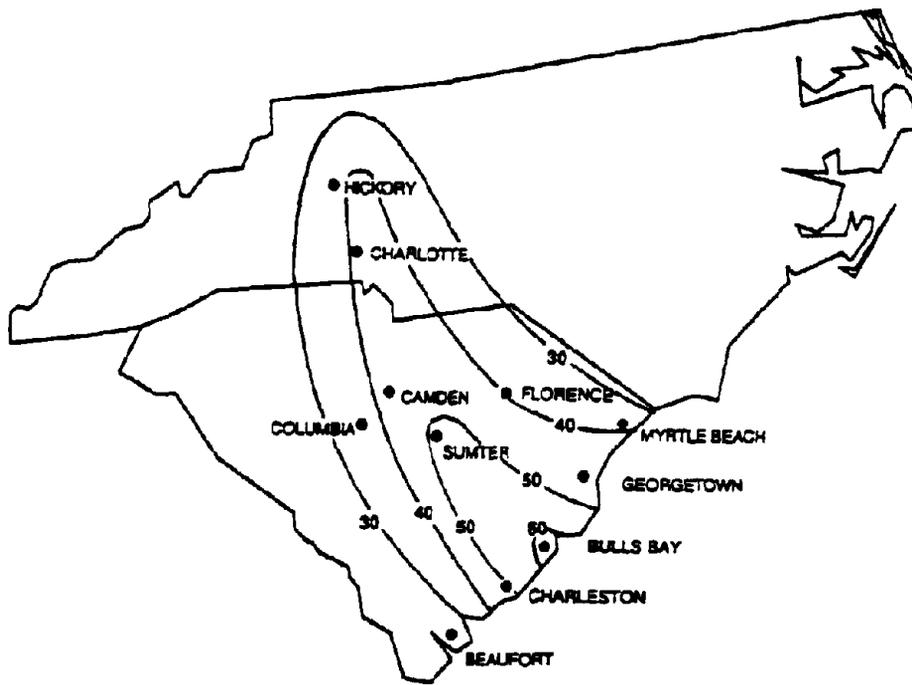
Figure 1. Probable Maximum Gust Wind Speeds (m/s)

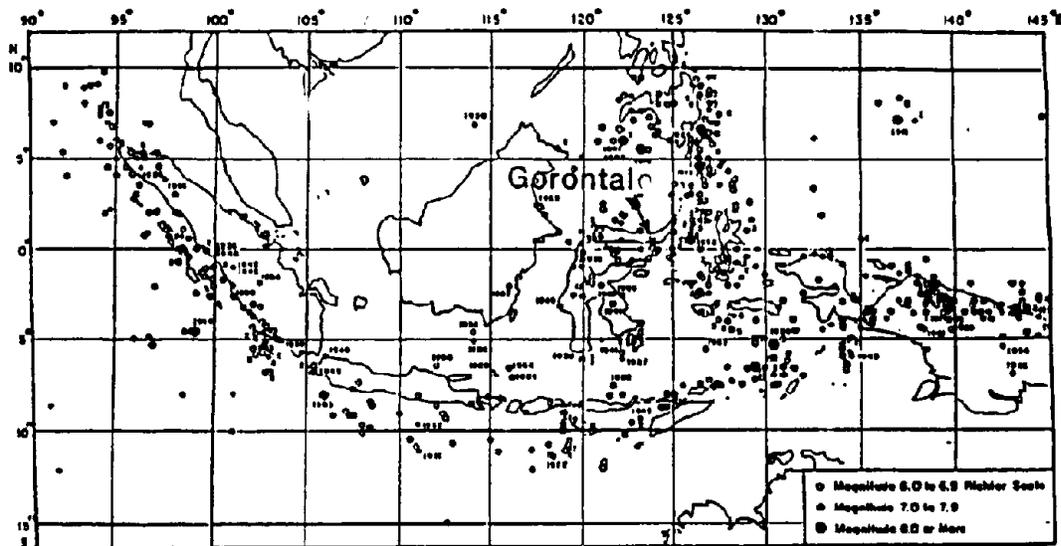
Figure 1. Seismicity of Indonesia showing the major shallow earthquakes 1897-1984 and the location of the selected study area. Note the high rate of seismicity in the Gorontalo area.

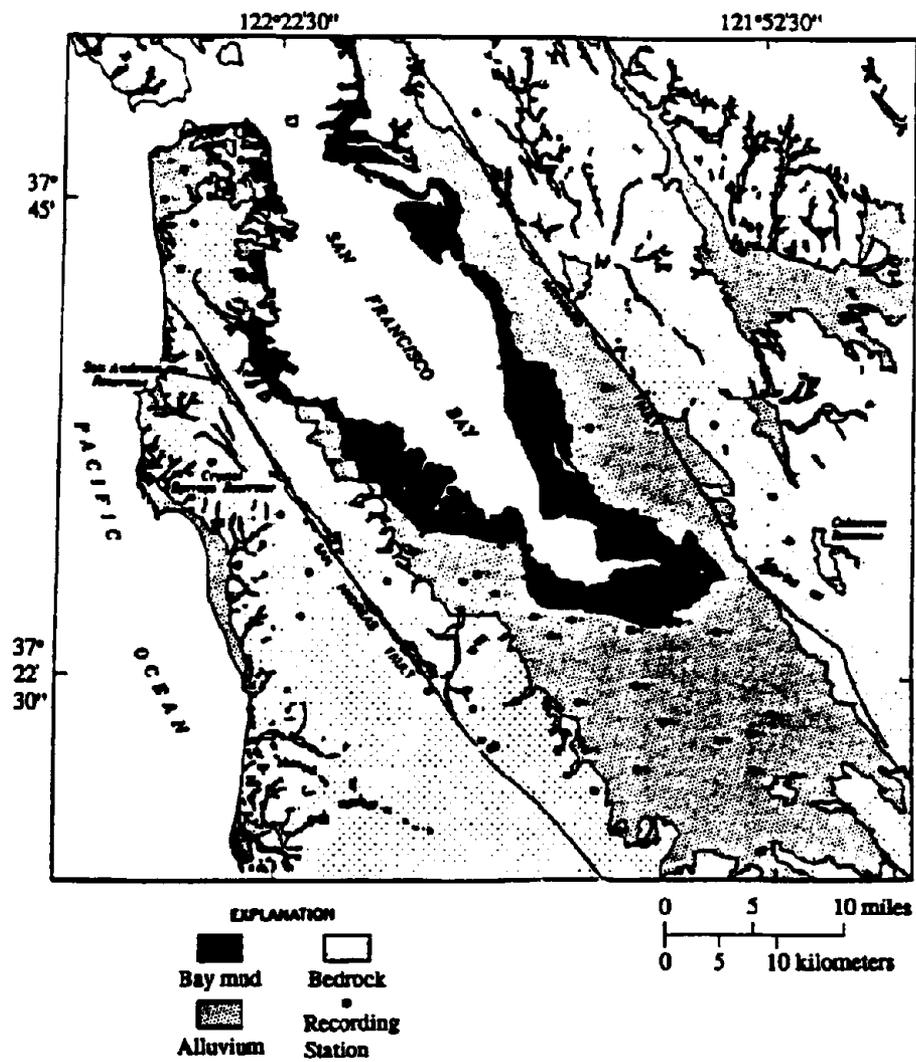
Figure 1. Geological conditions in the vicinity of San Francisco Bay (after Brocherdt, et al., Ref 8).

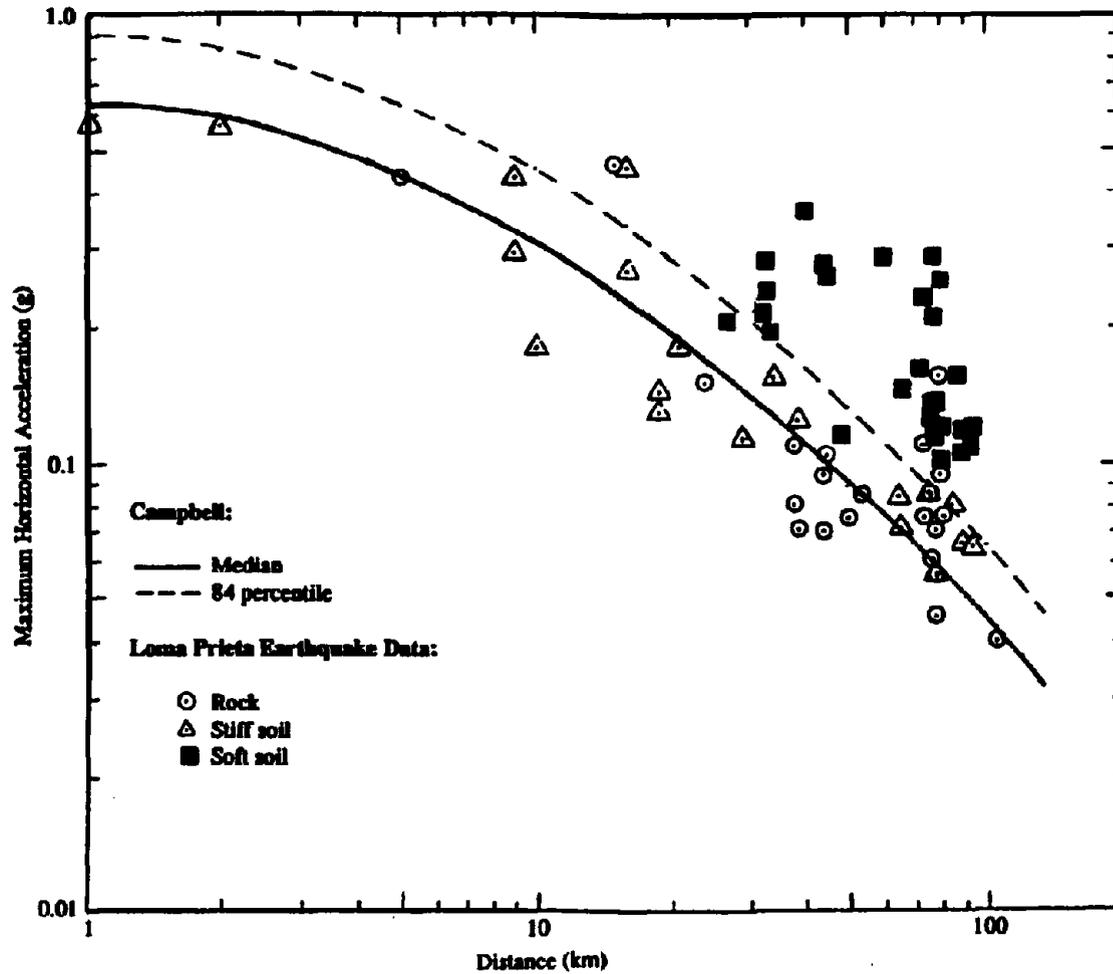
Figure 2. Comparison of maximum ground acceleration in 1989 Loma Prieta Northern California earthquake with those from Campbell's (Ref 11) attenuation equation.

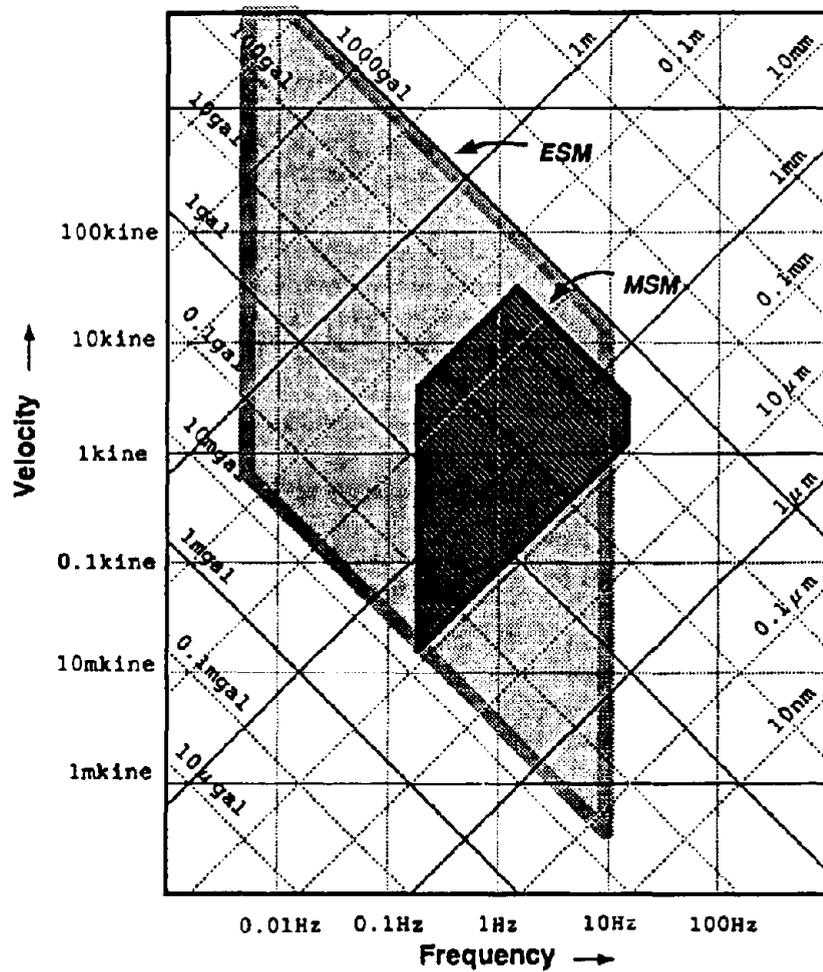
Fig. 1 Observational Domains in frequency and dynamic ranges of Mechanical Strong Motion seismograph (MSM) and Electromagnetic Strong Motion seismograph (ESM).

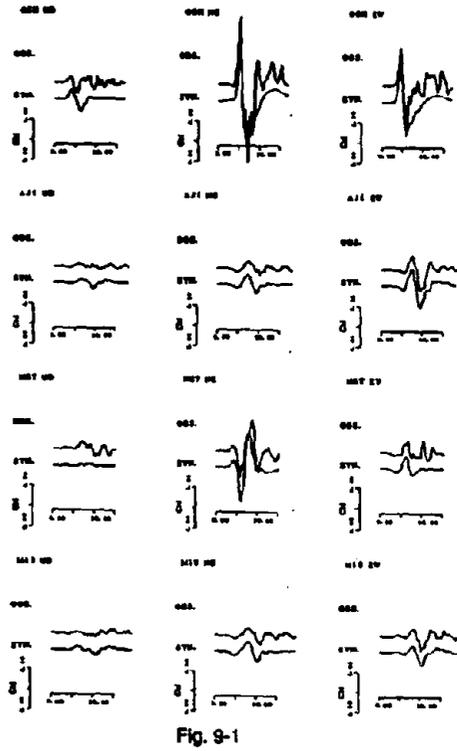
Fig. 9 Source process of 1990 near Izu-Oshima earthquake

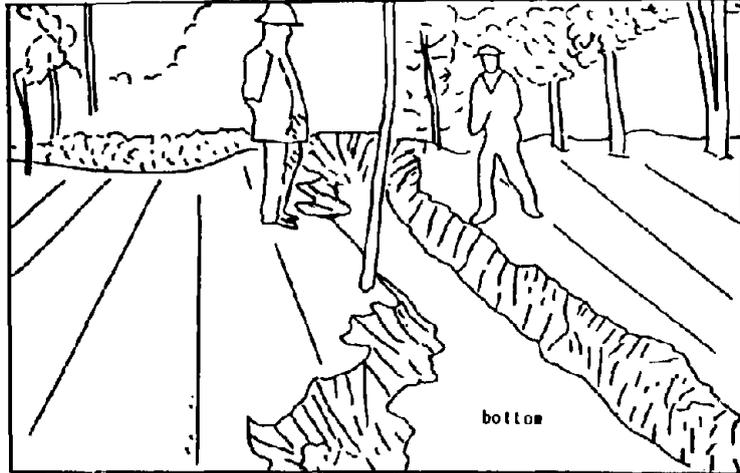
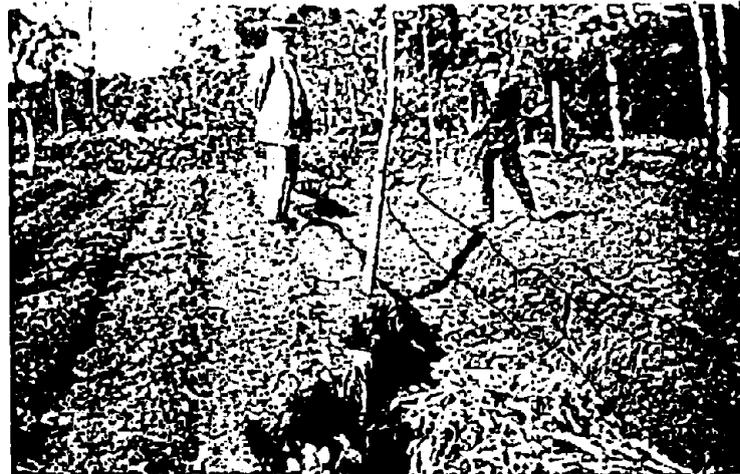
Figure 3. A crack at Kavakubo
Geological Survey Institute(1924)

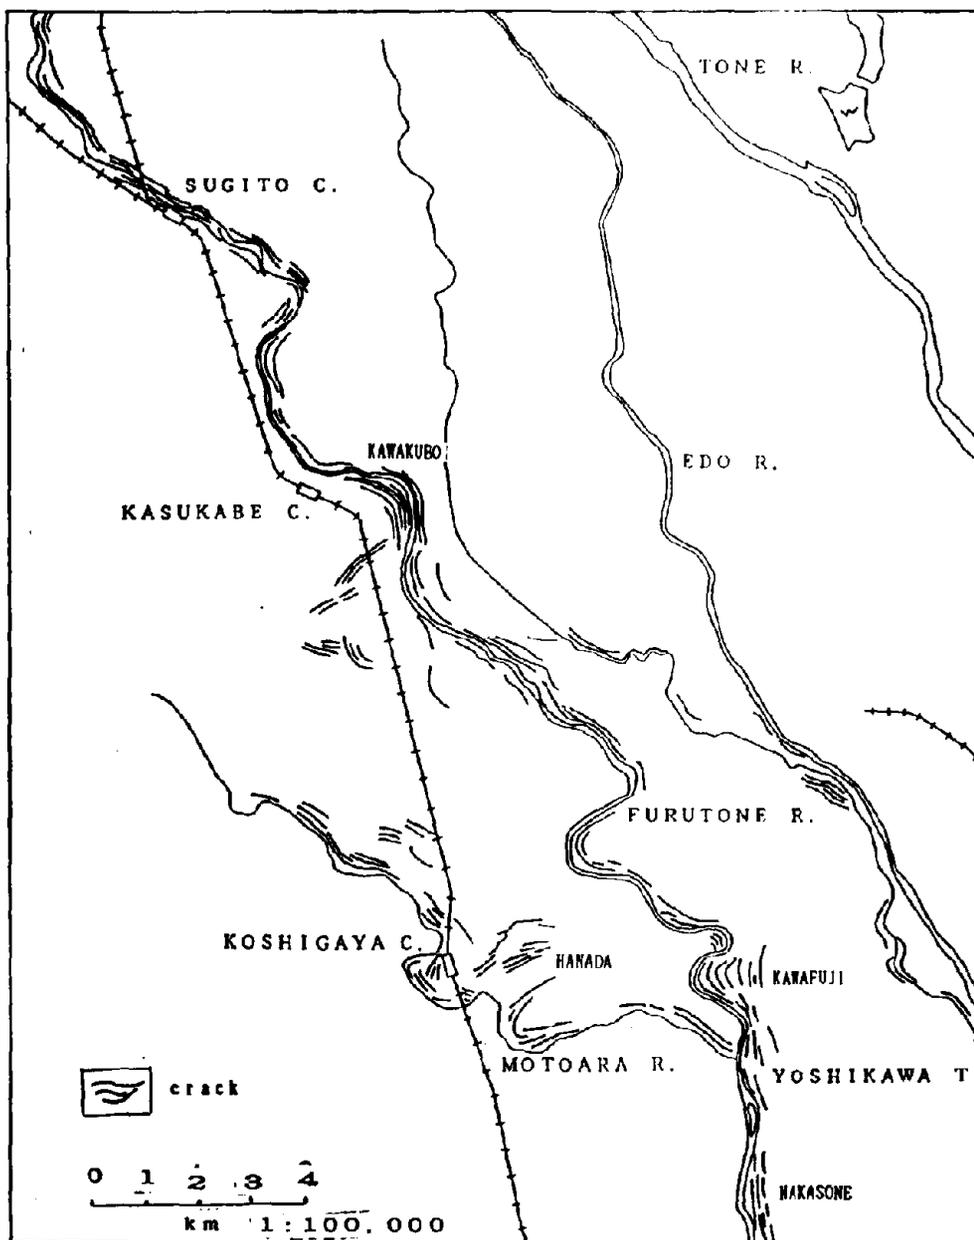
Figure 4. Distribution map of Cracks in the lowland
in the southern area of Saitama pref.

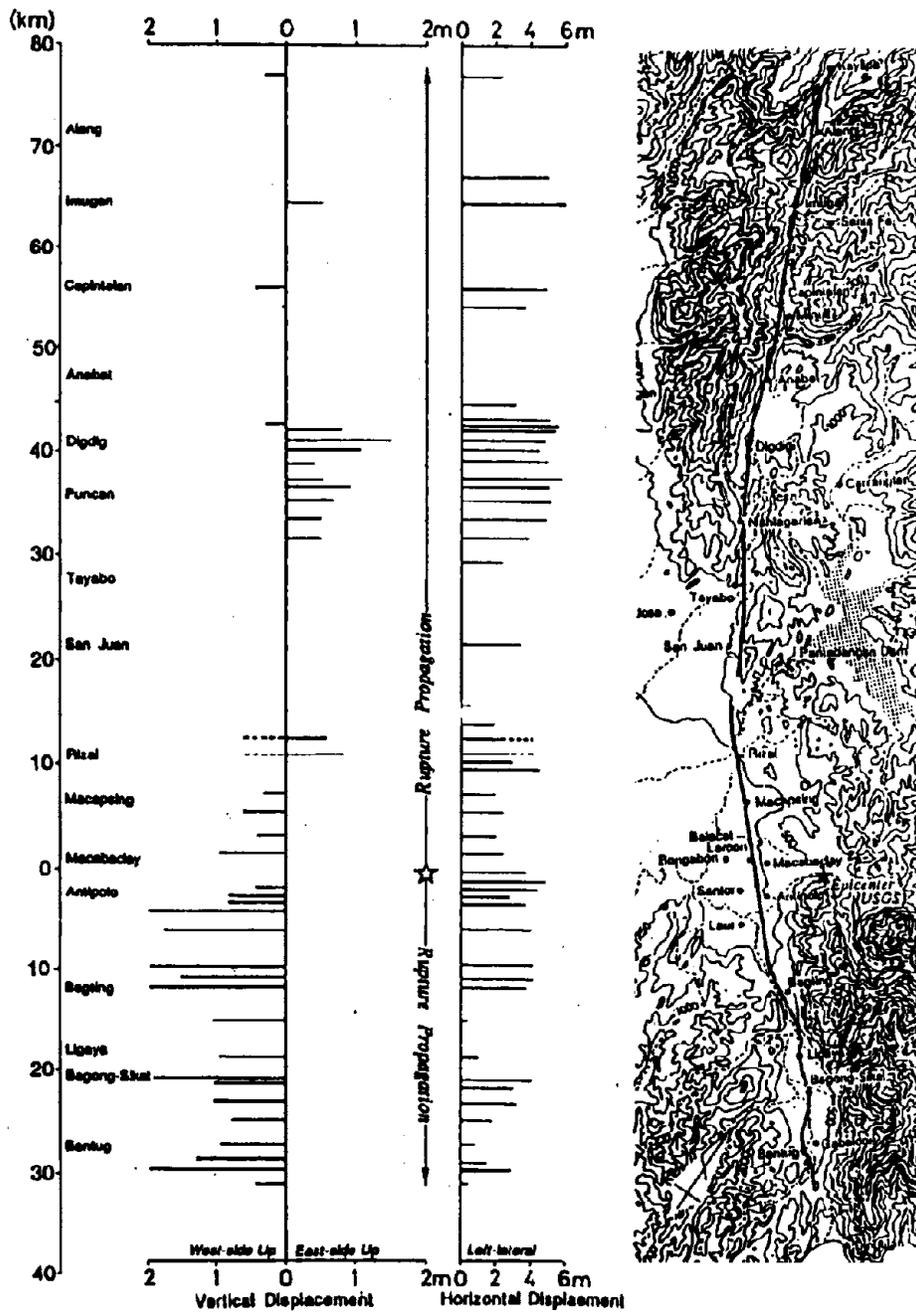
Fig. 2.4 Displacements along the Fault Caused by the 1991 July Earthquake

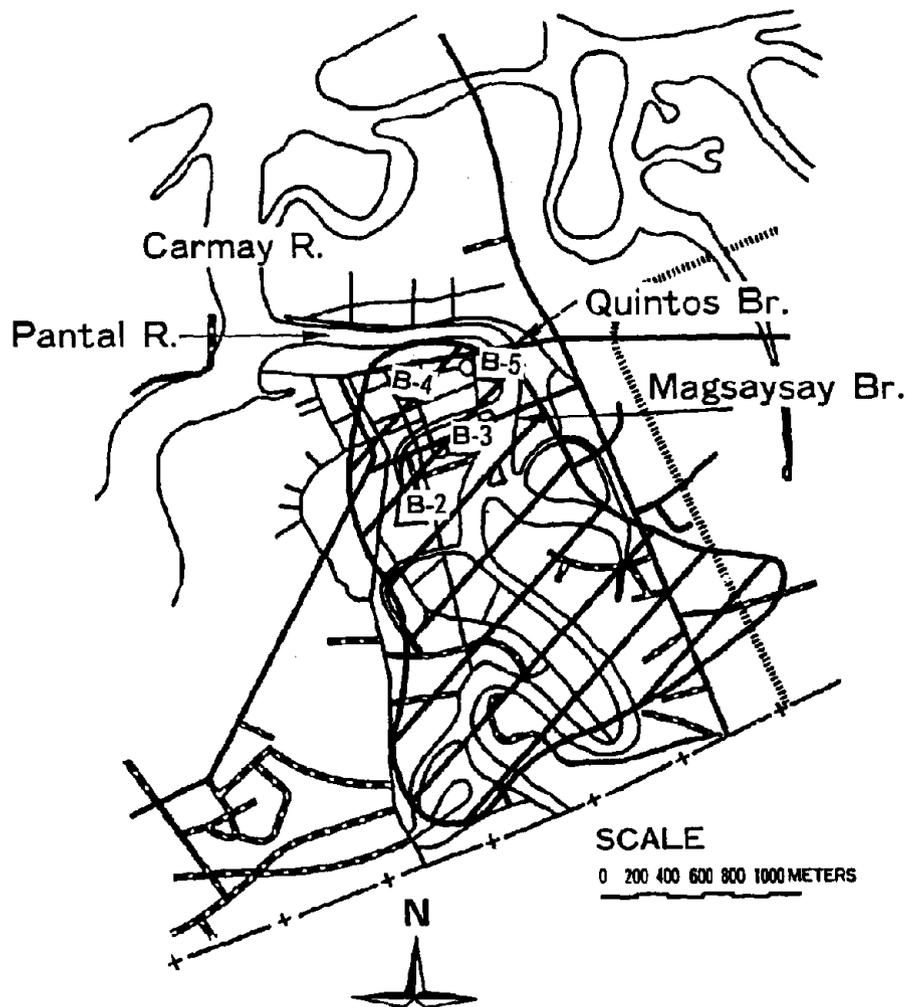
Fig. 3.1 Damaged Area of Dagupan City
due to Liquefaction

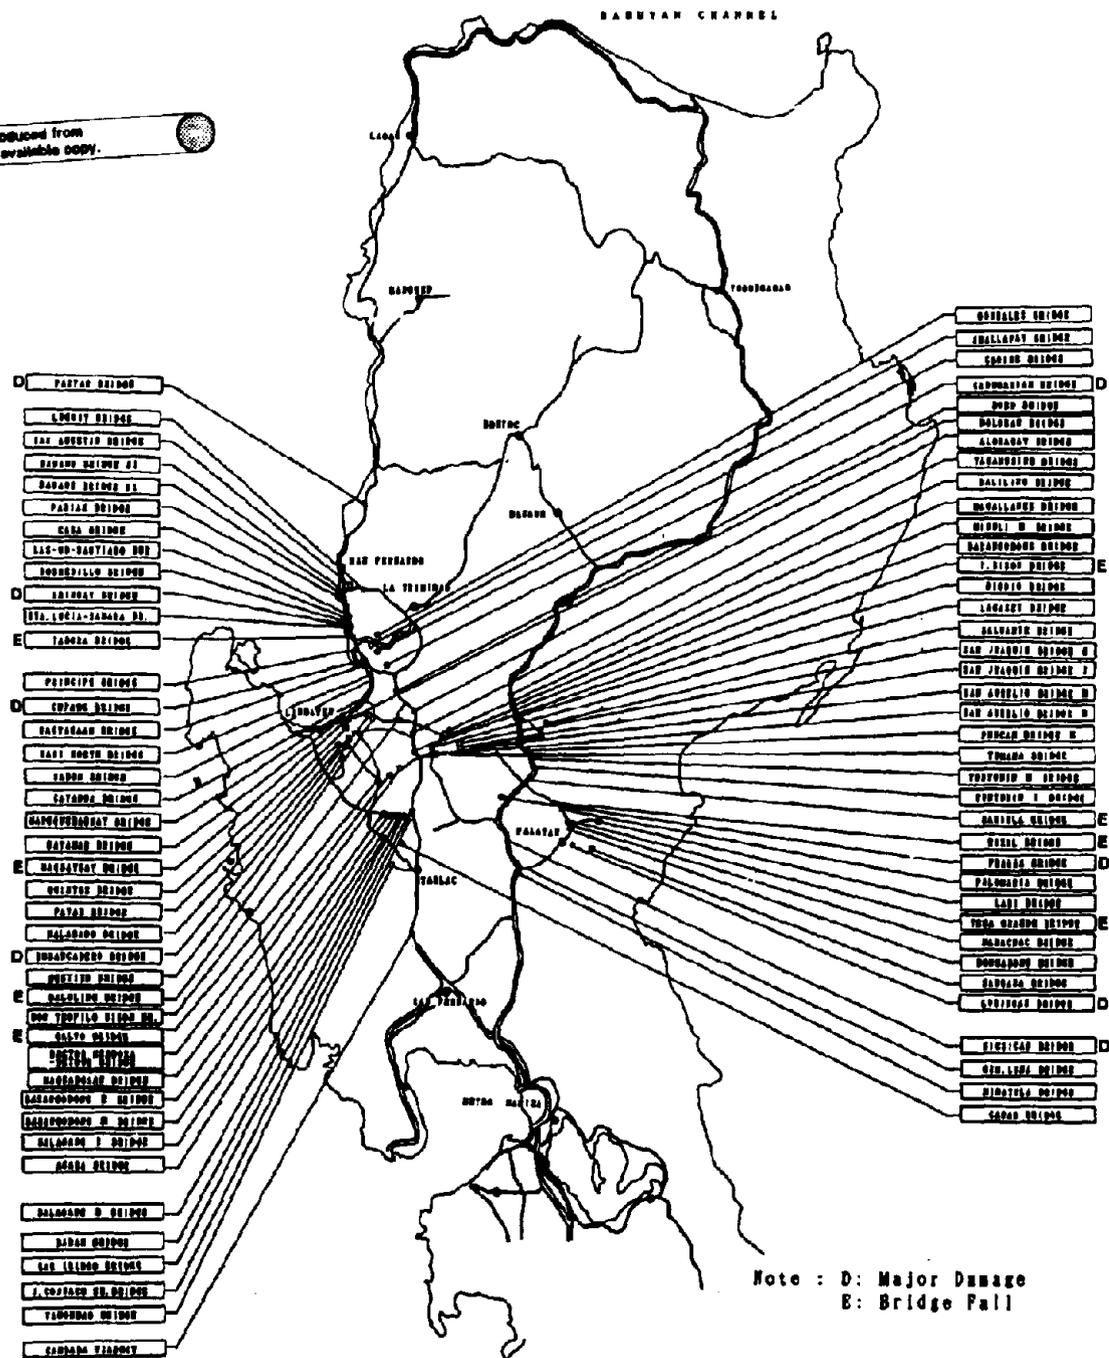
Fig. 5.1 Location of Damaged Bridges

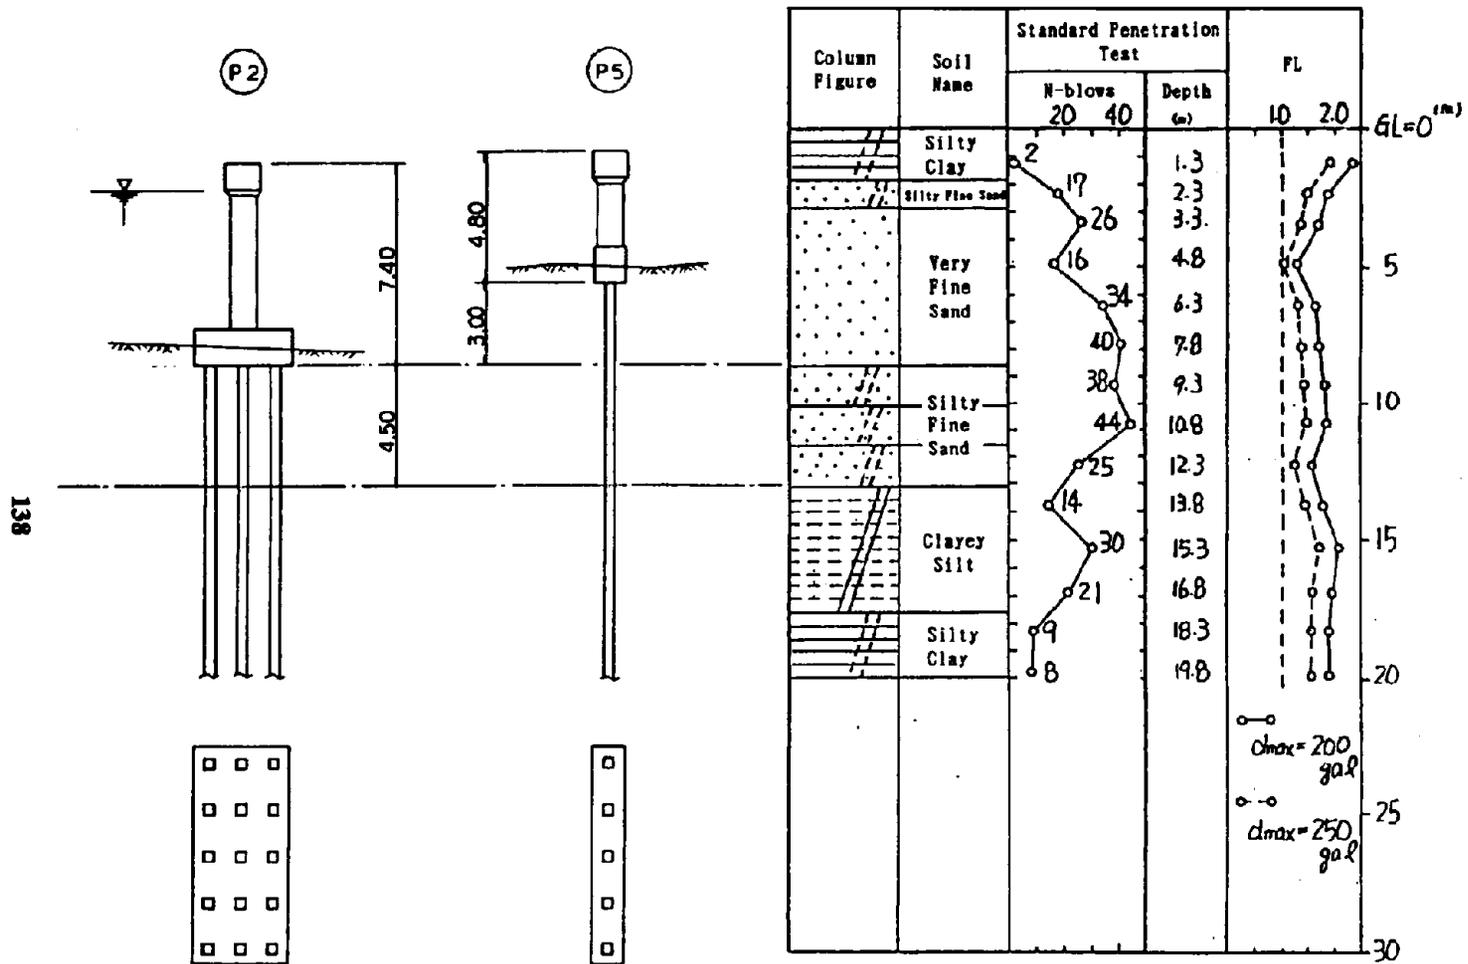
Fig. 5.5 Conditions of Calculation

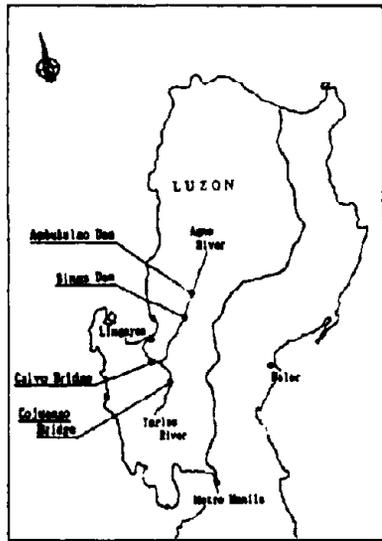
Fig. 6.1 Location of Damages to Rivers and Dams

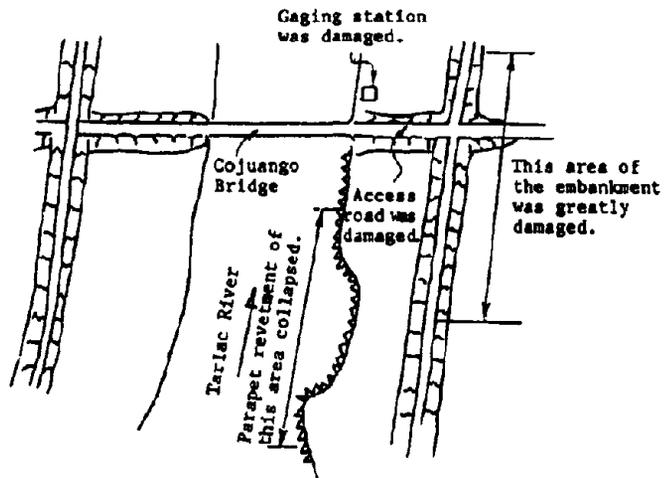
Fig. 6.2 Damaged Site of Tarlac River

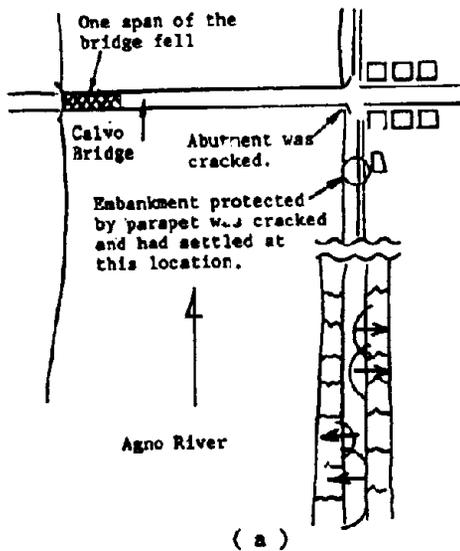
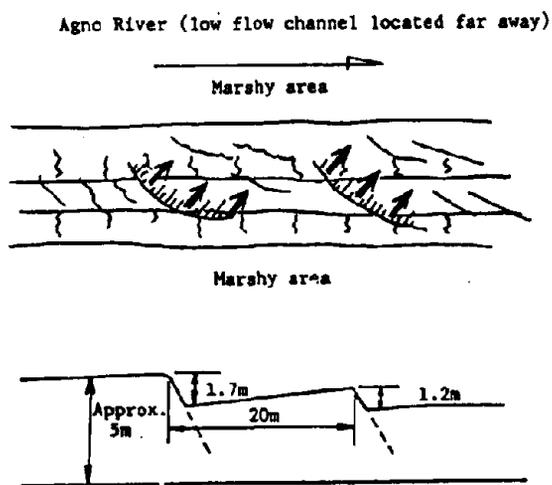
Fig. 6.3 Damaged Sites of Agno River

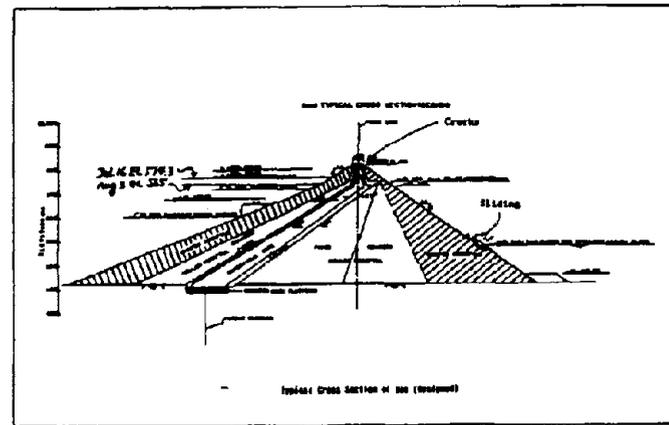
(b) Standard Cross Section of Binga Dam

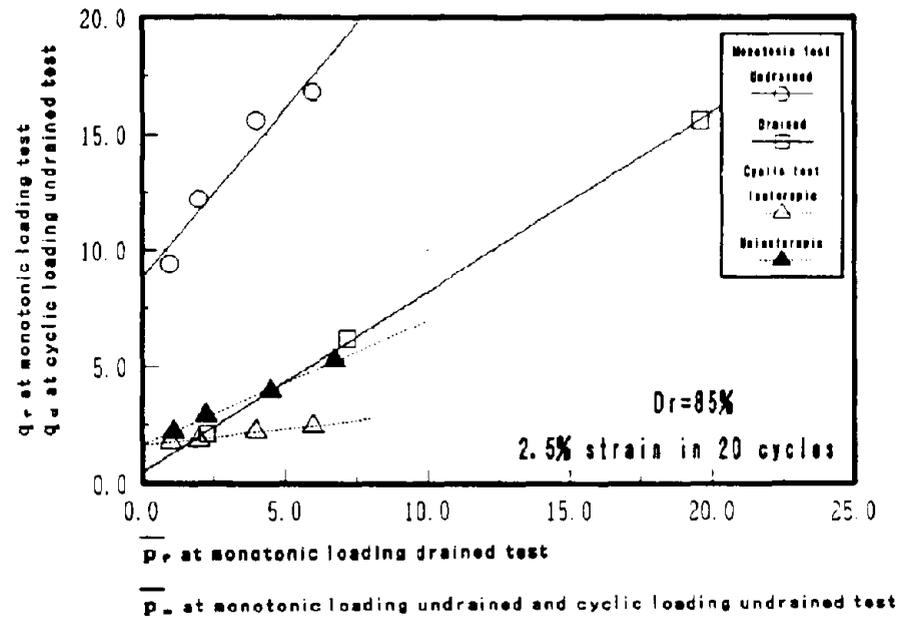
Fig. 8 The relationship between shear strength and normal stress on the failure plane

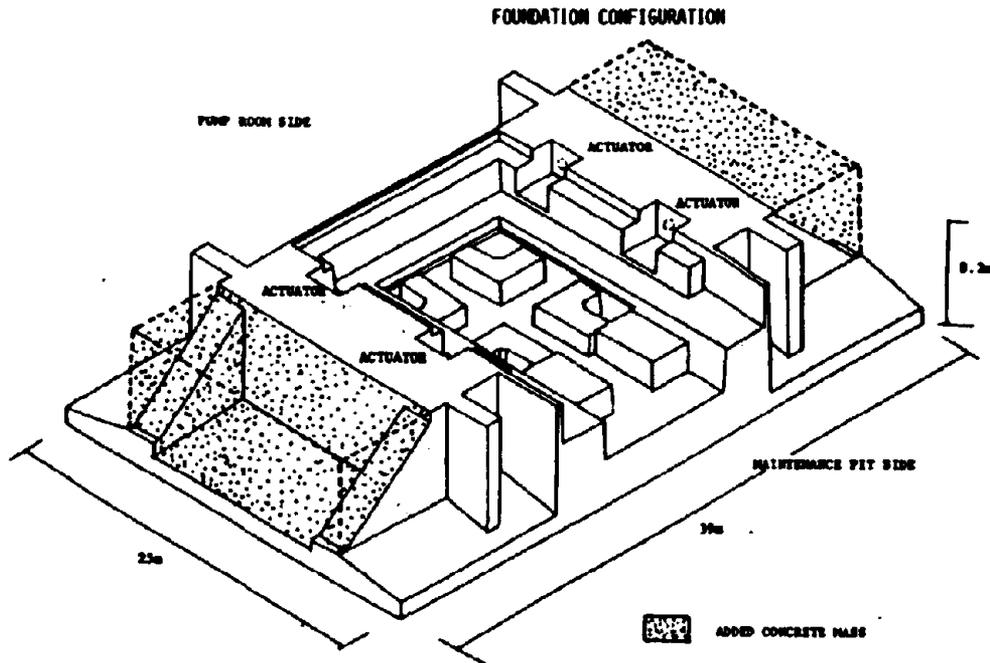
Fig. 1 Outline of Shaking Table foundation

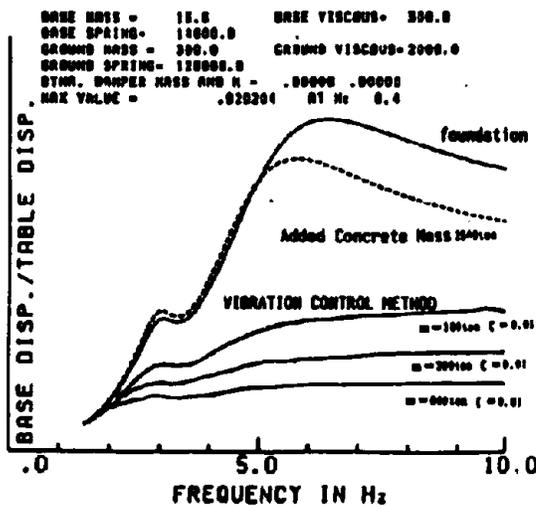
Fig. 15 Calculated Foundation Responses with Vibration Control System

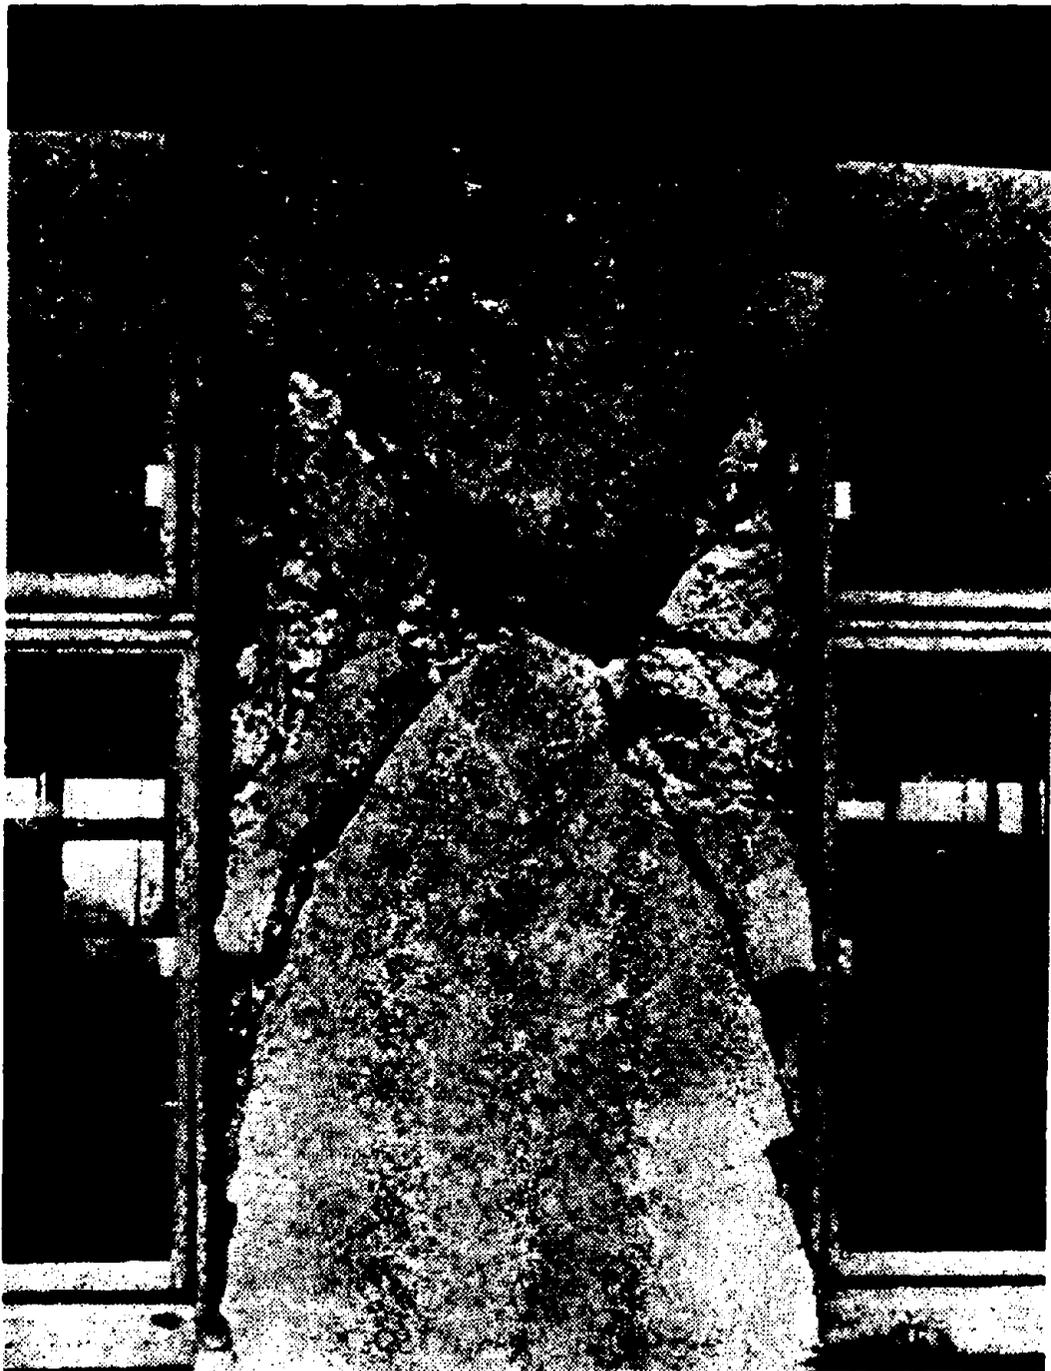
Figure 7. Diagonal Tension Failure in Window Pier
Misawa Commerce High School
Tokachi - Oki Earthquake 1968

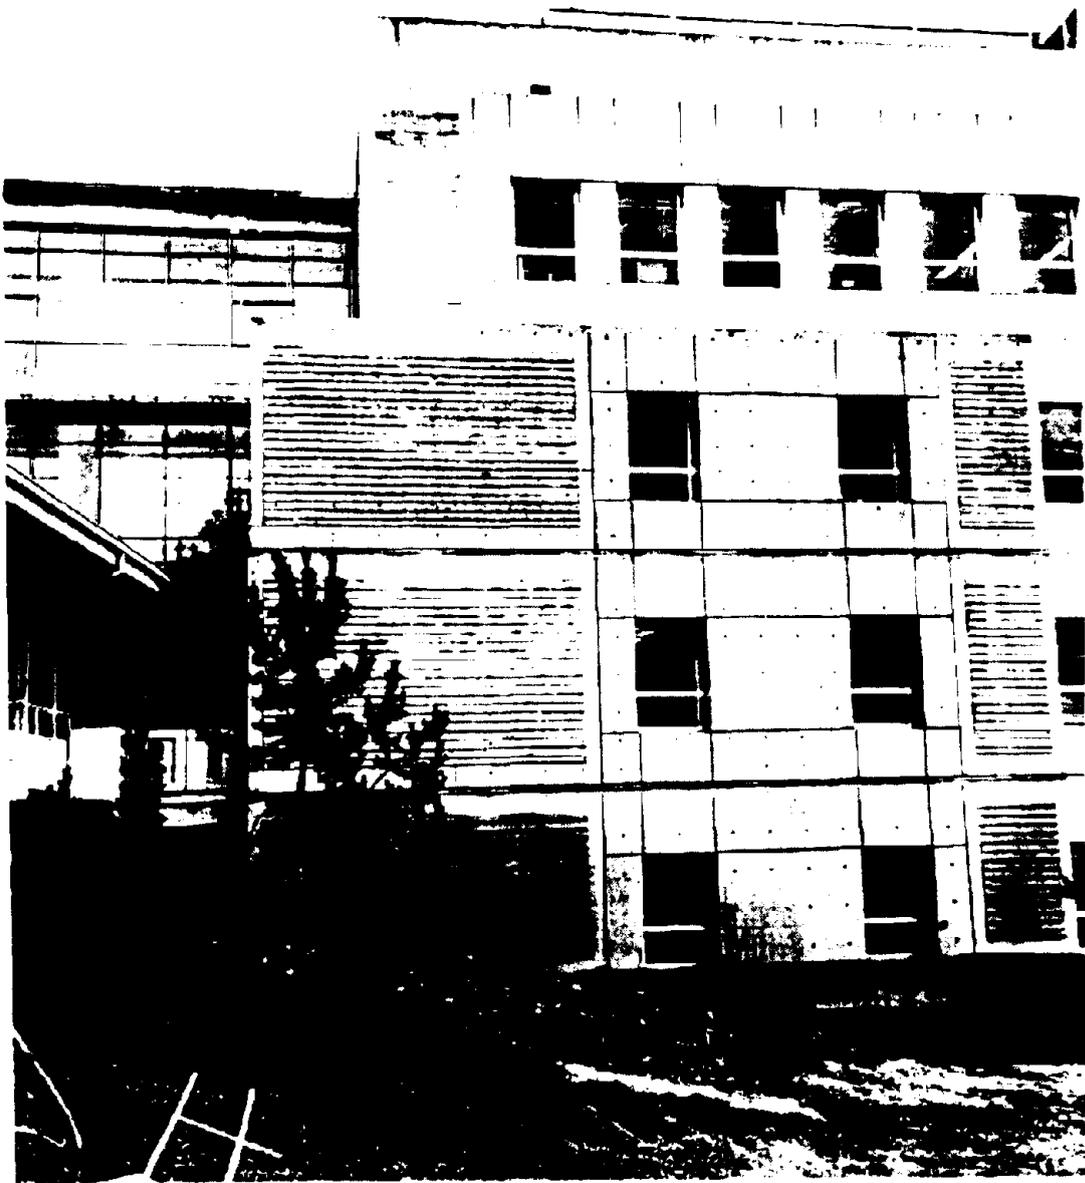
Figure 8. Longitudinal Buttress
Uphill End of Building 50B

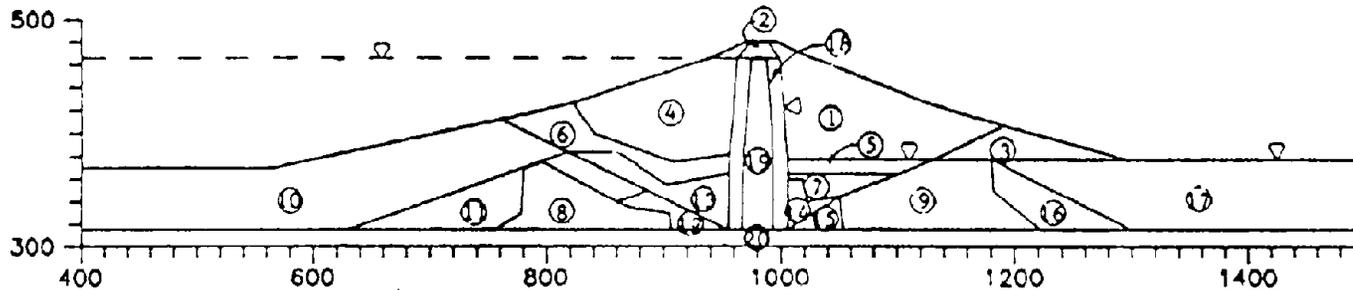
Figure 4. Material zonation for slope stability analyses, design pool and earthquake conditions
