Wind and Seismic Effects

Proceedings of the 23rd Joint Meeting

NIST SP 820

PROCEEDINGS OF
THE 23RD JOINT
MEETING OF
THE U.S.-JAPAN
COOPERATIVE PROGRAM
IN NATURAL RESOURCES
PANEL ON WIND AND
SEISMIC EFFECTS

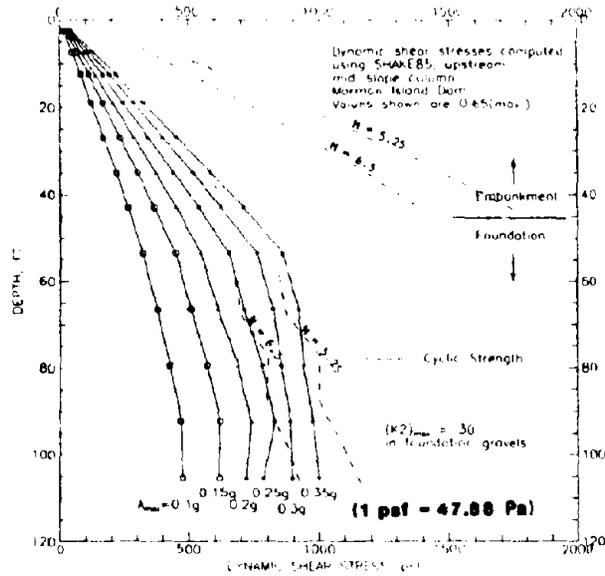
Figure 5. Profiles of average shear stress for upstream, mid-slope column with $(K_2)_{max} = 30$ in foundation gravels, showing cyclic strength profiles for earthquakes ranging in magnitude from 5.25 to 6.5

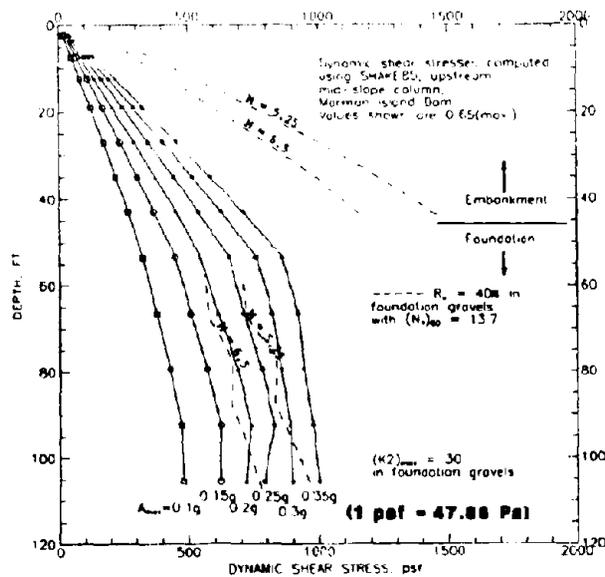
Figure 6. Profiles of average shear stress for upstream, mid-slope column with $(K_2)_{max} = 30$ in foundation gravels, showing cyclic stress profiles required to produce $R_v = 40$ percent with $(N_1)_{80} = 13.7$ for earthquakes ranging in magnitude from 5.25 to 6.5

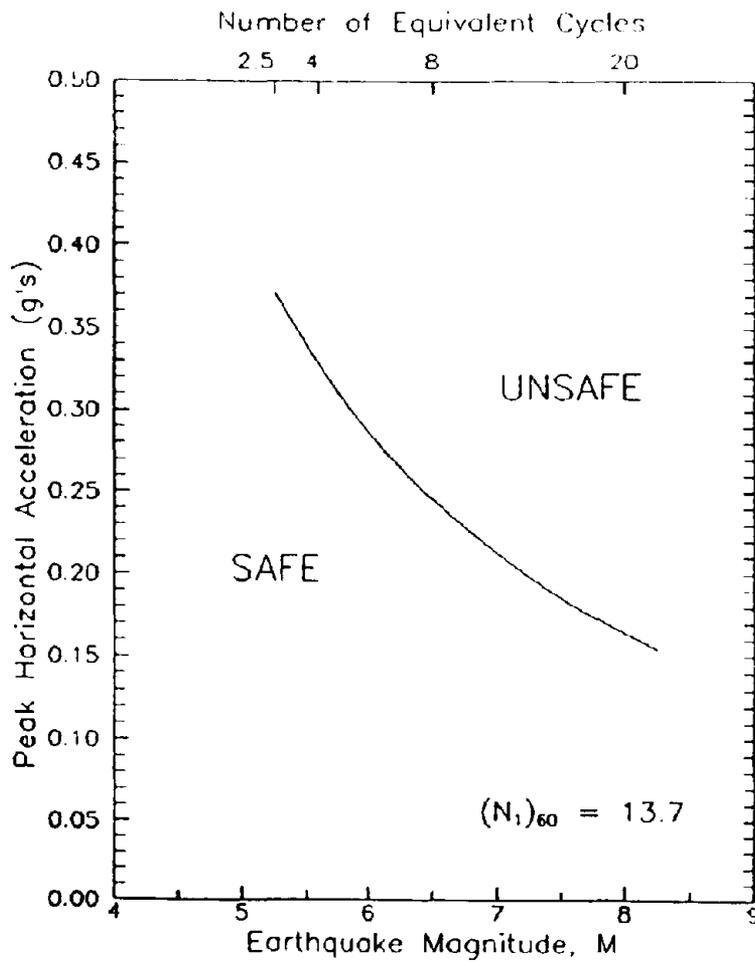
Figure 7. Estimated combinations of a_{max} and earthquake magnitude causing liquefaction of dredged foundation gravels for $(N_1)_{60} = 13.7$

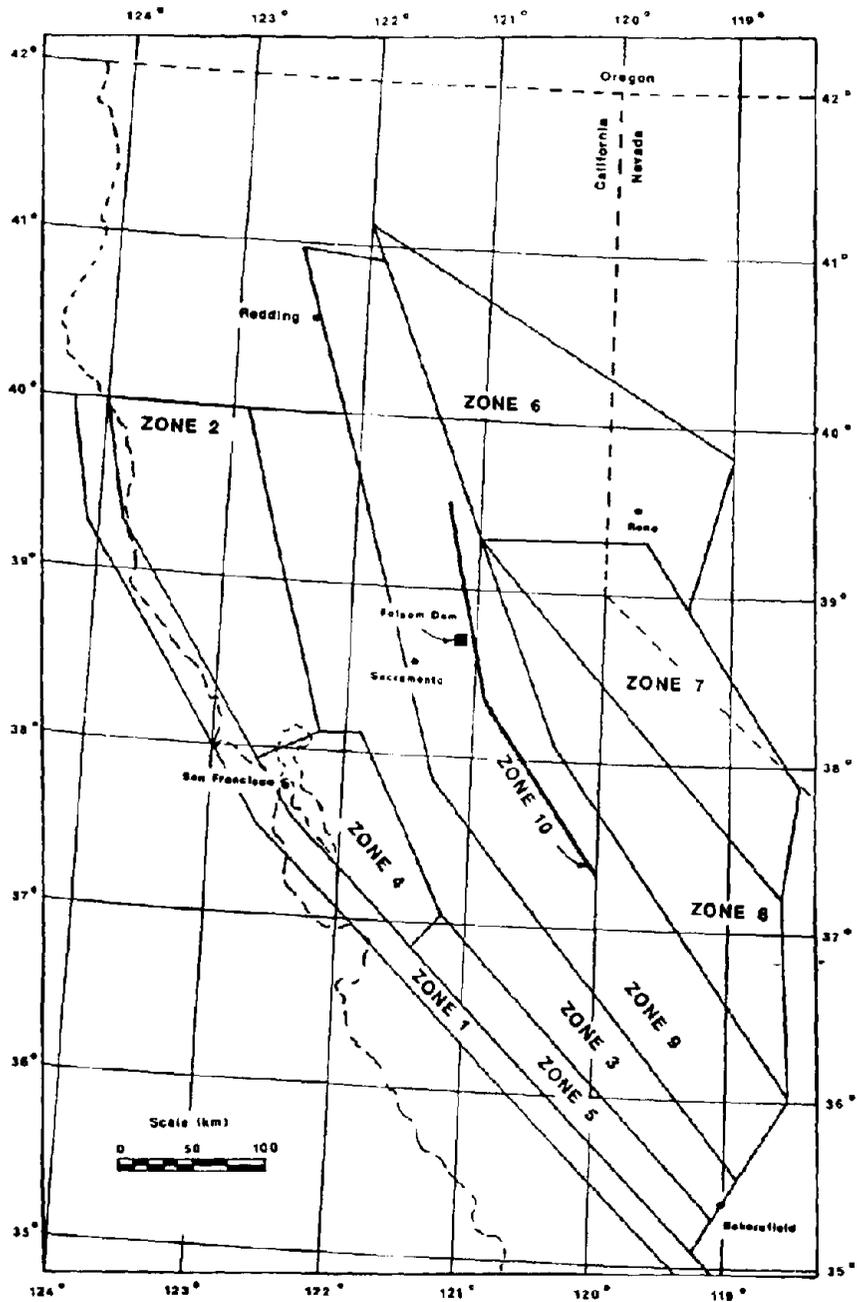
Figure 8. Location of seismic zones used for this study

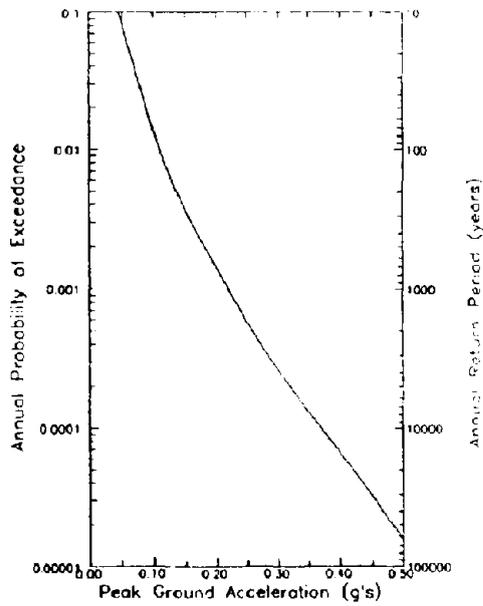
Figure 10. Best estimate of seismic hazard versus peak horizontal acceleration recommended for use in selecting remedial measures

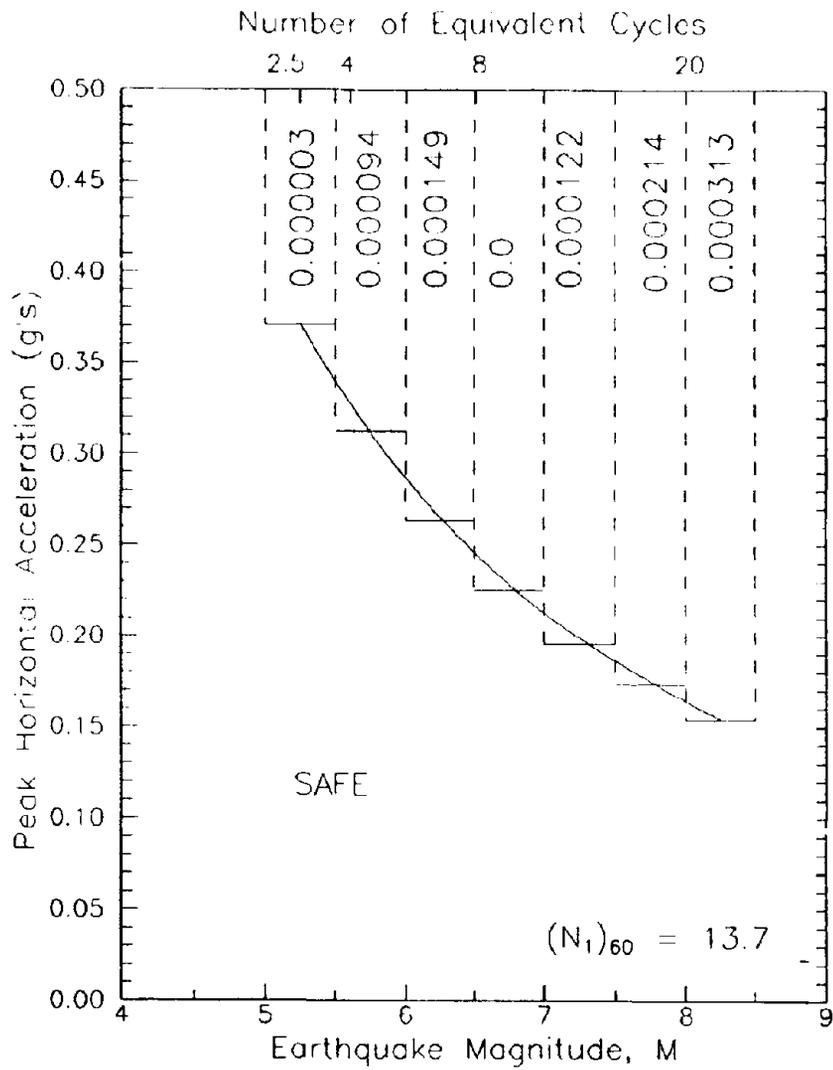
Figure 11. Probabilities of occurrence for different ranges in magnitude at combinations of a_{max} and earthquake magnitude causing liquefaction of dredged foundation gravel for $(N_1)_{60} = 13.7$

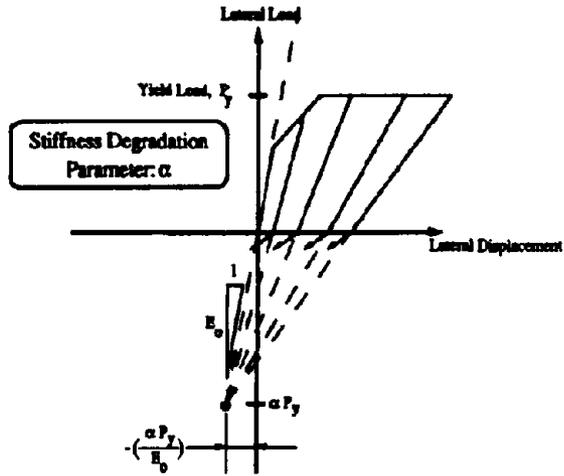
Figure 2. Effect of varying stiffness degradation parameter alpha.

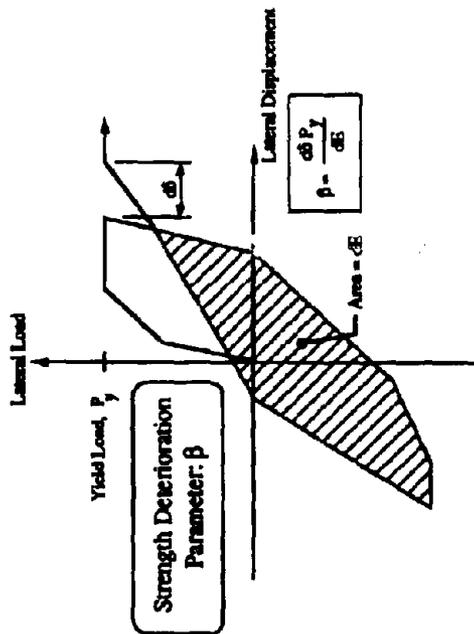
Figure 3. Effect of varying strength deterioration parameter beta.

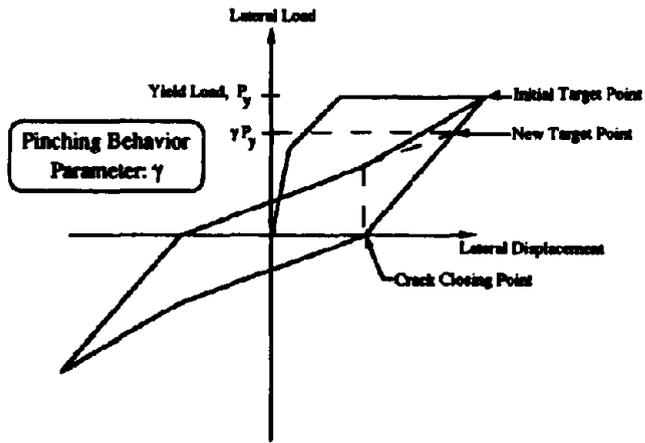
Figure 4. Effect of varying pinching behavior parameter gamma.

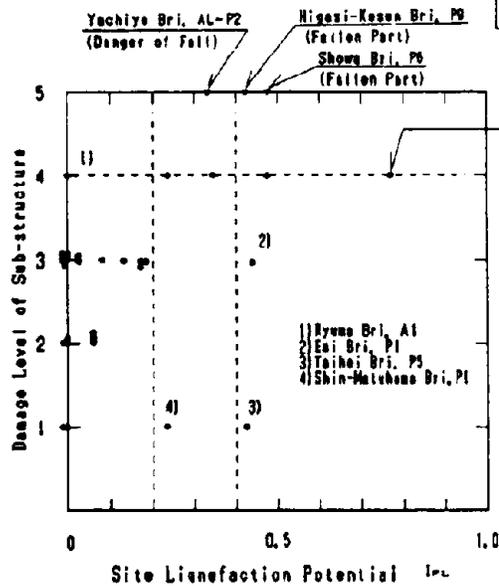
Fig. 1 Relation between Site Liquefaction Potential (I_{WL}) and Damage Level of Sub-structure

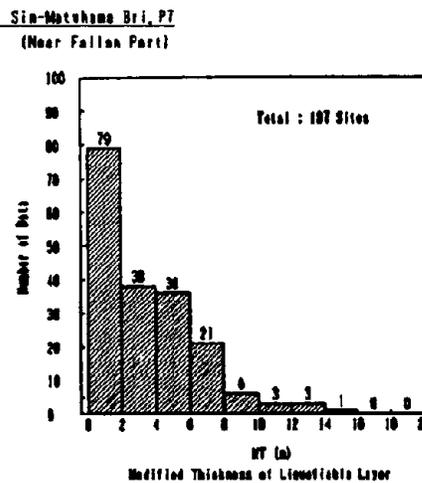
Fig. 2 Distribution of Modified Thickness of Liquefiable Layer (RT)

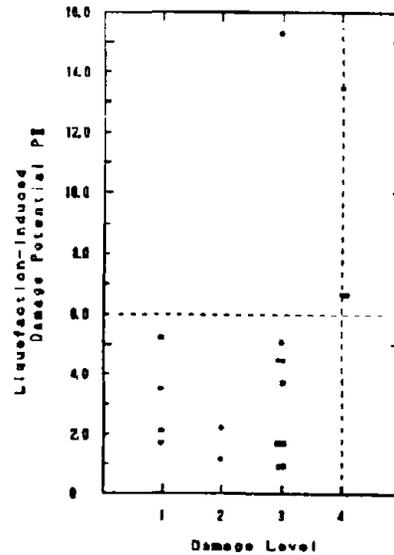
(3) PI for Fixed Pier

Fig. 4 Relation between Damage Level of Substructure and Liquefaction-Induced Damage Potential

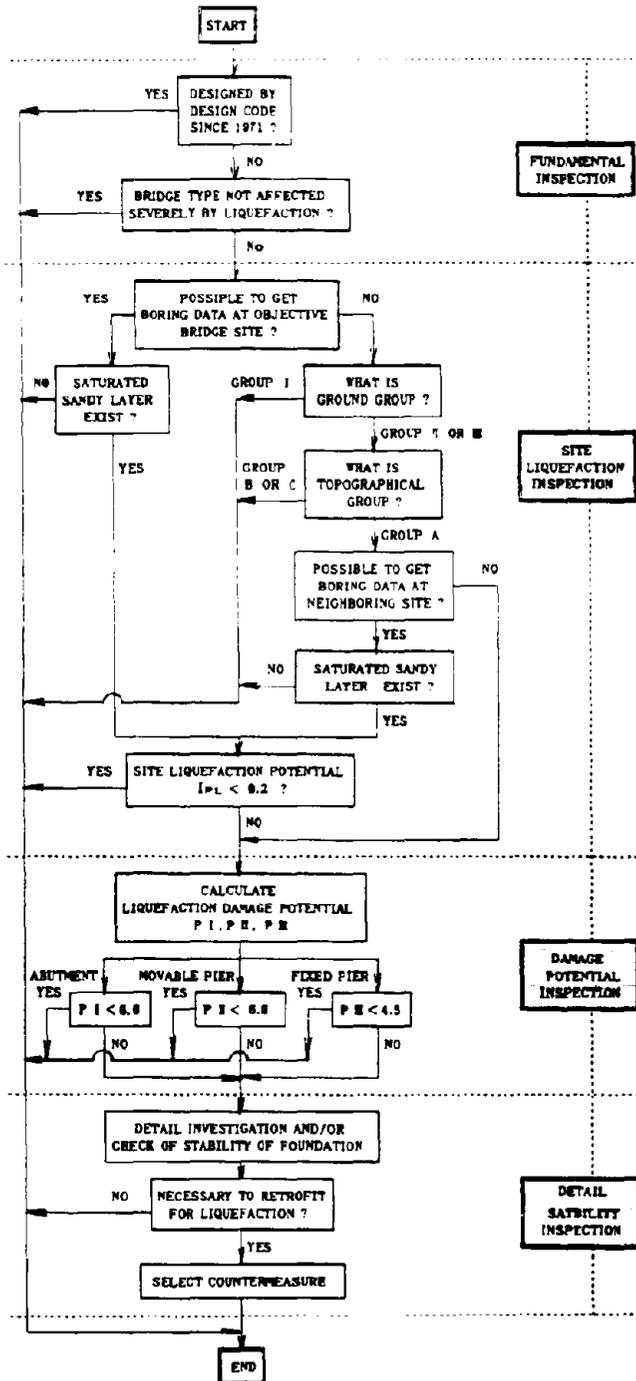
Fig. 5 Example of Flow Chart for Inspecting Earthquake Resistant Potential of Highway Bridge Foundation

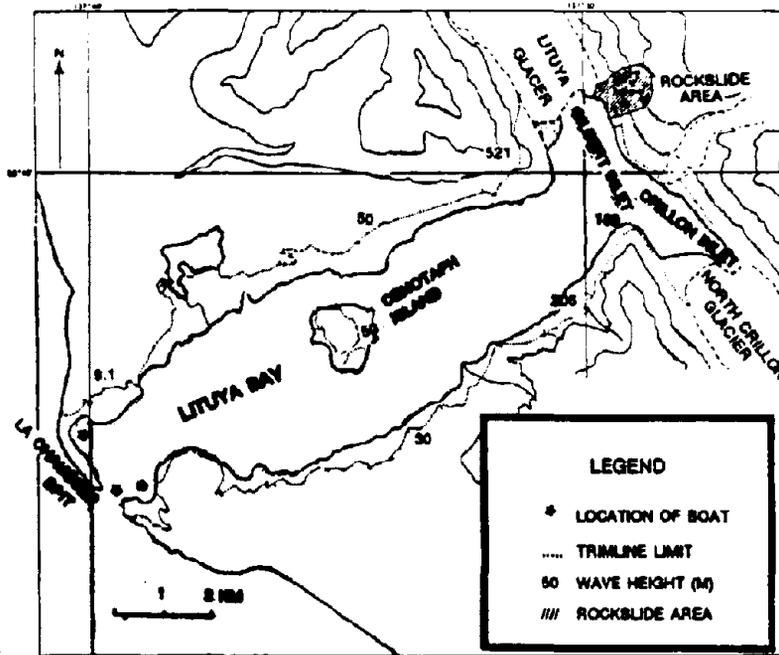
Figure 2. Map of Lituya Bay showing setting, location of boats, and trimline caused by the 1958 tsunami.

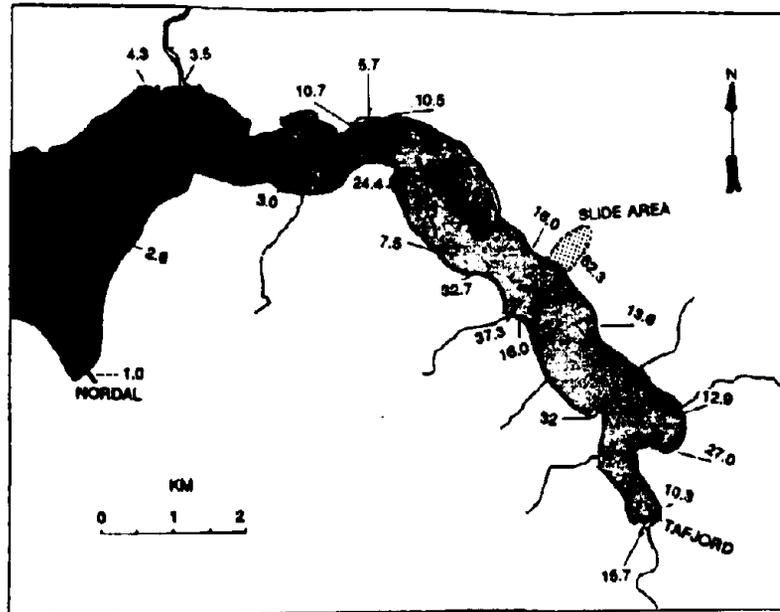
Figure 3. Tafjord showing wave heights in meters produced by the rock slide of 1934.

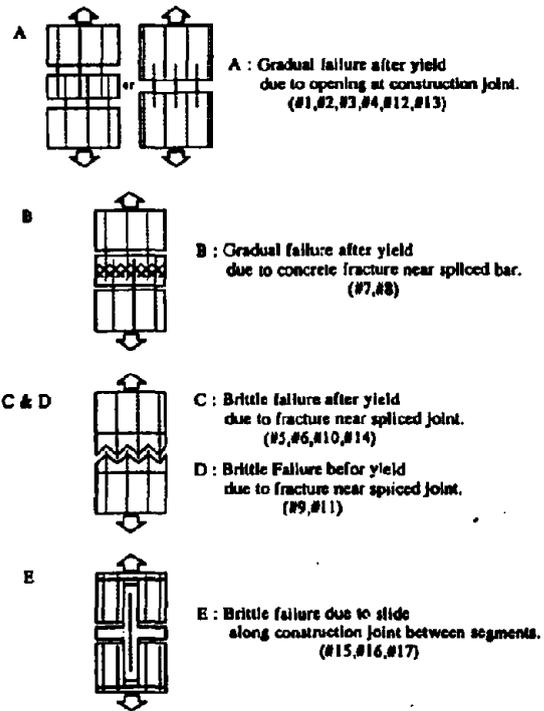
Figure 5: Failure Modes

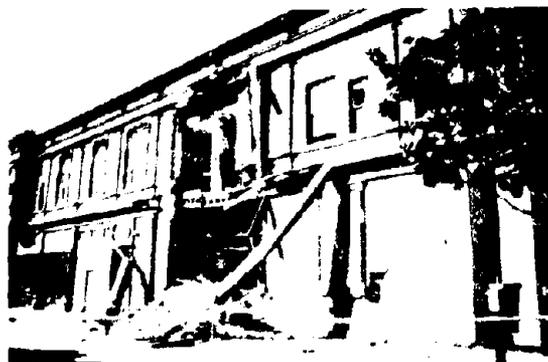
Fig. 20 In-Plane Failure of Masonry Wall

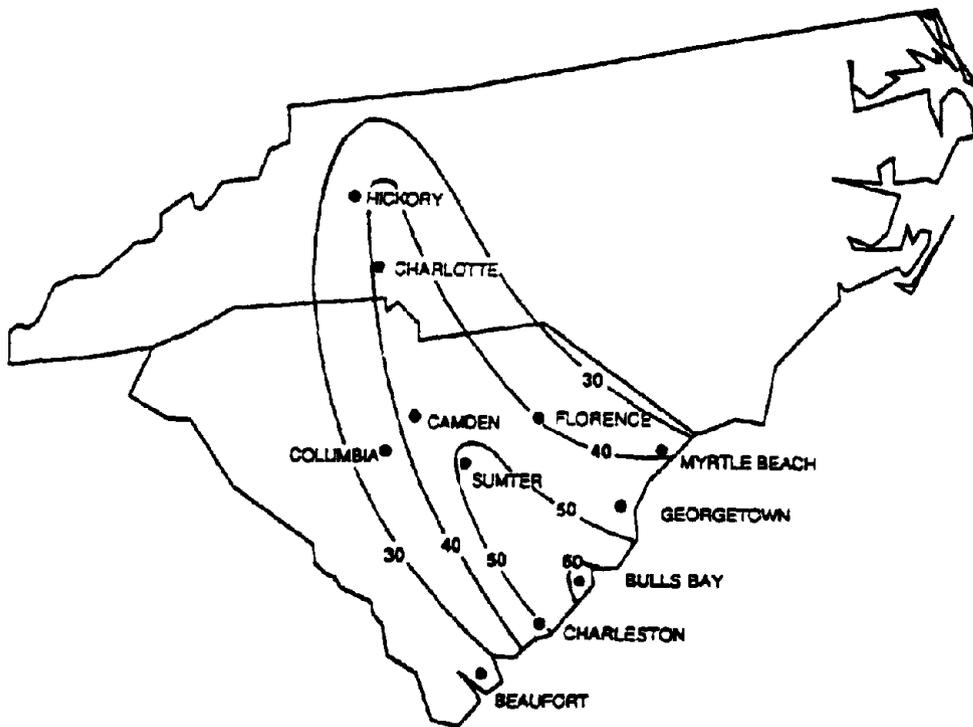
Figure 1. Probable Maximum Gust Wind Speeds (m/s)

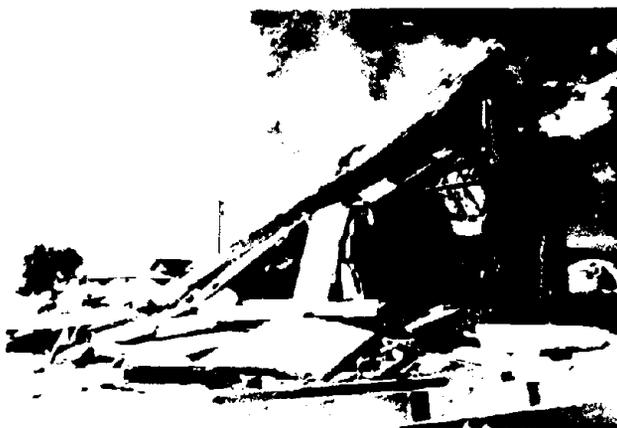
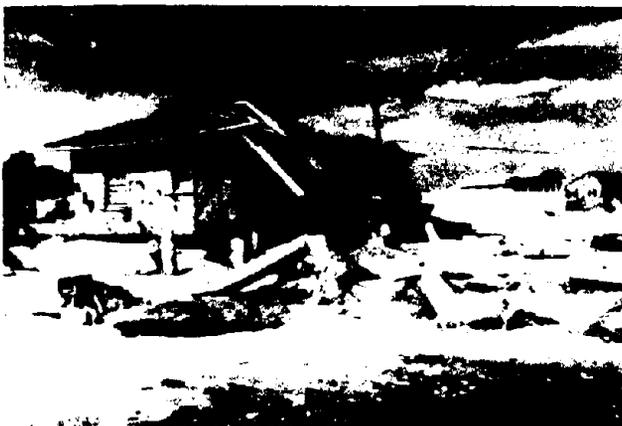
Figure 8. Wave Damage to
Masonry Building
Near Myrtle Beach

Figure 9. Concrete Pier
Failure by Wave
Action Near
Myrtle Beach

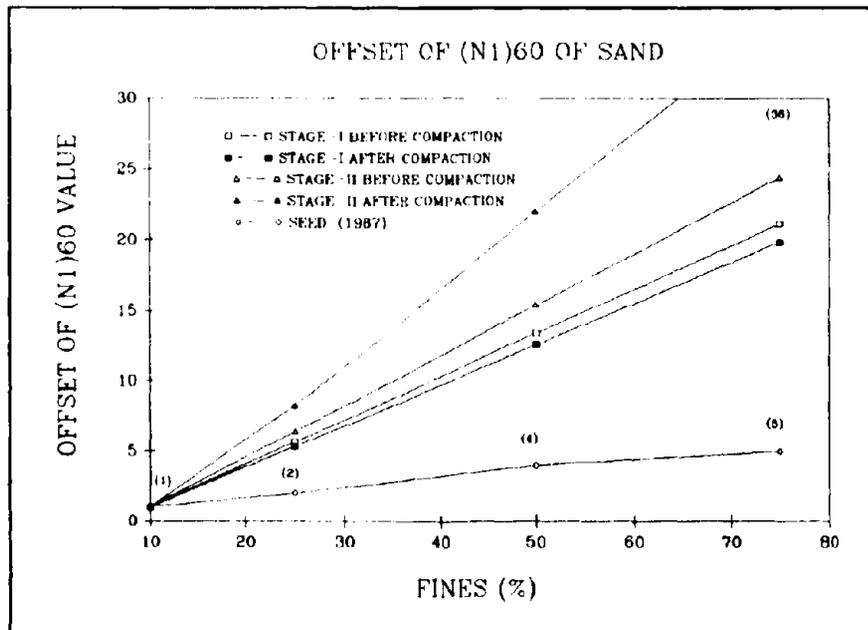
Figure 32. Offset of N₁₆₀ values versus fines content.

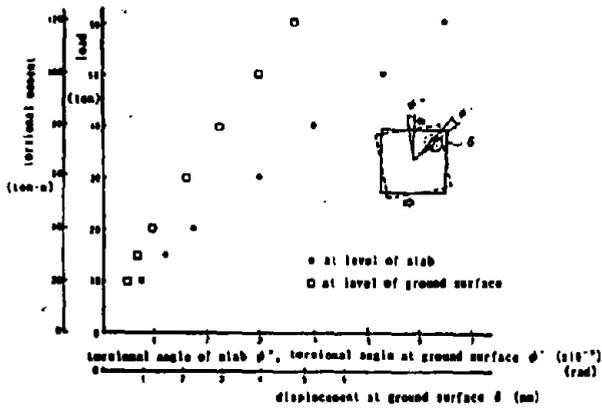
Fig. 3 Torsional load and deformation
