# Earthquake Resistant Construction of Electric Transmission and Telecommunication Facilities Serving the Federal Government Report

NISTIR 89 - 4213

EARTHQUAKE RESISTANT CONSTRUCTION OF ELECTRICAL TRANSMISSION AND  
TELECOMMUNICATION FACILITIES SERVING THE FEDERAL GOVERNMENT

Felix Y. Yokel

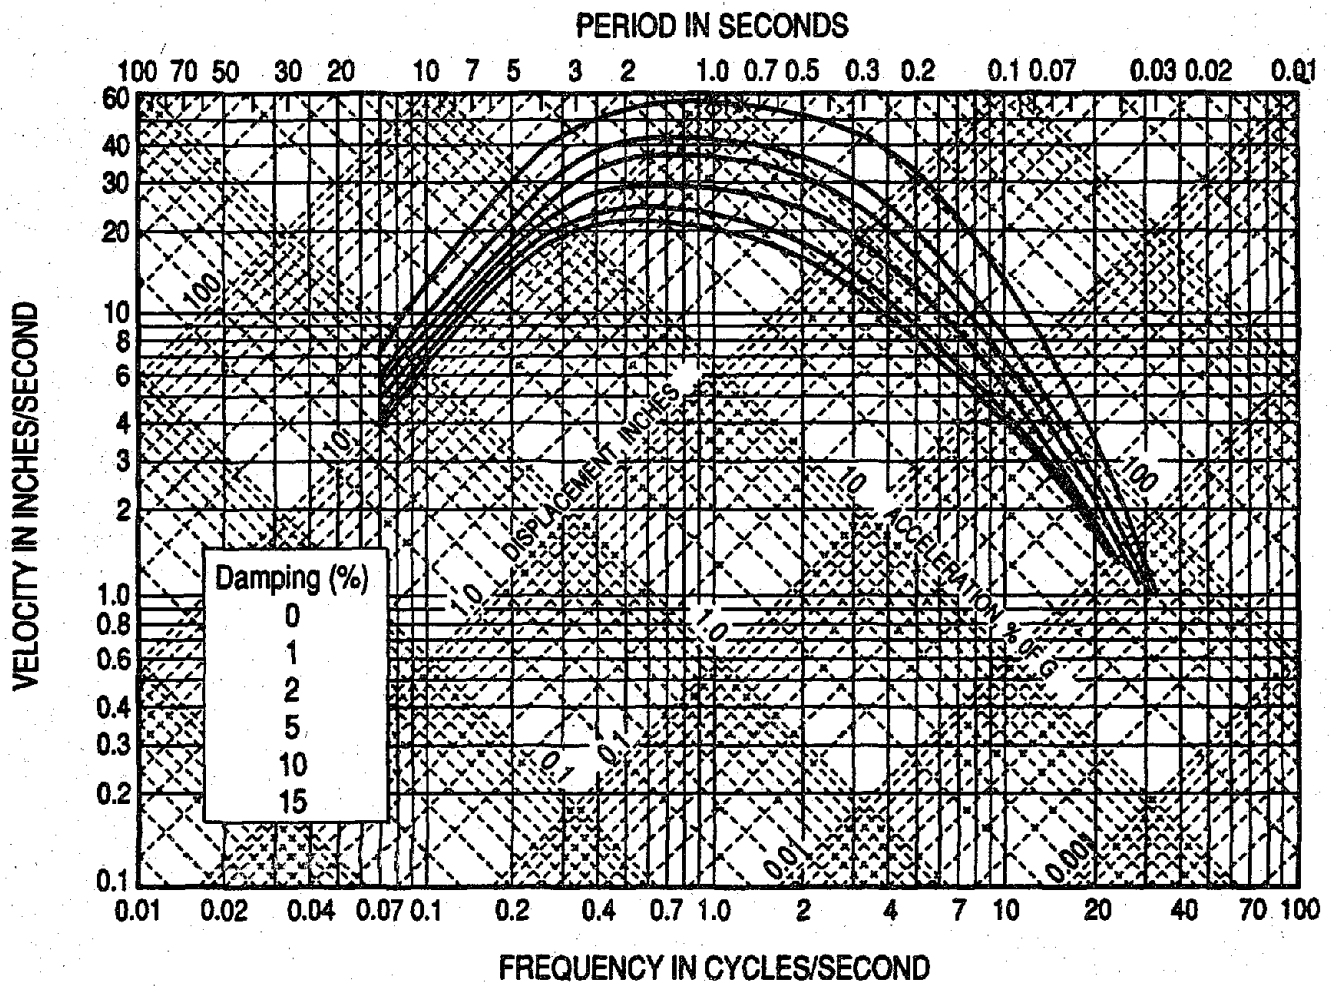
Figure 1: Seismic Design Response Spectra for Electrical Substation Equipment (from City of Los Angeles, 1988).

Seismic design of electrical equipment in substations is covered by the American National Standards Institute (ANSI) and the Institute of Electrical and Electronics Engineers, Inc.(IEEE), ANSI/IEEE Standard 693-1984, which in turn references ANSI/IEEE Standard 344-1987, "IEEE Recommended Practice for Seismic Qualification of Class 1E Equipment for Nuclear Power Generating Stations". The standard identifies Class A equipment or systems, whose failure would prevent the proper functioning of the substation, and equipment of lesser importance. Equipment can be qualified by testing, analysis, or on the basis of prior experience. The standard contains performance criteria for all substation components. However, its most important features are criteria for the qualification of equipment. These criteria, together with a specified maximum design ground acceleration, specify the seismic resistance of equipment to be furnished by suppliers. West Coast power companies consider the present ANSI/IEEE Standard 693 inadequate and substitute their own specifications for the performance of individual components. Figure 1 shows design spectra specified by the City of Los Angeles for various damping ratios for a maximum ground acceleration is 0.5 G. The accelerations in the spectra are scaled up or down in accordance with the stipulated maximum ground acceleration.

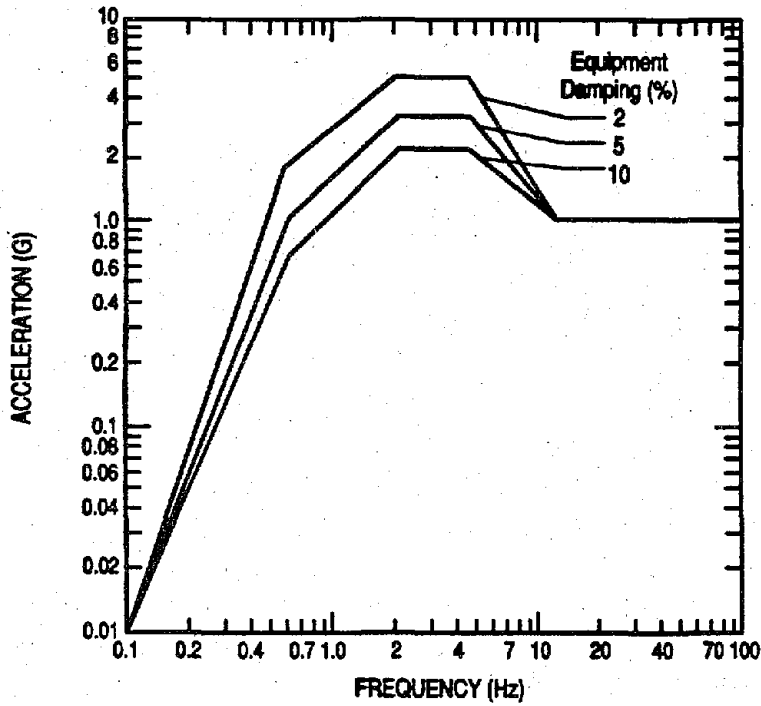
Installation Location	Zone			
	4	3	2	1
Upper Floors	1.0	0.6	0.4	0.3
Midlevel Floors	0.9	0.5	0.3	0.2
Ground-Level and Basement Floors	0.8	0.4	0.2	0.1

Figure 2: Seismic Design Response Spectra Recommended for Telecommunication Equipment (reproduced from Bellcore, 1988)

Available protective measures are standardized bracing systems developed by Bellcore and others, vibration-resistant equipment meeting Bellcore or similar requirements, standby power supplies in the form of batteries and generators, and slack in cables and ducts crossing active faults and at the connections to buildings and other fixed structures. In addition there is considerable redundancy in communication systems. Inoperative portions of the system are automatically bypassed, so that the impact is minimized. Additional safeguards
