Wind and Seismic Effects

NIST SP 904

PROCEEDINGS OF
THE 28TH JOINT
MEETING OF
THE U.S.-JAPAN
COOPERATIVE PROGRAM
IN NATURAL RESOURCES
PANEL ON WIND AND
SEISMIC EFFECTS

Issued August 1996

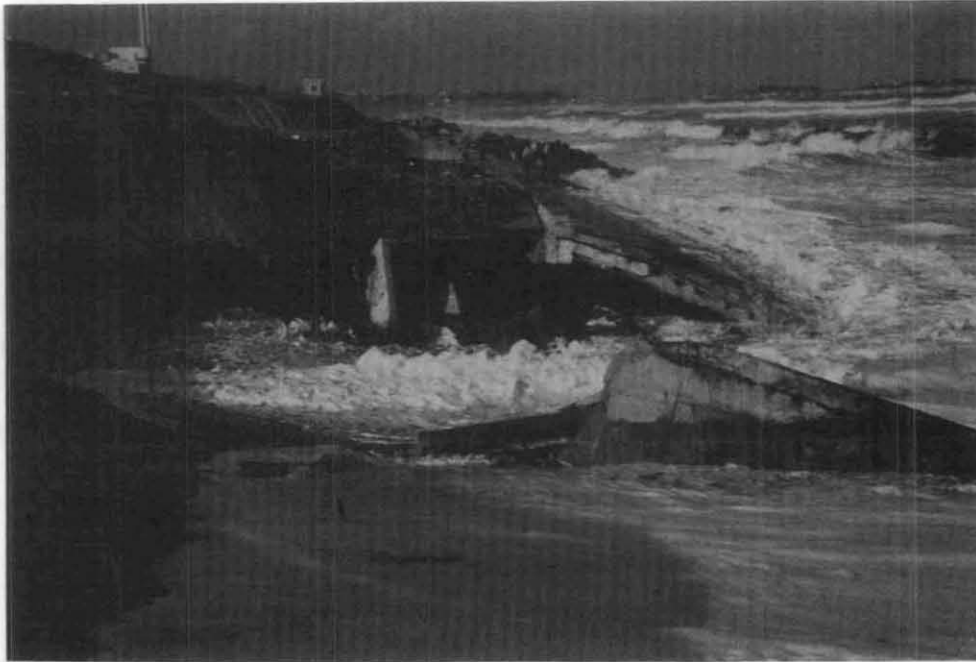
Photo 6 Seawall Damage by Erosion at Oarai Beach

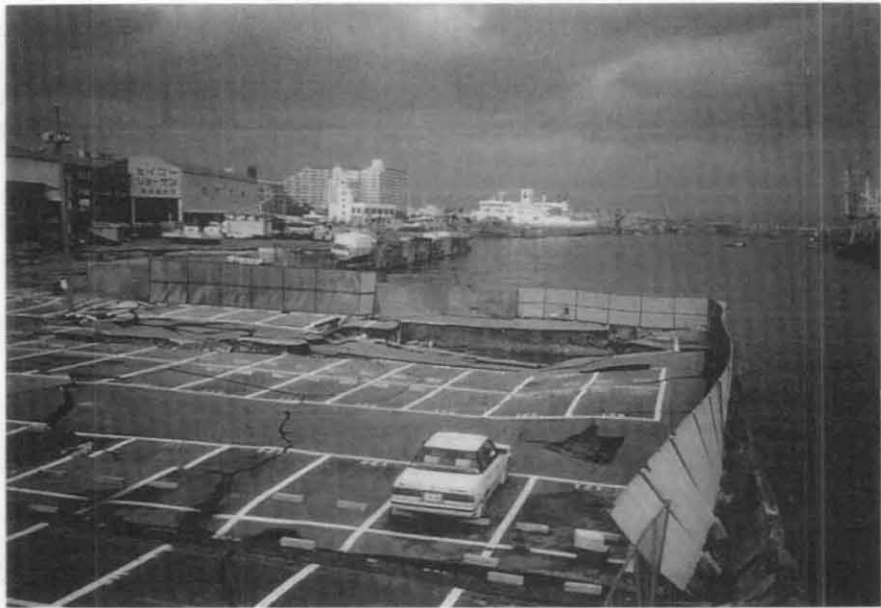
Photo 1 Damage to a Parking Lot at Uozakihama

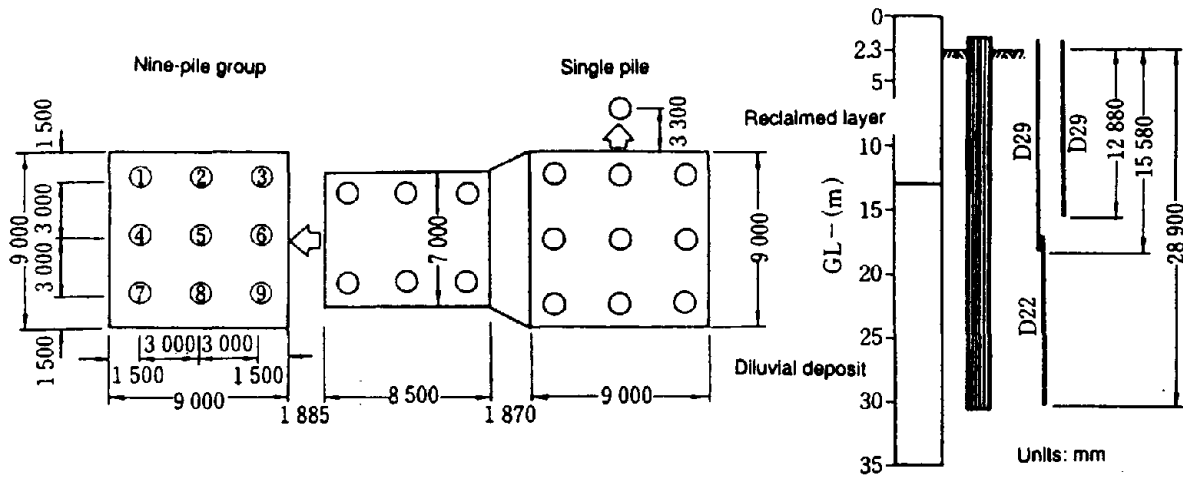
Fig. 1 Arrangement of test piles

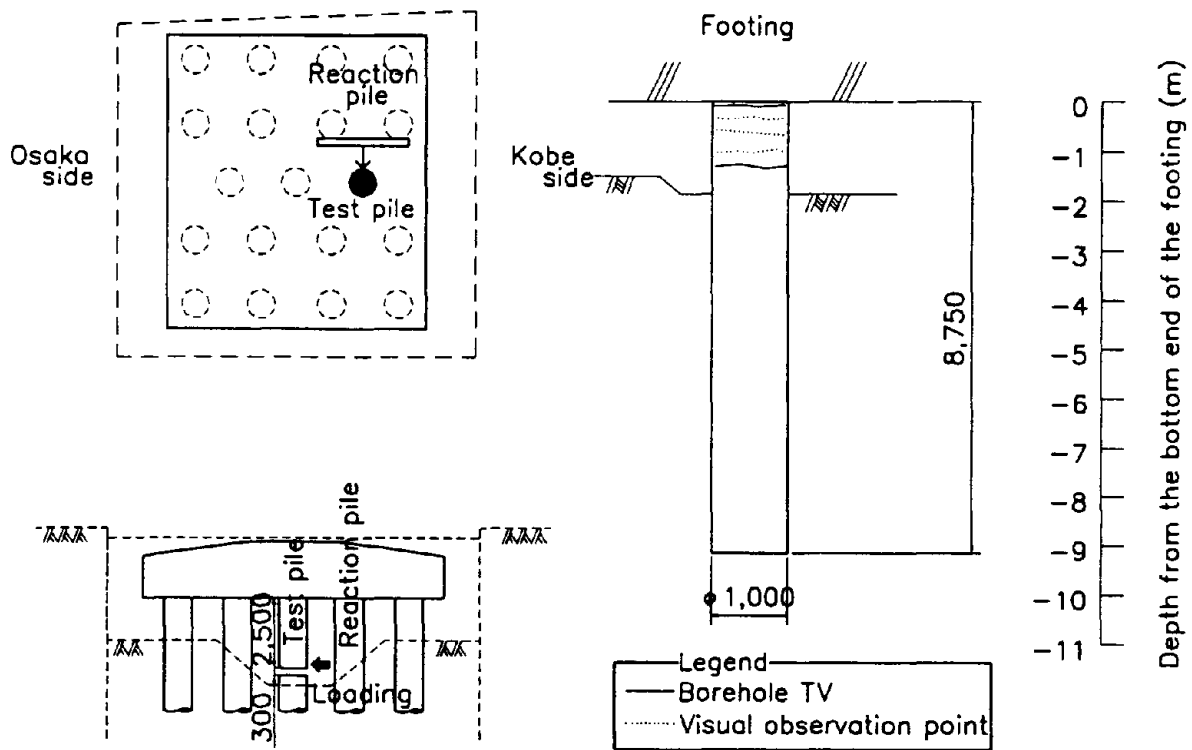
Fig. 7 Bending load test
