**CUMULATIVE SEISMIC DAMAGE OF REINFORCED
CONCRETE BRIDGE PIERS**

Sashi K. Kunnath, Ashraf El-Bahy, Andrew Taylor and William Stone

Technical Report NCEER-97-0006

September 2, 1997

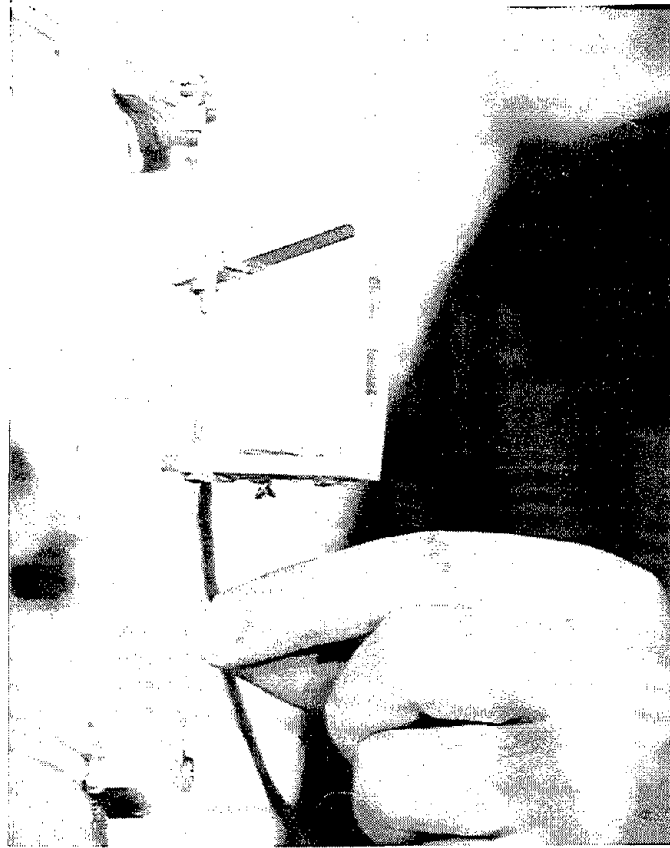
FIGURE 2-21 Clip Gage Mounted on Column for Curvature Measurement

The clip gages consist of two strain gages mounted on light gage C-shaped steel sections which in turn are hooked between two points on the specimen equal to the gage length, L (Figure 2-21). The curvature is calculated using the following expression:

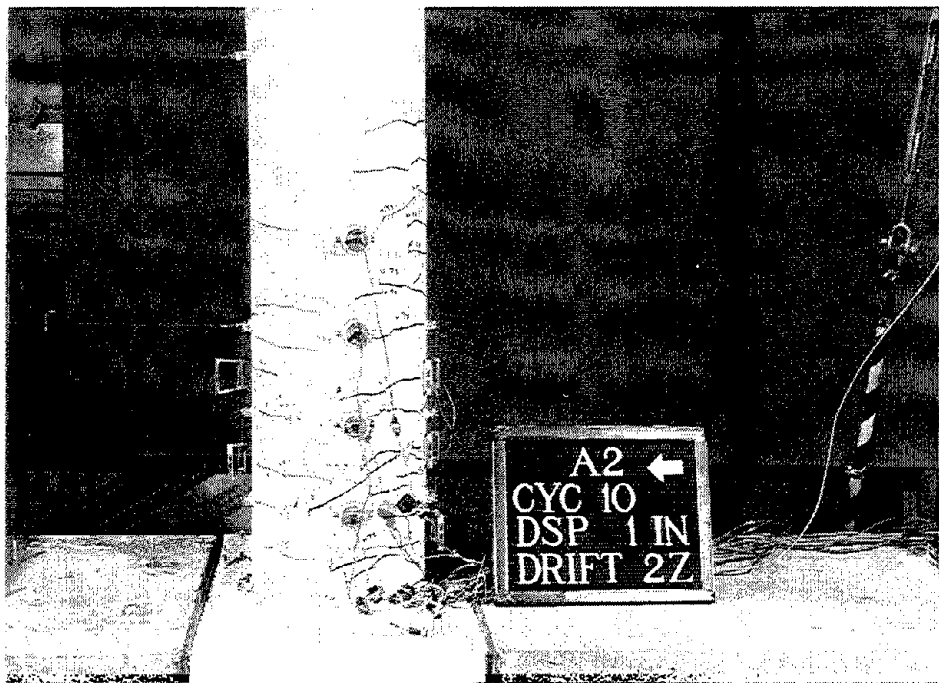
FIGURE 2-22 Electric Clinometers Used for Rotational Measurement

Four electric clinometers were mounted on the specimen in the central plane to measure the angle of rotation at the base of the column during testing. The clinometers were connected to a special base, which in turn was connected to threaded rods that were embedded inside the specimens. The clinometers were attached to the specimen at 150, 300, 450 and 600 mm, respectively, from the base of the column (top of the footing). The electric clinometer is composed of a metal gravity sensor with no moving parts such that when rotated, its sensitive axis provides a linear variation in capacitance, which is electronically converted into angular data (Figure 2-22).

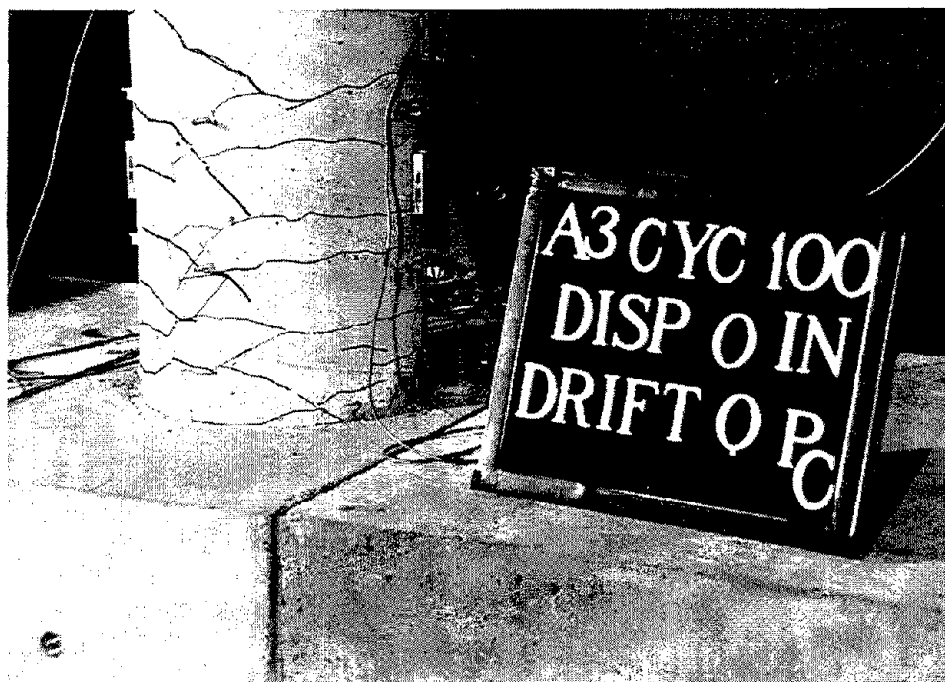
FIGURE 4-9 Specimen A3 at Cycle 100

Table 4-4 provides a detailed summary of observed results related to testing of specimen A3. Figure 4-9 shows the state of specimen A3 after 100 cycles of loading. The column condition at the end of testing is shown in Figure 4-10. Figure 4-11 shows the imposed displacement history on specimen A3 and Figure 4-12 displays the resulting lateral force vs. displacement response history.

| <u>Cycle No.</u> | <u>Notes</u> |
|---|---|
| 100 | Significant Spalling |

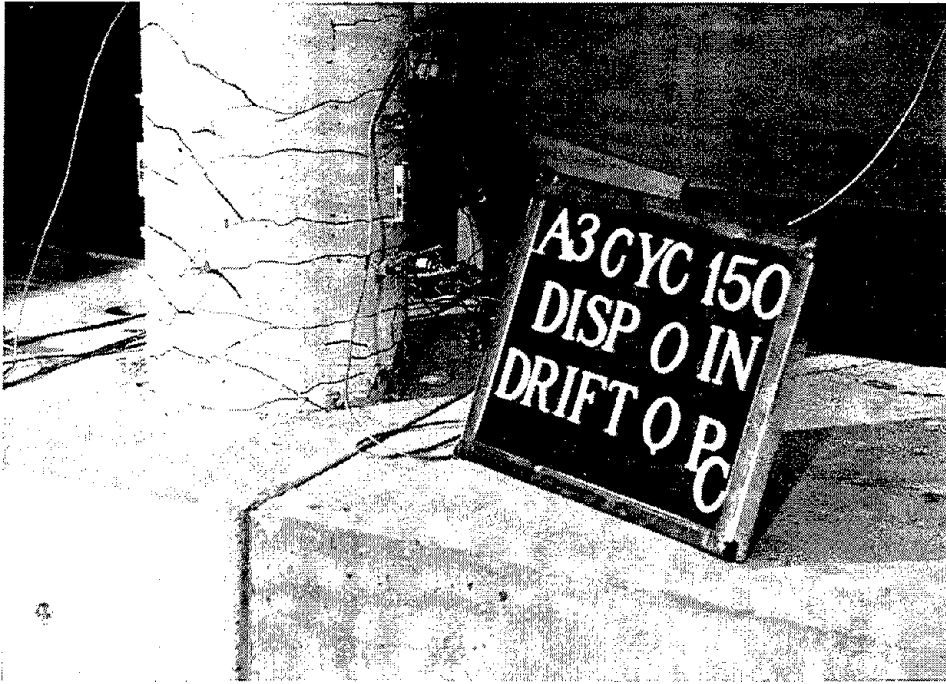
FIGURE 4-10 Specimen A3 at End of Fatigue Testing

| <u>Cycle No.</u> | <u>Notes</u> |
|---|---|
| 150.5 | Failure (due to monotonic load) |

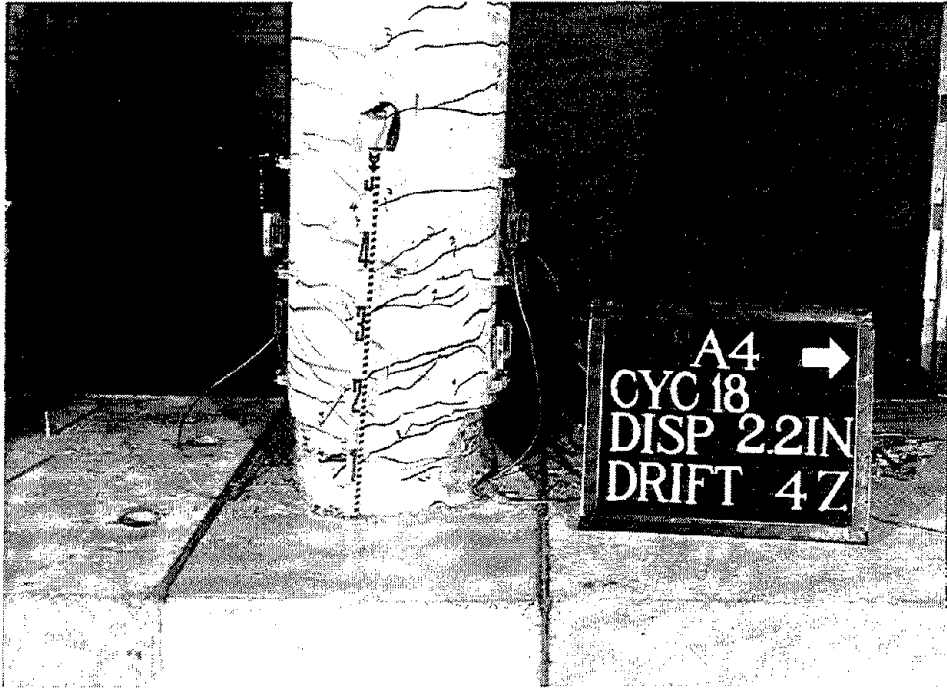
FIGURE 4-13 Condition of Specimen A4 at Cycle No. 18

| 25-26 | Hoop Failure |

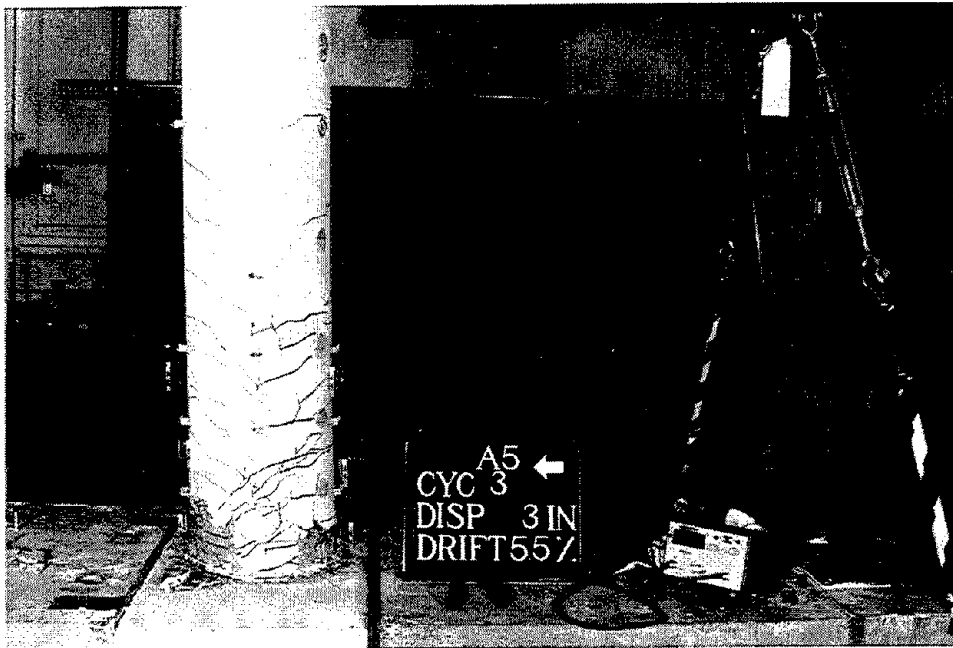
FIGURE 4-17 Specimen A5 at Cycle No. 3

Table 4-6 presents a summary of test observations for specimen A5. Figure 4-17 shows the condition of specimen A5 after 3 cycles of loading. The state of the column at the end of testing is shown in Figure 4-18. Figure 4-19 shows the constant-amplitude displacement history applied to specimen A5. The resulting lateral force vs. displacement response history is displayed in Figure 4-20.

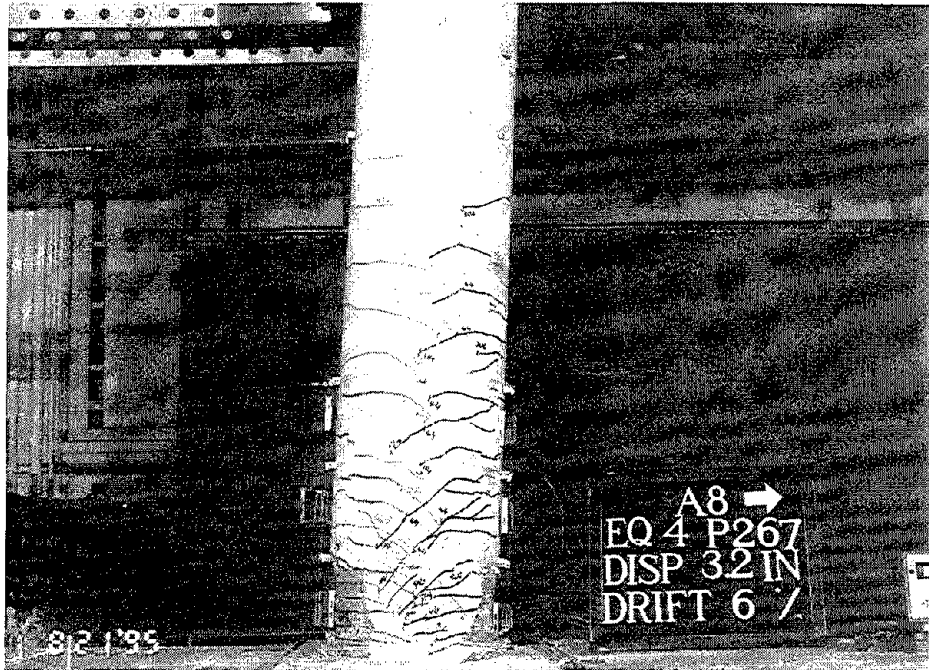
FIGURE 5-8 Specimen A8 at Half-Cycle # 267 During Earthquake 4

Figure 5-8 displays the accumulated damage to the specimen towards the end of the loading when significant spalling, necking of spiral reinforcement and some visible buckling of the longitudinal bars had already taken place. Figure 5-9 shows the failure of the two spirals. The sequence of the imposed displacements is shown in Figure 5-10 while the resulting force-deformation response is shown in Figure 5-11.

| <u>Half Cycle No.</u> | <u>Notes</u> |
|---|---|
| 267 | Necking of spiral reinforcement |

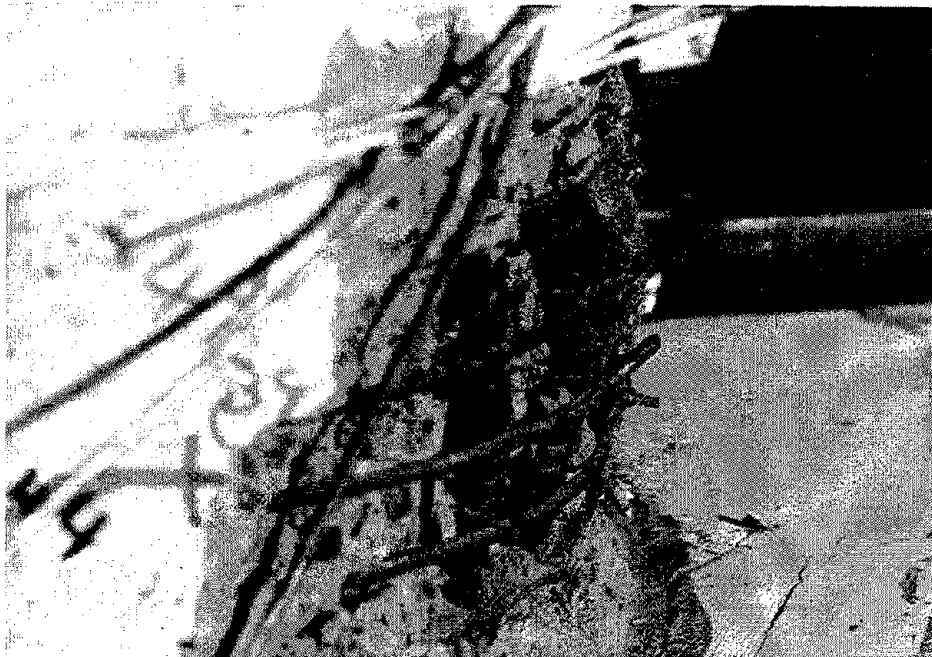
FIGURE 5-9 Specimen A8 at Final Damaged State

| <u>Half Cycle No.</u> | <u>Notes</u> |
|---|---|
| 270 | Two Spirals Failed on the Left Side |

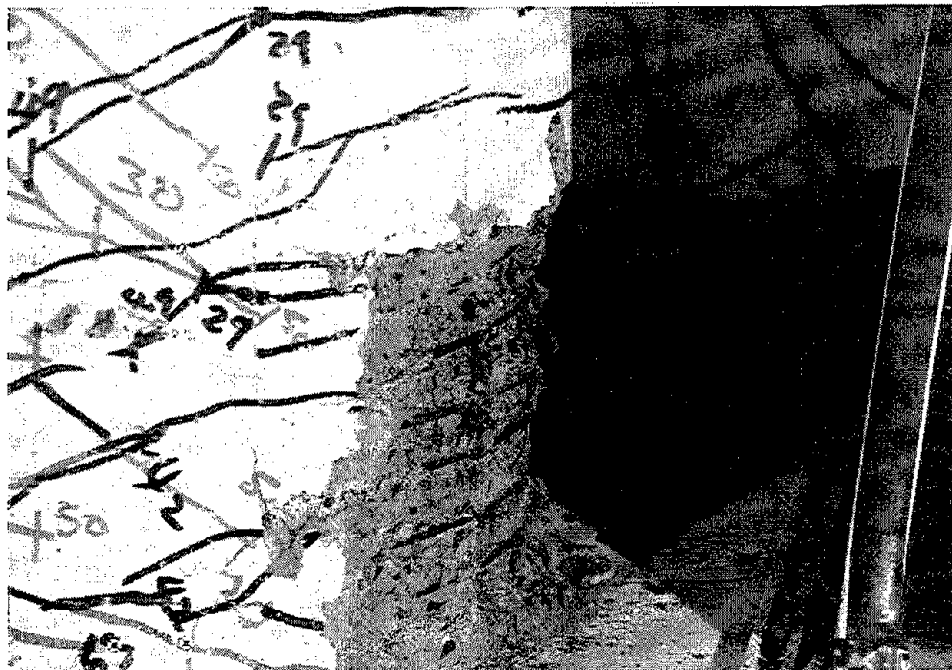
FIGURE 5-13 Final Damaged State of Specimen A9

| <u>Half-Cycle No.</u> | <u>Notes</u> |
|---|---|
| 260 | Spiral Failed on the Left Side of Column A9 |

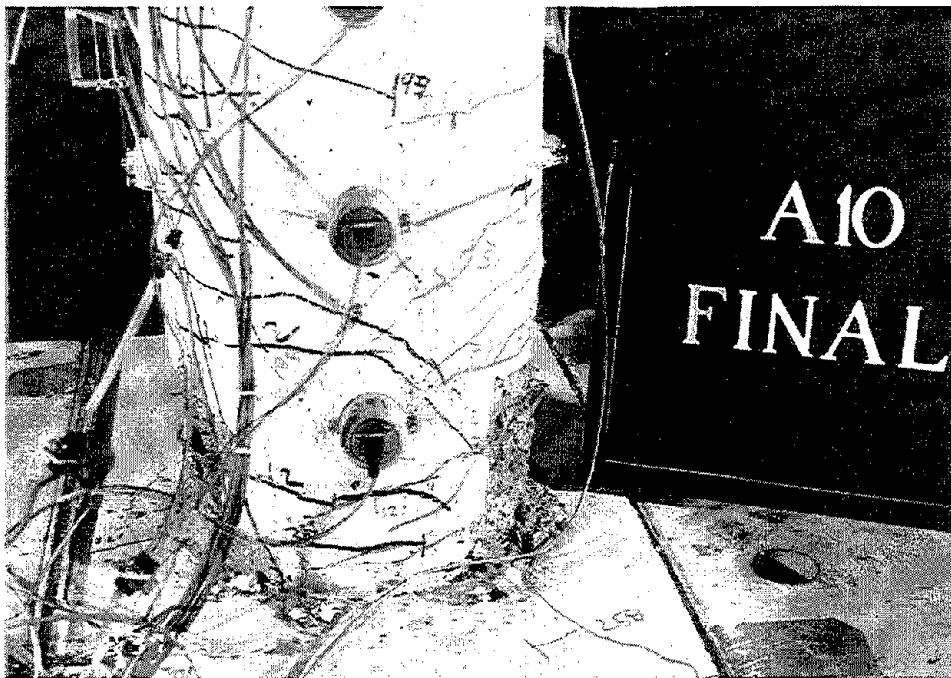
FIGURE 5-17 Final Damaged State of Specimen A10

| 260 | Spiral Failed on the Left Side of Column |

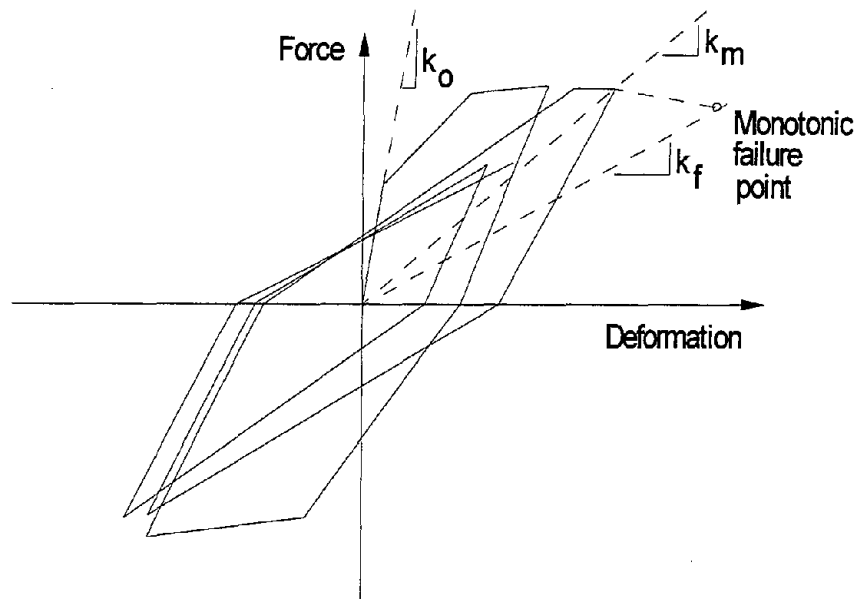
FIGURE 6-1 Parameters Used in Softening Index

With reference to Figure 6-1, k_m is the stiffness of the structure at the maximum induced displacement, k_f is the pre-established stiffness at failure of the system (typically under monotonic loads), and k_o is the initial stiffness prior to loading.
