# Seismic Reliability Assessment of Critical Facilities: A Handbook, Supporting Documentation, and Model Code Provisions

EQE International, Inc.  
1111 Broadway, 10th Floor  
Oakland, California 94607-5500

Technical Report MCEER-99-0008

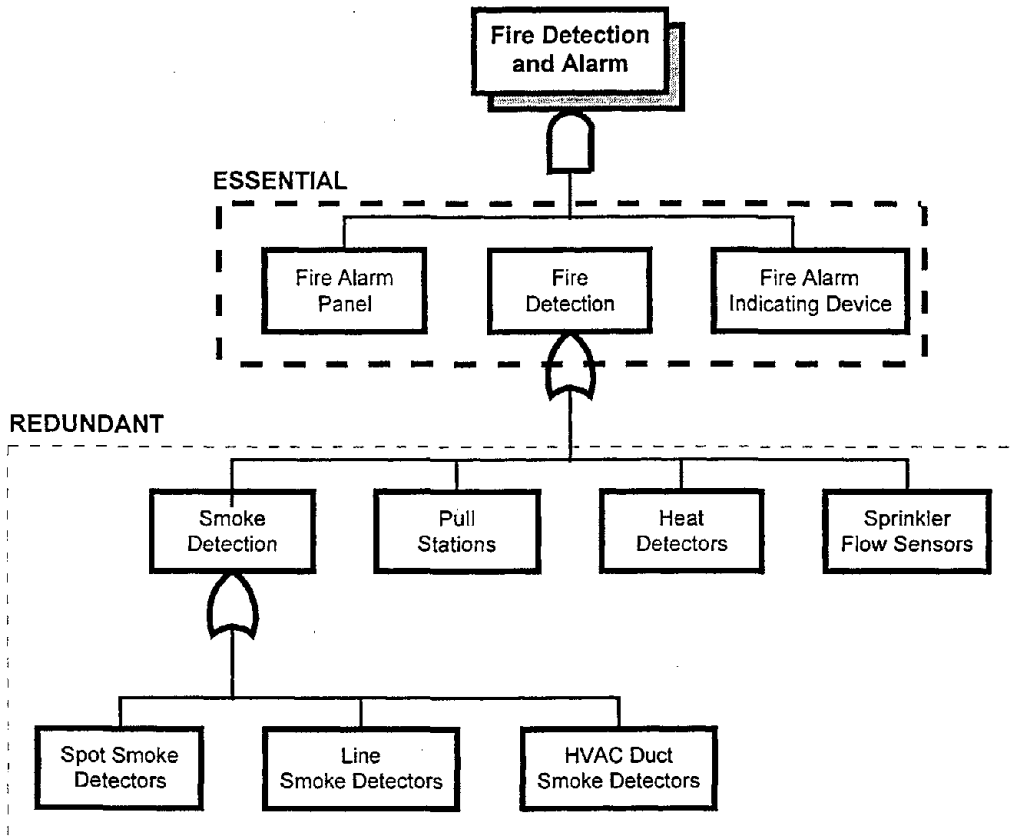
Figure 3-4: Fire Detection and Alarm Logic Example

OR GATE	Component above gate functions if any component below functions

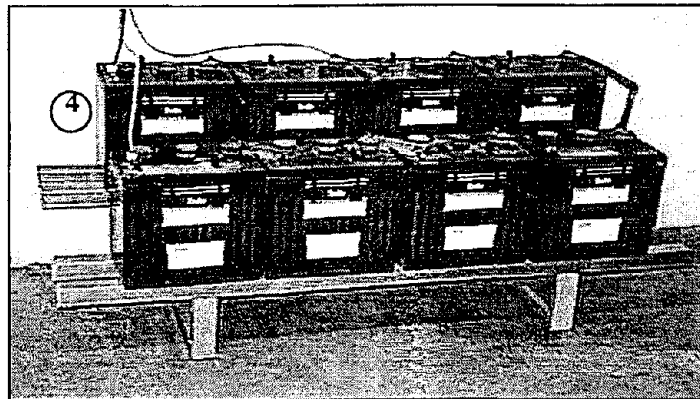
Figure 4-1: Battery Score Sheet (cont.)

- 5 Racks with long rows of batteries need to be sufficiently stiff or braced longitudinally as shown in the photo to the left. Select PMF 5 if no cross-bracing is present.

- 6 If large items such as non-structural walls could fall and impact the battery racks, select PMF 6.
- 7 For other conditions that the reviewer believes could inhibit battery function following an earthquake (e.g., a history of problems with this piece of equipment), assign a PMF value relative to the existing PMFs in the table. Add a descriptive statement for the concern.

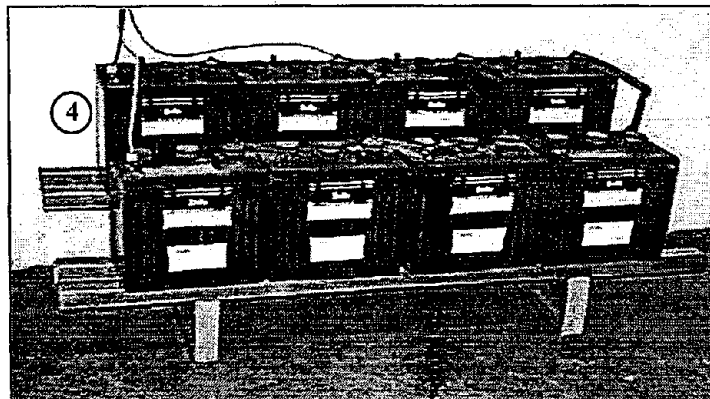
- 5 Racks with long rows of batteries need to be sufficiently stiff or braced longitudinally as shown in the photo to the left. Select PMF 5 if no cross-bracing is present.

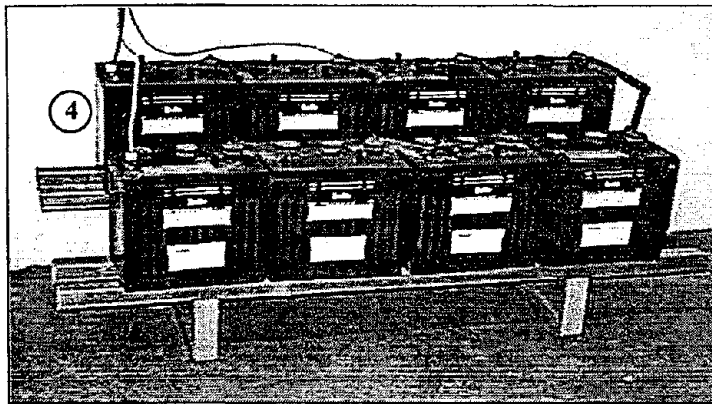
Figure 3-1: Sample Data Sheet

- 5 Racks with long rows of batteries need to be braced longitudinally as shown in the photo to the left. Select PMF 5 if no cross-bracing is present.
- 6 If large items such as non-structural walls could fall and impact the battery racks, select PMF 6.

Figure 3-1 shows an example data sheet from Reference 1.8b. The first step in component assessment is to identify the seismic load level that the component is expected to experience. This is a function of the regional seismicity, expressed in terms of the seismic zone, and the location in the building. The matrix in the data sheet is used to assign a load level classification to account for both of these features. The following should be considered when using this matrix.

As shown in Figure 3-1, a basic score is provided for each of the load level classifications. The basic score in the appropriate column should be circled on the data sheet.

As shown in Figure 3-1, several potential vulnerabilities have been identified for each general type of component, with a relative effect on reliability quantified in terms of a performance modification factor (PMF). The next step in the evaluation process is to identify which PMFs are applicable to the specific component being evaluated. The individual should use the column on the score sheet for the appropriate seismic load level classification, the same as used for the basic score. The values assigned to all applicable PMFs should be circled in that column. It is critical that the evaluator not simply evaluate for the worst-case PMF and then stop the evaluation process. All PMFs should be evaluated and applicable PMFs identified for use in Risk Management, as described in Chapter 5. The following should be considered when performing this evaluation:
