FINAL REPORT

SEISMIC RESISTANCE OF COMPOSITE FLOOR DIAPHRAGMS

ISU-ERI-AMES-80133
Project 1270

**National Science Foundation
Grant ENV75-23625**

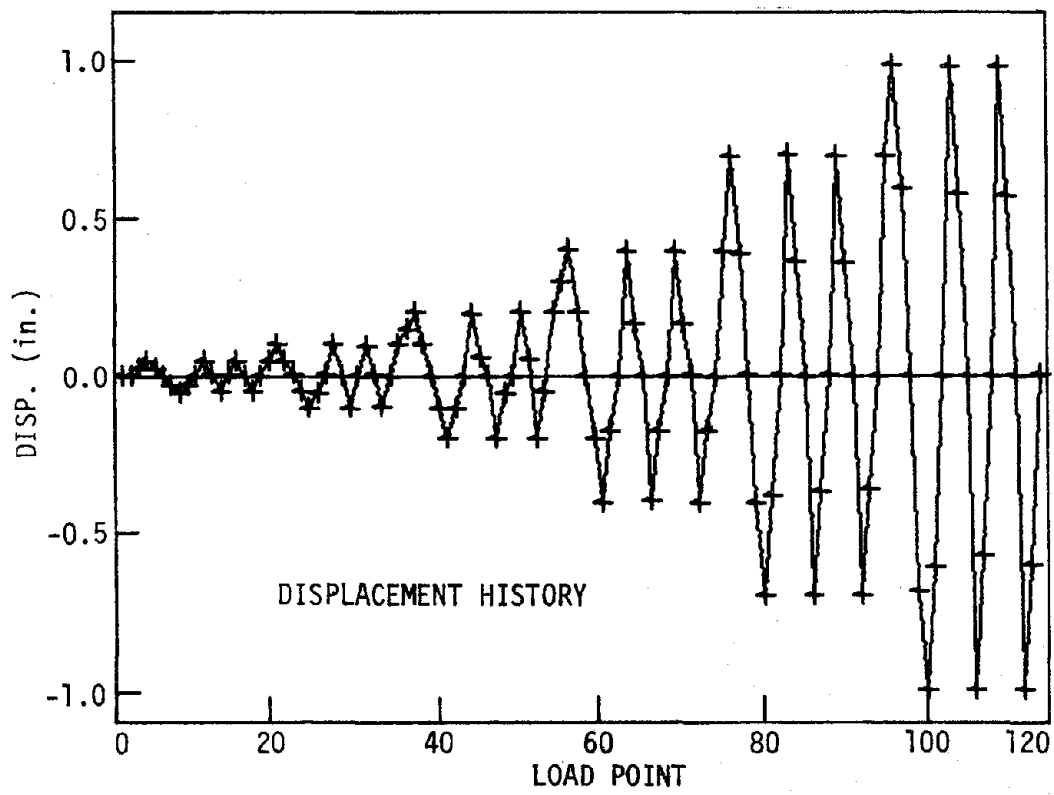
Fig. 17. Typical load-displacement history.

For each slab, a test program was established from the anticipated working and maximum loads and the estimated displacements. The program was monitored by displacement control, which was held constant at various increments while instrumentation readings were being recorded, cracks marked and labeled, and photographs taken. A load point (LP) was assigned to each displacement increment where readings were taken. A typical test program is shown in Fig. 17. Data readings were taken at each load point up to a maximum of ± 1 in. At this time all vertical displacement DCDT's, slip gages, and dial gages were removed from the slab. The loading cycle was subsequently continued to ± 5 in. in order to observe the complete failure breakdown of the composite slab. (Note: positive displacement is taken as movement to the East for all slabs.)

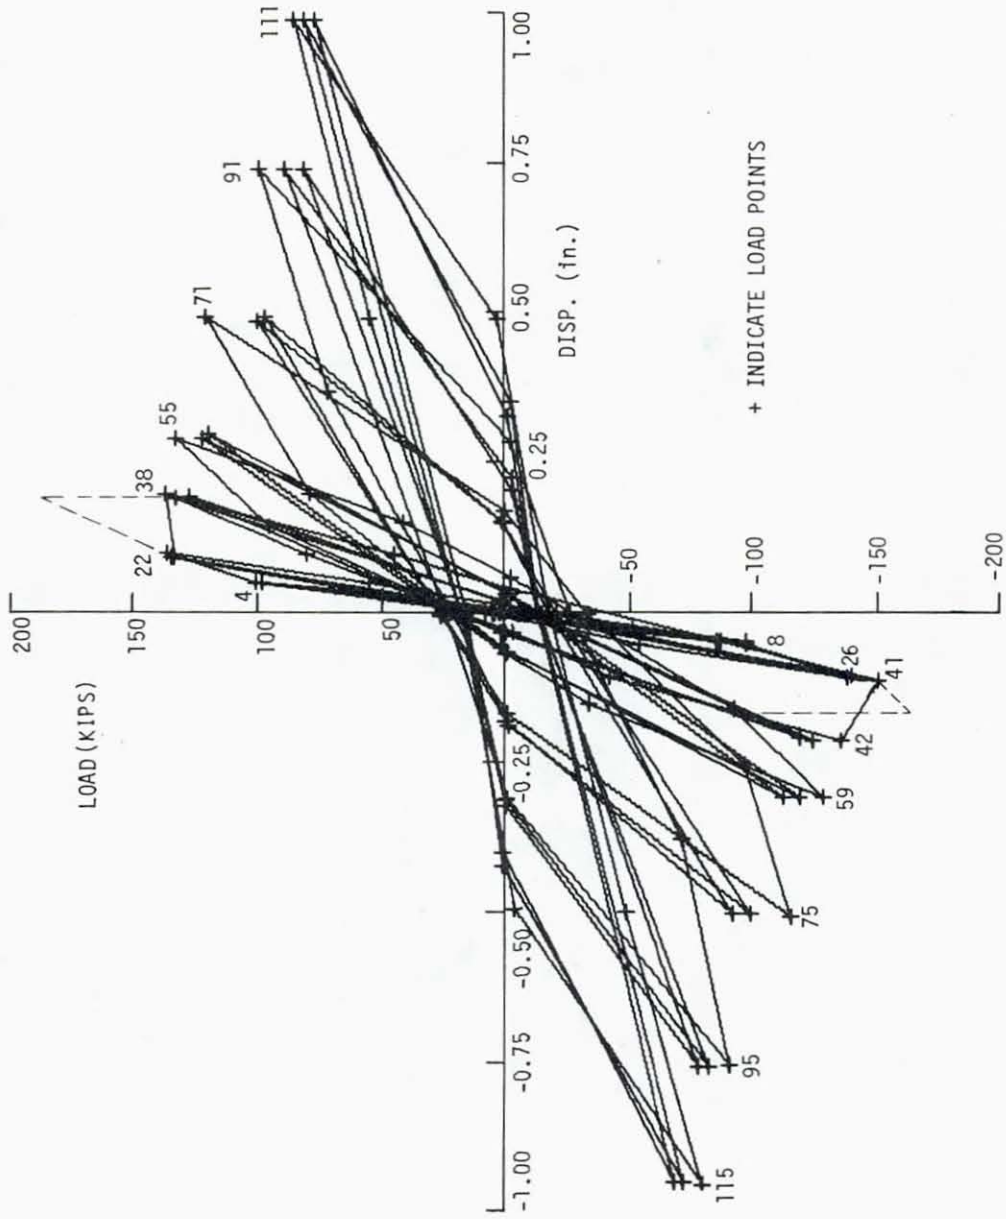
Fig. 20. Load-displacement diagram, Specimen 2.

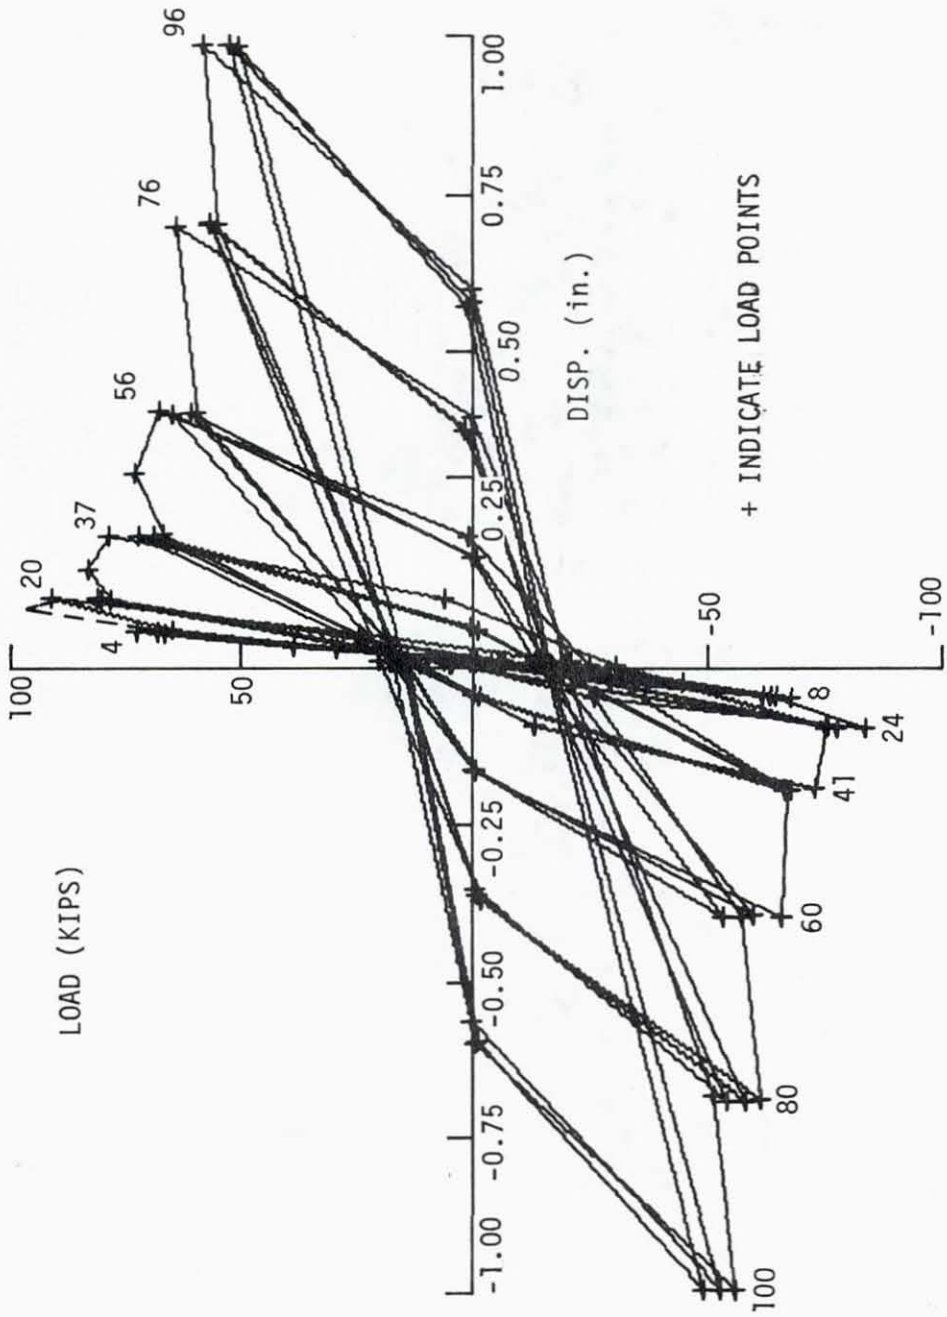
Fig. 22. Load-displacement diagram for Slab 3.

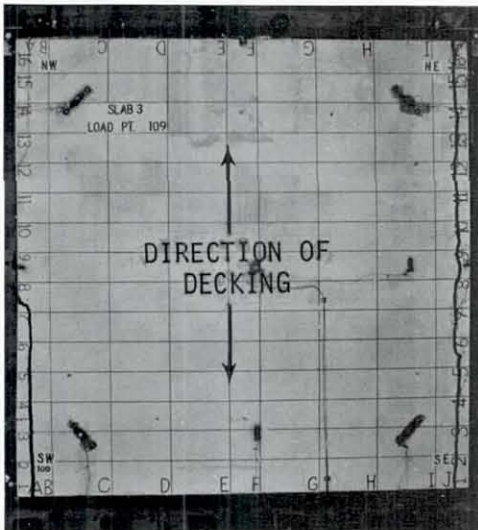
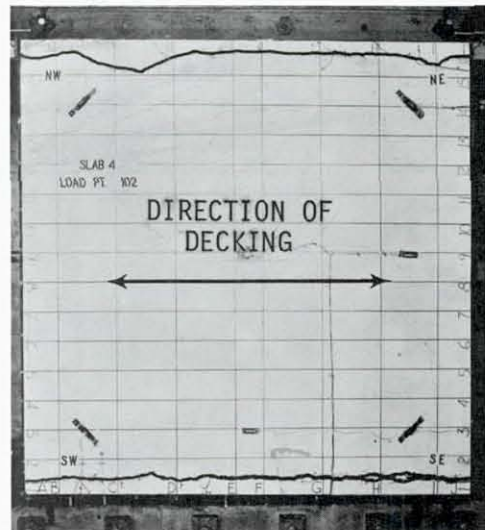
(a) SLAB 3.

(b) SLAB 4.

Fig. 26. Top surface cracking for Slabs 3 and 4.

The crack patterns for Slabs 3 and 4 were very similar. There were two significant crack patterns: (1) diagonal cracks that formed on the vertical edges at each deck seam, near the maximum load (see Fig. 25), and (2) top surface cracks that occurred near the edges and parallel to the corrugations (see Fig. 26). The deck seam at each overlapping connection between deck panels forms a ridge that prevents

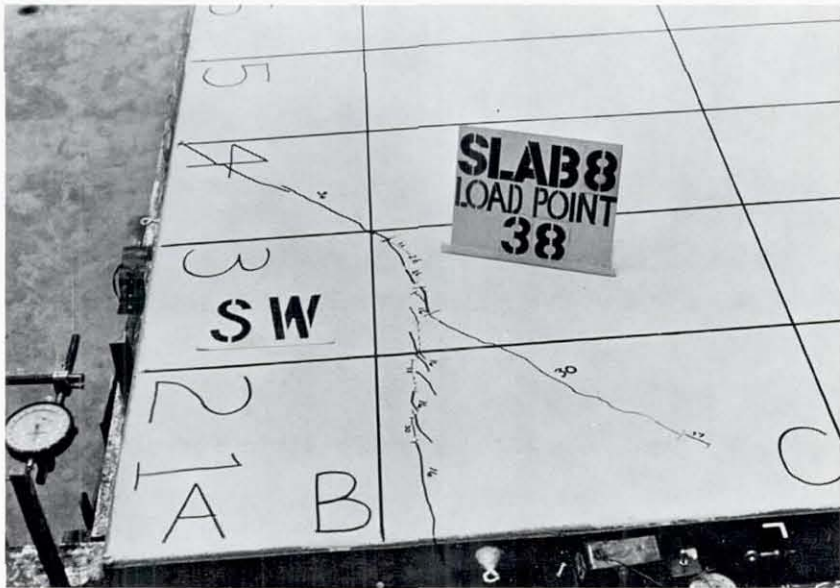
(a) INITIAL CRACKING AROUND EDGE CONNECTORS (STUDS).

(b) DIAGONAL CRACKING TYPICAL AT CORNERS.

Fig. 36. Early crack patterns for Slab 8.
