GEOLOGY AND COASTAL HAZARDS IN THE NORTHERN MONTEREY BAY, CALIFORNIA

Field Trip Guidebook

Open-File Report 00-438

**Geology and Coastal Hazards of Northern Monterey Bay
Field Trip Guidebook
November 4, 2000**

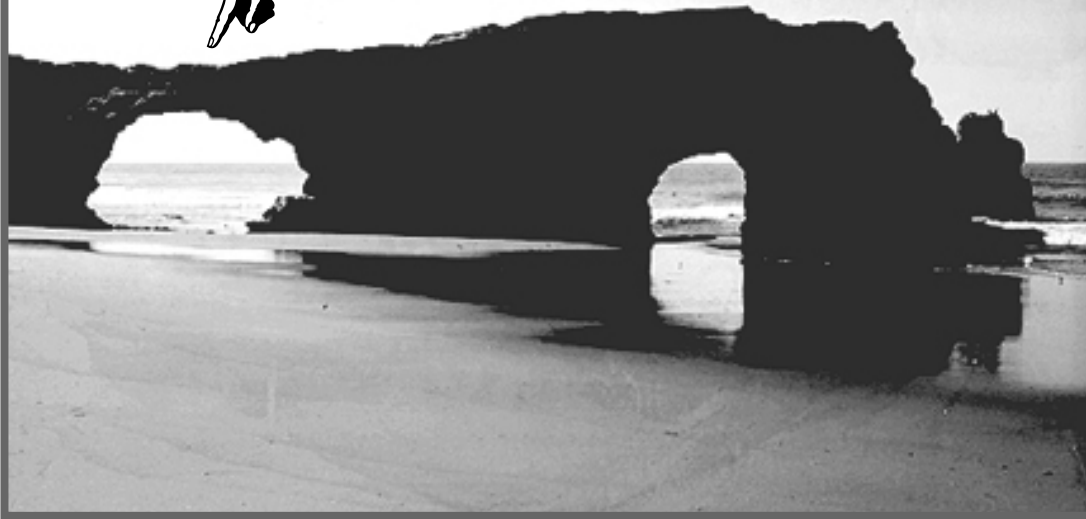
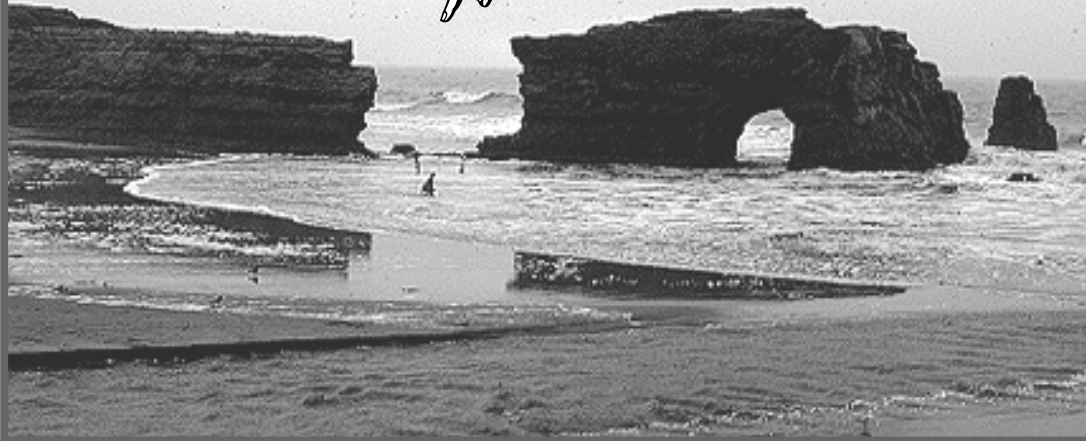
Natural Bridges State Beach, 1970

The cliffs and arches of Natural Bridges State Beach, just east of the Long Marine Lab, are formed within the Santa Cruz Mudstone. Although this geologic unit is more resistant than other lithologies in the northern Monterey Bay, zones of weakness within the mudstone lead to the formation and ultimate collapse of features such as the one shown above at Natural Bridges State Beach.

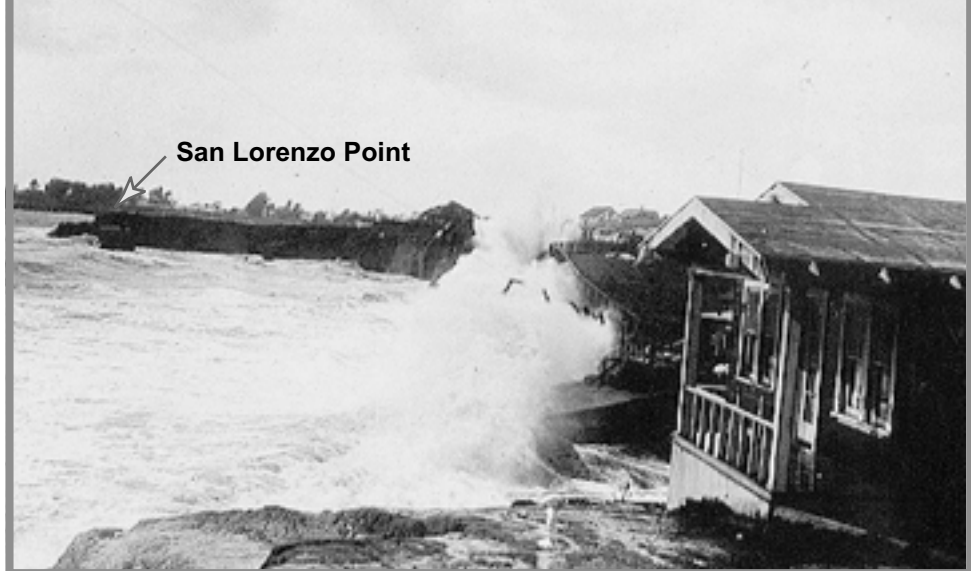
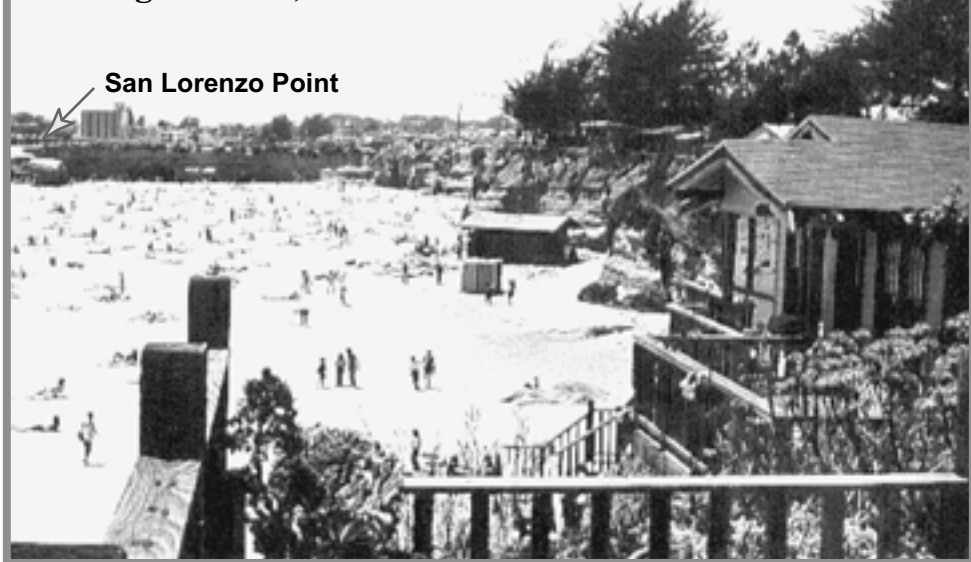
Seabright Beach, 1900

The photos above, taken from approximately the same location (the house on the right is the same house), show the Seabright Beach area, looking west towards San Lorenzo Point. The cliffs here were once subjected to regular wave action (top), with little or no fronting beach. Since the emplacement of the Yacht harbor jetty in the early 1960's the beach has progressively widened to be one of the widest beaches in the northern Monterey Bay.

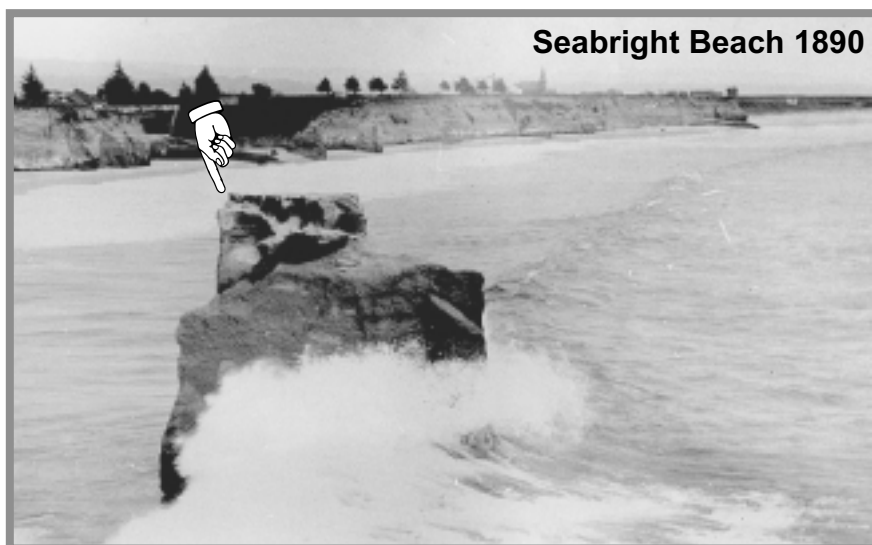
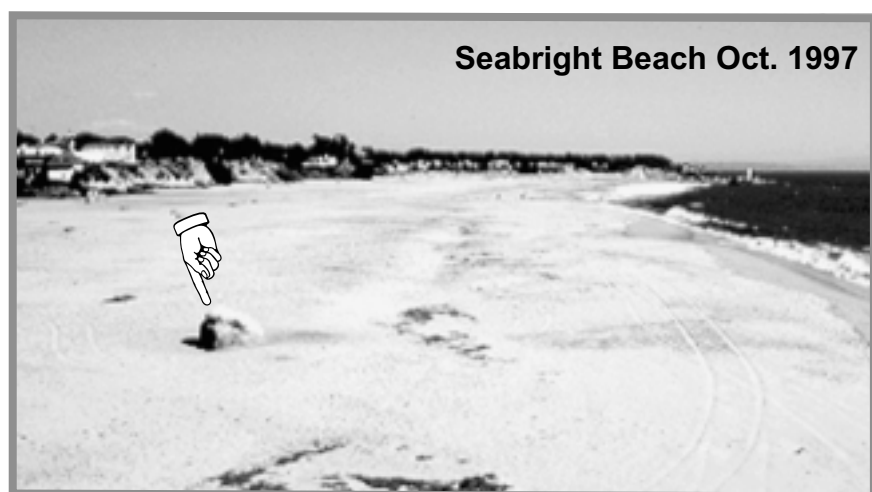
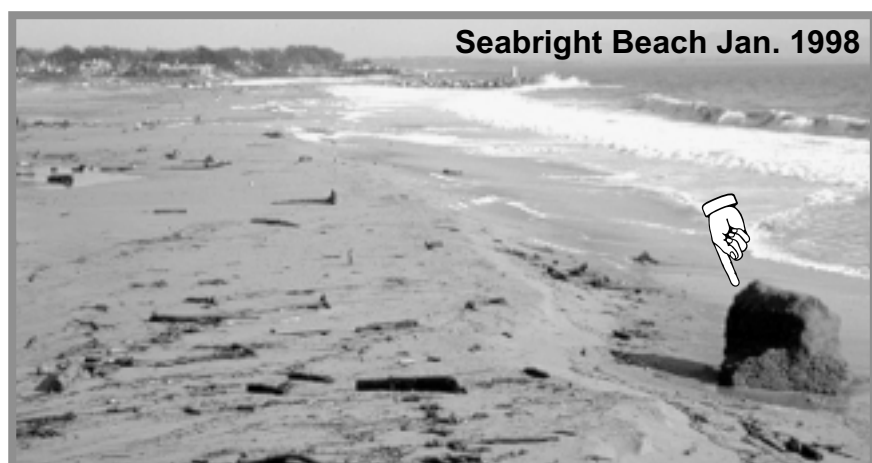
Stop 2: Seabright Beach and the effects of the Santa Cruz Yacht Harbor Jetty

These 3 photos, shown looking east towards the Yacht Harbor, show the remains of a seastack at Seabright Beach (shown by arrows). The beach has increased significantly in volume since the construction of the jetty, nearly burying the seastack. Barely exposed above the sand during the summer months (center photo), the rock is occasionally exposed as storm waves remove sand from the beach (bottom photo), such as during the 1997-98 El Nino winter.

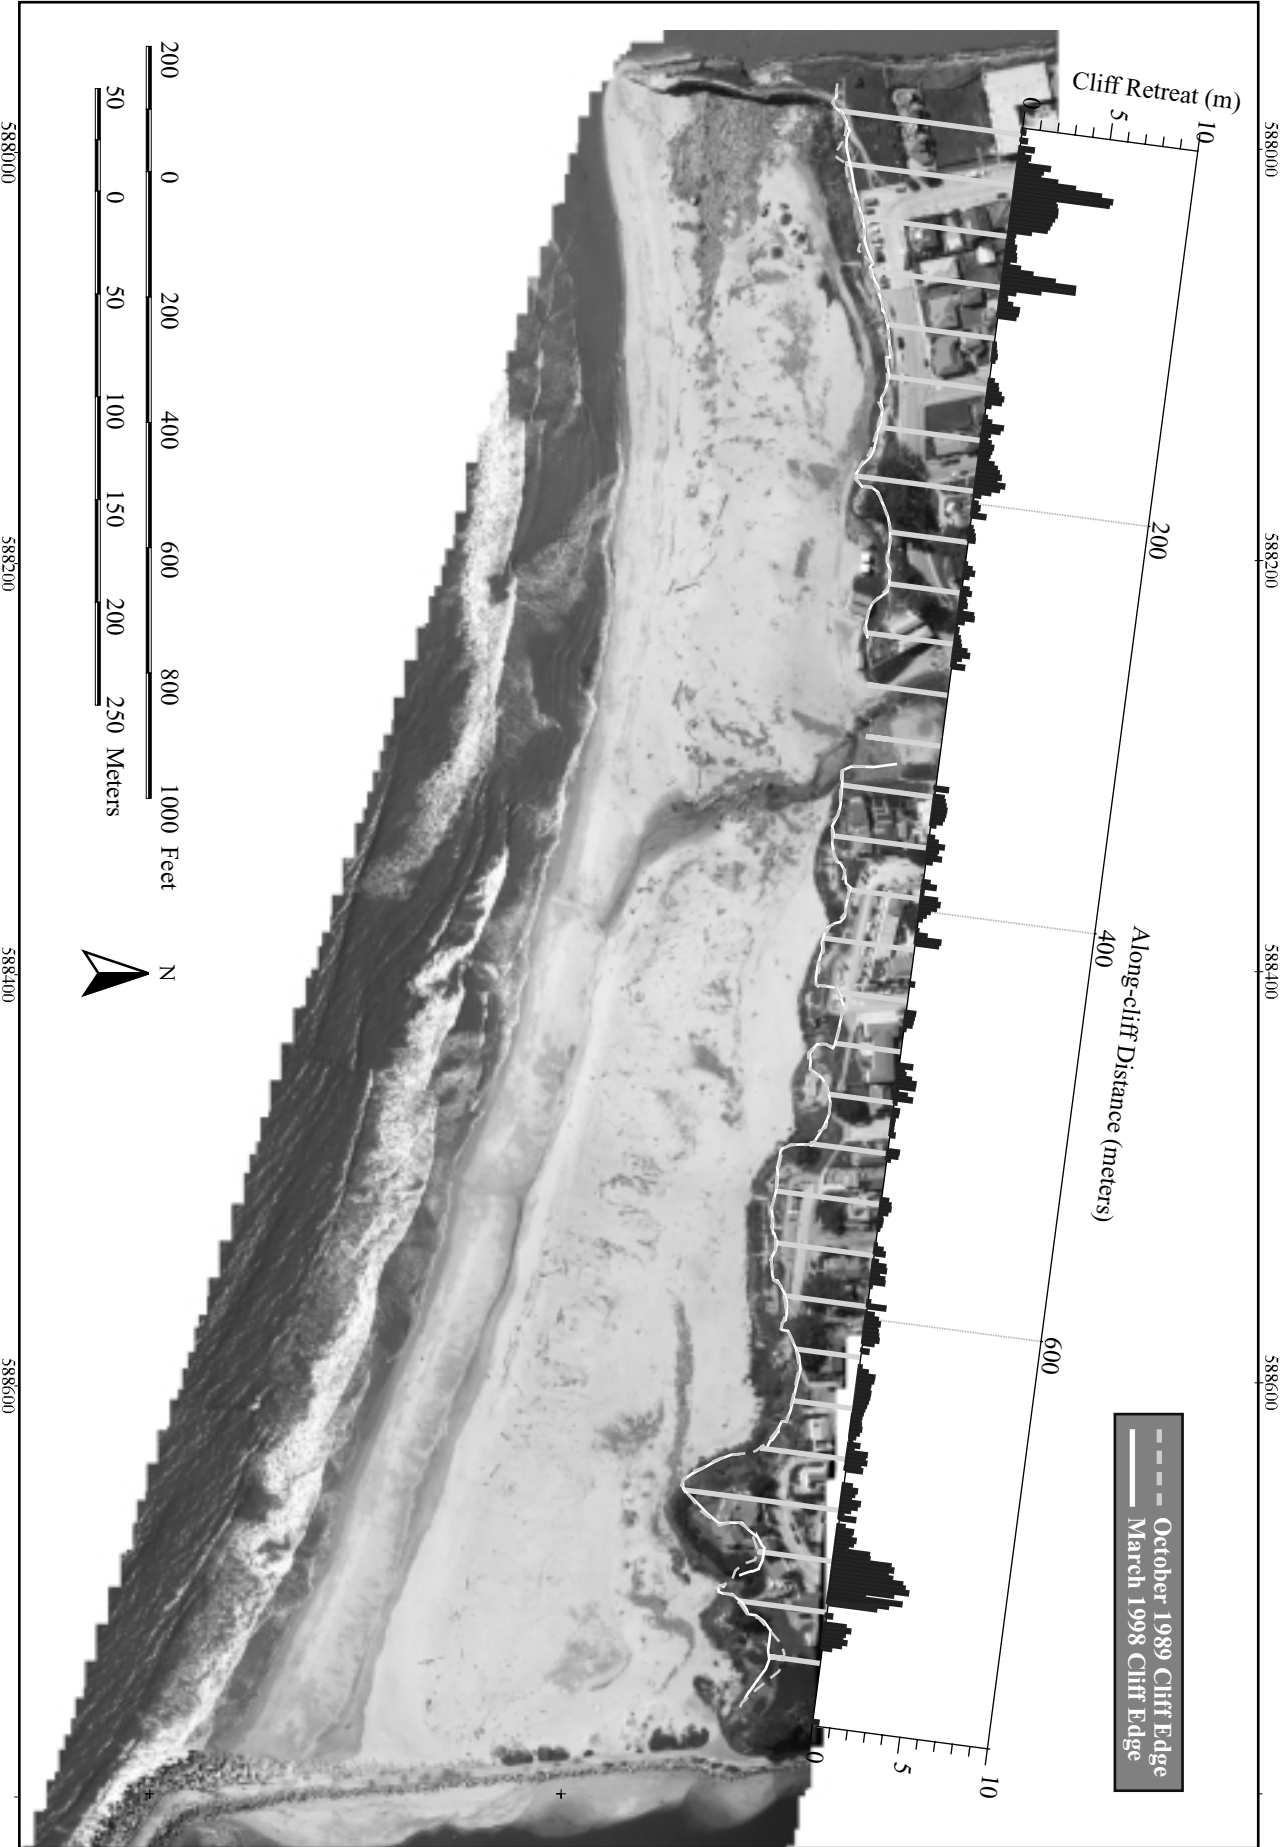
Orthophotomosaic of Seabright Beach from 3/6/98 Coastal Aerial Mapping System (CAMS) data. Retreat magnitudes are shown for the decade between October 1989, immediately after the Loma Prieta earthquake, and March 1998.

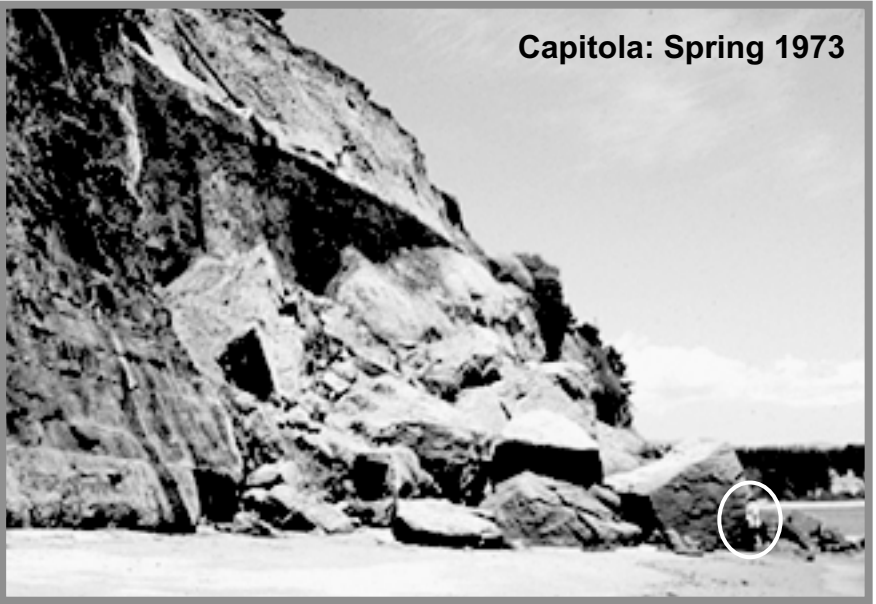
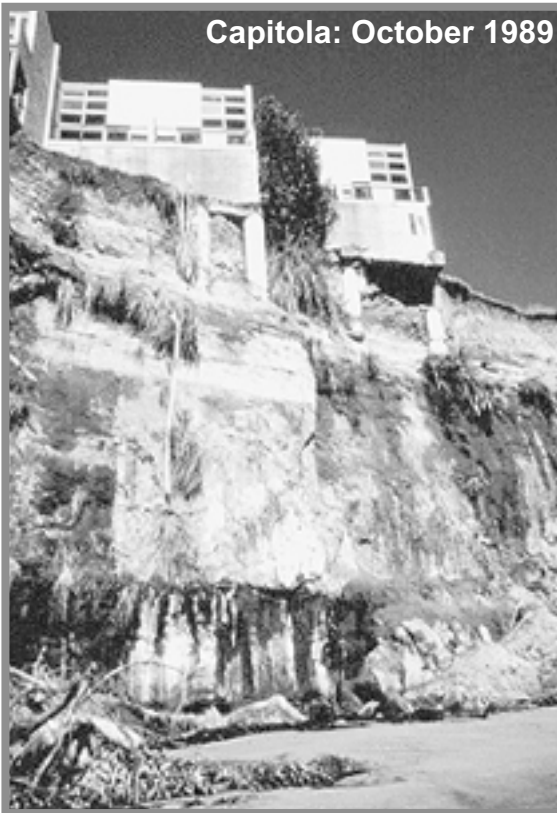
Capitola: Spring 1973

Photo at top shows a large blockfall, a common style of failure along the Depot Hill cliffs. A person (circled) gives an indication of scale. The lower photo shows the undercutting of the Crest Apartments from cliff failures associated with the Loma Prieta earthquake.

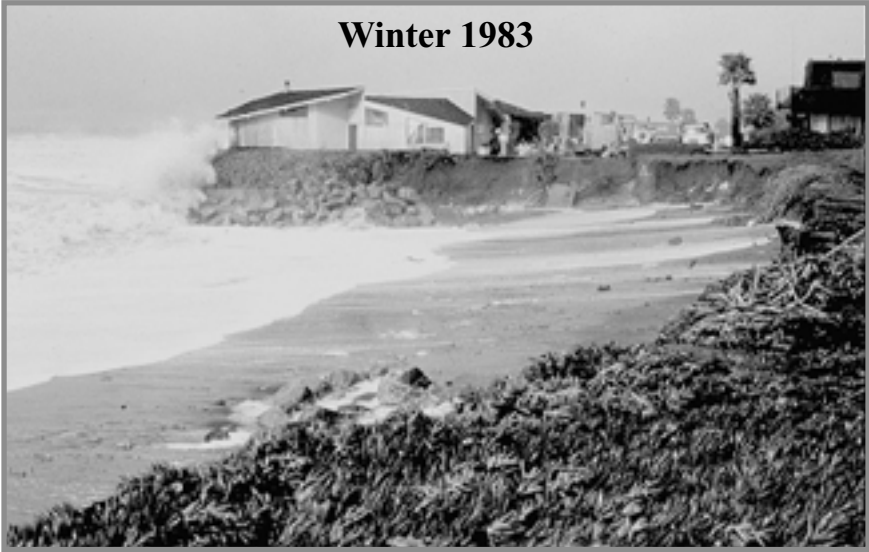
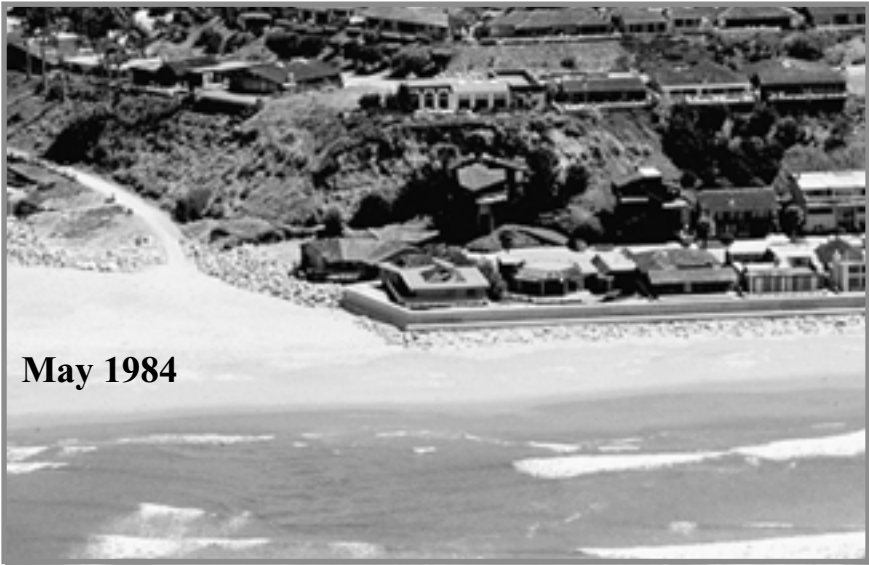
Stop 5: Seawall at Via Gaviota, Seascape

A group of homes built on the beach in 1969 were initially protected by riprap. Waves associated with large southwesterly storms in early 1983 overtopped the riprap and caused major damage (top photo). In June of 1983, a 1000-foot concrete seawall was emplaced to protect the houses from further damage (bottom photo).
