OBSERVATIONS ON THE BEHAVIOR OF BUILDINGS IN THE ROMANIA EARTHQUAKE OF MARCH 4, 1977

NBS SPECIAL PUBLICATION 490

U.S. DEPARTMENT OF COMMERCE / National Bureau of Standards

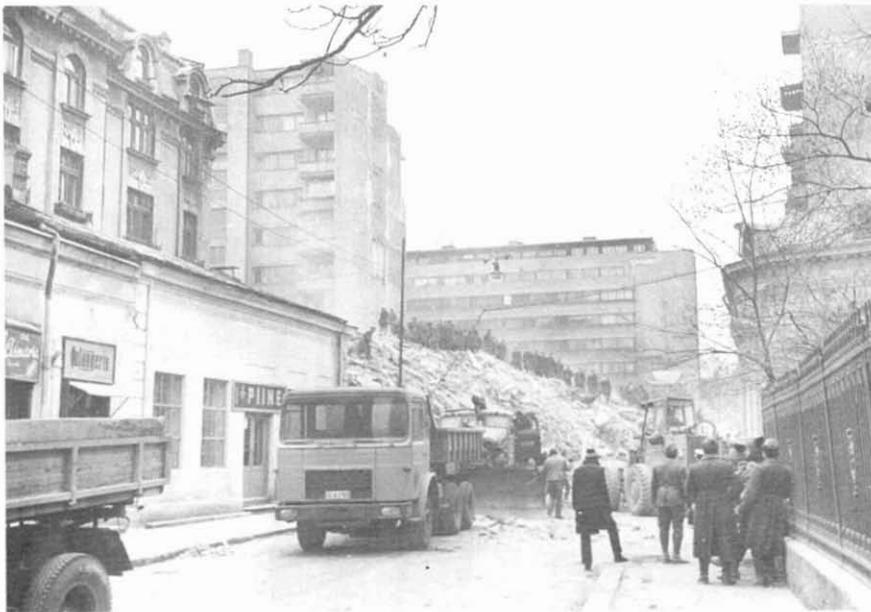
Figure 3.3. Opposite view of the Cafe Scala building ruins.

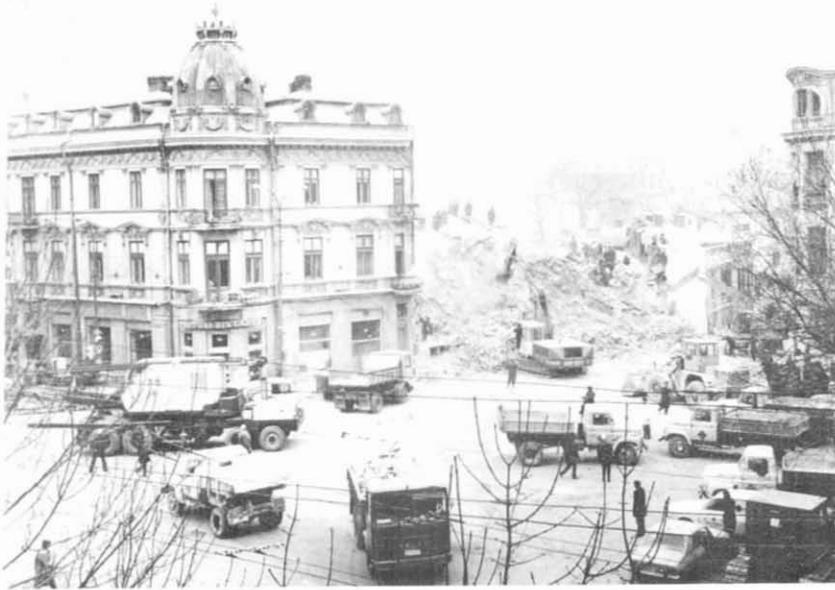
A peculiar phenomenon associated with the collapse of the older structures is evidenced by the extensive pulverization of the concrete as indicated in Figures 3.2 and 3.4. A member of the INCERC team that examined wrecked structures immediately after the earthquake noted that in many instances the concrete had disintegrated completely and a haze of dust particles hung in the air surrounding the sites. This pulverization effect, also noted during the November 1940 earthquake (see Ref. 3 and Section 2.3.2), may possibly be attributed to the cumulative degradation of concrete through exposure to cyclic loading during past earthquakes. Well-rounded ends of story-high concrete columns that had pried loose and fallen to the ground (see, for instance, Figures 3.3 and 3.6), as opposed to jagged ends normally found in concrete failures, may be evidence of internal pulverization of concrete in the joints attributable to past extreme events. It should also be noted that the use of relatively low-strength concrete (as low as grade B100 with approximately 10 MN/m^2 cube strength) was prevalent in the construction of pre-1940 buildings.

Figure 3.4. Avintul building near Piata Rosetti destroyed by the earthquake.

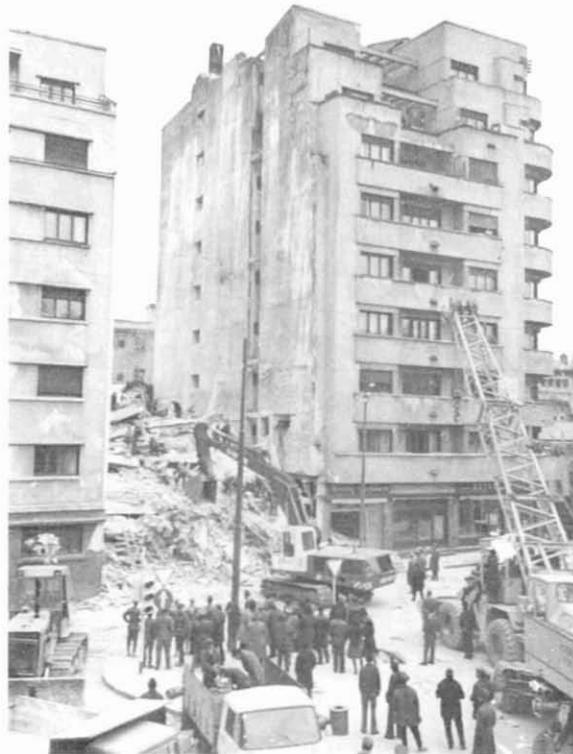
Figure 3.5 exhibits a rare instance of a collapsed building which was an interior unit. In general, the collapsed structures were either isolated buildings or were the end or corner units of a block of adjacent buildings. A plausible explanation of this trend is provided by the fact that the corner and end units tend to be less symmetric and more irregular in plan and structural configuration than those at the interior. Consequently, torsional effects, including the likelihood of coupling of the torsional and translational modes, and unfavorable stress distribution under lateral loads, would tend to be relatively greater in the end and corner units.

Figure 3.5. Multistory apartment on Sahia Street near corner of Piata Rosetti totally destroyed by the earthquake.

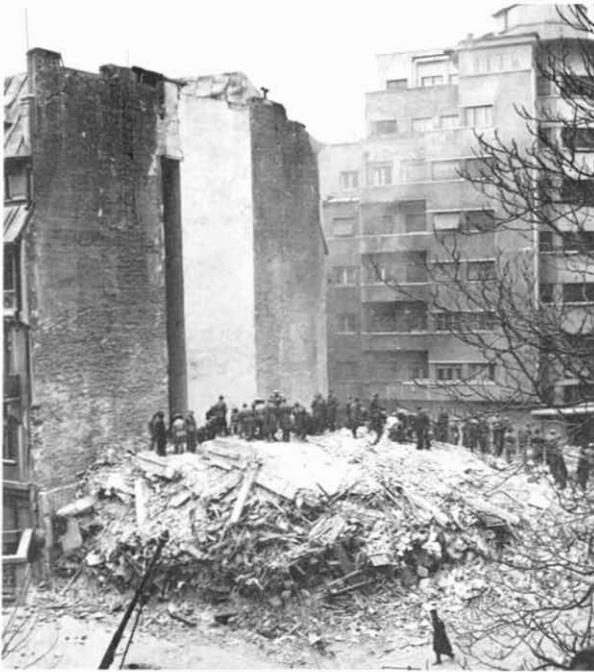
Figure 3.6. View of wreckage of the multistory apartment building at Boulevard Hristo Botev No. 10.

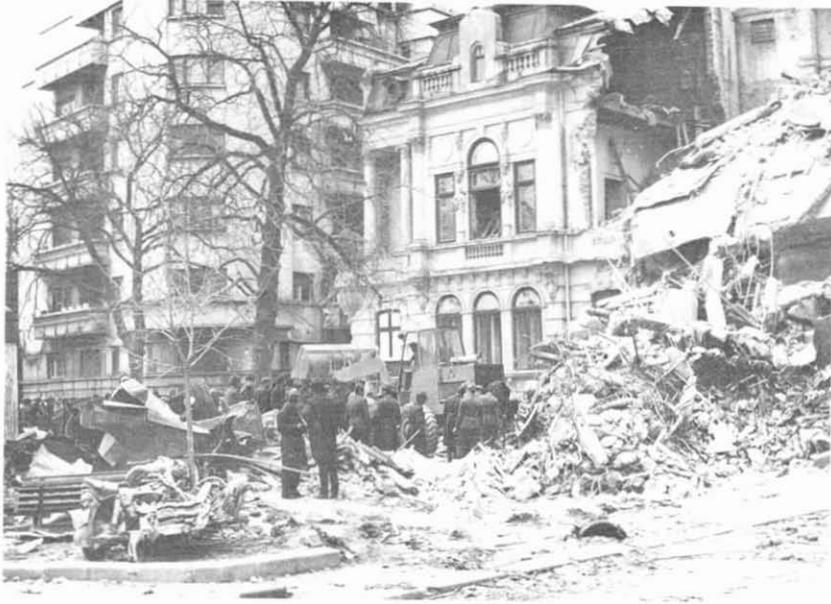
Figure 3.10. Close-up view of the collapsed bay of the building on Snagov Street.

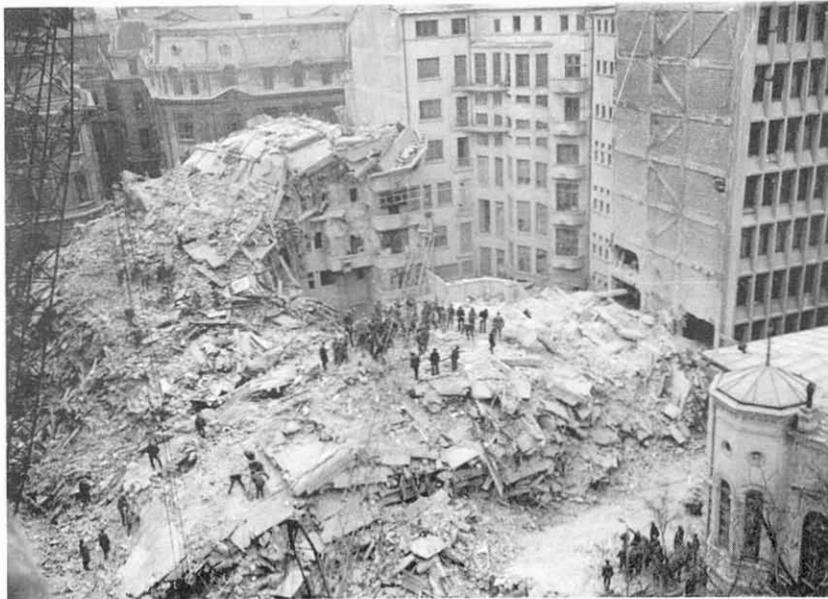
Figure 3.11. General view of the collapse of the multistory Continental building before removal of the wreckage.

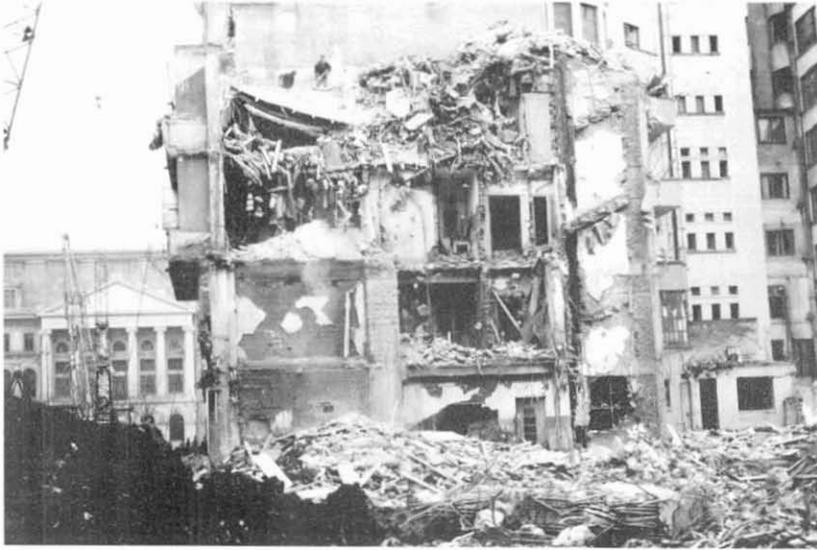
Figure 3.12. View of Continental building after partial removal of debris.

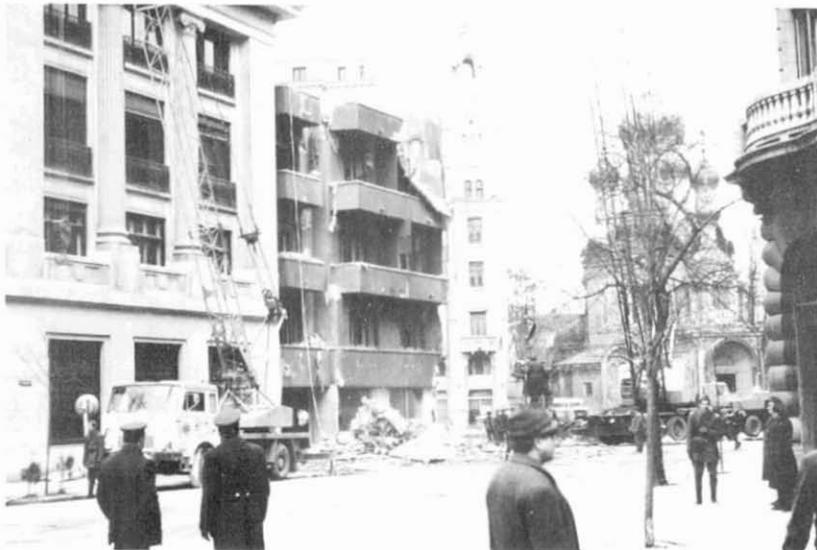
Figure 3.13. Standing left wing portion of Continental building with Russian church in the background.

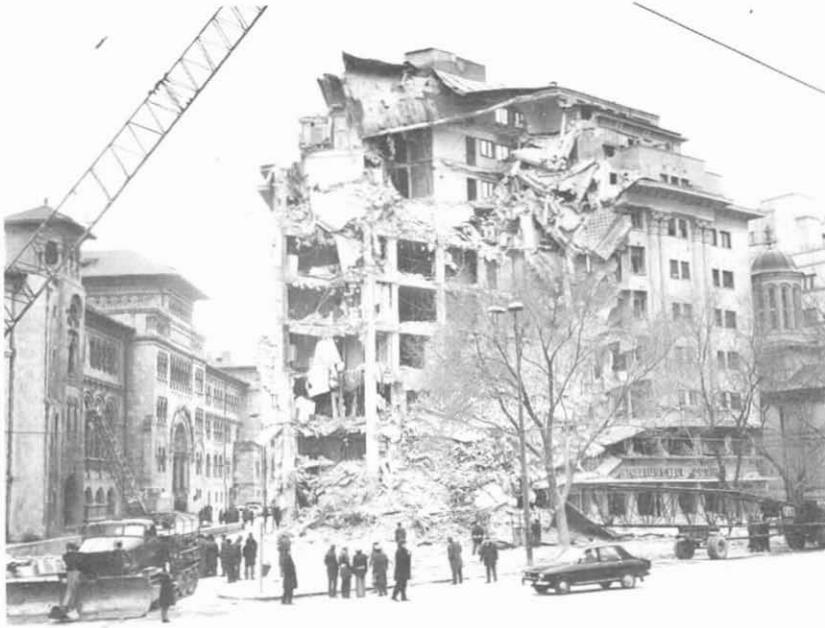
Figure 3.14. View of partially collapsed Dunres building before removal of debris.

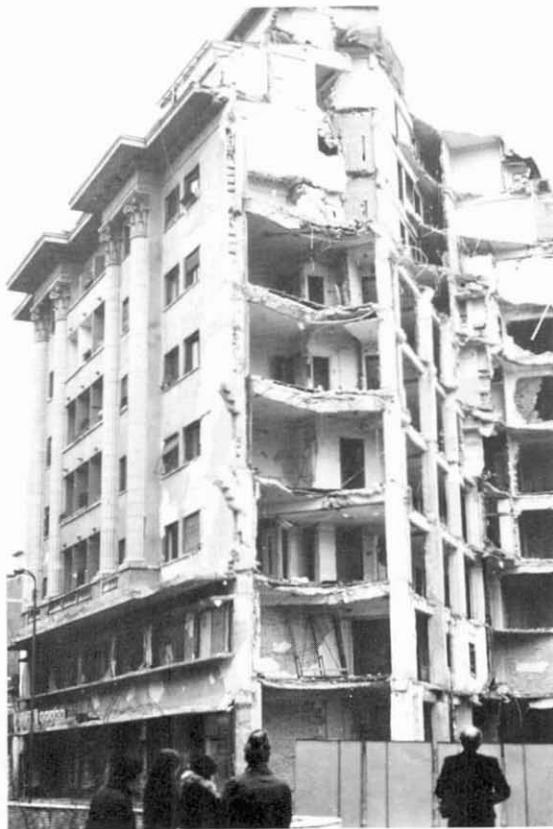
Figure 3.15. Southeast view of Dunres building after clearing of debris.

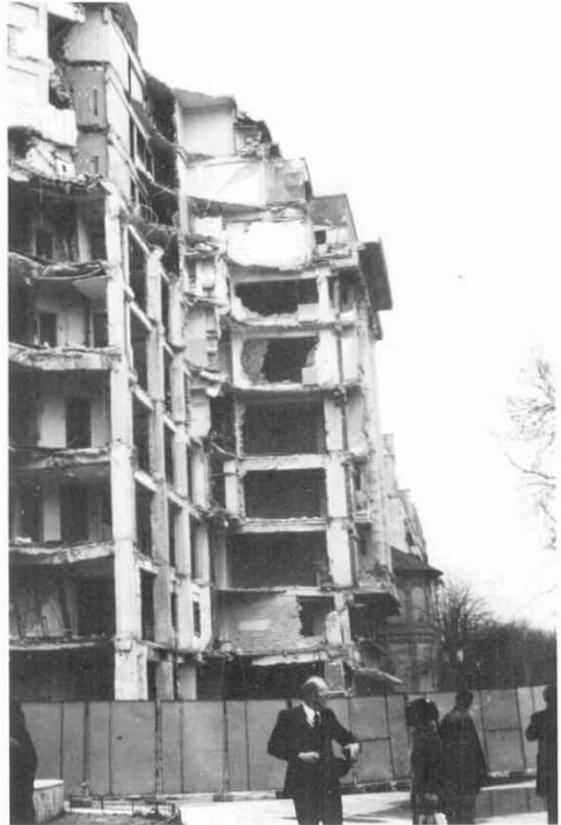
Figure 3.16. View of Dunres building looking north.

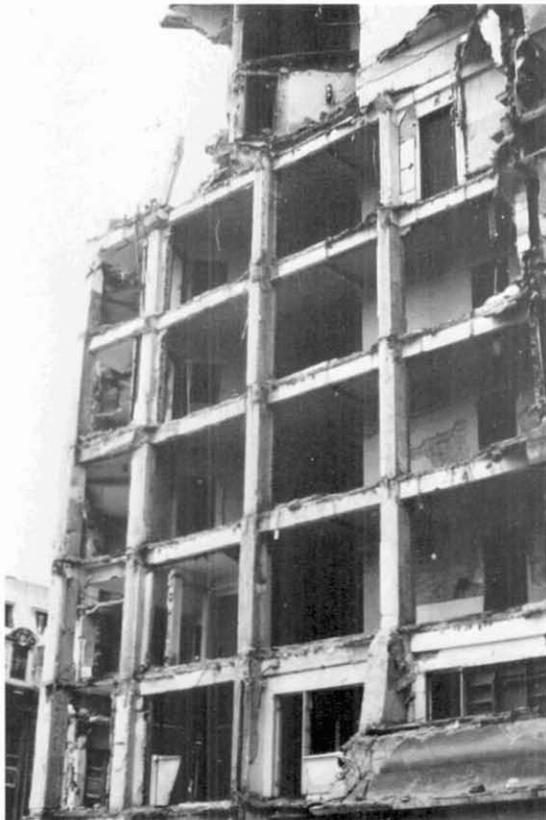
Figure 3.17. Close-up view of Dunres building.

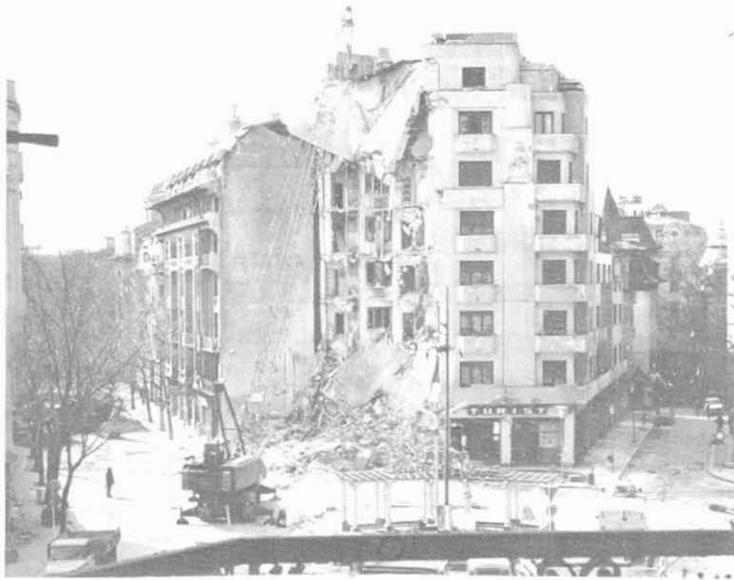
Figure 3.18. Partial collapse of Lido building.

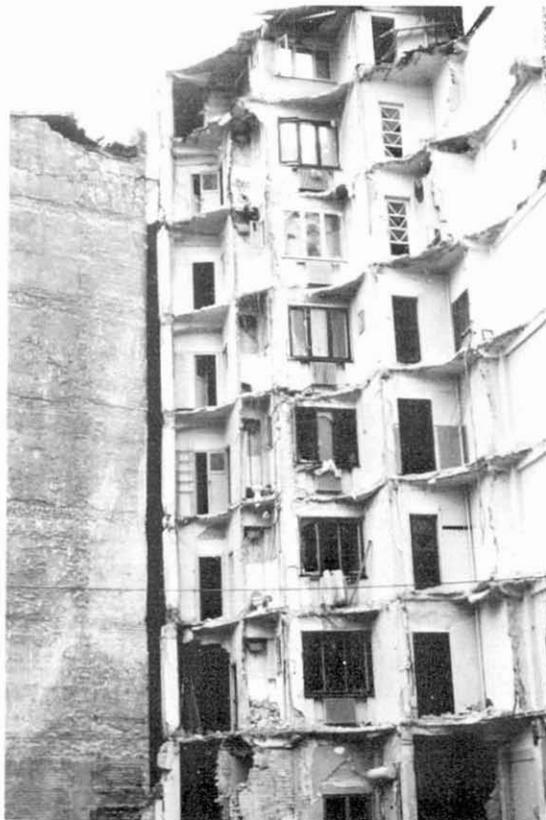
Figure 3.19. Close-up view of Lido building after removal of suspended wreckage.

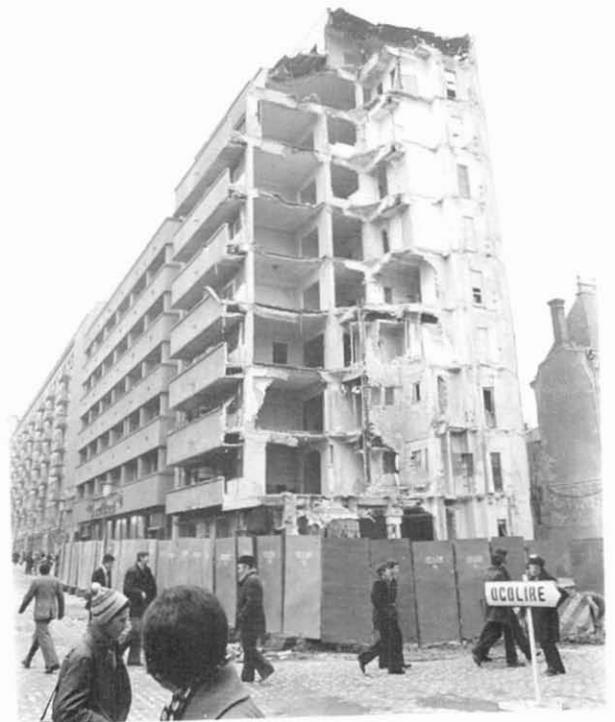
Figure 3.23. Casata building after removal of debris.

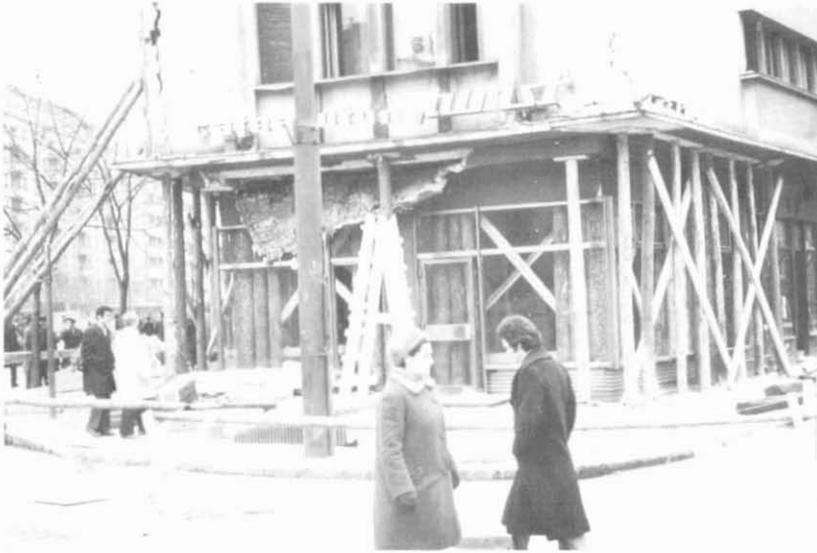
Figure 3.28. General view of the Turist building after the earthquake.

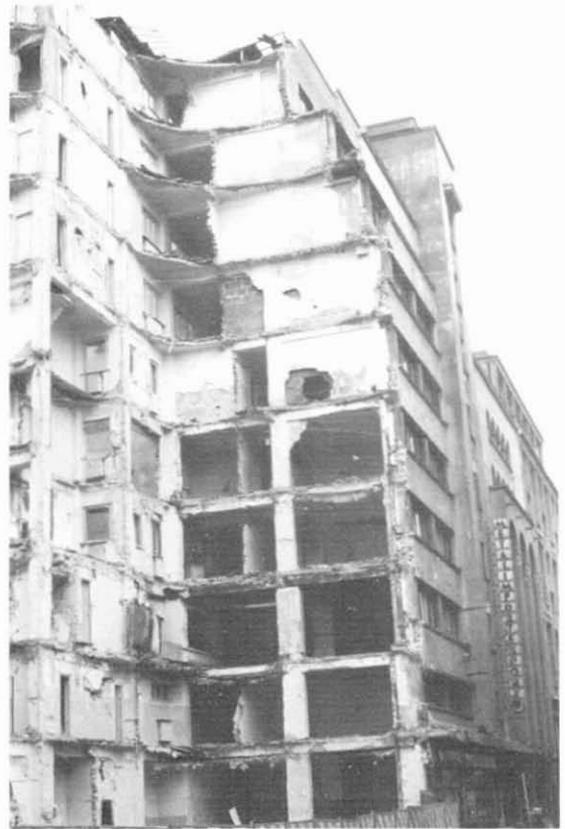
Figure 3.34. Partial collapse of 10-story Metalimport building.

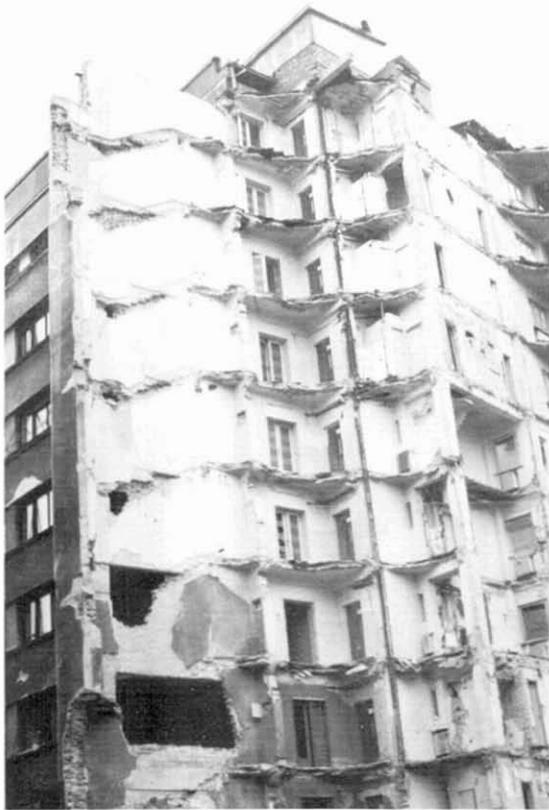
Figure 3.35. Left view of the collapse of Metalimport building.

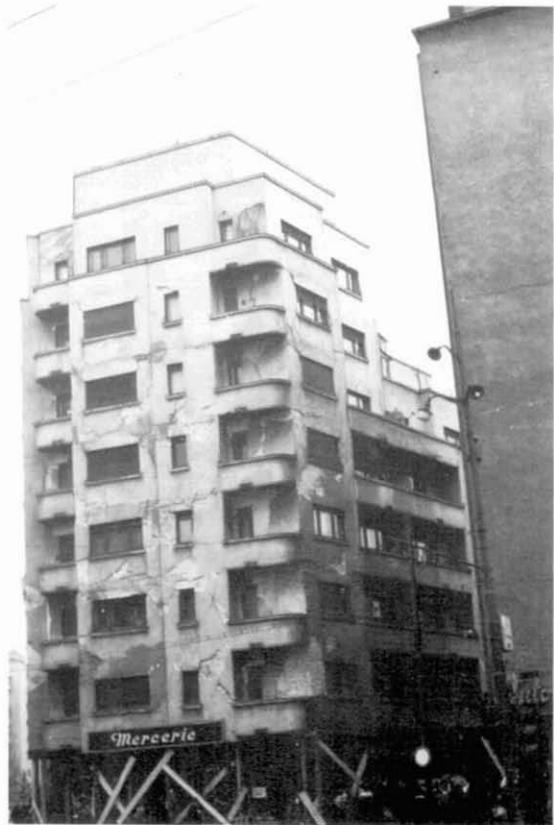
Figure 3.37. Another view of Mercerie building showing configuration of upper story setbacks.

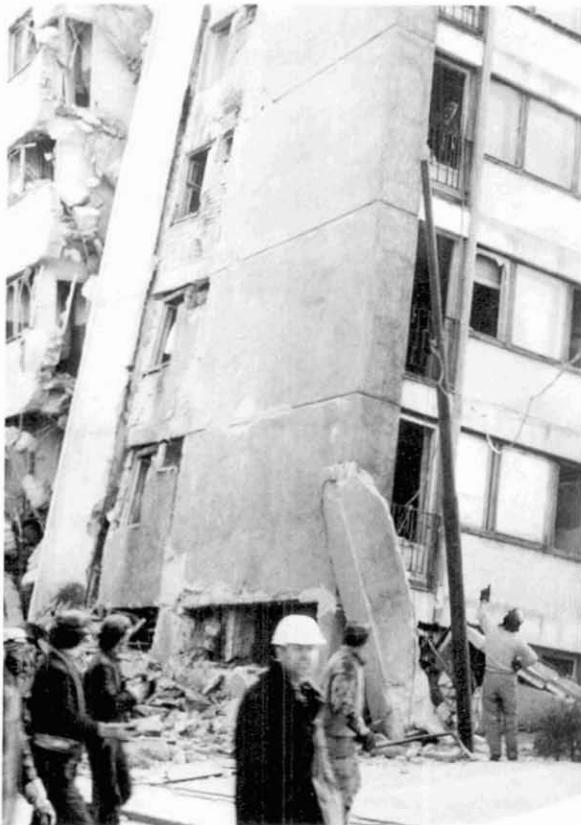
Figures 3.40 through 3.45 present several photographs of the building taken from different angles at the time of the visit, except for the rear corner view shown in Figure 3.41, which was taken by an INCERC crew

Figure 3.41. Rear view of collapsed portion of Lizeanu building before removal of debris.

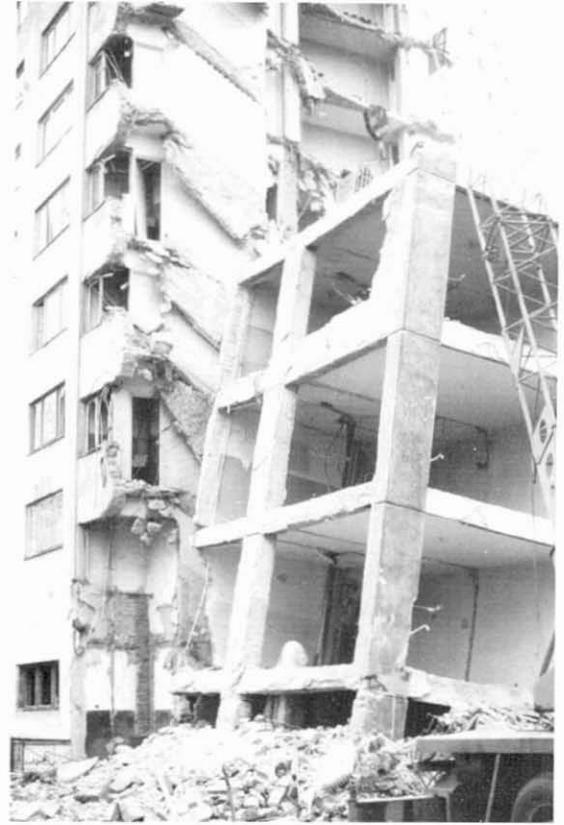
Figure 3.42. Rear corner view of collapsed end bays after tearing down of walls by wrecking crew.

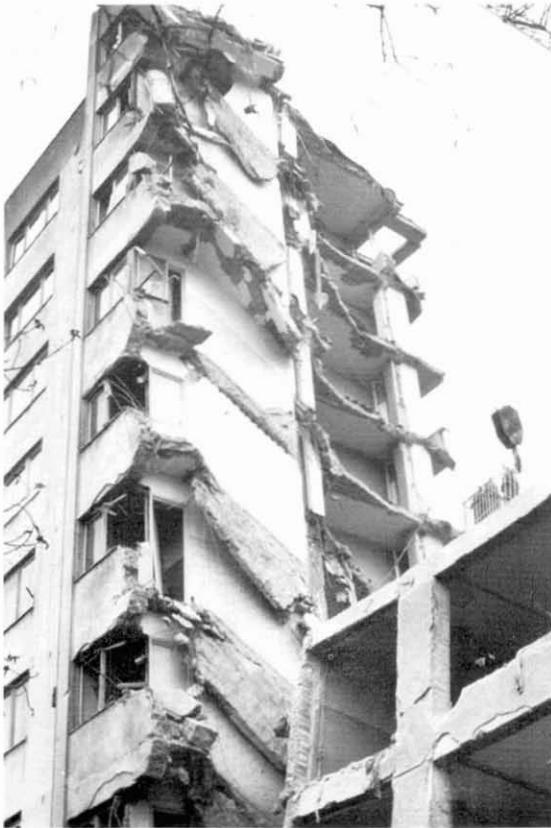
Figure 3.43. Close-up view of region near collapsed stairs.

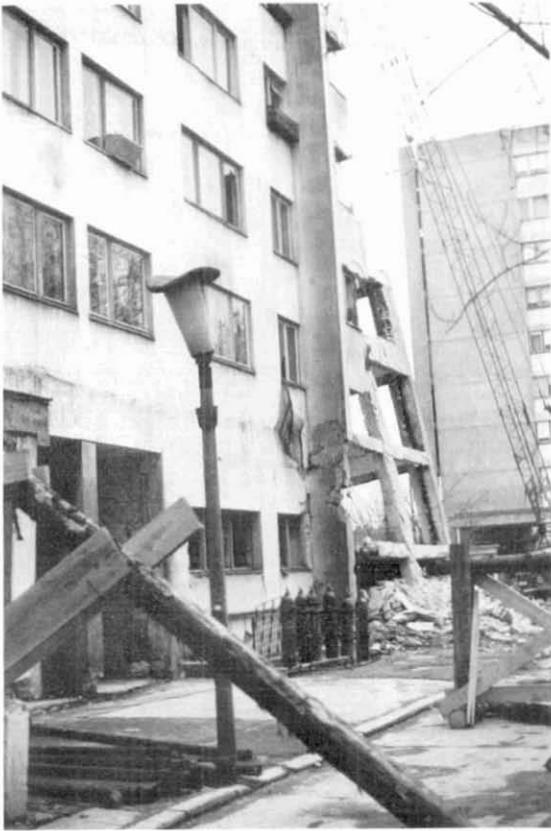
Figure 3.44. Rear view of collapsed end bays looking west.

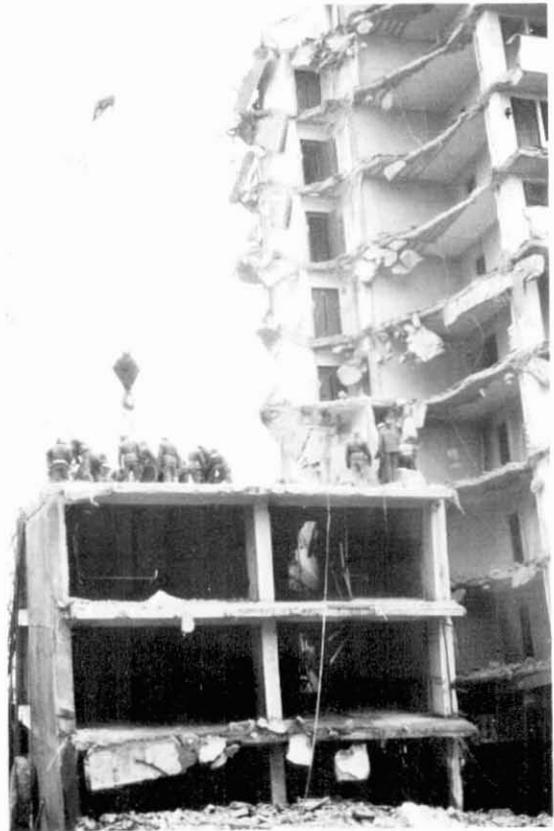
Figure 3.45. Front view of the collapsed bays taken from Stefan Cel Mare Avenue looking north.

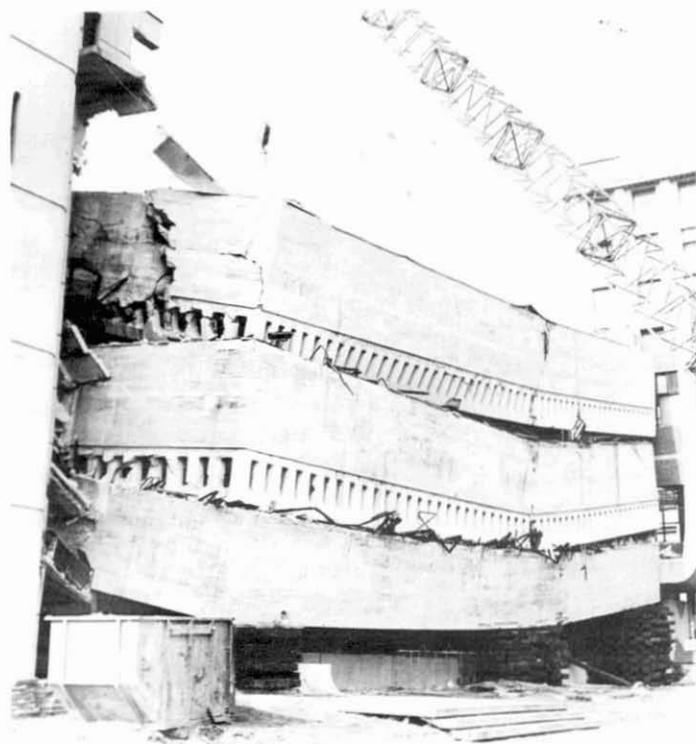
Figure 3.48. Northeast view of the computer center building after the earthquake.

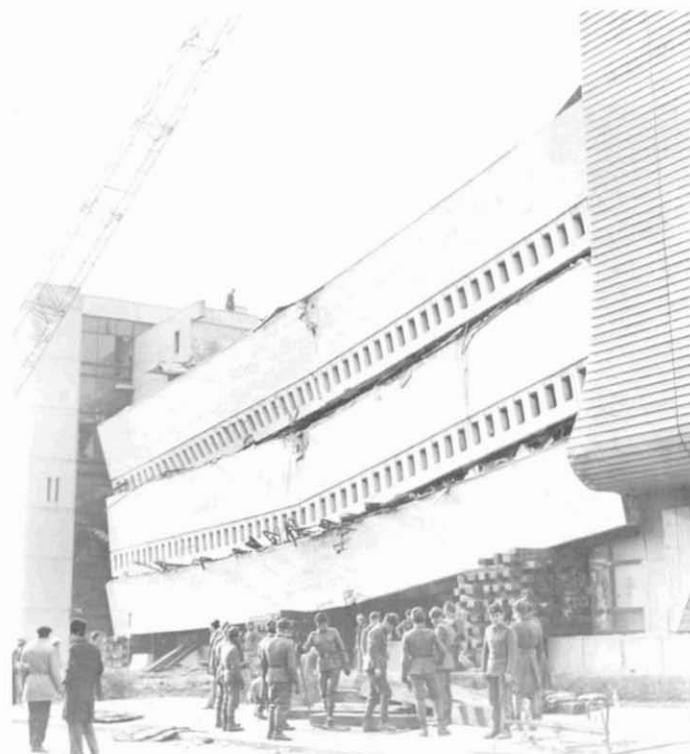
Figure 3.49. Northwest view of the computer center building after the earthquake.

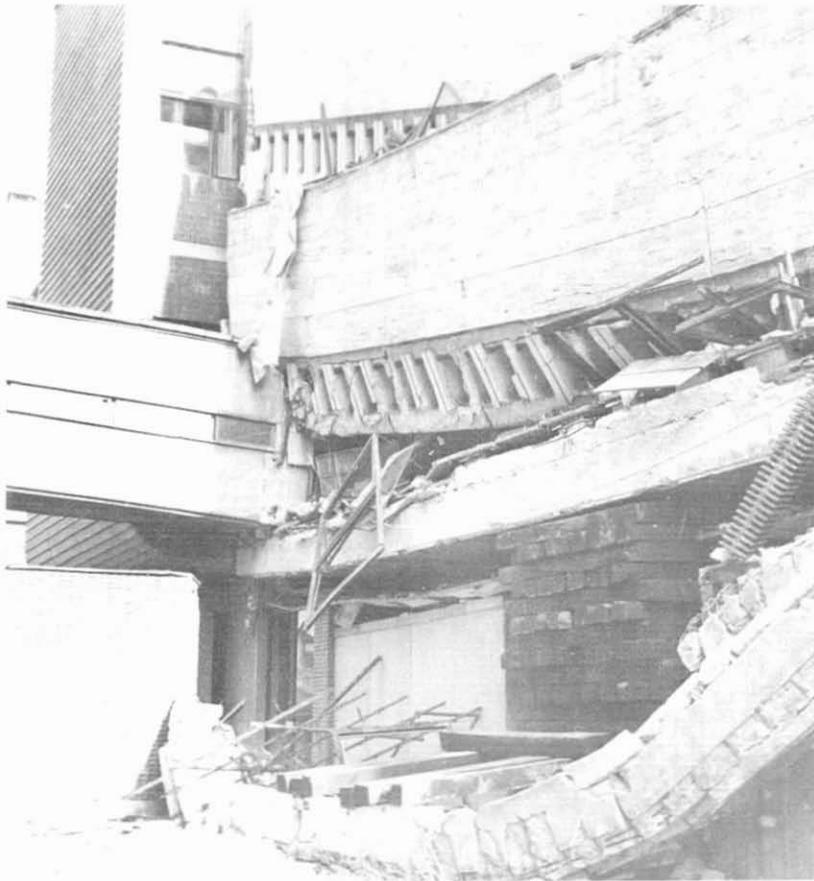
Figure 3.50. South side of computer building after the earthquake-

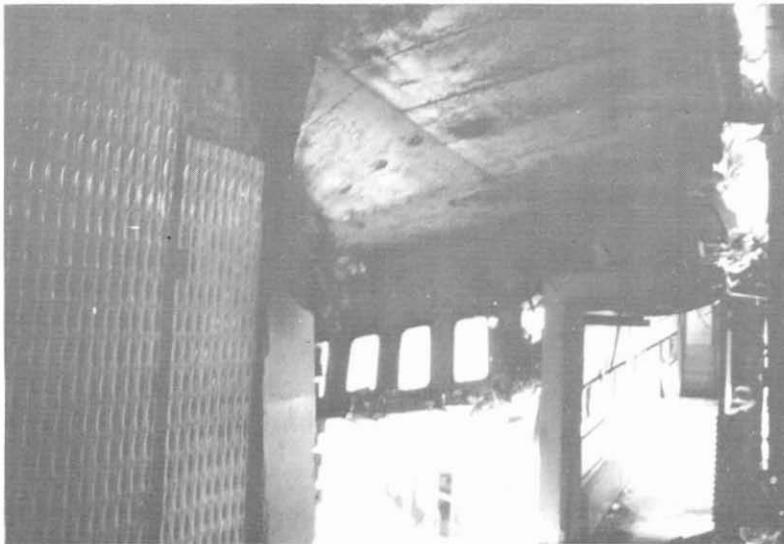
Figure 3.51. Interior view of second story wreckage.

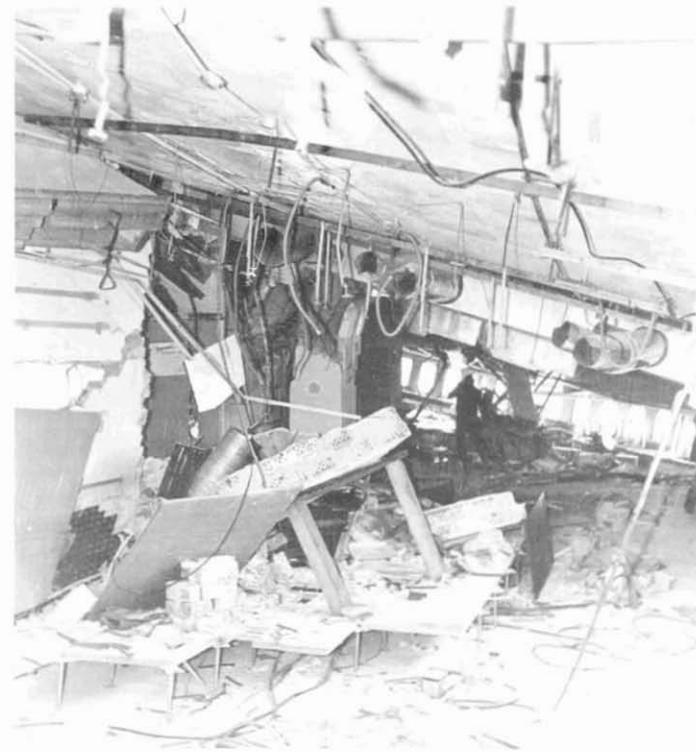
Figure 3.53. Inside view of the main computer room in the second story.

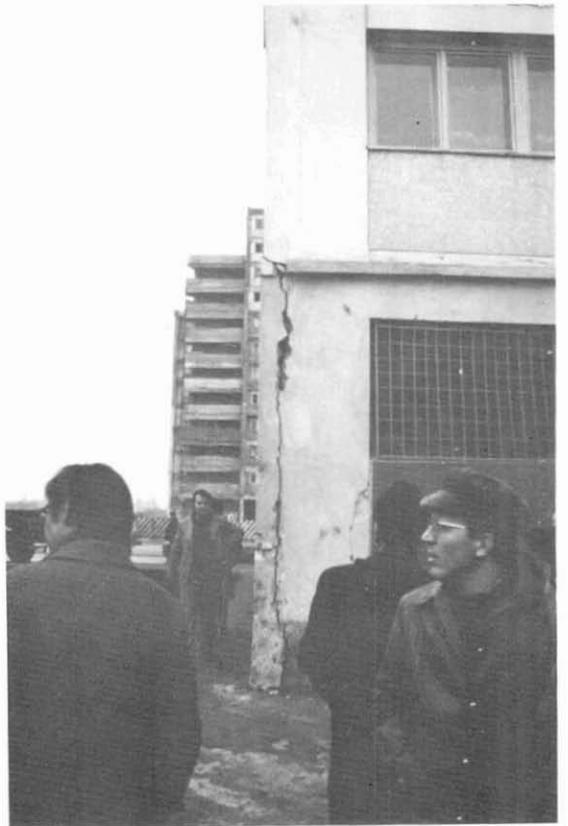
Figure 3.59. View of rear corner of Building 16 showing detached insulation wall.

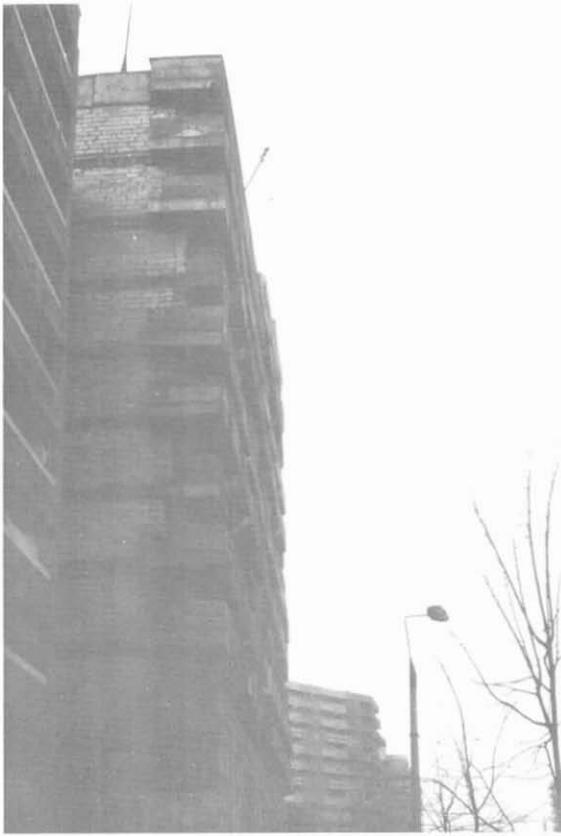
This was another instance where low quality workmanship and materials were found in the construction of masonry filler walls, as well as walls built exterior to the frame (Figures 3.62 and 3.68). Appearance is not a factor here because the walls are plastered before the structure is put in service. However, it seems that the structural integrity of the walls

Figure 3.62. Side view of 11-story concrete frame building on Pantelimon Avenue. (Building No. 17)

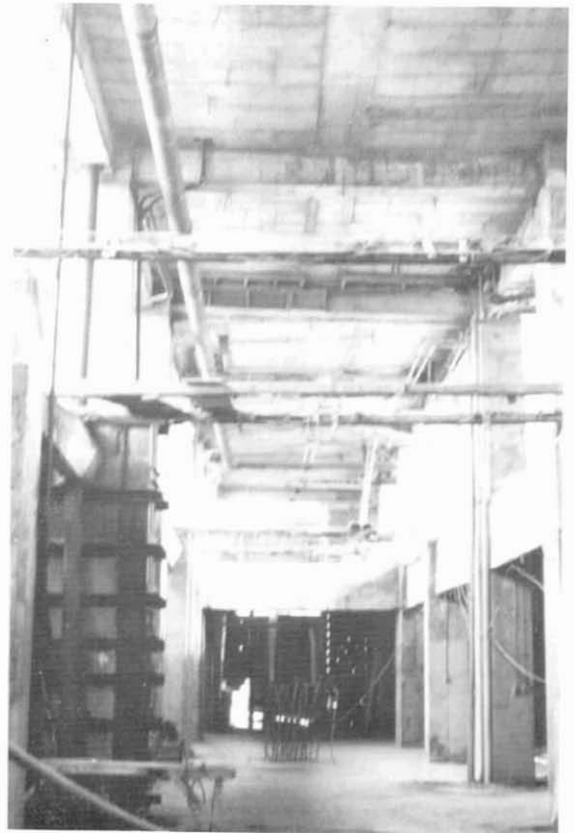
The ground floor of this building was actually two stories in one, with a built-in mezzanine accessed from within (Figures 3.63 and 3.69). The longitudinal bay nearest the street was two stories (about 8m) high as seen in Figure 3.63 and, therefore, the unsupported length of front exterior columns in the transverse (approximately N-S) direction was twice that of columns at other locations. Without shear walls in this area, the lateral resistance of the first two stories was entirely dependent on continuous frame action.

Figure 3.63. General view of longitudinal bay within the first story of the building.

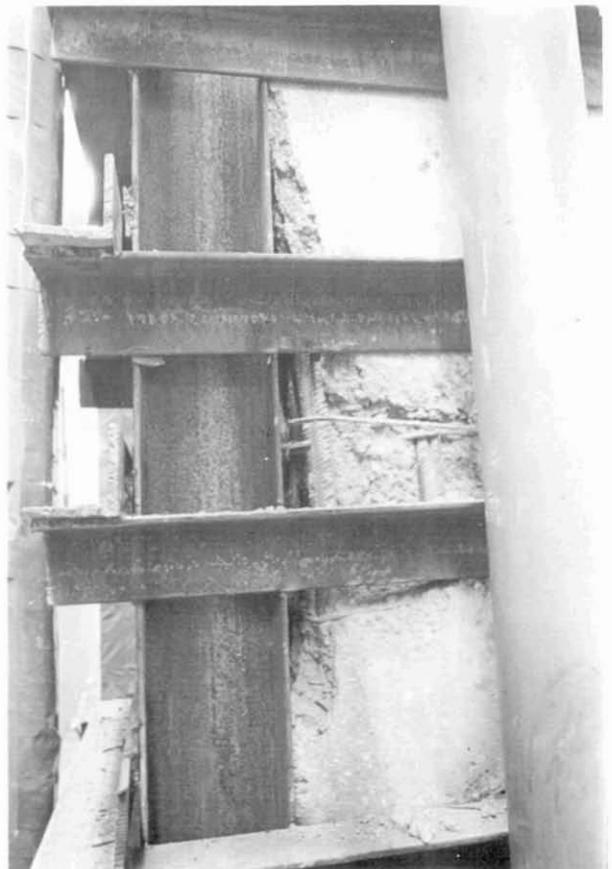
Figure 3.65. Close-up view of steel framing used for confinement of ruptured column.

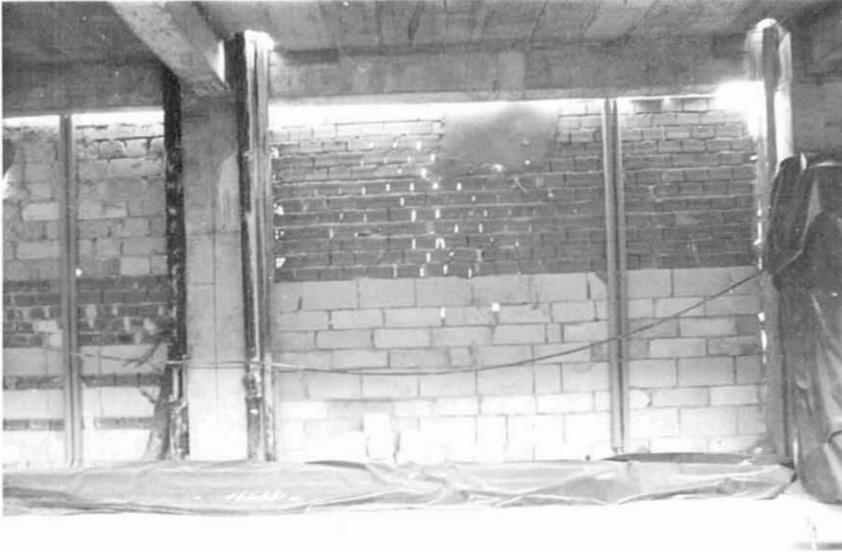
Figure 3.68. Exterior masonry walls at the first story level.

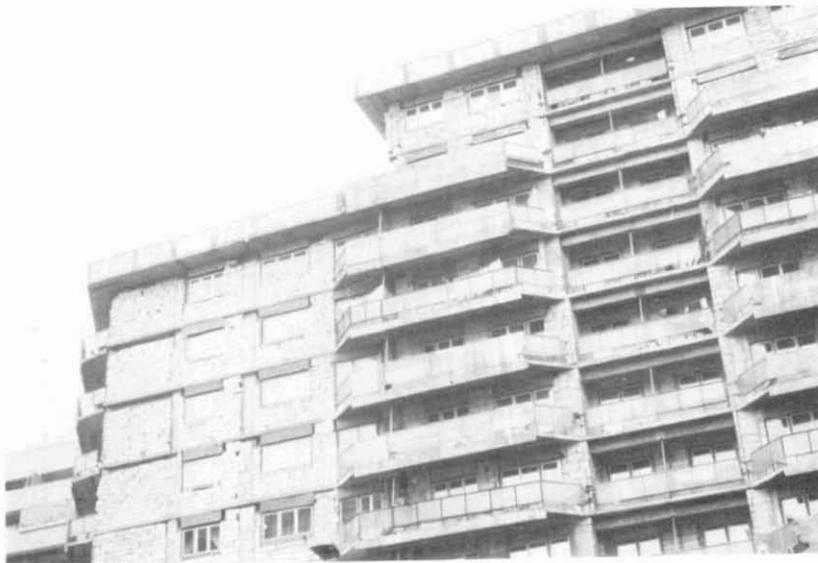
Figure 3.77 provides a further illustration of the general lack of emphasis placed on the quality of masonry construction when used in filler walls, parapets and other non-load bearing applications. Exposed concrete columns at several locations suggests that there may have been considerable shedding of masonry units from the walls of this building during the earthquake. Figure 3.78, which is the rear view of the same building, shows substantial pounding damage to this structure and the one adjacent to it, including the partial collapse of several masonry filler walls and possibly structural damage to a fifth story corner column in the adjacent building. In the building further to the left (Figure 3.79), many of the piers that had been already repaired but not plastered over, showed classical X cracking patterns.

Figure 3.77. Exterior view of multistory apartment building.

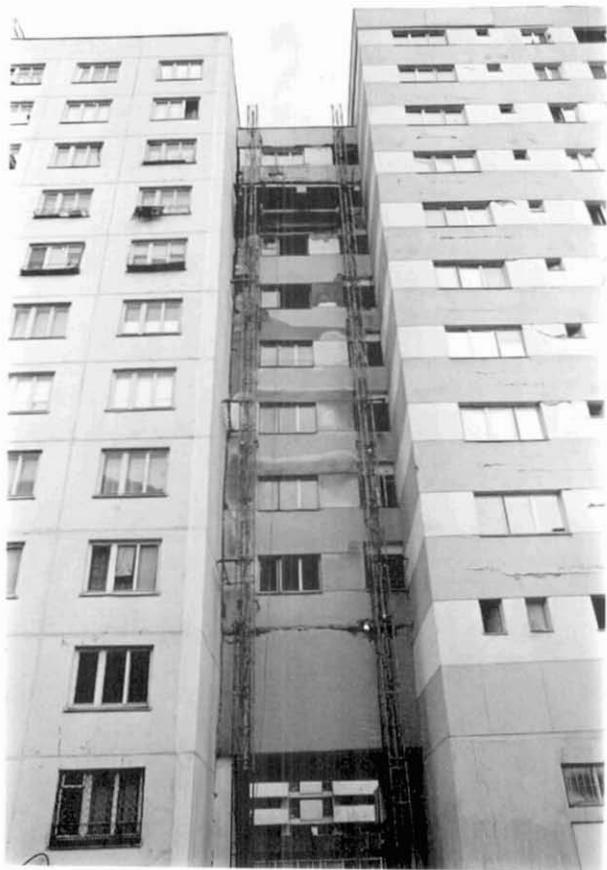
In this general area, several other instances of pounding damage were witnessed, such as shown in Figures 3.80 and 3.82 to 3.84. The former was a frame building located next to a shear wall structure which showed no visible signs of exterior damage (Figure 3.81). The most severe pounding damage observed had occurred as a result of the collision between a taller frame building and a shorter structure having adjacent corners.

Figure 3.80. General view of superficial damage in concrete frame building next to shear wall building on the left.

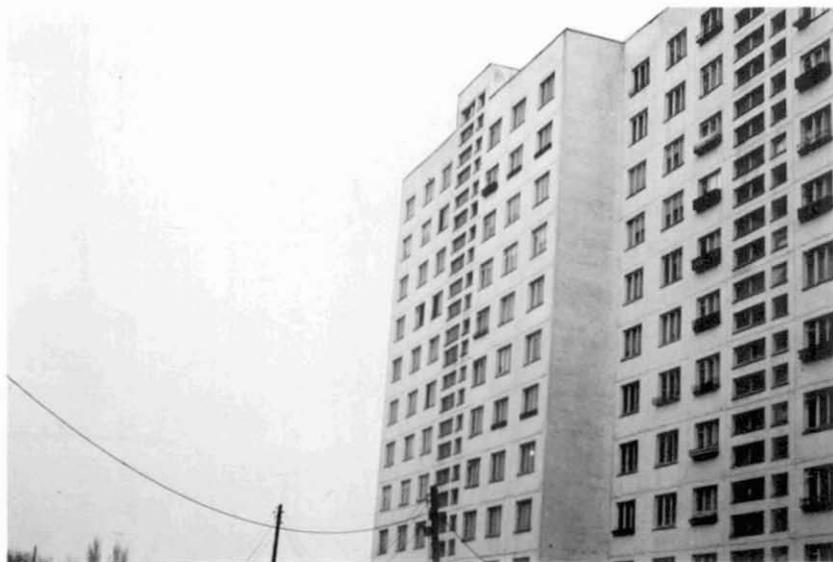
Figure 3.81. Front view of 10-story shear wall building.

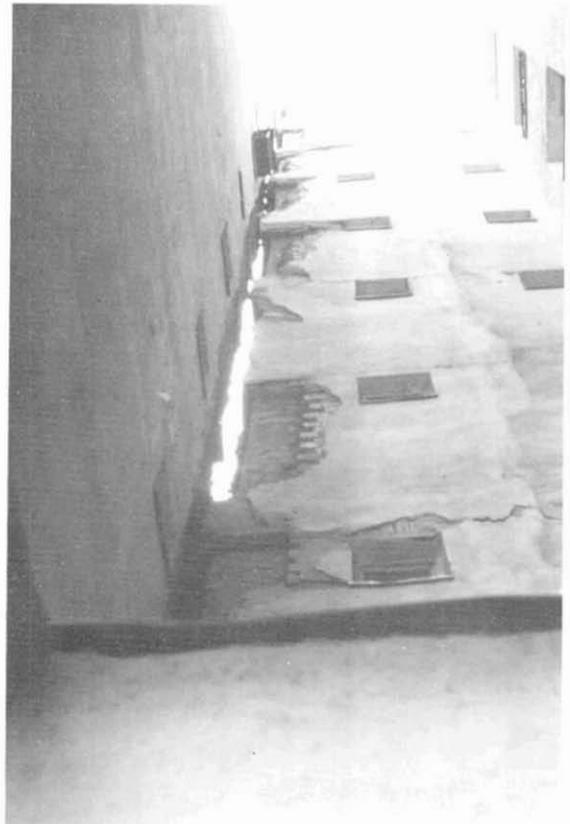
Figures 3.83 and 3.84 are two opposite views of the damage which seemed to have occurred mostly in the frame structure including the rupture of a corner column in the story opposite the top of the next building.

Figure 3.83. Heavy pounding damage to buildings with adjacent corners.

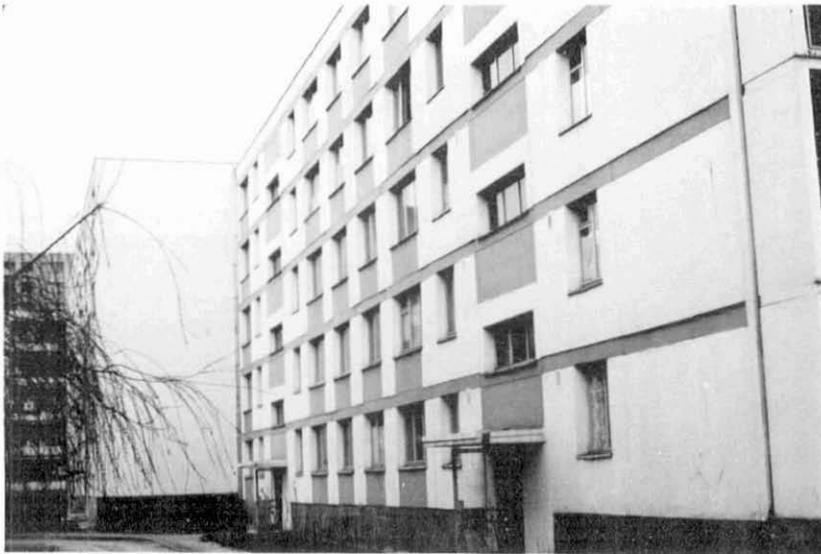
A number of apartment buildings of relatively recent construction were examined in the southern part of the city near Boulevard Magurele. These buildings are collectively identified by the number 19 on the map shown in Figure 2.2. The first building was a 5-story precast panel structure shown in Figures 3.85 and 3.86. No evidence of damage, not even signs of hairline cracks, was found inside or outside the building.

Figure 3.85. Front view of 5-story large panel building.

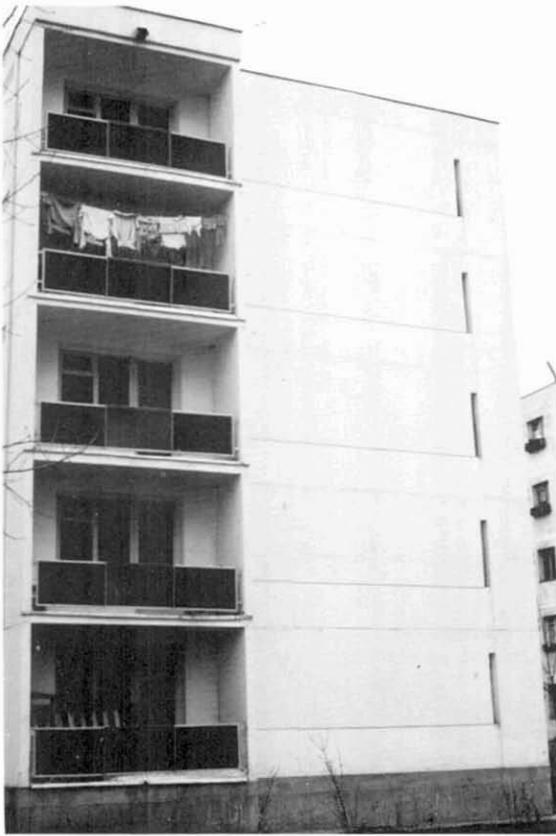
Figure 3.86. End view of 5-story panel building.

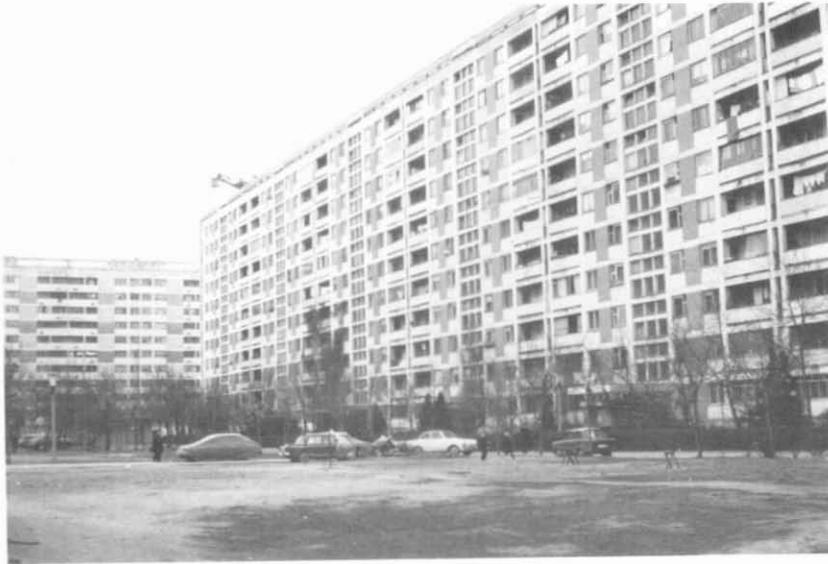
Figure 3.88 is a view showing some of the other typical layouts used in multistory apartment construction in this section of the town. Insofar as could be discerned by cursory visual examination, there were no conspicuous signs of major exterior damage to these structures.

Figure 3.88. Row of 11-story apartments.

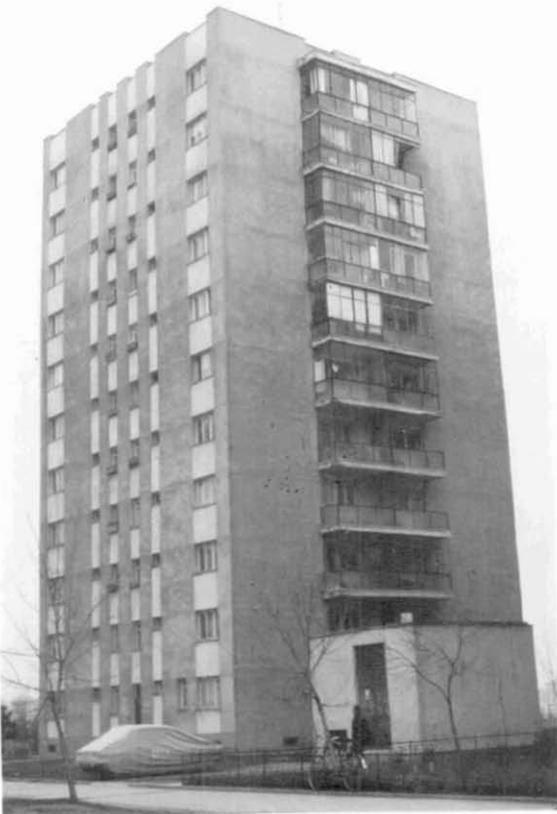
The third building, shown in Figure 3.89, was a 4-year old slip-formed shear wall structure which was likewise used exclusively for residential

Figure 3.89. Eleven-story slip-formed shear wall building.

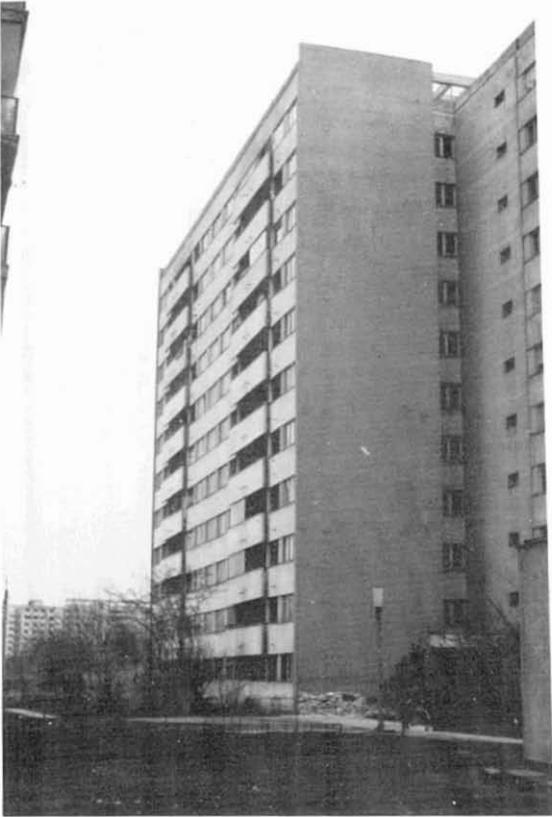
Secondly, potential hazards to pedestrians and dwellers from falling debris in an earthquake can be reduced by improving the quality of materials and workmanship used in the construction of masonry walls for non-structural applications. Examples of exposed masonry construction of superior quality (see Figures 3.90 and 3.93, for instance), suggest that the skills required to bring about such improvements are at hand.

Figure 3.90. Another 11-story slip-formed shear wall building.
