OBSERVATIONS ON THE BEHAVIOR OF BUILDINGS IN THE ROMANIA EARTHQUAKE OF MARCH 4, 1977

NBS SPECIAL PUBLICATION 490

U.S. DEPARTMENT OF COMMERCE / National Bureau of Standards

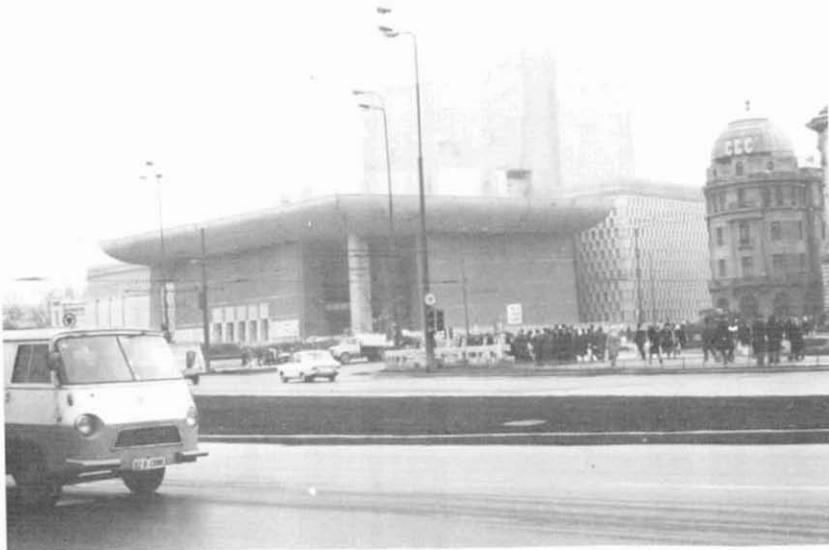
Figure 3.91. National Theater next to Intercontinental Hotel.

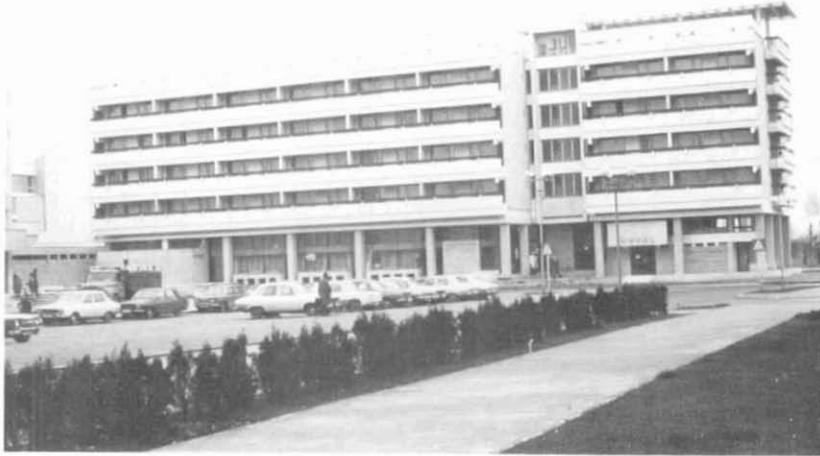
Figure 3.92. Five-story hotel on campus of National Center for Physics in Magurele.

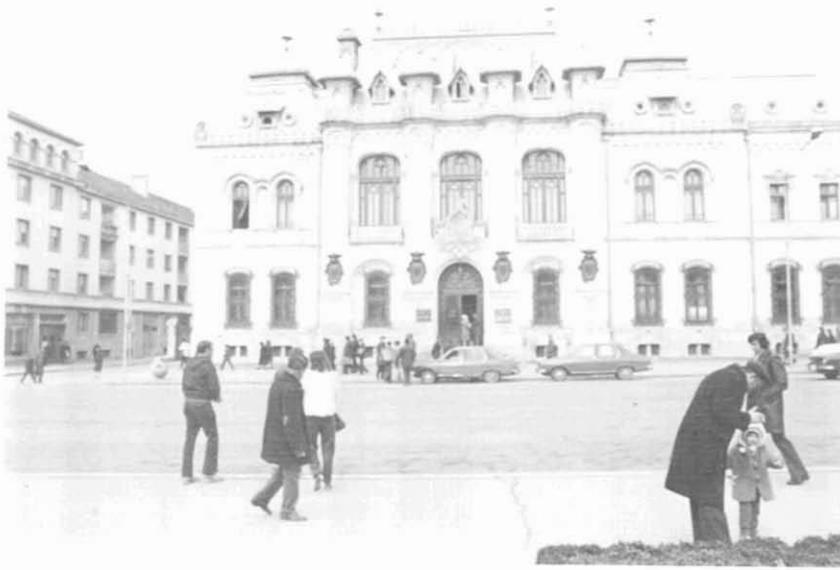
The city government office building (Figure 3.94) where the meeting was held showed no damage. After the meeting, the first building toured was the city administration headquarters (Figures 3.95-3.98). Major vertical cracks had occurred at the top of the brick wall of the central tower as seen in Figure 3.95. The cracking had developed just below the pyramidal high pitched roof and had propagated downward on both sides, putting the structural integrity of the steeple in jeopardy (Figure 3.96). To maintain stability, two Vierendeel type steel joists were installed horizontally on the near face and were anchored by cables to the rear portion of the tower as indicated in Figures 3.95 and 3.96. There was also evidence of roof damage due to collapse of the cupolas, as shown in Figure 3.95.

Figure 3.94. City government office building in Craiova.

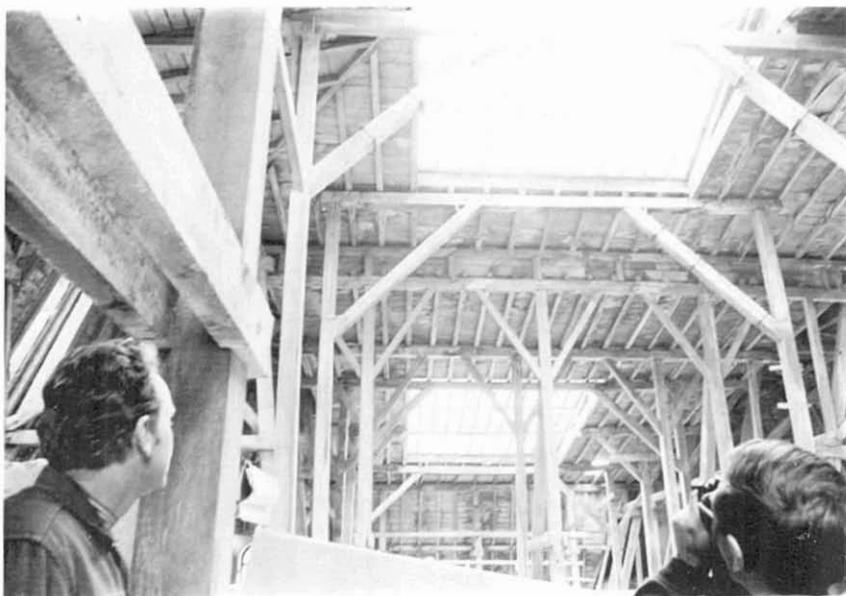
The attic of the building was accessed by narrow stairs that had been seriously damaged. Within the attic, the high-pitched timber roof was supported by a timber framing system laterally stiffened by knee braces as shown in Figure 3.102. At a few locations splitting of knee

braces and frame members were noted. Figure 3.103 shows the splitting of one of the laterally unbraced brick chimneys projecting beyond the roof. In general, the extent of damage was such that the building will be relatively easy to repair without compromising its historical appearance. On the other hand, retrofitting it for resistance against future earthquakes will not be as simple. One possibility discussed with the Romanian engineers involved stiffening of the attic floor to give it increased diaphragm capability to improve the distribution of lateral forces to the shear walls below.

Figure 3.102. Timber framing of the roof within the museum attic.

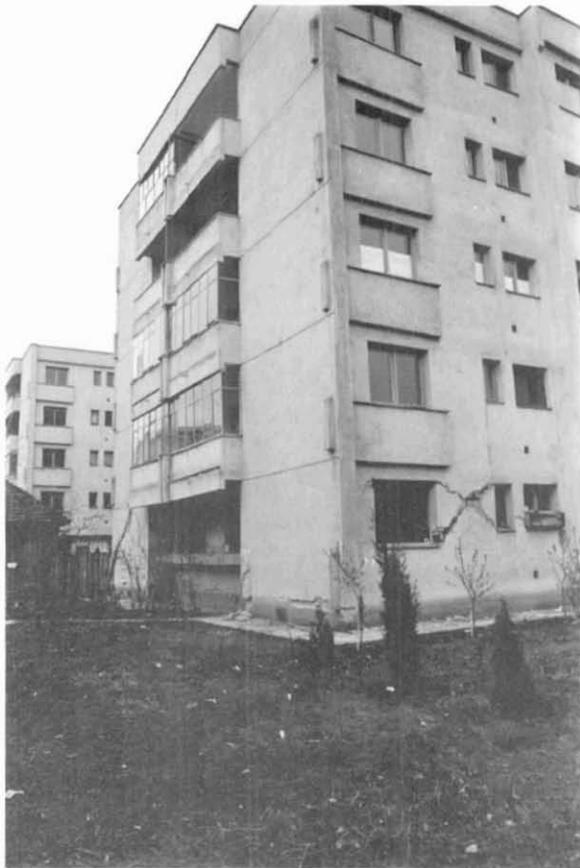
The third building examined was a 5-story unreinforced masonry load-bearing wall system. Two of the wings of the building shown in Figures 3.104 and 3.105 exhibited cracking of first story piers. The latter also shows the development of a major vertical crack between two first story abutting walls at one corner of the building. It appeared that most of the damage had occurred in the first story where many of the exterior piers exhibited severe diagonal cross cracking as shown in Figure 3.106. By reference to this figure, two distinct modes of failure can be identified. In each of the four different instances shown, the wide pier had attained its collapse limit state, characterized by through tension cracking along the diagonal(s), while the slender pier located next to it had developed horizontal flexure cracks at the ends (a first limit state), without appreciably losing its vertical load-bearing capacity.

Figure 3.104. General view of load-bearing masonry apartment building.

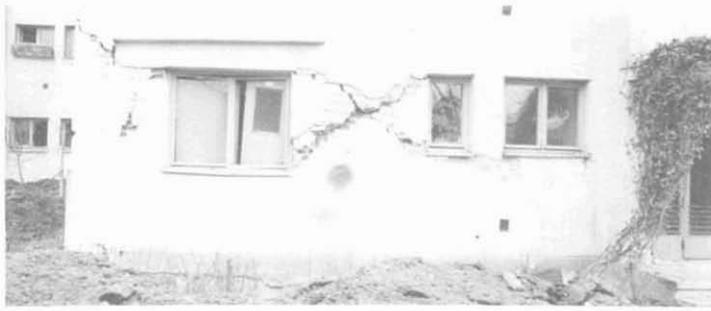
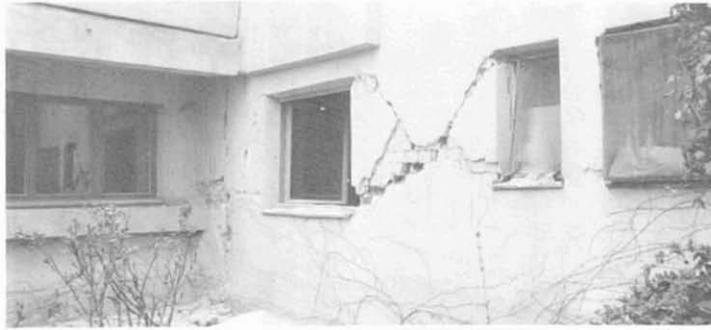
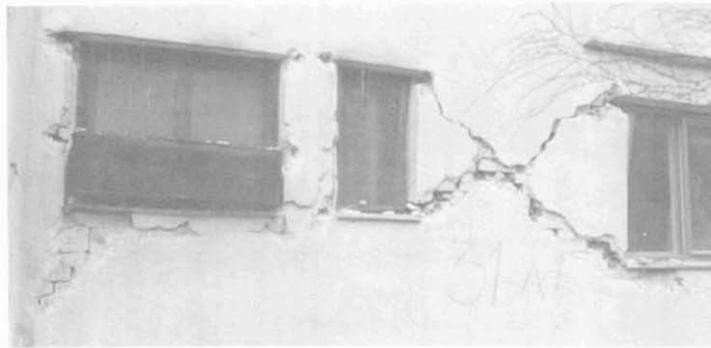
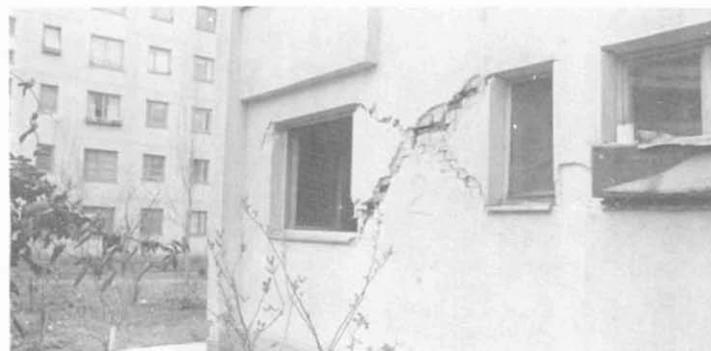
Figure 3.106. Failure of first-story piers.

Figure 3.107. Damage of interior masonry wall.

Inside the first story, the solid interior walls were not as severely damaged (Figure 3.107) but most lintels above openings had received a good pounding (Figure 3.108). One of the repair schemes that was being considered for this building was the application of gunite over wire mesh on both sides of the first and second story walls. The Romanian engineers also expressed interest in learning more about the structural rehabilitation methods used in the United States, particularly tuckpointing of masonry and use of epoxy resins in the repair of concrete and masonry cracks.

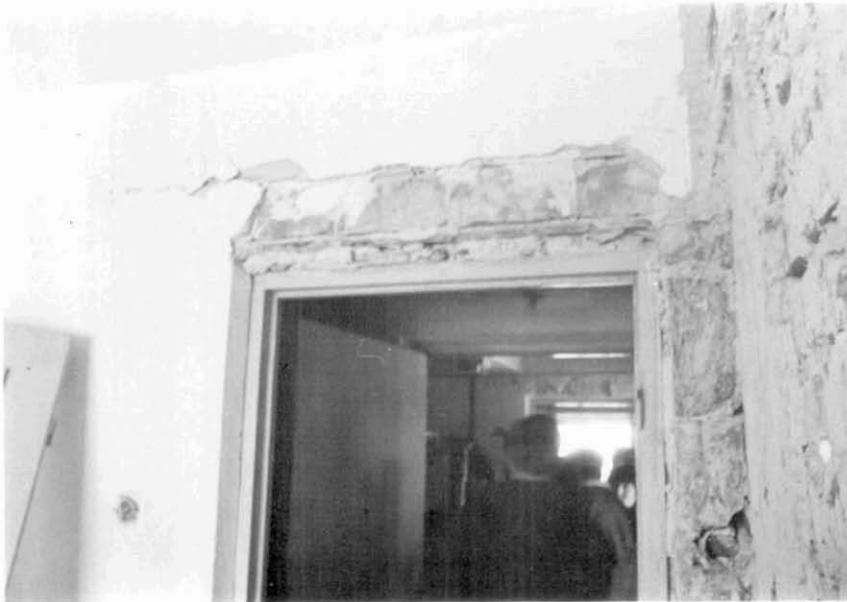
Elsewhere in the city, two or three instances of pounding damage between buildings were noted during the survey such as shown in Figure 3.109. There were also a number of buildings with partly missing roofs and fallen chimneys. Inspection of 10-story reinforced concrete shear wall buildings, some of which were reportedly erected quite recently using the slip-form method, revealed minor non-structural damage, mainly in the first story exterior insulation walls as seen in Figure 3.110.

Figure 3.108. Damage of lintel wall in first story.

Figure 3.109. Pounding damage between adjacent buildings.

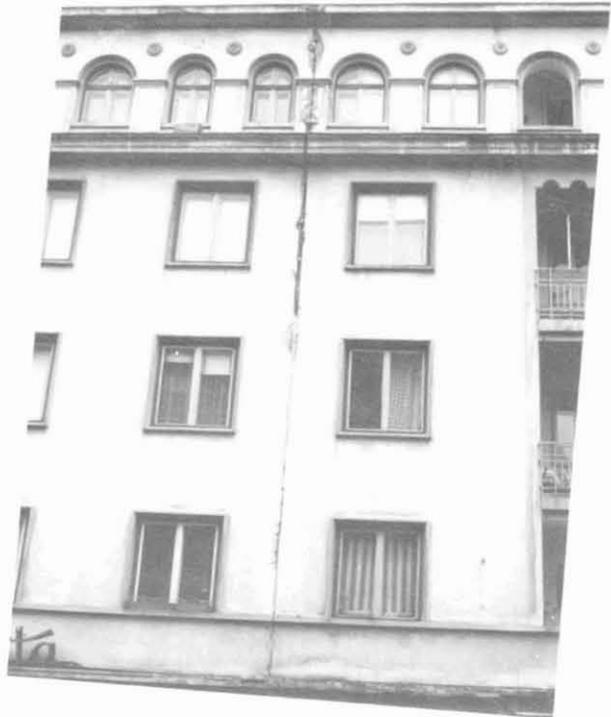
Figure 3.110. Cracking of facing wall in multistory apartment building
