NIST GCR 97-720

**A STUDY OF THE PERFORMANCE OF
PETROLEUM STORAGE TANKS DURING
EARTHQUAKES, 1933-1995**

Thomas W. Cooper
T.W. Cooper, Inc.

June, 1997

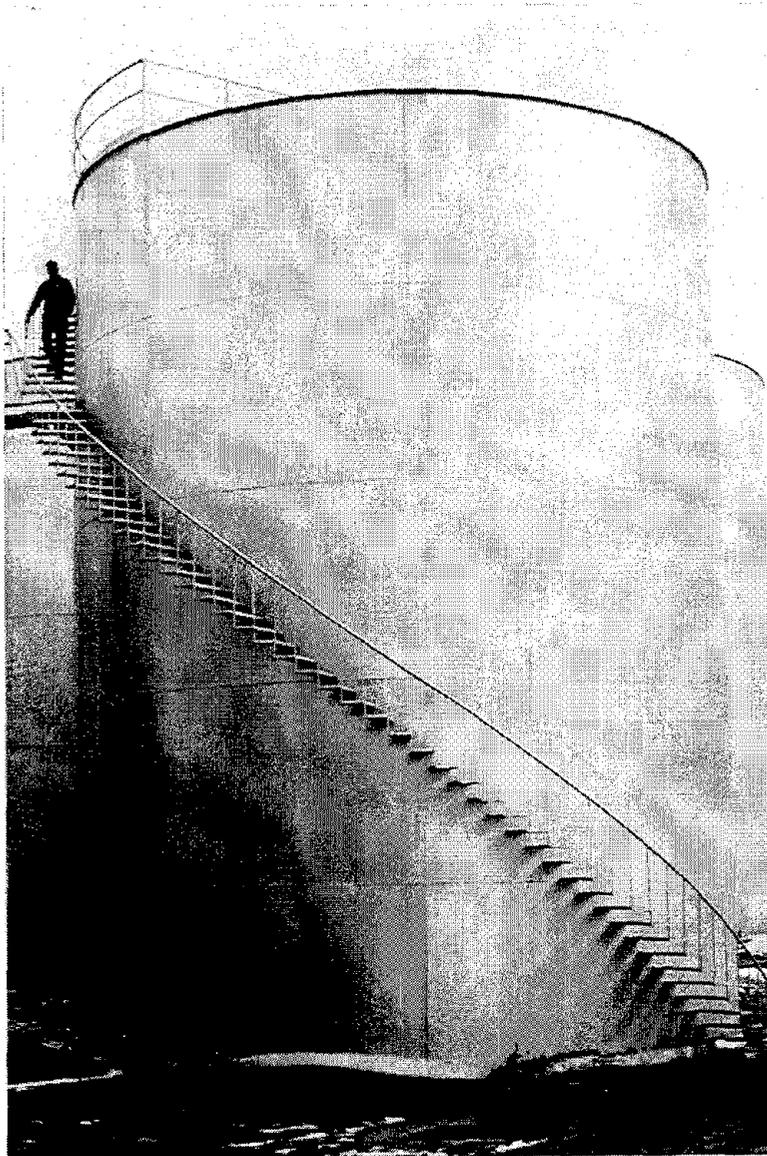
Figure 4.3 Port area, Anchorage [Steinbrugge Collection at UCB EERC Richmond]

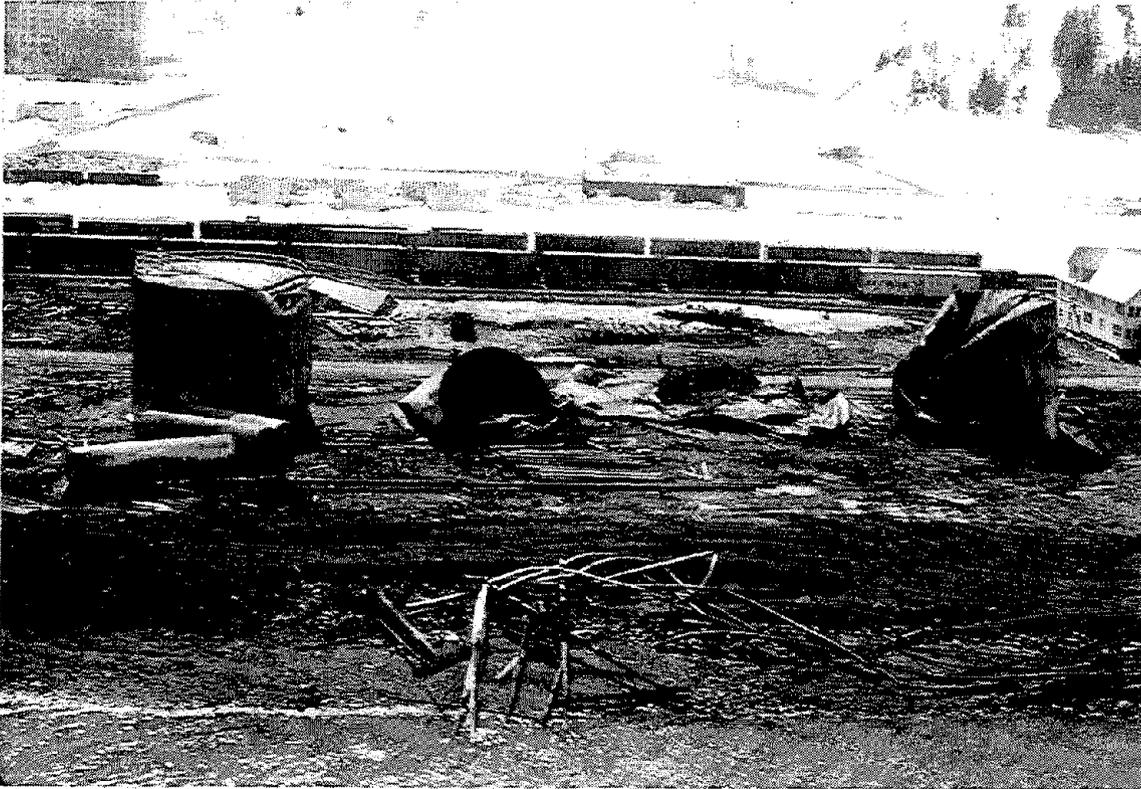
Figure 4.4 Whittier tanks near waterfront (Courtesy W. Daniels)
