# ARCHITECTURAL AND URBAN DESIGN LESSONS FROM THE 1985 MEXICO CITY EARTHQUAKE

June, 1988

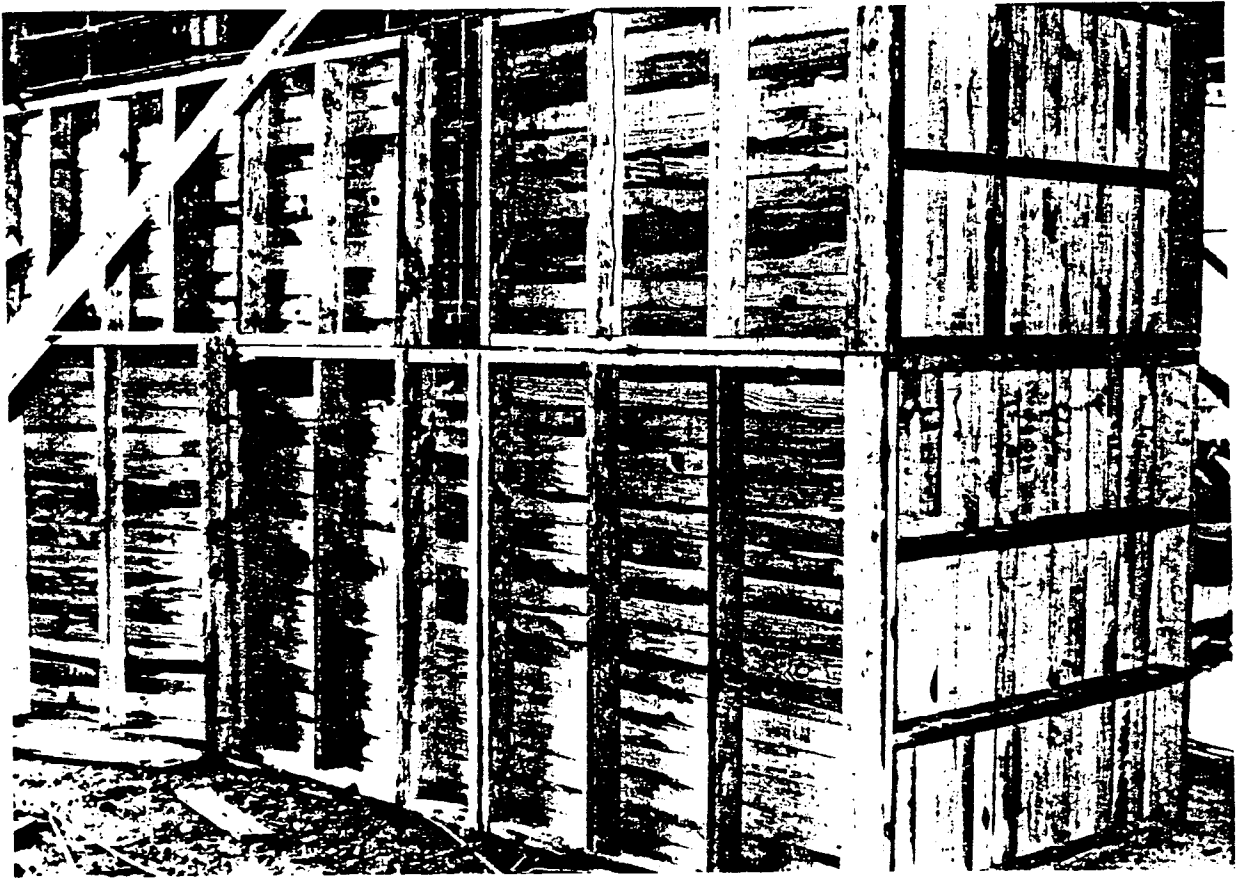
Armado y cimbrado de muros

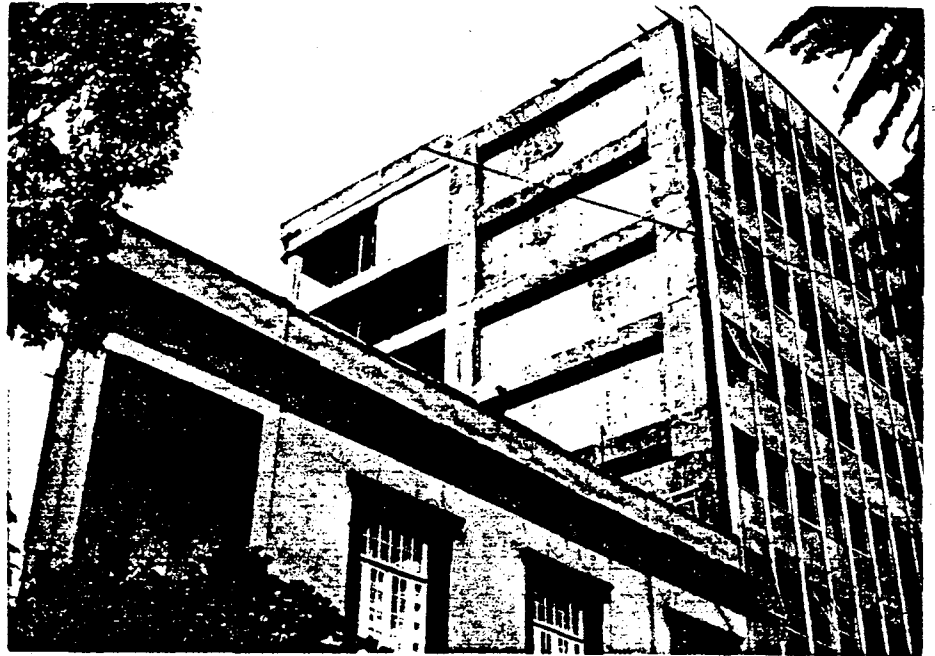
Muro De Cortante  
En Colindancia  
Usando Unicamente  
Un Entreje En Pisos  
Superiores

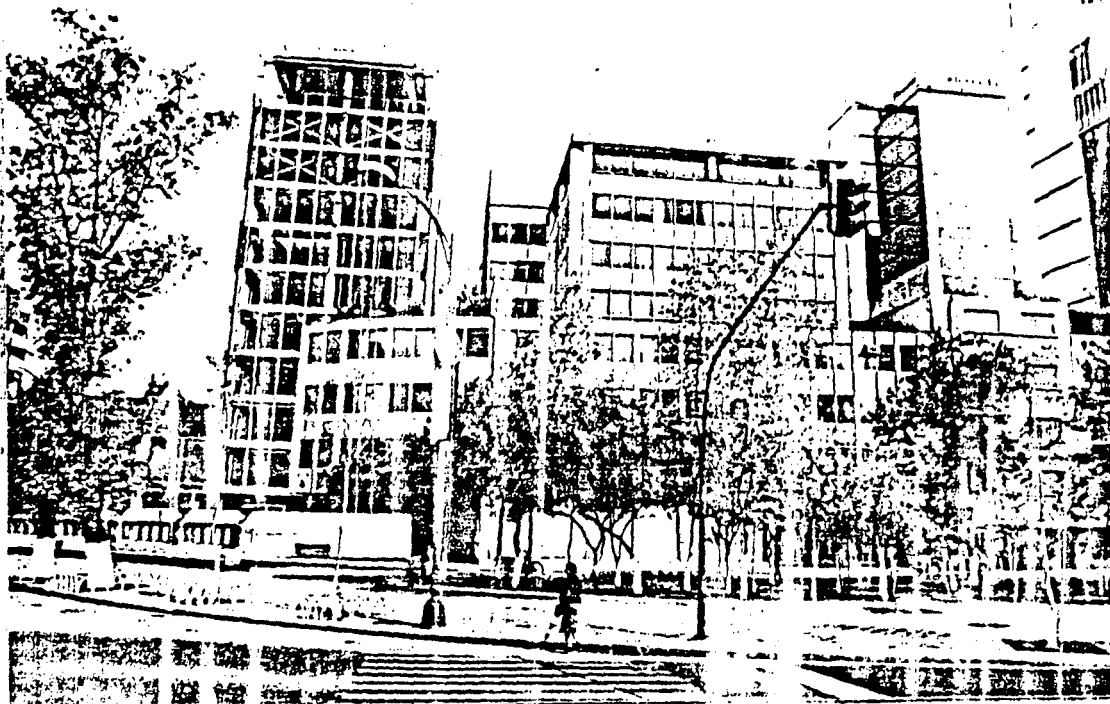
AGOSTO/86  
REFORMA No. 243  
CONJUNTO DEL INMUEBLE

Fachada Principal Con  
El Inicio De Las Cruceas  
De Arriba-Abajo

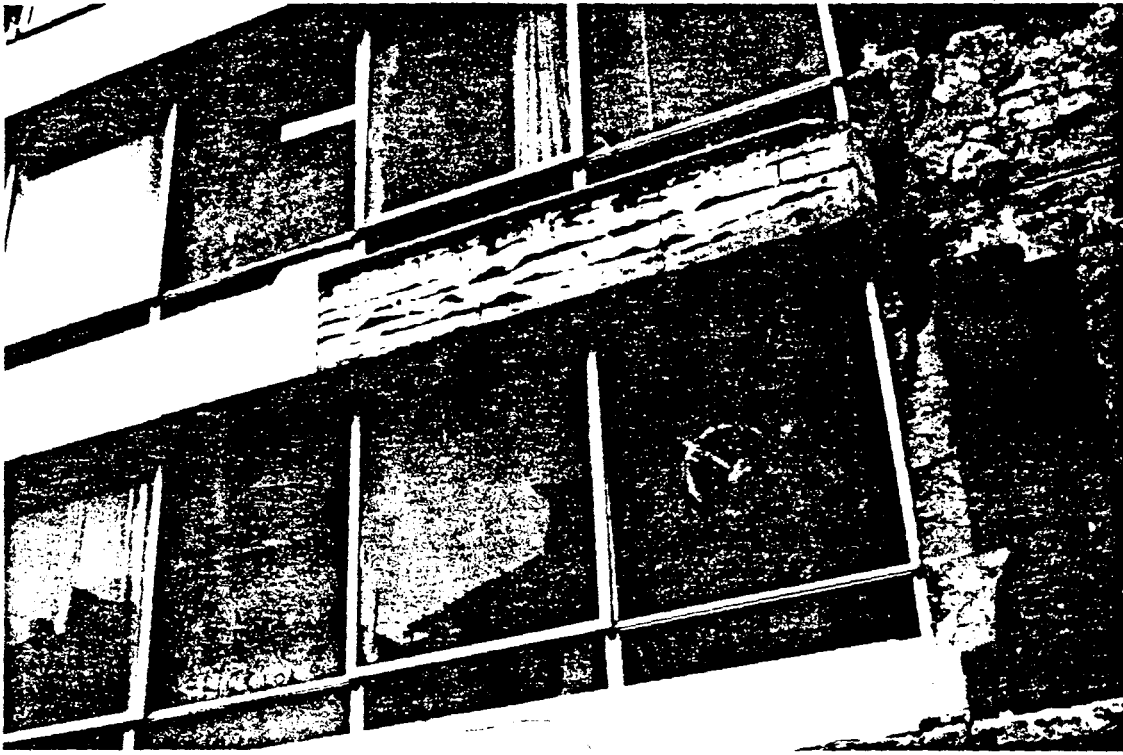
Serious glass damage (above 25 percent) appears to be closely associated with the amount of total drift or displacement the building experienced. In the data base, 23 percent of the buildings had no information on building drift, 33 percent appeared to have no drift or displacement, 39 percent had some degree of minor drift or displacement, and 5 percent appeared to receive major amount of drift or displacement. Of the building receiving no drift only 9 percent received serious glass damage, while with those buildings receiving minor drift 28 percent were recorded with serious glass damage, and of those buildings with major drift a very high 43 percent received serious glass damage.

Buildings which experienced large drifts or displacements tended to experience higher levels of serious glass damage.

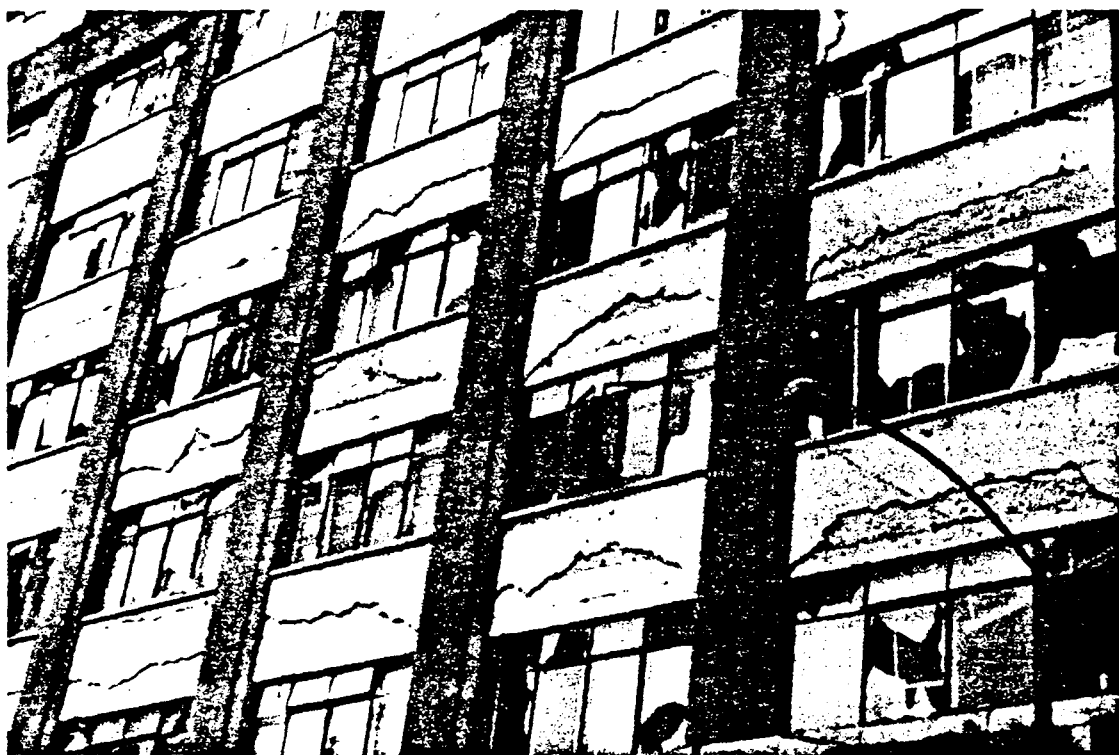
The seriousness of glass damage appears to be closely associated with the severity of structural damage caused in the building. Of those buildings with no structural damage only 2 percent reported serious glass damage, of those reporting minor cracks and deflections 10 percent recorded serious glass damage, of those buildings with major cracks and deflections a larger 28 percent recorded serious glass damage, and of those buildings with limited collapses a very high 74 percent reported serious glass damage.

Buildings which experienced larger amounts of structural or envelope damage tended to experience higher levels of serious glass damage.
