REPORT NO.
UCB/EERC-90/21
DECEMBER 1990

OBSERVATIONS AND IMPLICATIONS OF TESTS ON THE CYPRESS STREET VIADUCT TEST STRUCTURE

MARTIN E. BOLLO
STEPHEN A. MAHIN
JACK P. MOEHLE
ROY M. STEPHEN
XIAOXUAN QI

Report to the California Department of Transportation

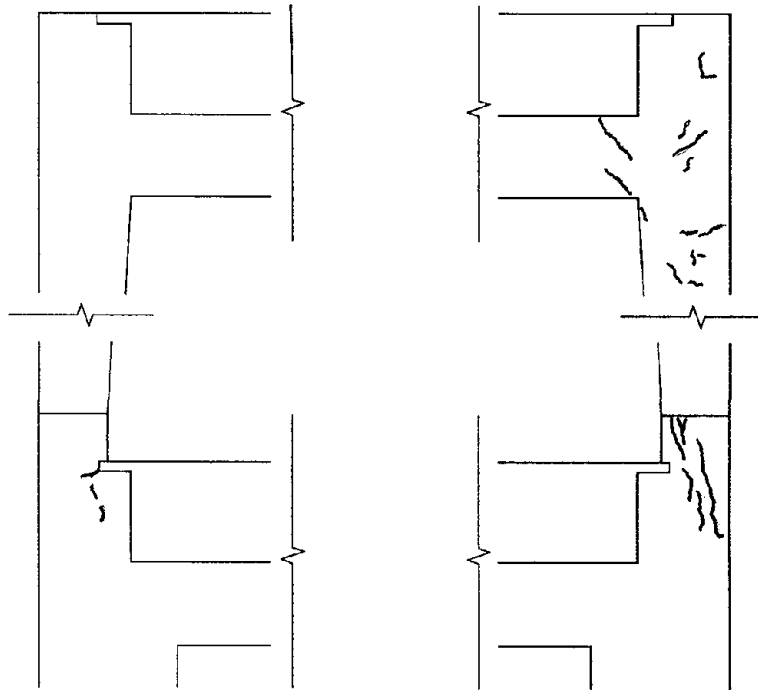
Fig. 2.8(c) Existing cracks in joint regions of Bent 47.
