REPORT NO.
UCB/EERC-94/01
JANUARY 1994

PRELIMINARY REPORT ON THE
SEISMOLOGICAL AND ENGINEERING ASPECTS
OF THE JANUARY 17, 1994
NORTHRIDGE EARTHQUAKE

Preliminary findings from field investigations by teams from the University of California at Berkeley immediately following the earthquake.

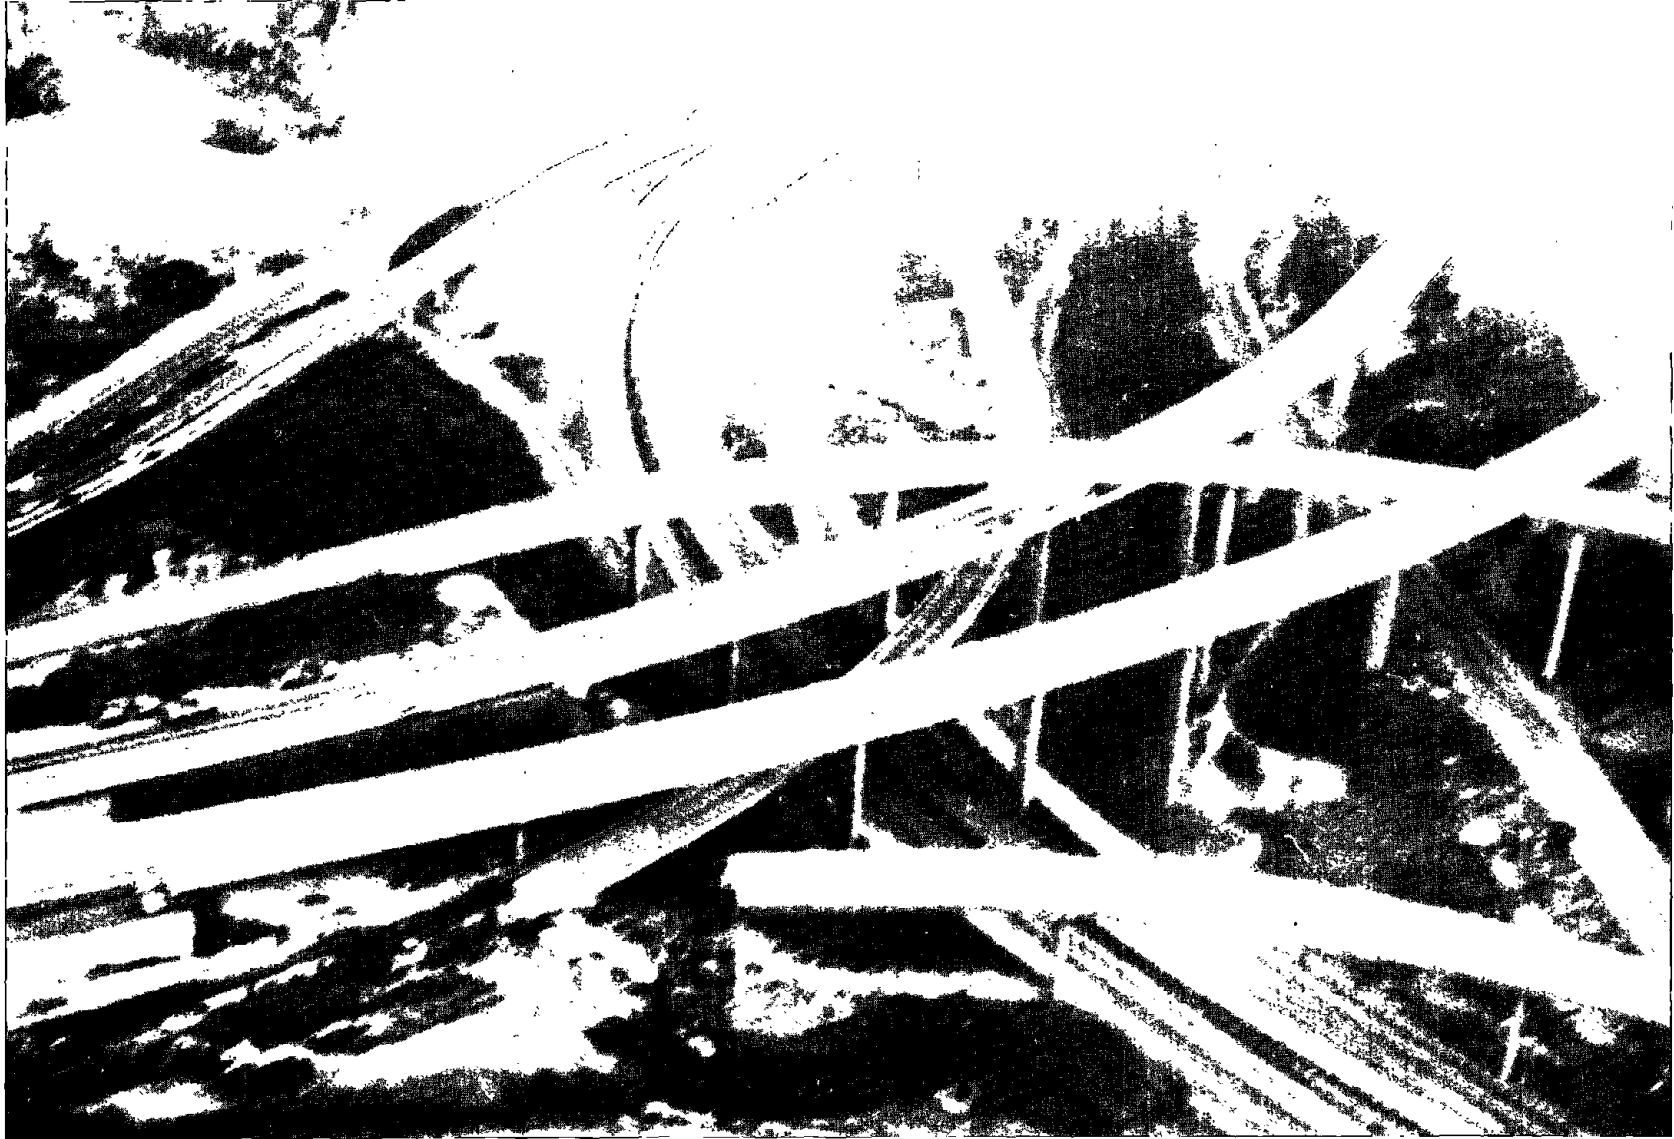
An overall view of the Interstate 5/Route 14 interchange in Fig. 5.1 shows that the most significant damage was in the North Connector Overcrossing (west 14 to north 5) and the South Overhead (west 14 to north 5). The connectors are box girders supported by single column bents. While under construction, several structures in the interchange collapsed or were damaged in the 1971 San Fernando earthquake. The North Connector was repaired shortly after that earthquake.

Fig. 5.1: Aerial View of Interstate 5/Route 14 Interchange Looking South

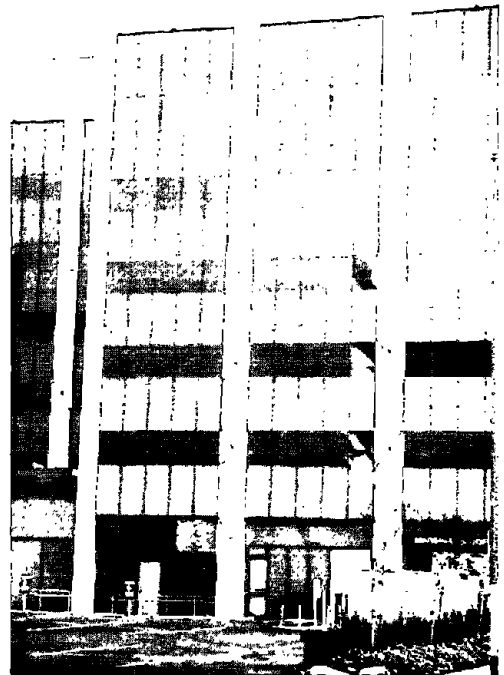
Fig. 6.4 Short Column Behavior in 6-story RC Moment Resisting Frame
