REPORT DOCUMENTATION PAGE		1. REPORT NO. NCEER-94-0005	2.
4. Title and Subtitle The Northridge, California Earthquake of January 17, 1994: General Reconnaissance Report		5. Report Date March 11, 1994

**The Northridge, California Earthquake
of January 17, 1994:
General Reconnaissance Report**

Technical Report NCEER-94-0005

March 11, 1994

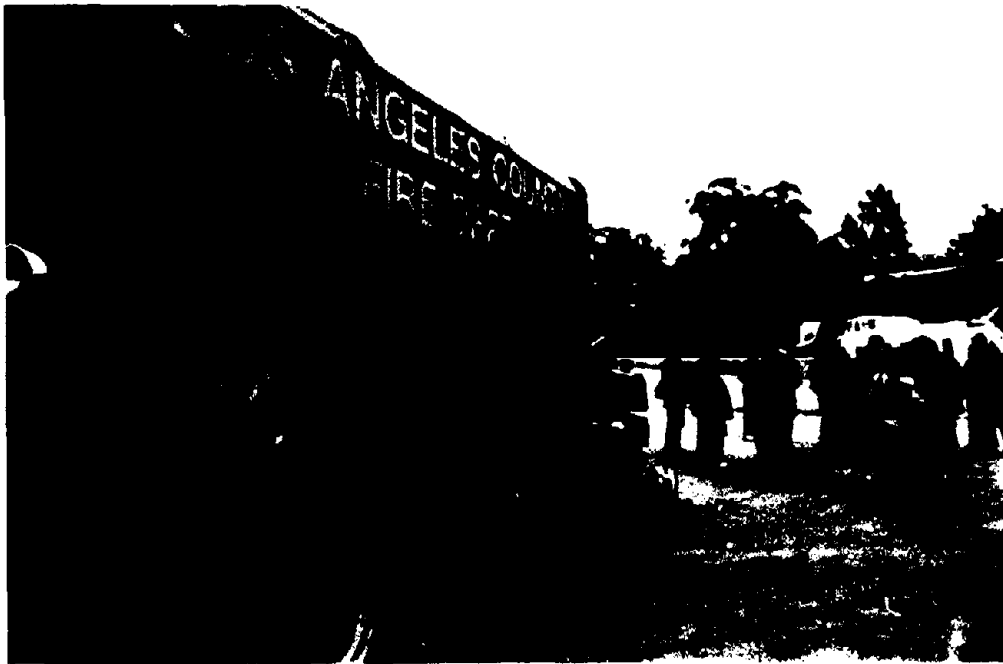
FIGURE 6-1 One of Eight California-based US&R Teams Activated for the Northridge Earthquake

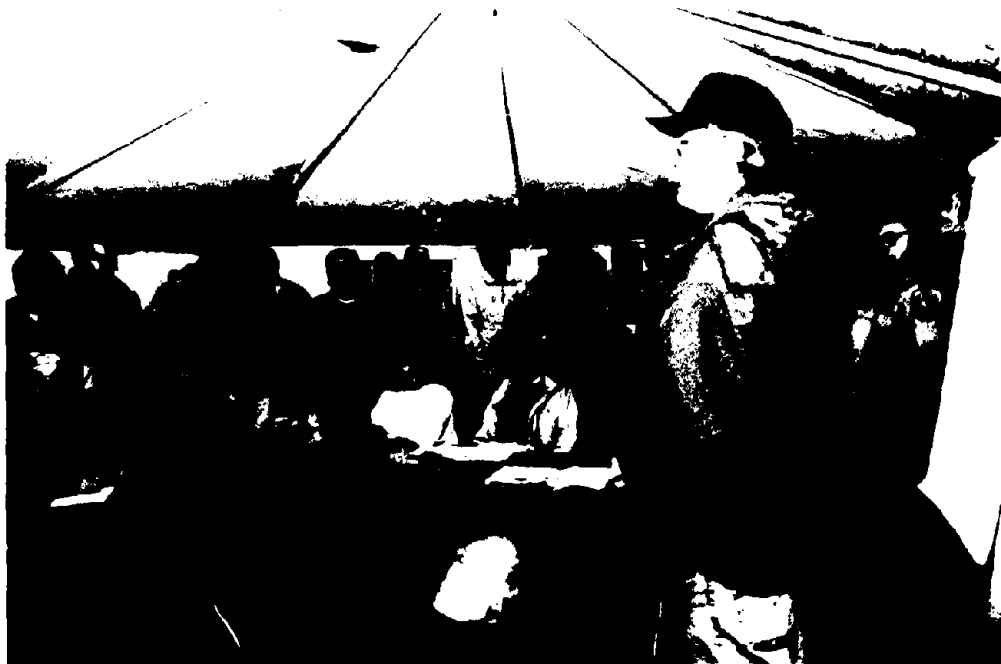
FIGURE 6-2 Volunteer Safety Inspectors Receive Briefing Prior to Assignment
