REPORT NO.
UCB/EERC-95/11
OCTOBER 1995

STUDIES IN STEEL MOMENT RESISTING BEAM-TO-COLUMN CONNECTIONS FOR SEISMIC-RESISTANT DESIGN

BRENT BLACKMAN
EGOR P. POPOV

UCB/EERC-95/11
Earthquake Engineering Research Center
College of Engineering
University of California at Berkeley

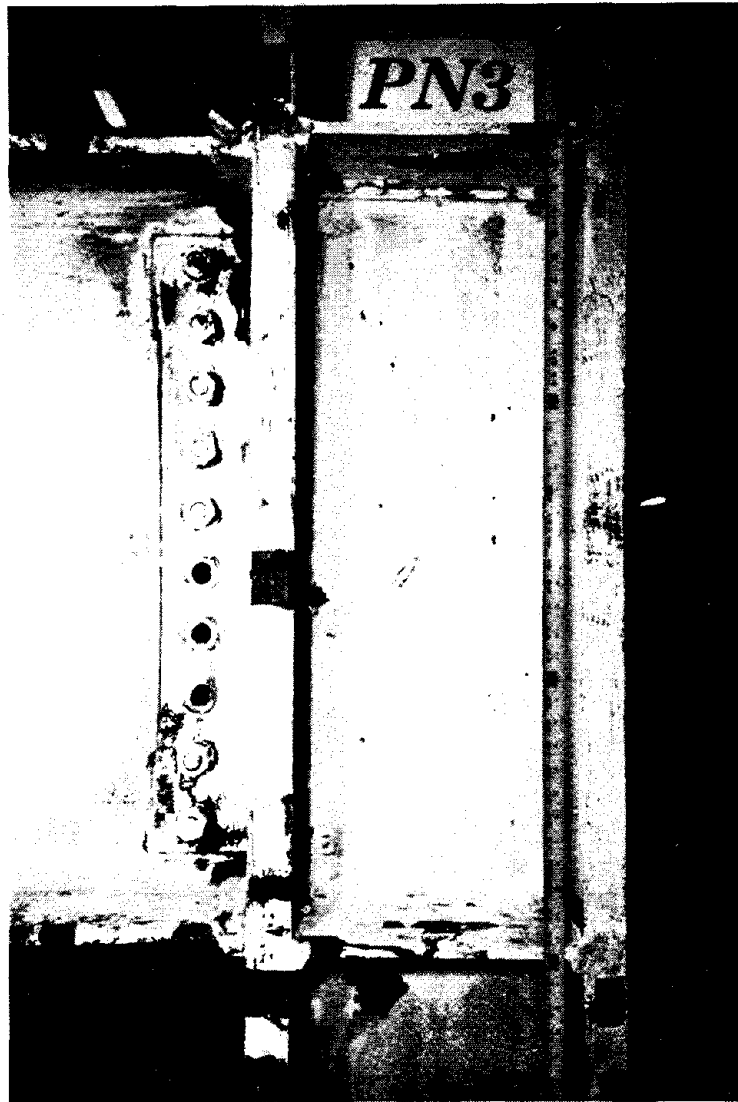
Figure 3-27. Specimen PN3 Joint after Test
