SEISMOLOGICAL AND ENGINEERING ASPECTS OF THE 1995 HYOGOKEN-NANBU (KOBE) EARTHQUAKE

REPORT NO.
UCB/EERC-95/10
NOVEMBER 1995

EARTHQUAKE ENGINEERING RESEARCH CENTER

A reconnaissance report by
teams funded by

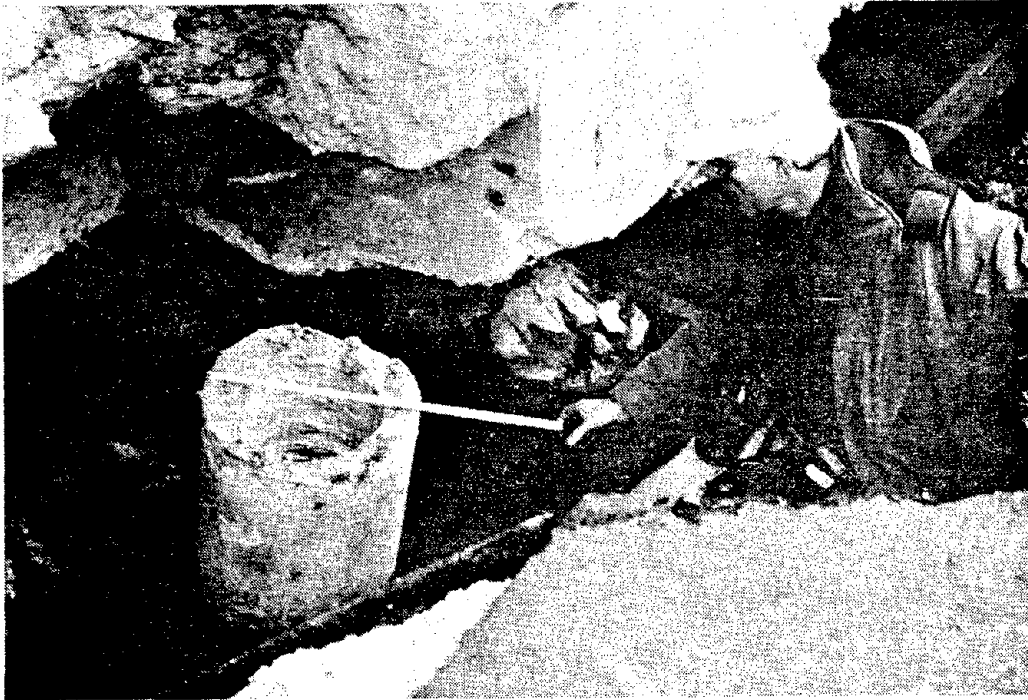
Fig. 4.6 Sheared and translated hollow tube pile.

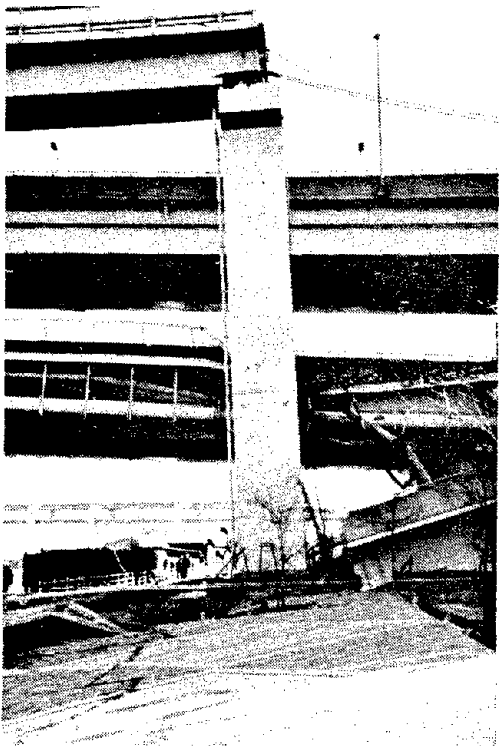
Fig. 4.7 Tilted pier of the Rokko Island causeway.

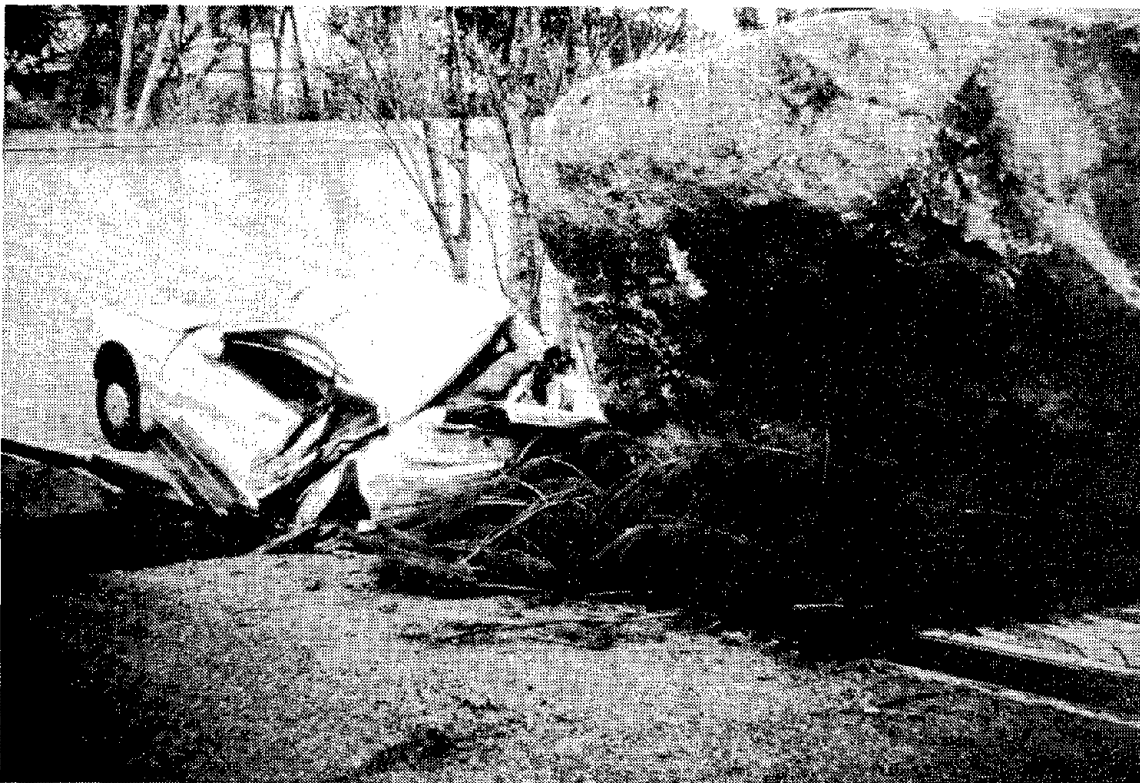
Fig. 4.17 Car crushed by a fallen boulder ~3 m in diameter.

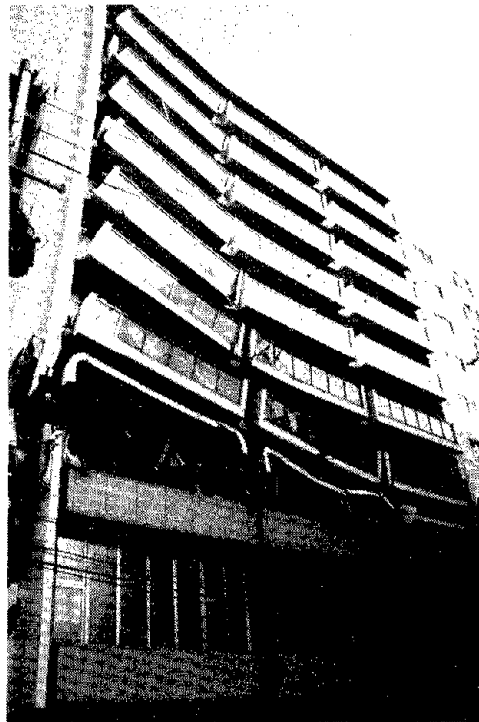
Fig. 6.59 Part-west elevation of the building shown in Figure 6.58

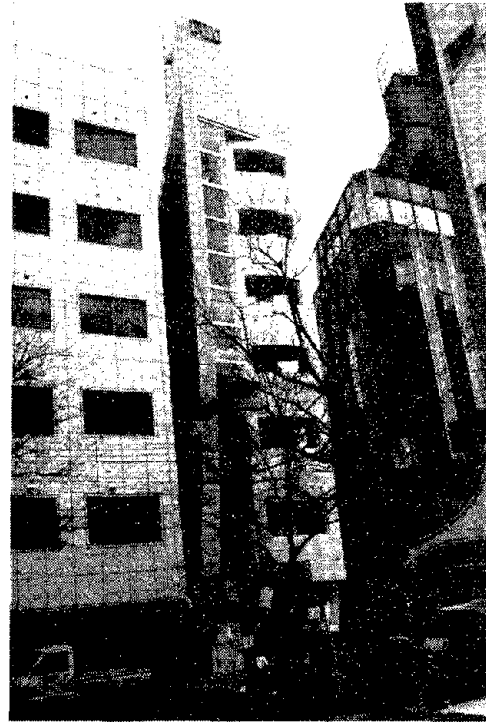
Fig. 6.101 Elevation of a high aspect ratio building

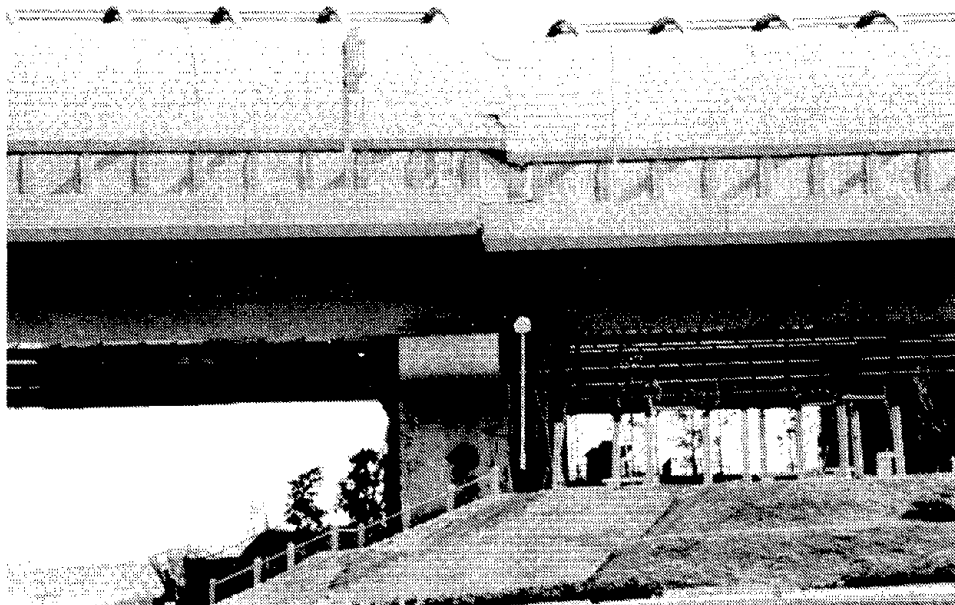
Fig. 7.22 Superstructure movement

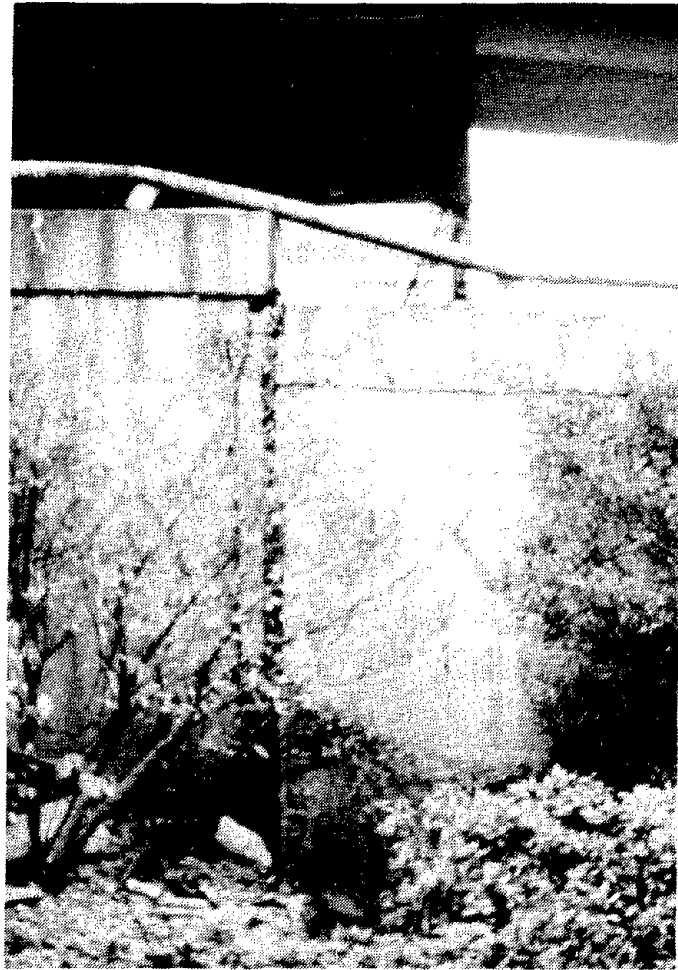
Fig. 7.34 Abutment settlement

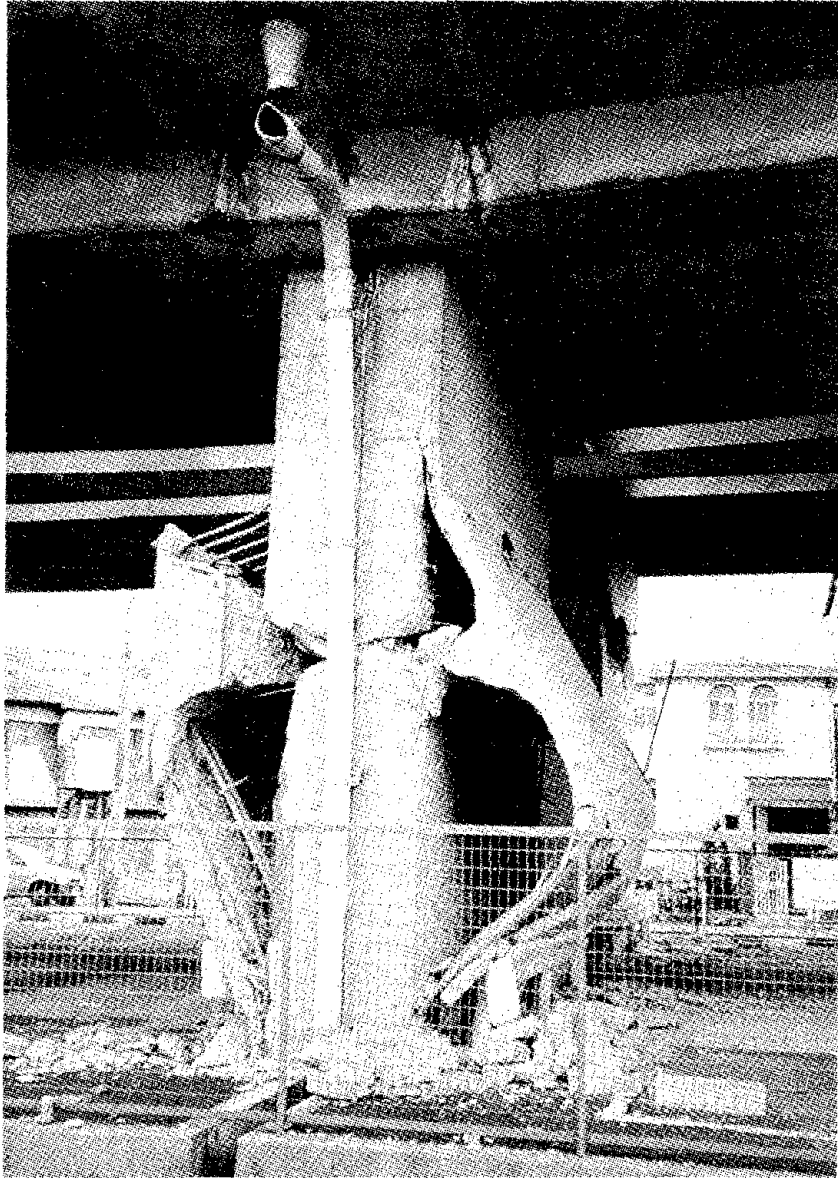
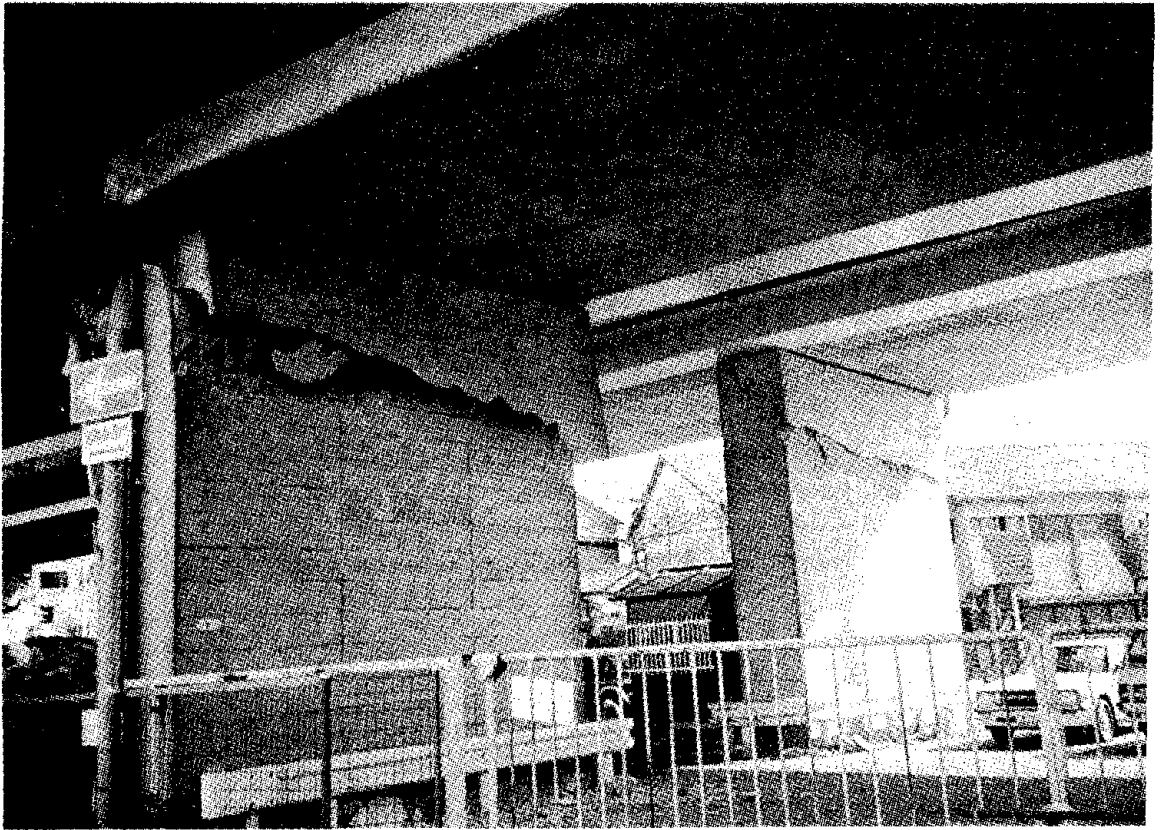
The bridges along the Meishin Highway consist of a series of relatively short span bridges supported on piers. Superstructures comprise either hollow reinforced concrete slabs or continuous steel bridges. Supports include reinforced concrete columns and wall piers. Damage was observed in columns, piers, and rocker bearings of several of the bridges. Figure 7.45 displays the typical failure modes of the Ohnishi Bridge, Suidoh Bridge, and Moribe Bridge. Ties through the wall thickness appeared to be absent, and at least in some cases the longitudinal reinforcement apparently was discontinuous near the midheight, factors which may have contributed to some of the failures. The Kawaragi-nish Bridge had 66-degree skewed supports, with pin-ended interior columns; failure included twisting in plan, span collapse, and torsional cracking of a pier wall (Figure 7.46).

Fig. 7.45 Typical failure modes of the Ohnishi, Suidoh, and Moribe Bridges [JHC, 1995]
